**AN INVESTIGATION
OF THE
INTERSTATE 80 RUTTING
IN
ADAIR COUNTY**

October 1983
Highway Division

**Iowa Department
of Transportation**

BY
VERNON J. MARKS
515/239-1447

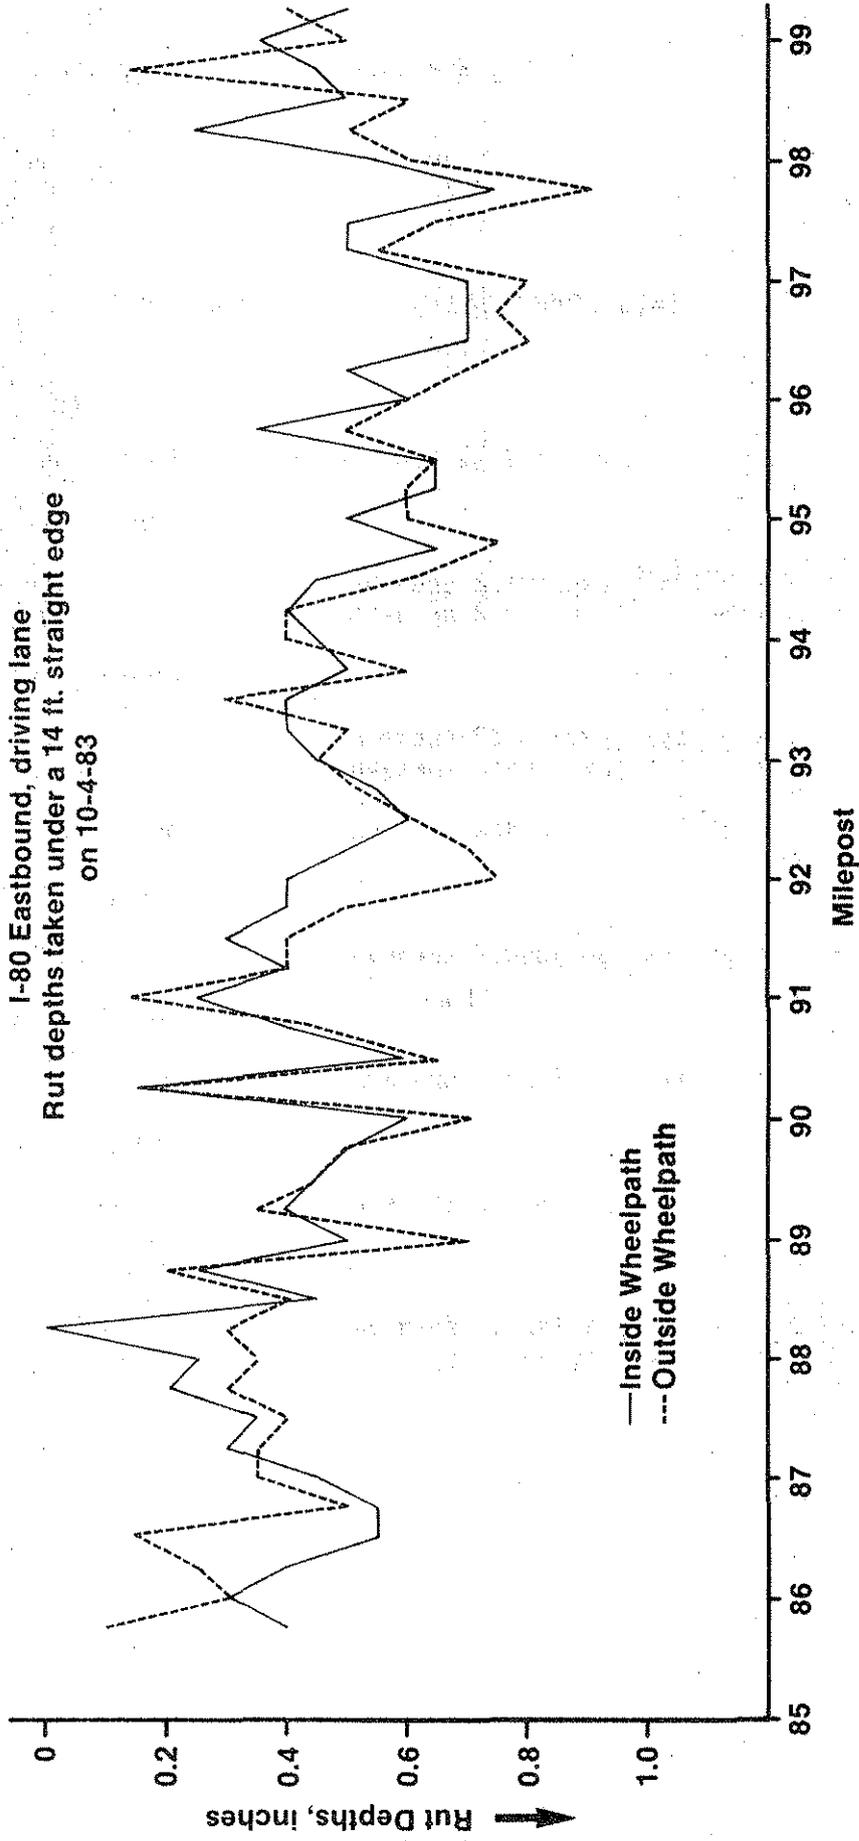
RUT DEPTHS

On October 4, 1983, cross sections of the driving lane of the eastbound roadway of Interstate 80 were taken at all milepost markers between MP 86 and MP 99 and at 1/4 of a mile increments between mileposts. These cross sections were taken utilizing a 14' straightedge. One end of the straightedge was placed at the centerline of the eastbound roadway, with the other end extending onto the outside shoulder. Measurements were taken at every low point and every high point across this outside lane. Rut depths of both the inside and outside wheelpaths were determined from plotted cross sections using these measurements. The rut depths varied from 0 to 0.9 inches (Appendix D-2, D-3 and D-4). Most of the roadway exhibits rutting in excess of 0.2". The general trend is for the rutting

to increase from a value of approximately 0.3" at MP 88 to a rut depth of approximately 0.7" at MP 98. Milepost 96.0 and 97.75 were selected as being exceptionally bad areas for further investigation. A cross section of a severely rutted section is plotted in Appendix D-5.

I-80 Eastbound, driving lane
Rut depths taken under a 14 ft. straight edge
on 10-4-83

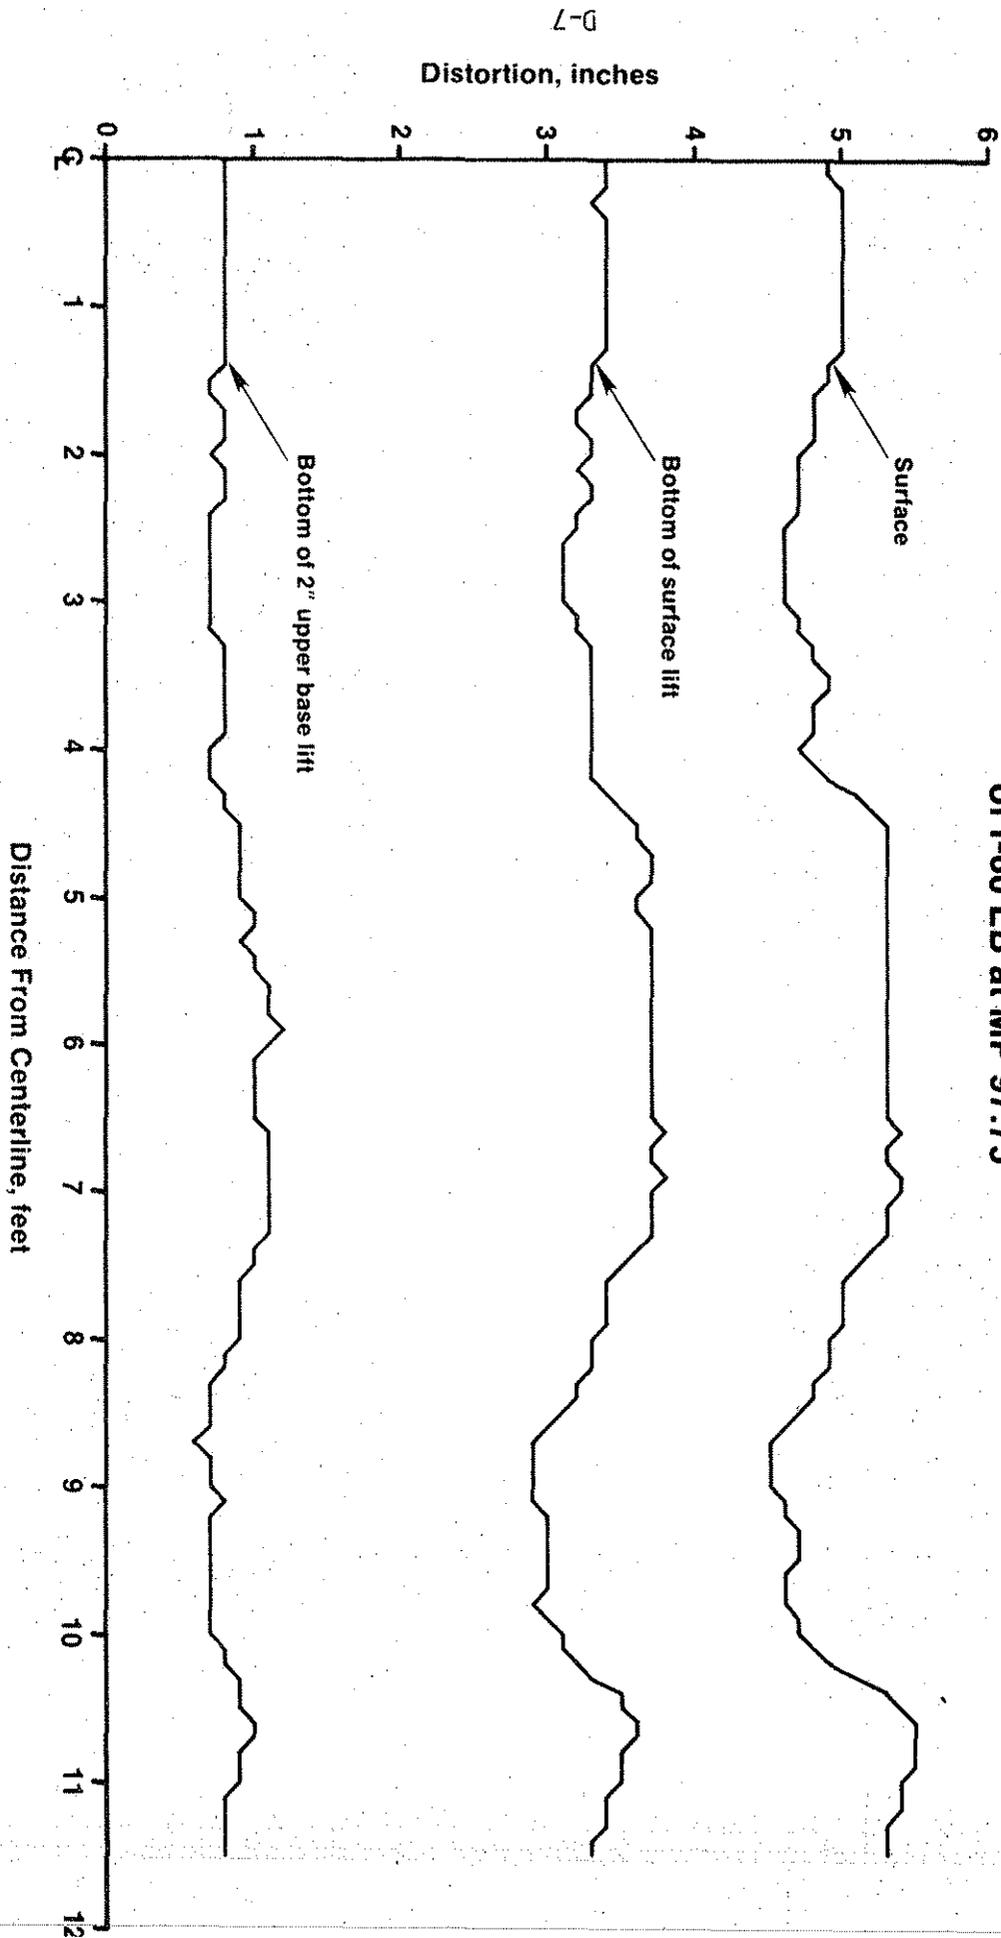
**A CROSS SECTION PLOT
OF THE SURFACE AND LIFT INTERFACES
OF THE TOP TWO LIFTS
of I-80 EB at MP 97.75**

The wheel saw was used to obtain two transverse pavement sections. One was taken near MP 96.0 and the other near MP 97.75. Two cuts were made leaving a section approximately 12" wide. Within this 12"-wide section, a diamond saw cut was made near one wheel saw cut. These cuts were made on October 7, 1983, and the resulting pavement sections were transported to Ames on October 10, 1983. Using cross sections obtained at these locations prior to the use of the wheel saw, these sections were restored to proper alignment in the central laboratory. The lines denoting the various lifts are readily apparent in the diamond cut. Severe distortion is noted in the line at the bottom of the 1-1/2" surface course. Only minor distortion is noted in the line at the bottom of the 2" base course

lift. The thickness of the surface lift is very uniform (Appendix D-7) indicating that the majority of the distortion is in the 2" upper base lift.

From the pavement sections it was apparent that the 2" upper base course did not exhibit satisfactory resistance to deformation from traffic and the majority of the rutting resulted from distortion of that lift. The core analysis indicates asphalt contents in the 2" upper base course in excess of the intended amount and confirms the asphalt content indicated by mix samples at time of construction.
