# **Evaluation of Deterioration on US 20 in Webster County**

**Final Report  
for  
MLR-91-1**

Final Report  
for  
Iowa DOT Project MLR-91-1

By  
Kevin Jones  
Cement and Concrete Engineer  
515-239-1649

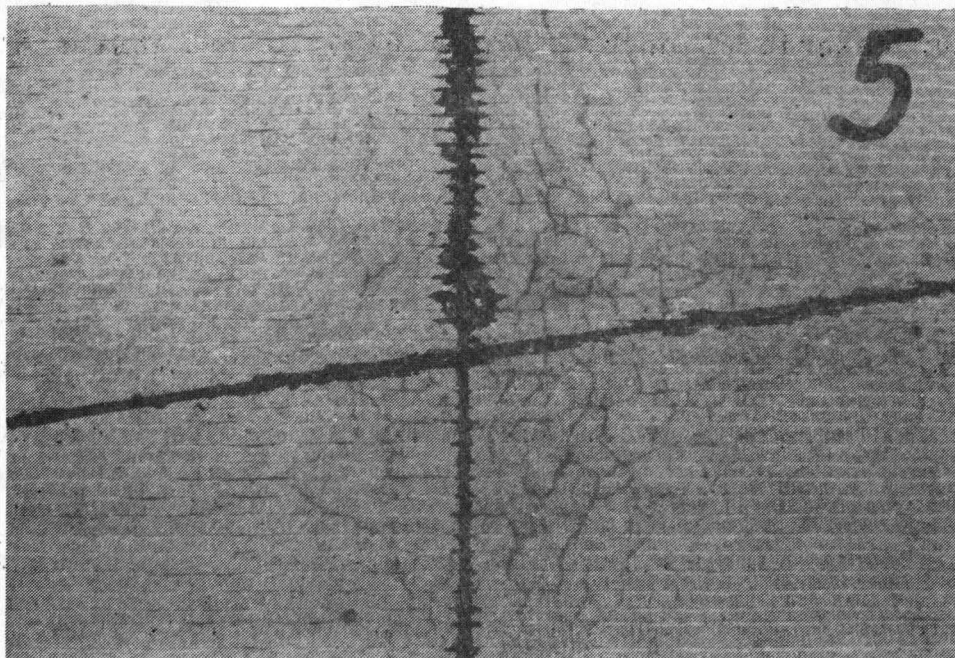
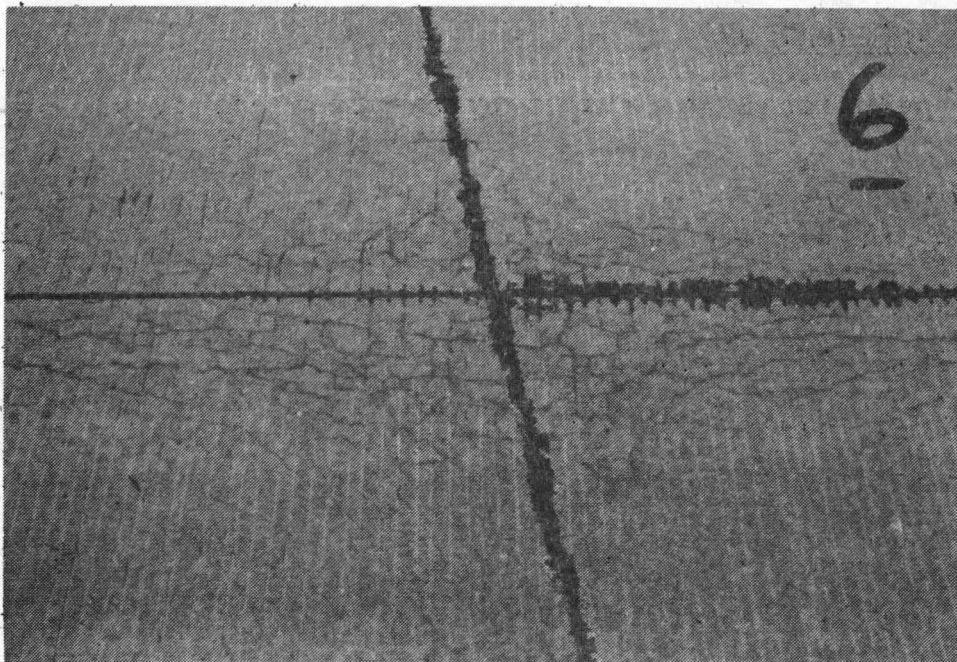
Minor deterioration of U.S. Highway 20 in Webster County was noticed in May, 1990. Any deterioration was unexpected, since the road was just constructed in 1986 and 1987. The appearance of several joints was similar to the staining and cracking associated with D-cracking, Figure 1. A class 3 durability stone not associated with early D-cracking was used on the project.

Figure 1  
Joint Deterioration on Pavement Section Placed 4-27-87  
Sta. 2065 to Sta. 2087 WB

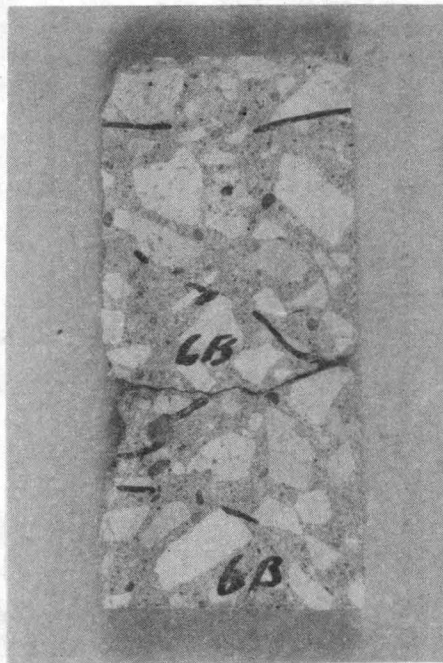
Figure 2  
Vertical Sawed Sections From Cores Showing Distress  
(Cracks have been highlighted for better visibility)

Sta. 2271+40 EB  
Taken at outside wheel path next  
to transverse joint

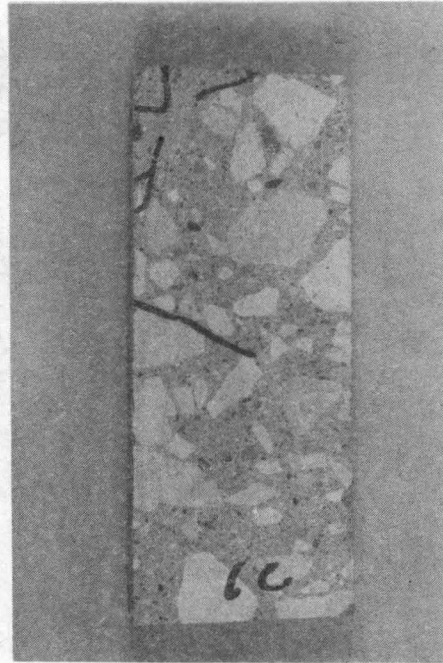
Sta. 2271+35 EB  
Taken at outside wheel path  
at mid panel

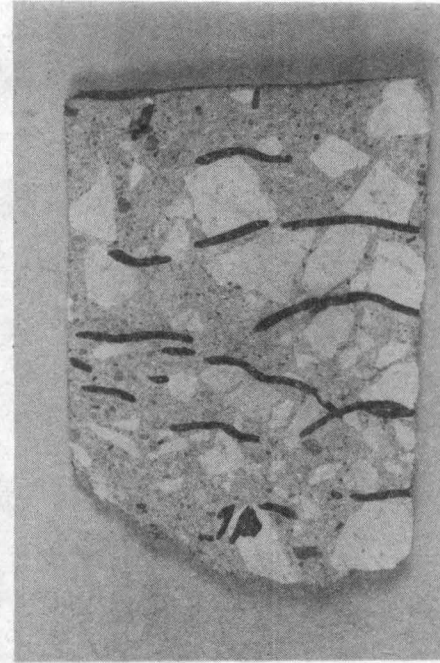
Sta. 2271+80 EB  
Taken at outside wheel path next  
to transverse joint

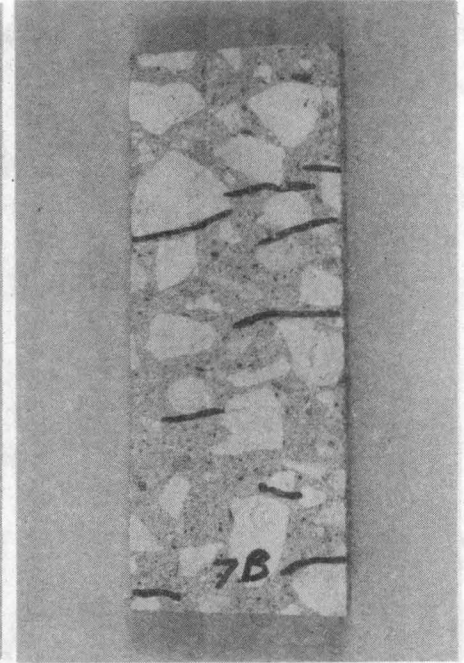
Sta. 2271+80 EB  
Taken at outside wheel path next  
to transverse joint

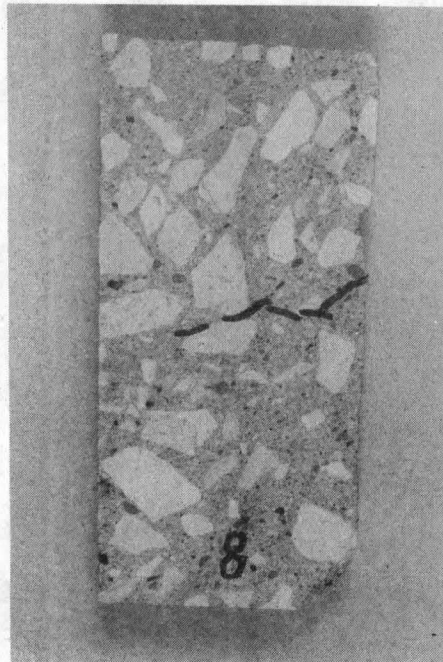
Sta. 2271+90 EB  
Taken at outside wheel path  
at mid panel

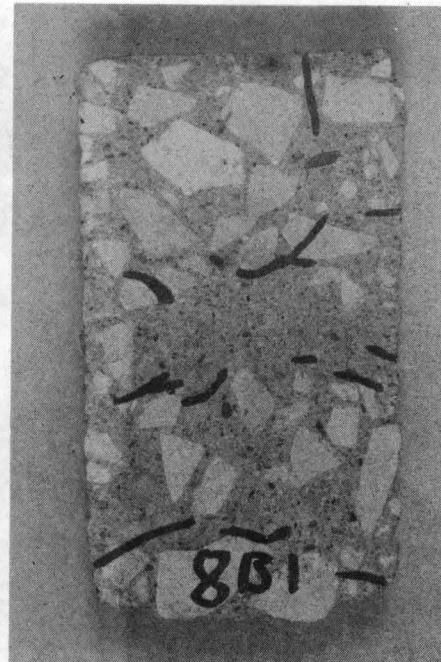
Sta. 2272+00 EB  
Taken at outside wheel path next  
to transverse joint

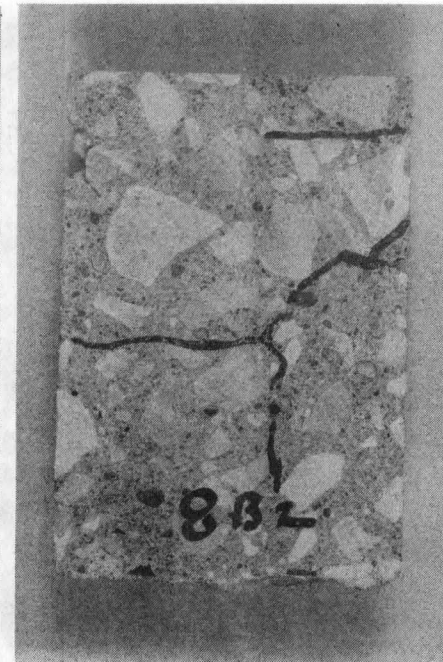
Sta. 2272+00 EB  
Taken at outside wheel path next  
to transverse joint

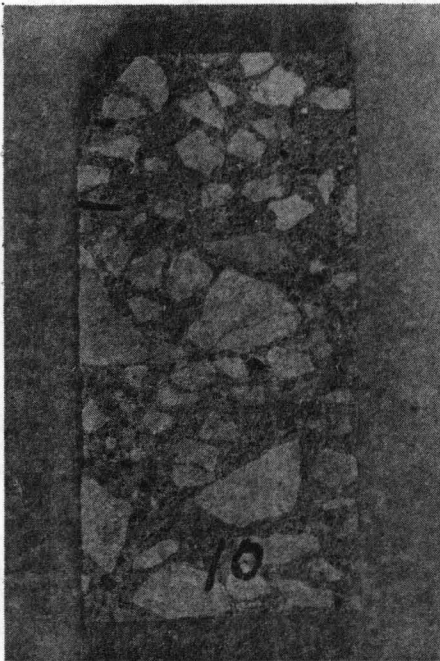
Sta. 2300+10 EB  
Taken at outside wheel track  
at mid panel

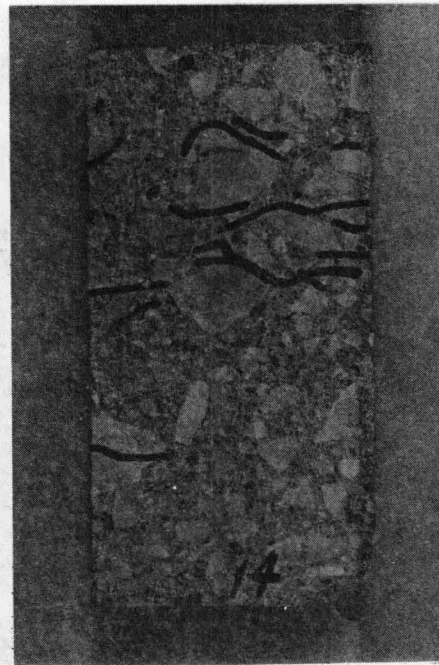
Sta. 2105+05 WB  
Taken near intersection of  
transverse and longitudinal joints

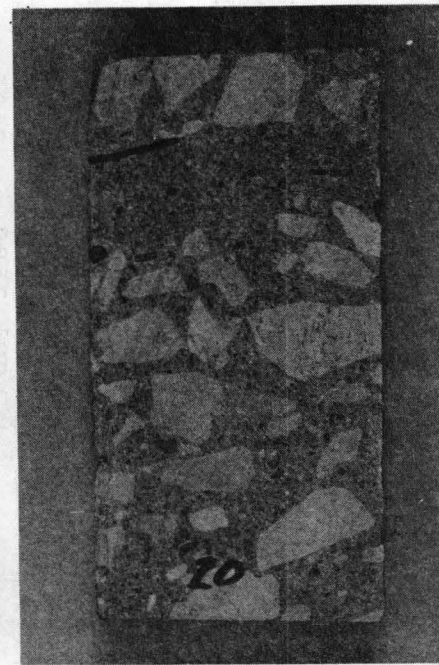
Sta. 27+20 WB  
Taken near intersection of  
transverse and longitudinal joints

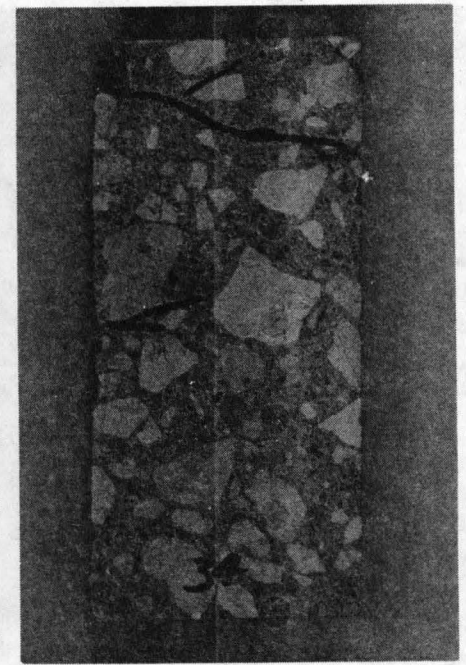
Sta. 2280+ EB  
Taken at intersection of  
transverse and longitudinal joints
