Longitudinal Joint Forming In PCC Pavements

Construction Report for MLR-00-05

June 2003

Highway Division

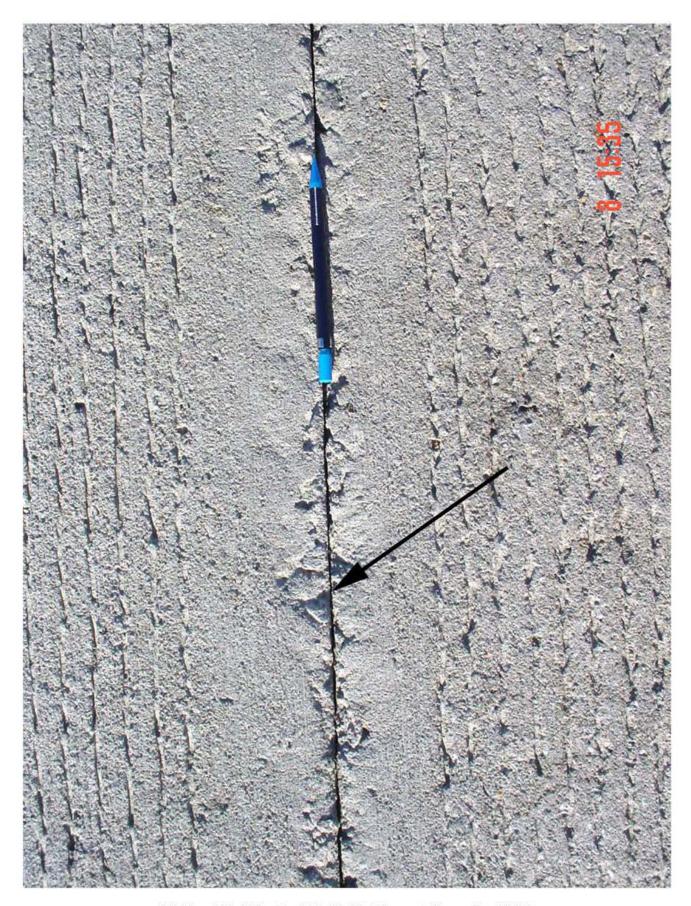
01) Hwy 218, NBL, Sta 838+50, Mt. Pleasant, Henry Co. 1/8/03 Open formed joint left by wide knife.

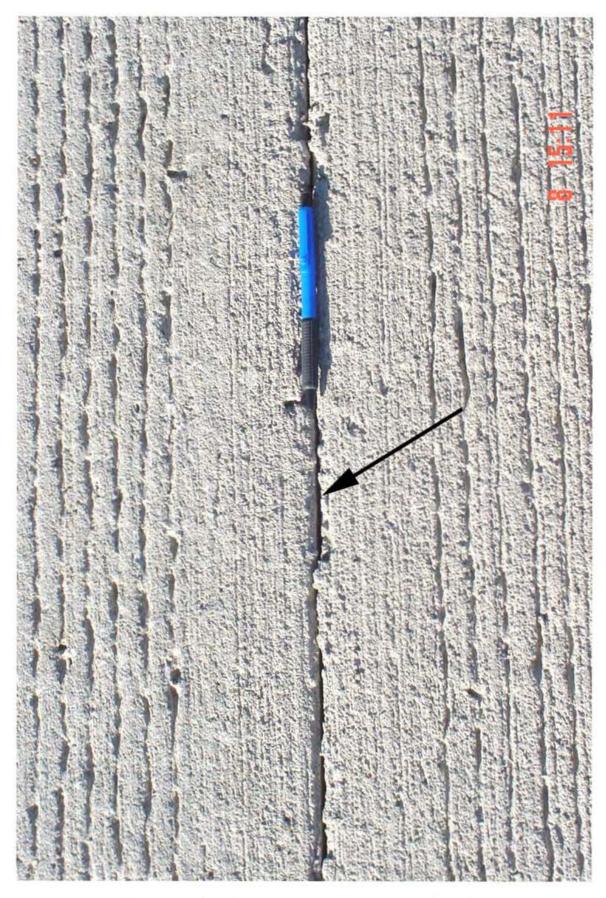
02) Hwy 218, SBL, Sta 863+37, Mt. Pleasant, Henry Co. 1/8/03 Open formed joint left by wide knife.

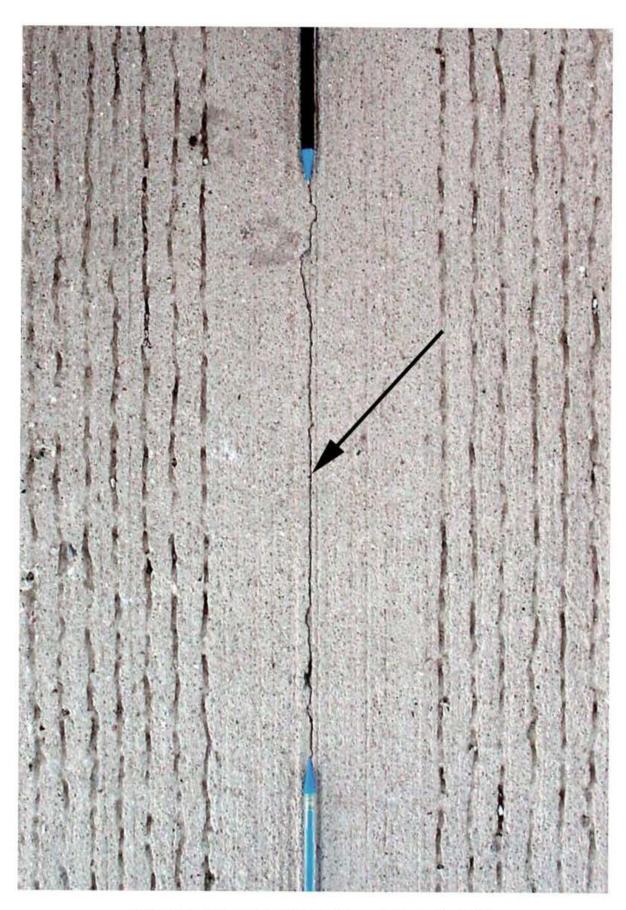
03) Hwy 34, EBL, Sta 255+85, Mt. Pleasant, Henry Co. 1/8/03 Formed joint hairline crack.

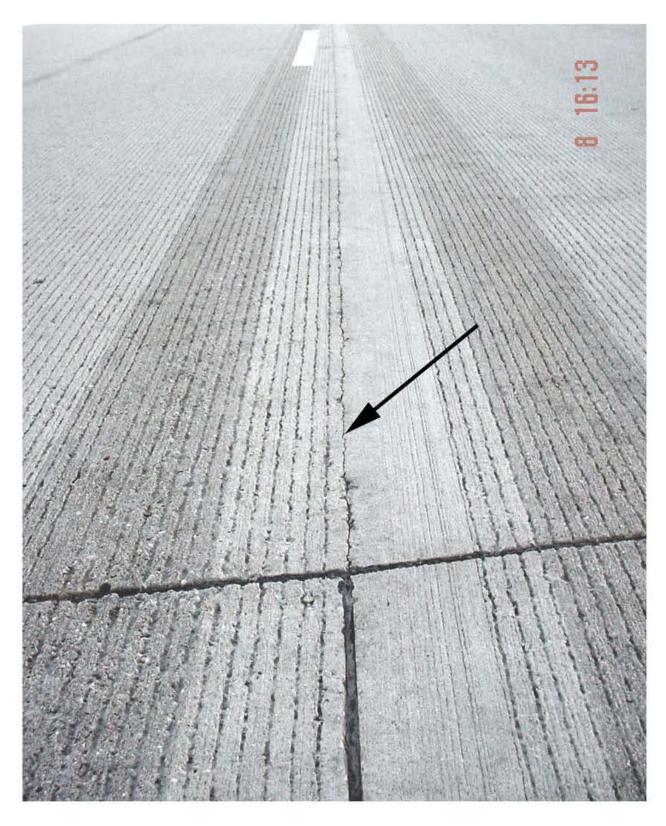
04) Hwy 218, NBL, Sta 905+20, Mt. Pleasant, Henry Co. 1/8/03 Beginning of formed joint test section.

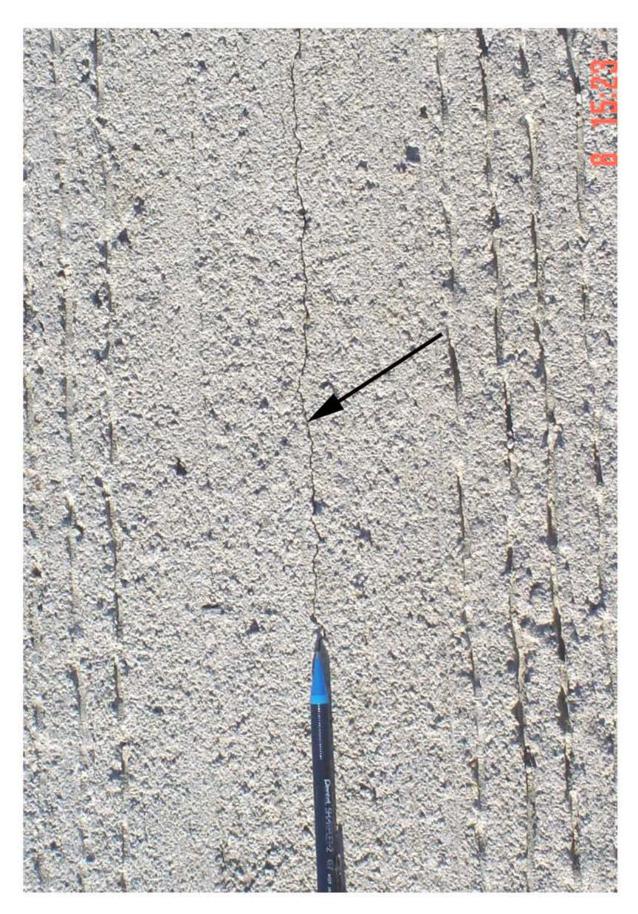
05) Hwy 218, SLB, Sta 853+00, Mt. Pleasant, Henry Co. 1/8/03 Formed joint hairline crack.

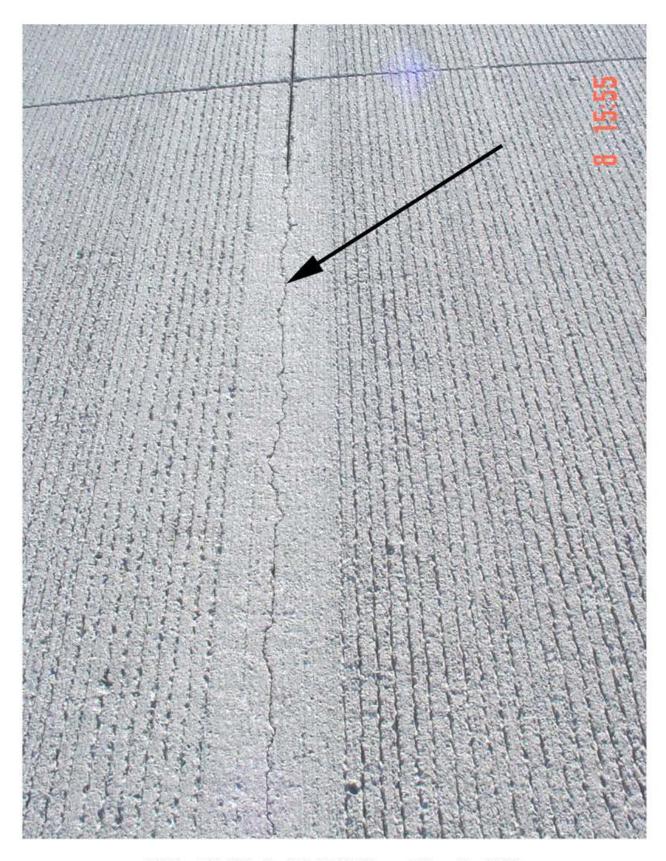
06) Hwy 218, NBL, Sta 853+21, Mt. Pleasant, Henry Co. 1/8/03 End of formed joint test section.

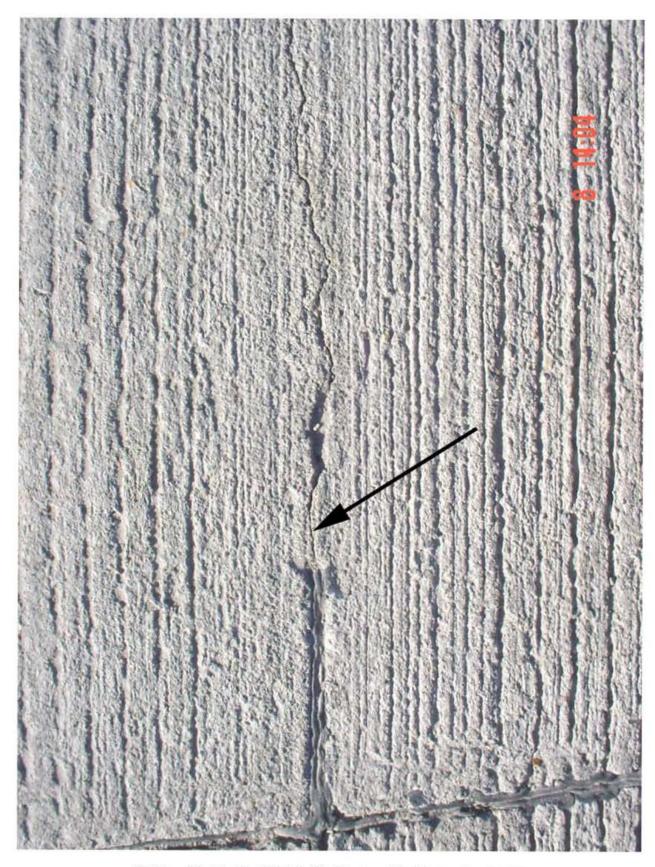
07) Hwy 92, CL, Sta 280+24, Washington, Washington Co. 1/8/03 Beginning of formed joint test section.

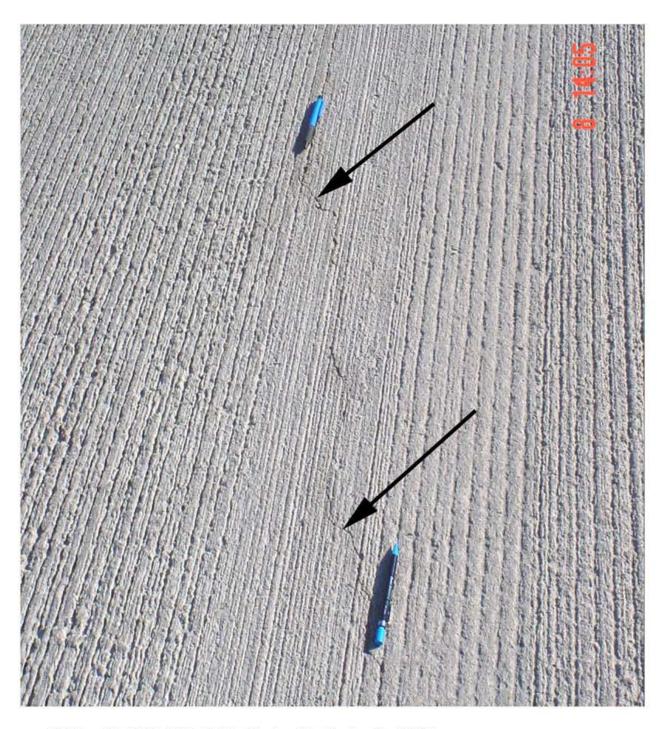
07) Hwy 92, CL Sta 280+06, Washington, Washington Co. 1/8/03 Random crack, 8' long, at beginning of joint test section.

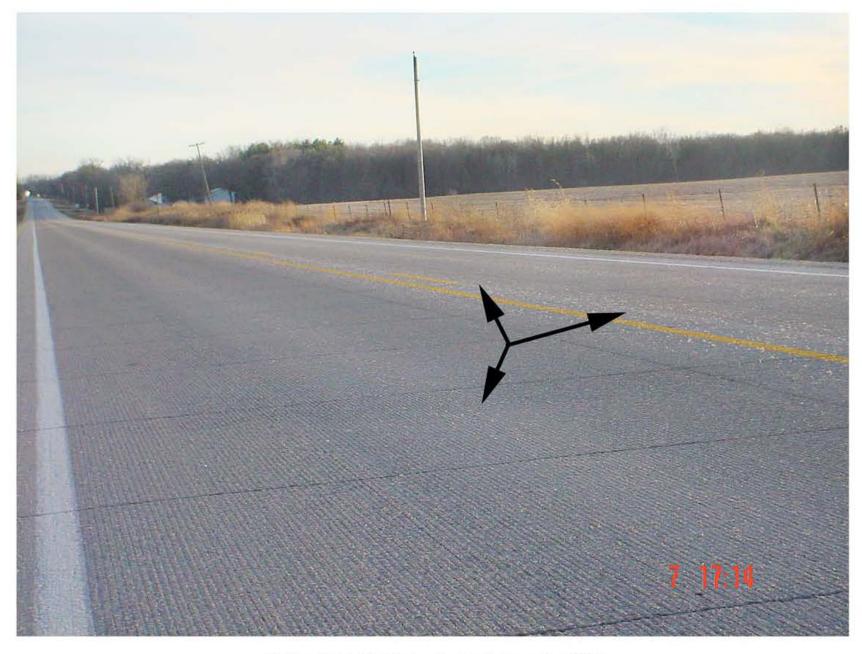
Paver pan / knife left slight surface depression 5' from shoulder.

08) Hwy 13, Sta 85+00, Manchester, Delaware Co. 1/7/03 Formed Joints 5 feet from each shoulder. Note white tips of fibers in the PCC.

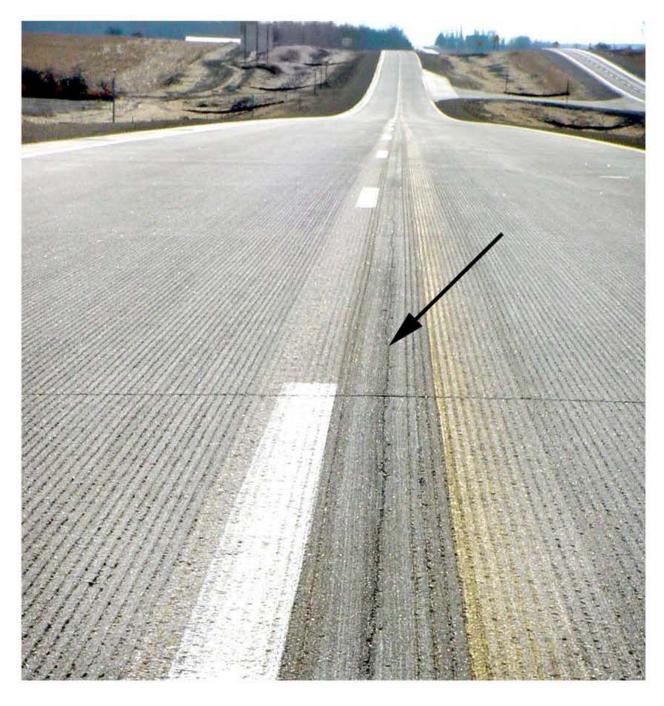
: In some sections of this test site the base was very soft or unstable at paving time. (Is this related to wide cracks in some places in the longitudinal joint?) (Is the slab shifting?) (Are tie

09.1) Hwy 63, NBL, Sta 54+00 (M.P. 195+95), New Hampton, Chickasaw Co. 1/7/03 Formed longitudinal joint.

Knife should be more forward giving more time for floating pan to smooth out roughness.

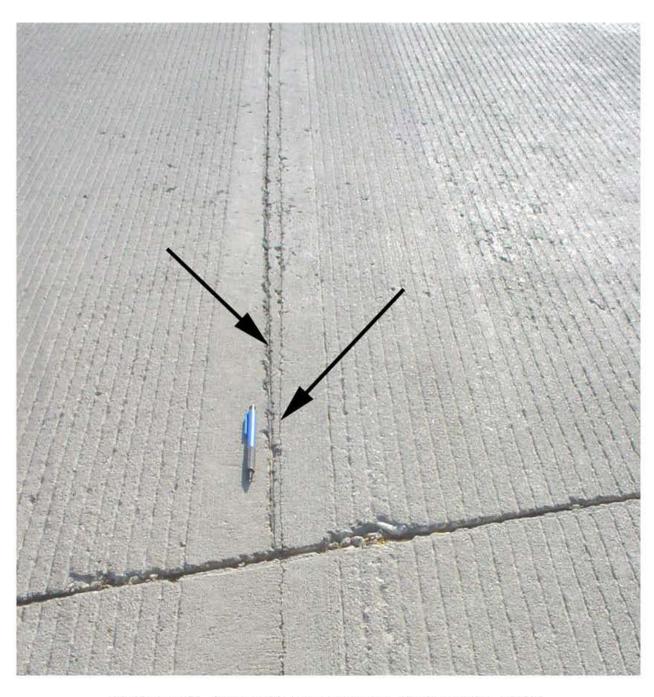
09.2) Hwy 63, Sta 74+00, New Hampton, Chickasaw Co. 1/7/03 Formed joint plus sawed joint at beginning of test section.

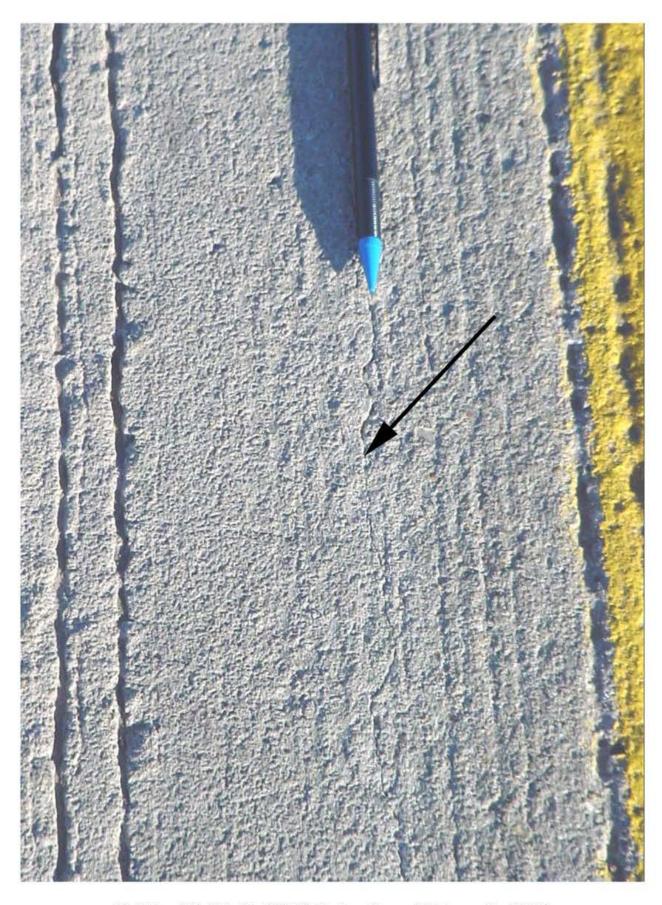
10.1) Hwy 218, SBL, Sta 386+00, Nashua, Bremer/Chickasaw Co. 1/7/03 Formed joint hairline crack.

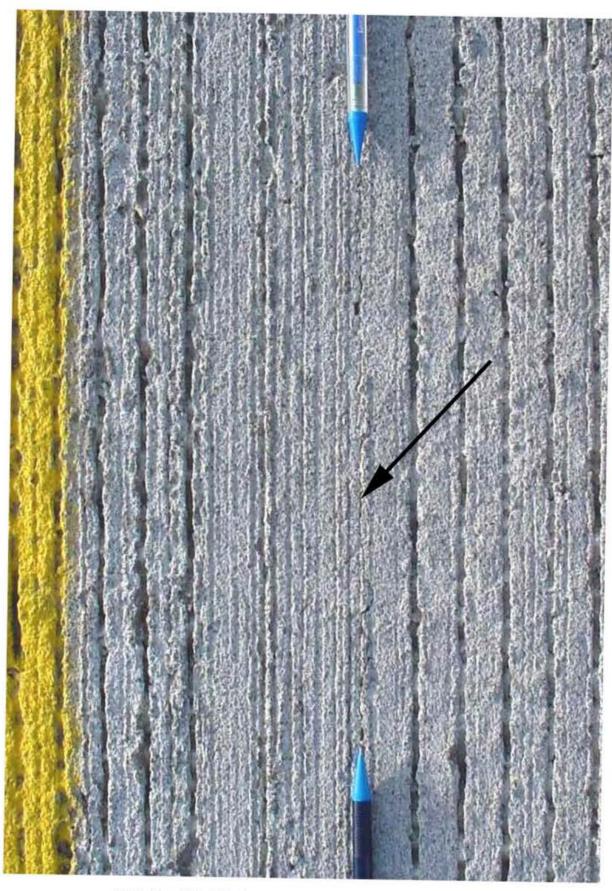
11.1) Hwy 151, SBL, Sta 383+00, Monticello, Jones Co. 1/8/03 Formed joint hairline crack.

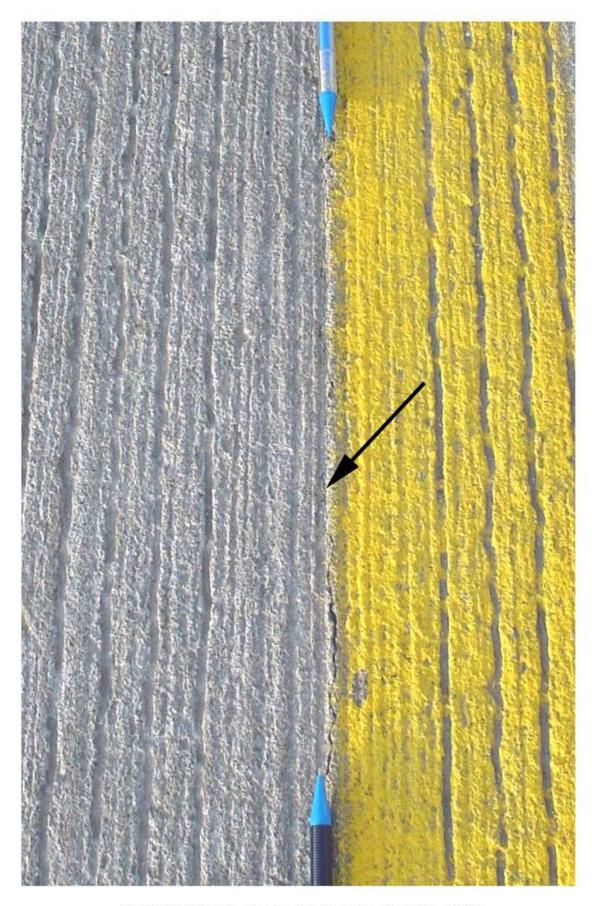
11.2) Hwy 151, SBL, Sta 428+00, Cascade, Jones Co. 1/8/03 Formed joint hairline crack.
