Evaluation of PCC Specification Changes Impact on Durability: 1992 to 1997 Core Study

Final Report
for
MLR-98-06

March 2005

Highway Division

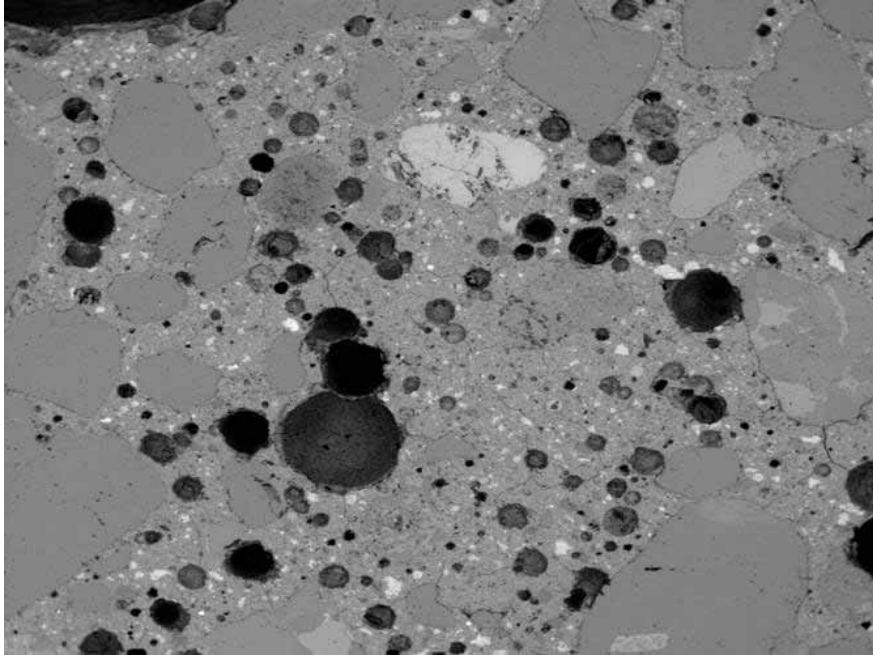
X-ray mapping was performed on selected images in 1998 and again in 2003. Infilling can be seen on images (Figures 8 and 9), but X-RAY mapping gives a better indication. (Figures 10 and 11) Elements were selected for detection based on their occurrence in certain materials that relate to a mode of deterioration such as ettringite, ASR, and brucite. Al and S were scanned due to their presence in ettringite. Si, Na, and K were scanned due to their presence in ASR gel. Mg was scanned due to presence in brucite.

Figure 8. Image of Clean Air Void System

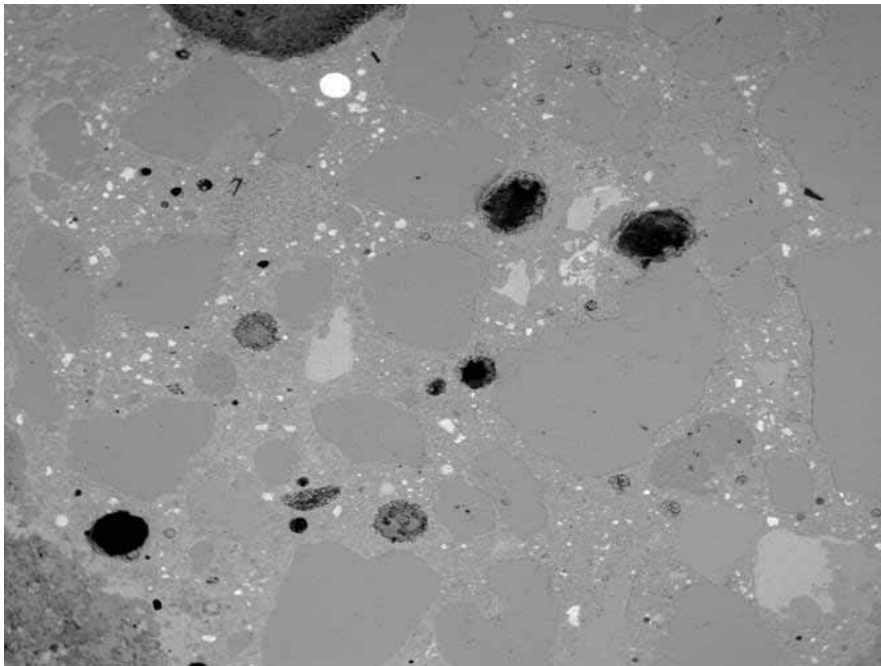
Little or no ASR or brucite was detected in any of the projects selected. The main element detected was Al and S in the air voids. It was assumed that the presence of Al and S related to presence of ettringite. Projects were ranked on a scale of 1 to 10, according to their relative presence of ettringite in the air voids. A rating of 10 means the air voids are completely clean and a rating of 1 means the air voids are completely full of ettringite. The ranking of infilling by project can be found in Table 6 of the Appendix.

The 1992 projects had much more infilling than the 1997 projects in 1998 and in 2003. The top of the 1992 projects indicated more infilling when the air content was less than 4.5%. In the 2003 study, the 1997 projects indicated some minimal infilling in the bottom of the cores. At the location of higher moisture areas infilling is increased. In the top of the 1992 cores with low air, freeze thaw damage has occurred allowing an increase in moisture and thus increased infilling. The bottom of all pavements are in high moisture areas and thus indicate some infilling although it is much less than the top of the 1992 projects.

Figure 9. Image of Infilled Air Void System

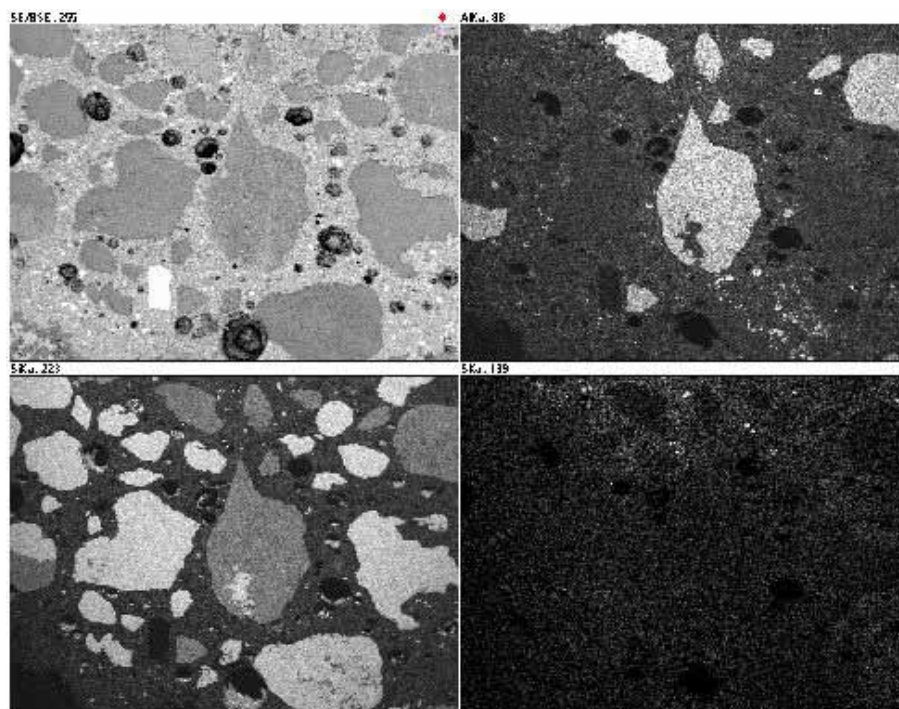
Figure 10. XRF Scan of Clean Air Void System (Note Sulfur (S) scan lower right - no highlighted areas)

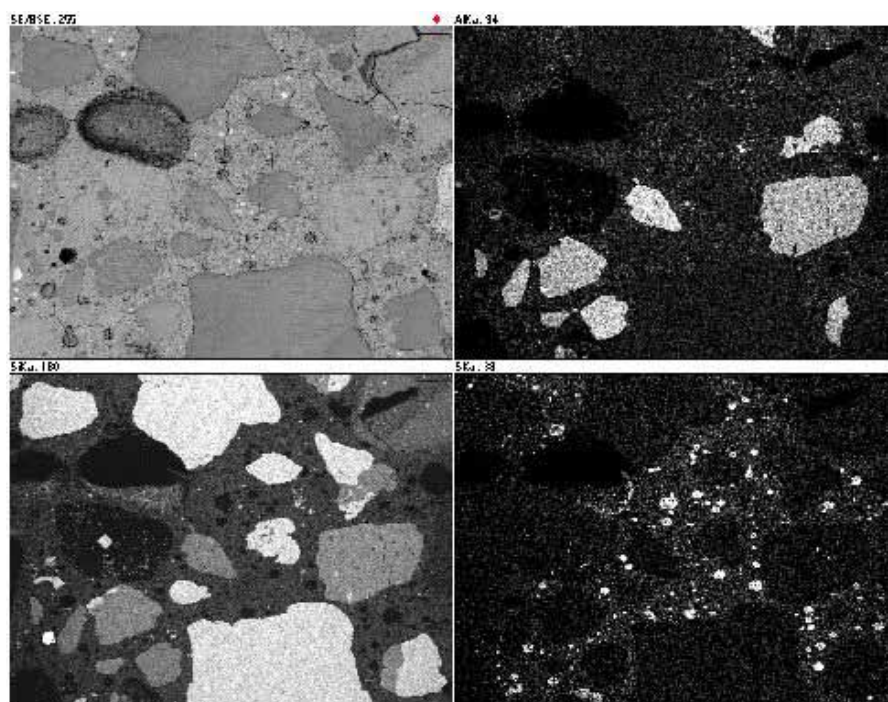
Figure 11. XRF Scan of Infilled Air Void System (Note Sulfur (S) scan lower right - highlighted areas)
