IOWA STATE HIGHWAY 92 OVER DRAINAGE DITCH #25

Performance Evaluation Galvanized Reinforcing Bars

Louisa County, Iowa

June 15, 2015

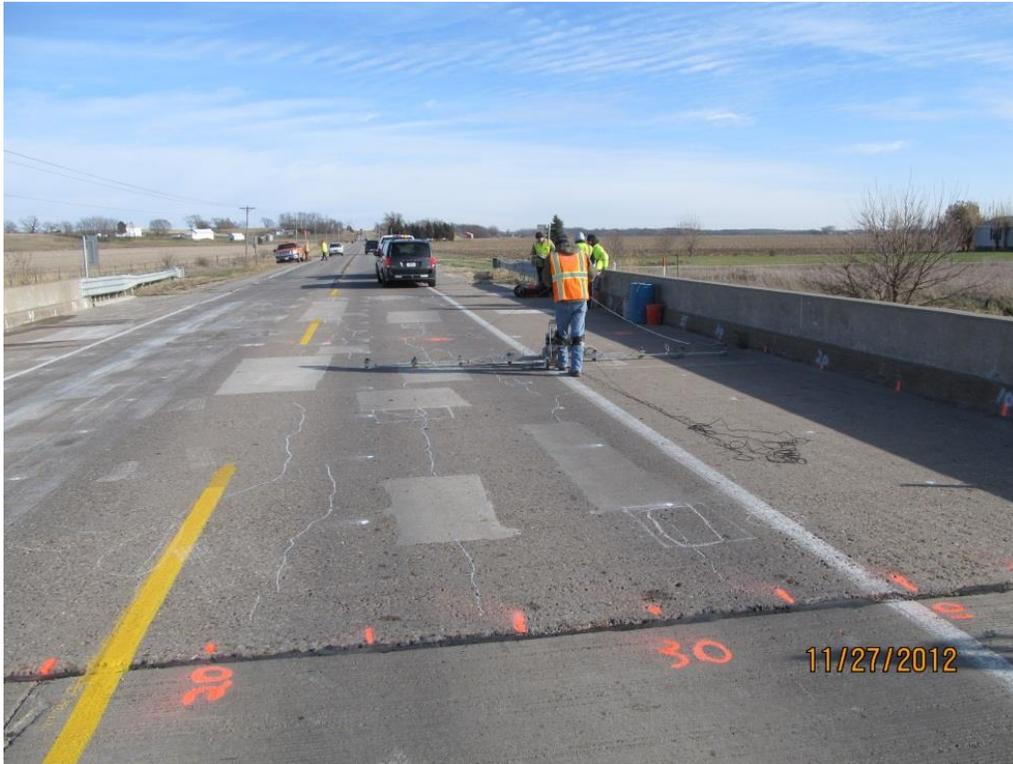
Overall photos of the deck top surface are shown in Figures 3.1 and 3.2. The deterioration noted during the visual and delamination surveys is presented on the plan drawings in Appendix A.

Figure 3.1. Overall view of eastbound lane of bridge, looking east. Chalk lines indicate cracks and delaminations identified by survey.

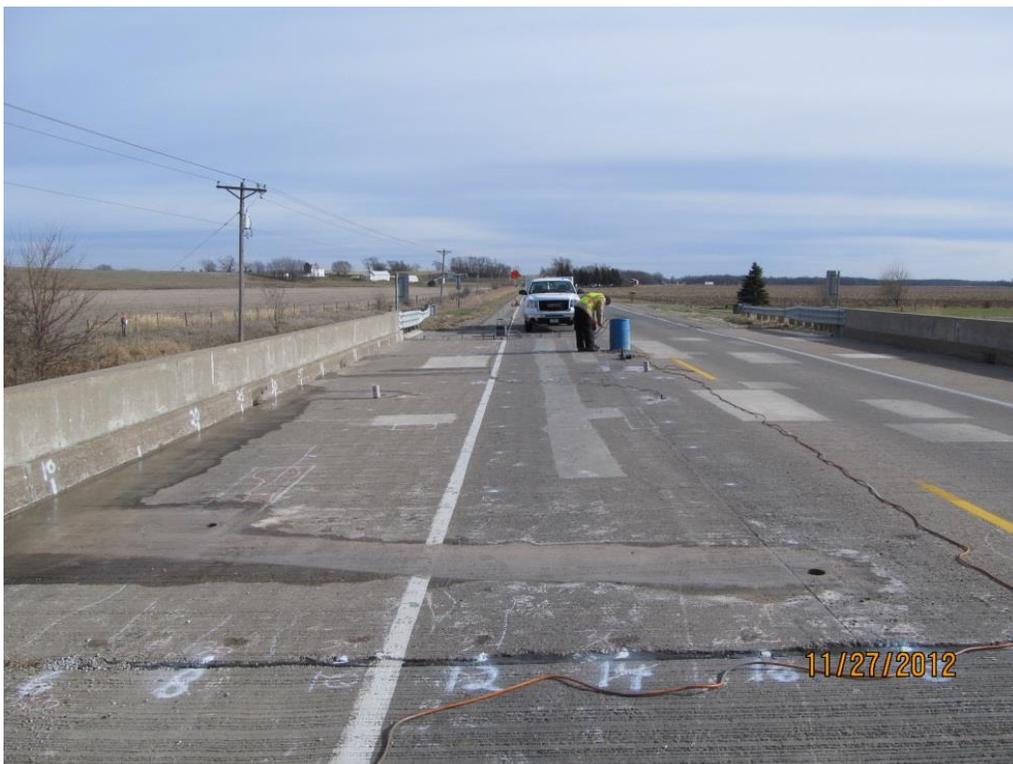
Figure 3.2. Overall view of westbound lane of bridge, looking east. Chalk lines indicate cracks and delaminations identified by survey.

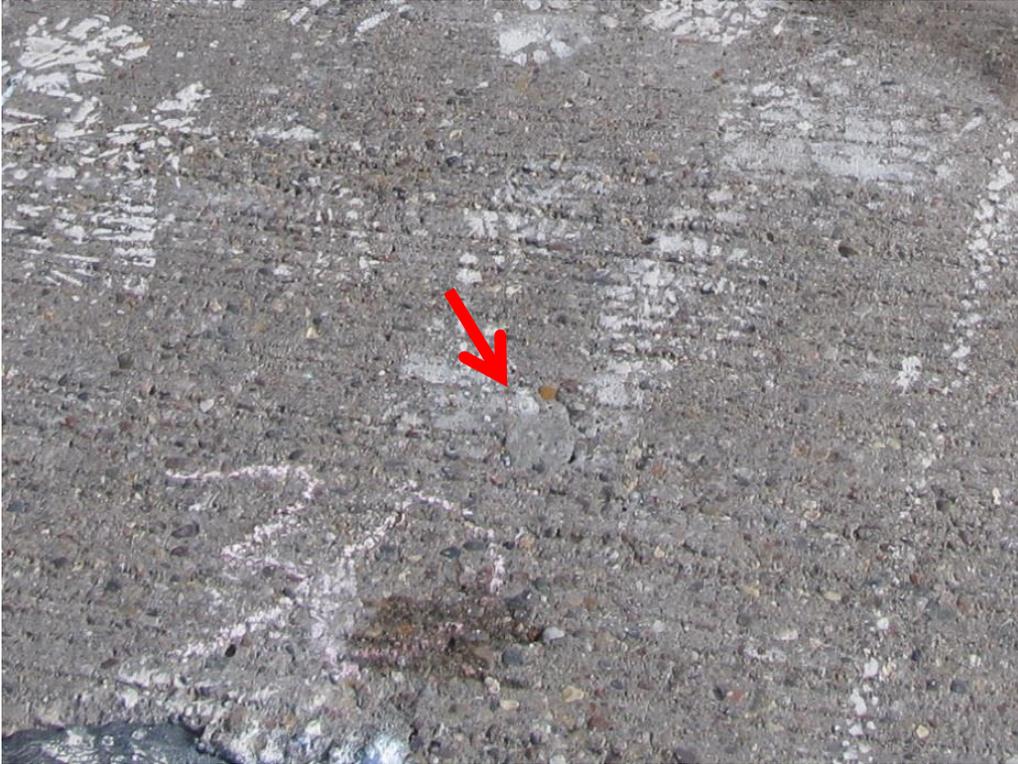
The patch repairs were generally distributed uniformly across the deck surface. One long, relatively narrow (approximately 24-inch wide) repair was present at the location where the temporary barrier rail had been installed during the original construction. It is unclear whether this repair was performed to address corrosion-related distress, but it is likely that the repair was prompted at least in part by the anchor holes for the barrier rail. These holes were partially filled with grout where they remained (see Figure 3.3).

Figure 3.3. Patched rail anchor hole at west end of westbound lanes.

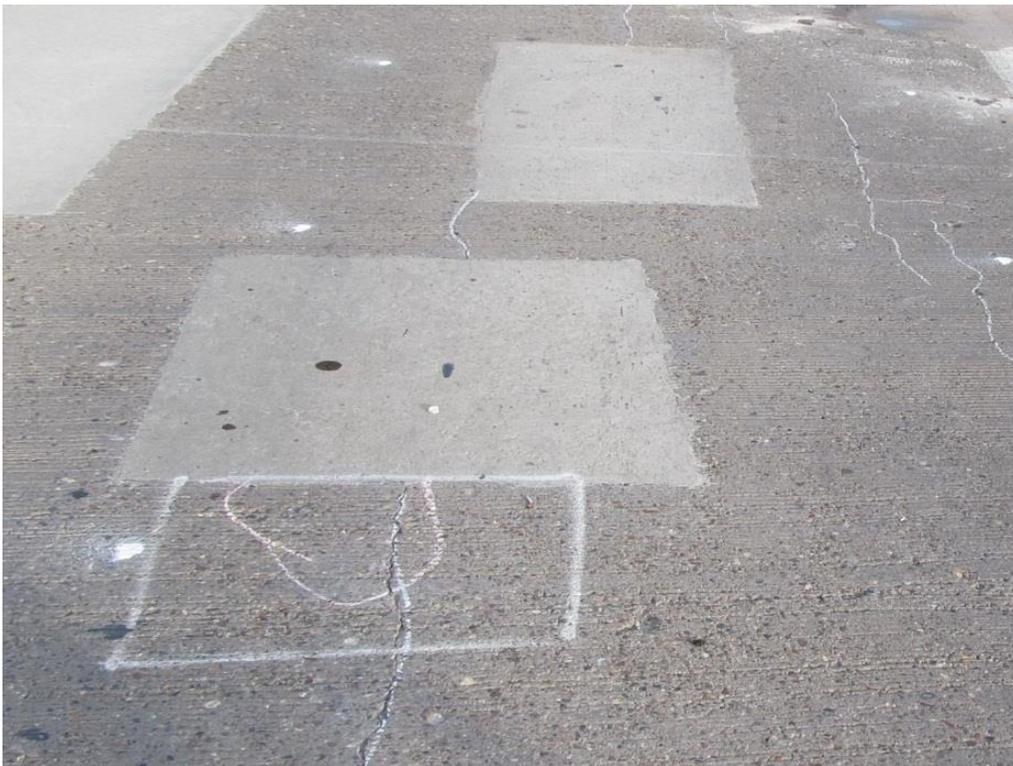
With one exception, the patch repairs were generally sound. Many of the new delaminations were located immediately adjacent to these repairs, and likely resulted from the “halo” or “ring anode” effect, a process by which corrosion of embedded reinforcing immediately adjacent to concrete repairs is accelerated by locally large differences in the internal concrete environment at the perimeter of the patch repairs. An example of a new delamination along a crack and adjacent to an existing repair is pictured in Figure 3.4.

Figure 3.4. Delamination marked in pink chalk and proposed repair location marked in white paint adjacent to previous patch repair.

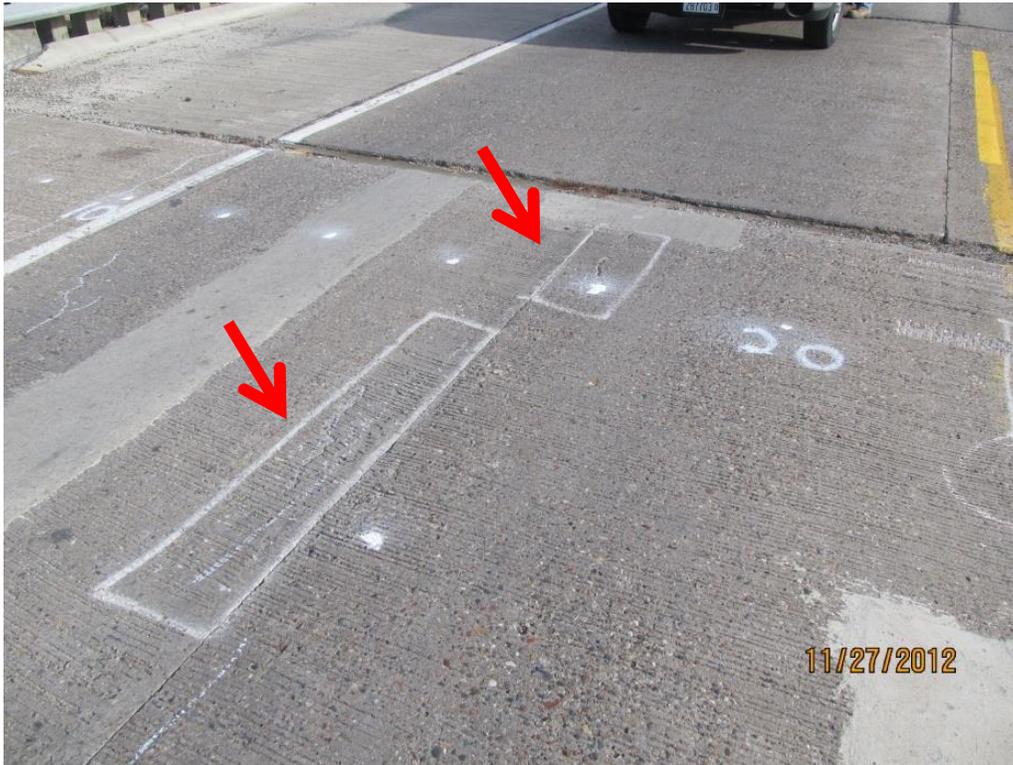
Three of the areas located adjacent to the construction joint marked by IaDOT for repair as part of the 2013 rehabilitation showed cracking distress (see Figure 3.5), but were not identified as delaminated during WJE’s survey. The cause of this distress is uncertain, but may be related to differential movement between the north and south portions of the deck, or freezing of water trapped in the construction joint.

Figure 3.5. Repair areas marked by IaDOT associated with cracking adjacent to construction joint, but not identified as delaminated.

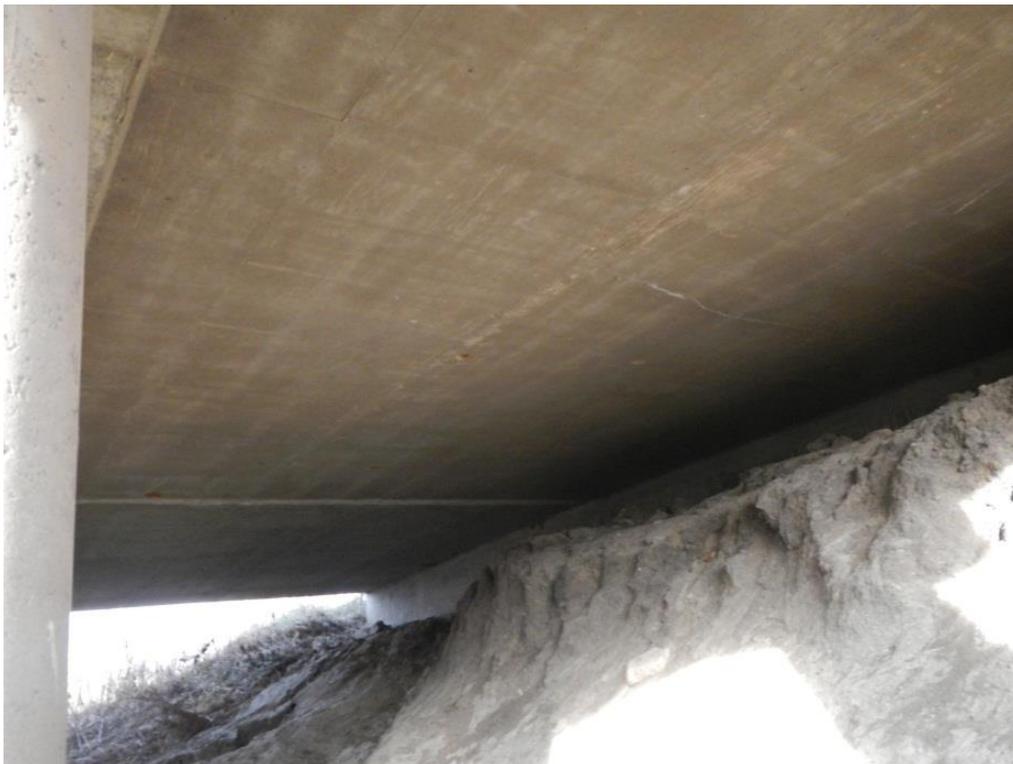
The underside of the deck is generally in very good condition, as can be seen in Figures 3.6 and 3.7. While some signs of efflorescence were present at the construction joint and at some other cracks, indicating moisture passing through the thickness of the deck, only a few through-deck cracks were observed. No underside spalls were identified, and the only moisture staining noted at the drain penetrations was limited to localized areas (see Figure 3.8).

Figure 3.6. Deck underside east span.

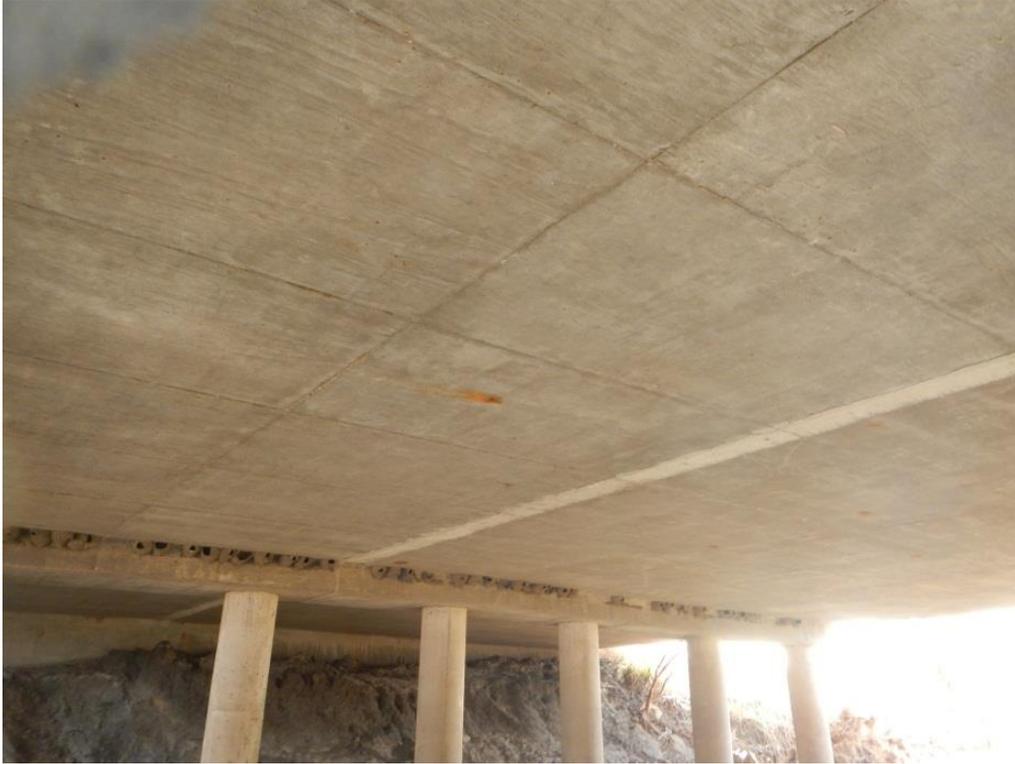
Figure 3.7. Deck underside center span.

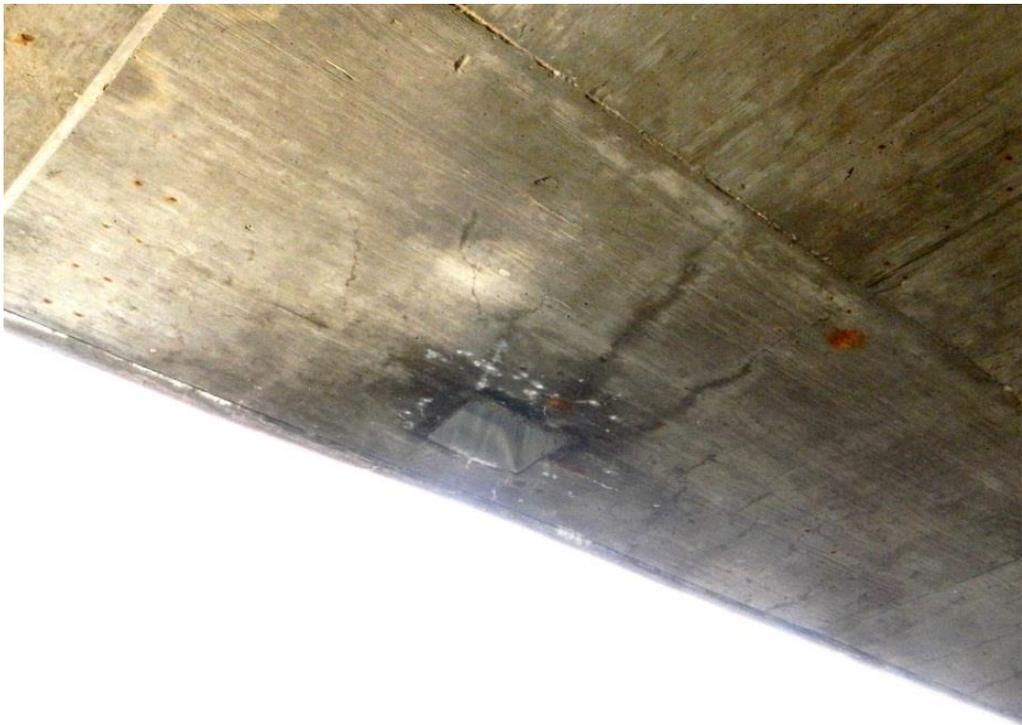
Figure 3.8. Moisture staining on deck underside surrounding drain penetration.

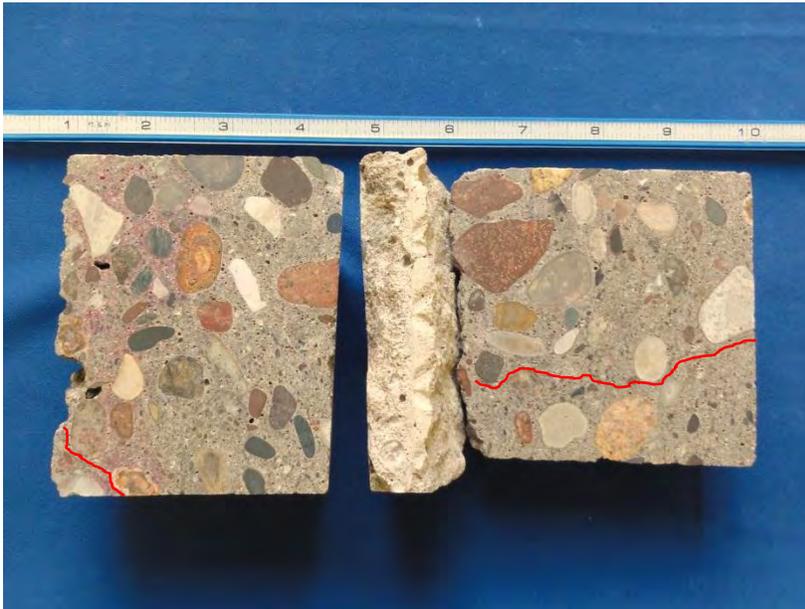
Figure 1. Sections of Core 8; top surface of the concrete is on the left of the photograph. The locations of the microcracks are outlined in red. Impression of a rebar is visible in the middle section of the core. Similar impression (not visible in photo) is also present at the top of the bottom section.

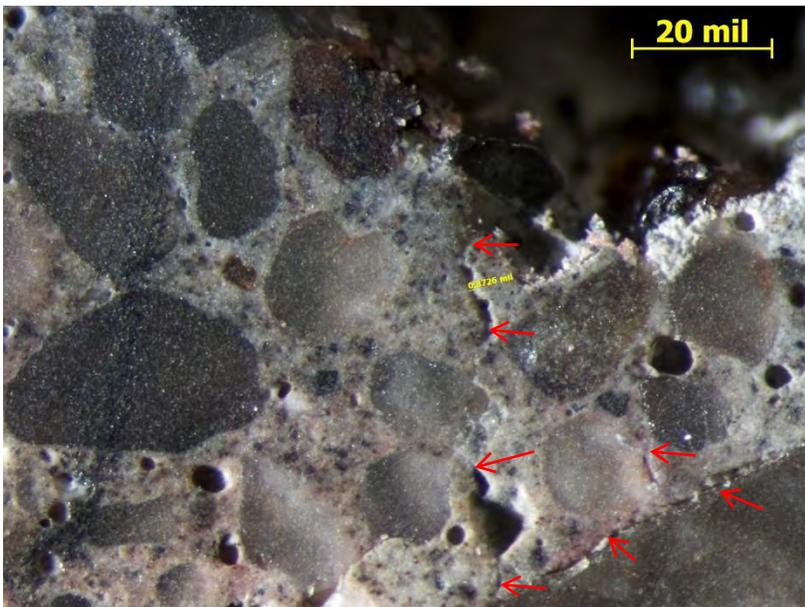
Figure 2. Lapped surface of Core 8 just below the top. The main microcrack split into a few tiny microcracks (indicated by red arrows) just below the very top surface of the core.

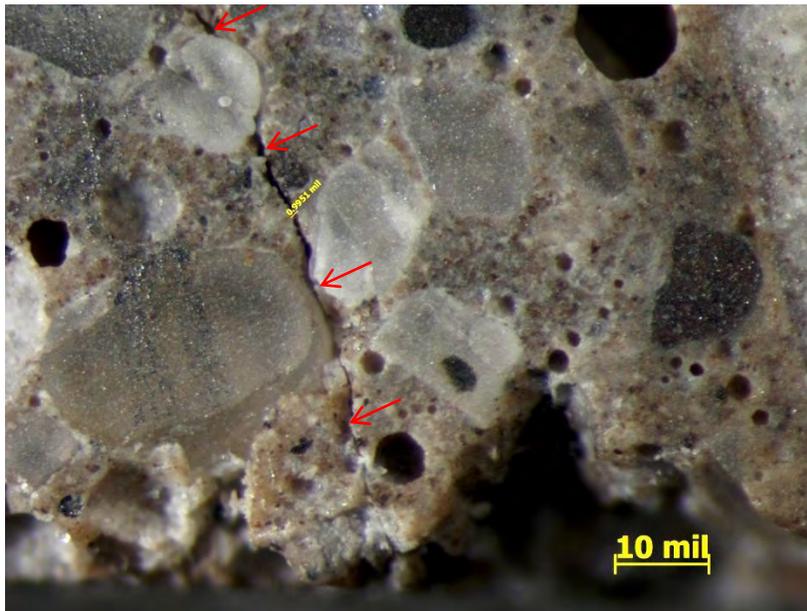
Figure 3. Shown is a microcrack (indicated by red arrows) on the lapped surface in bottom region of Core 8.

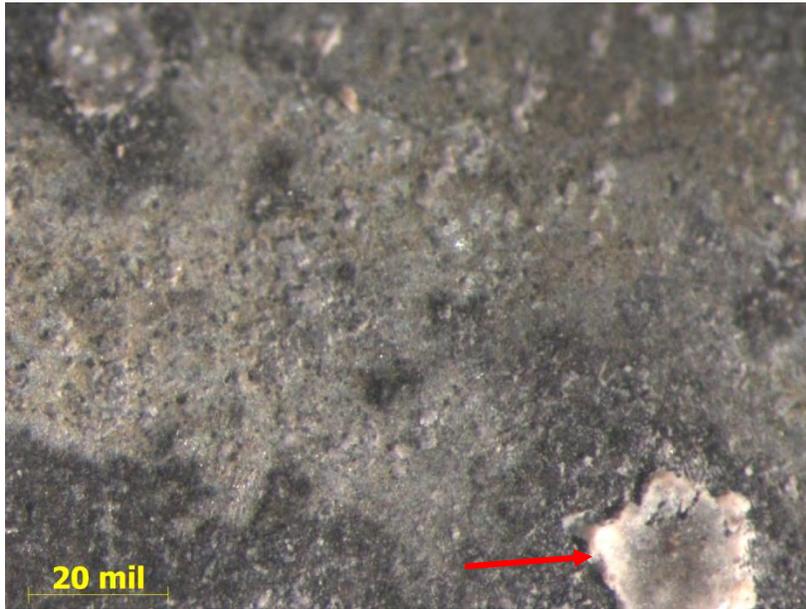
Figure 3. Micrograph of the bottom side of Sample 8. Note the dark to light coloration, with some white deposit indicated with an arrow.

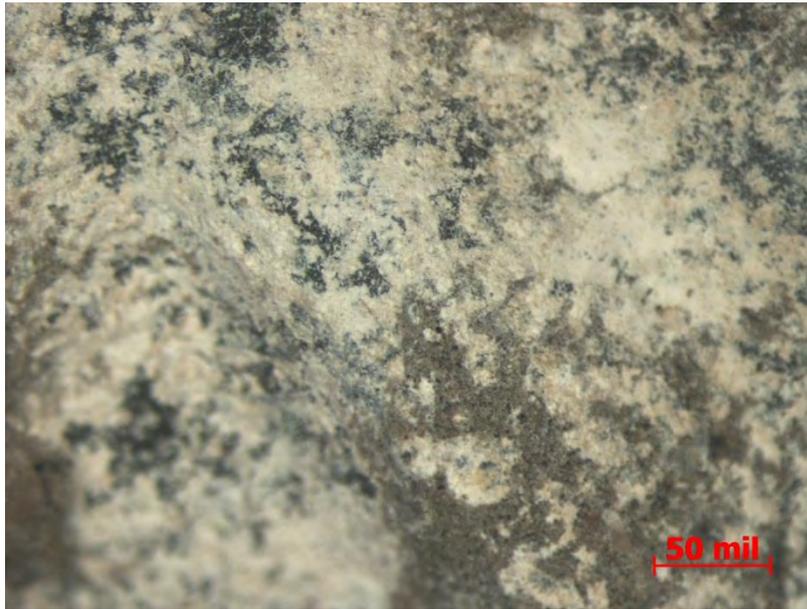
Figure 7. Micrograph of the top surface of Sample 3, showing white deposits.

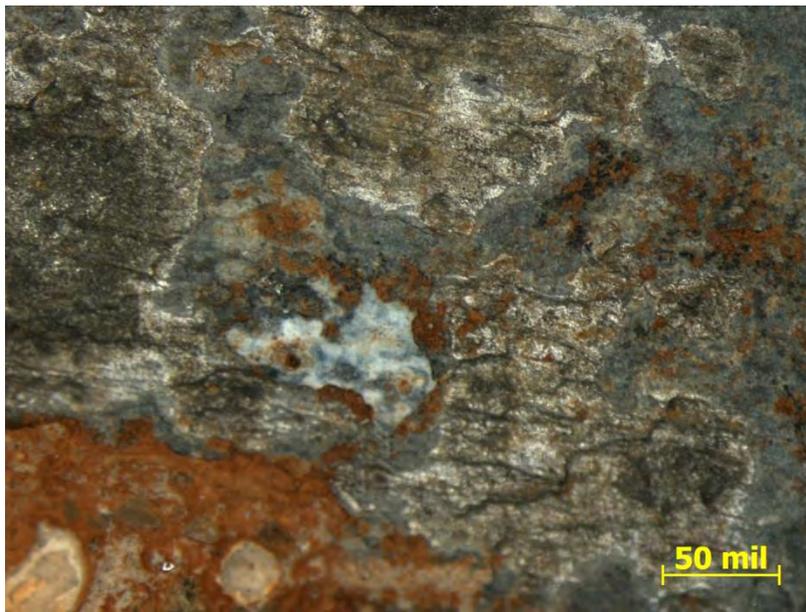
Figure 14. Micrograph of the bottom surface of Sample 9, showing localized areas with no deposits, nearby areas of white and red deposits.

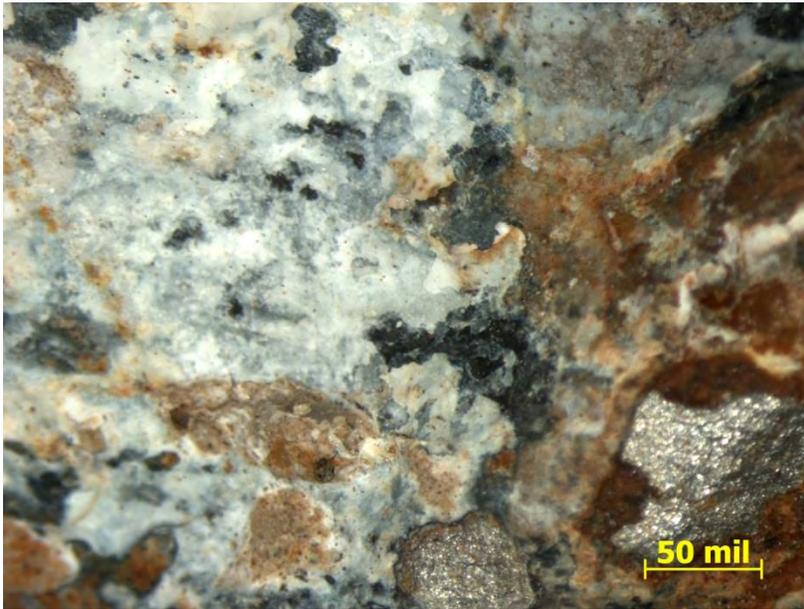
Figure 15. Micrograph of the bottom surface of Sample 9, showing white corrosion product.

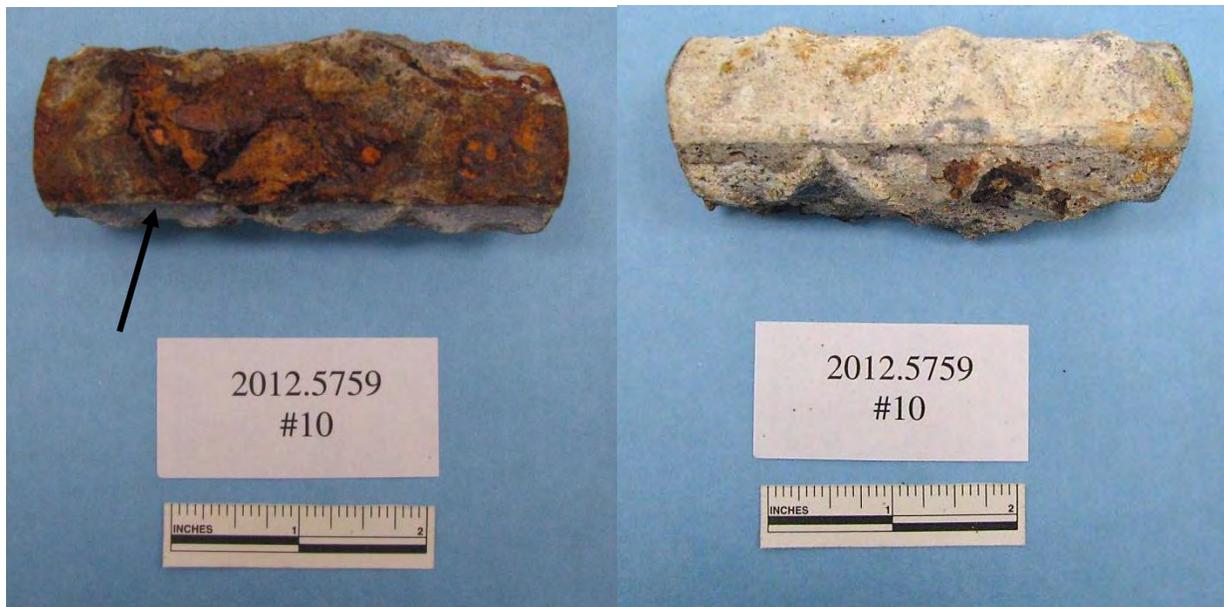
Figure 16. Sample 10. Top side (left) and bottom side (right). The stripe of blue-gray deposit is indicated with an arrow.

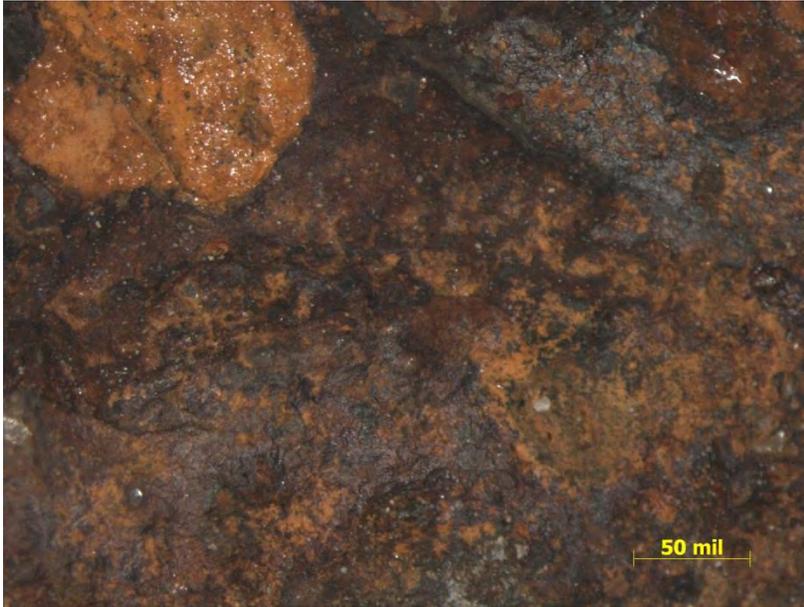
Figure 17. Micrograph of the top surface of Sample 10, showing red corrosion product from the steel.

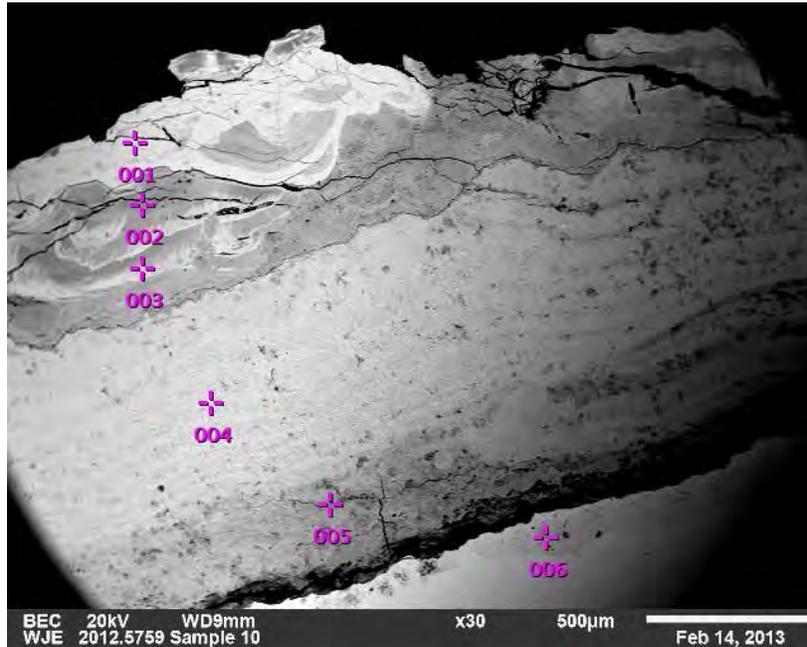
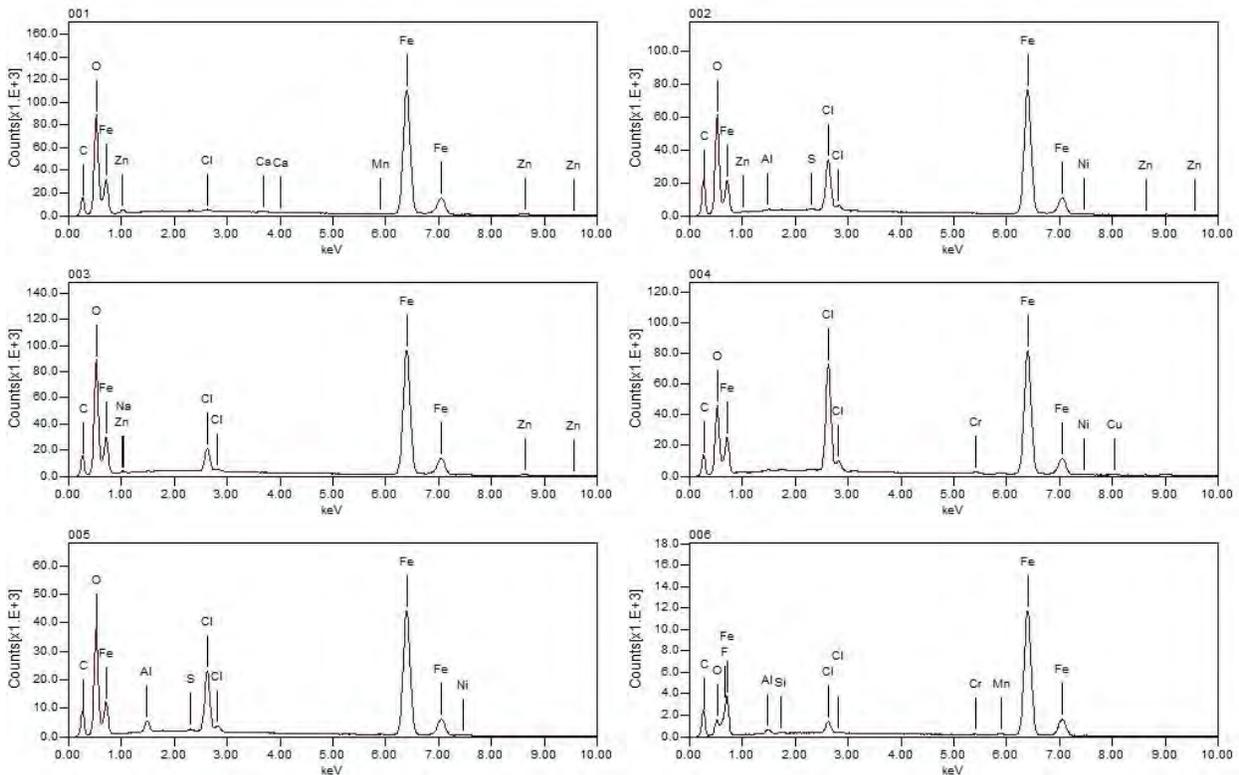
Figure 24. Cross-sectional BE image and point EDS spectra of a corroded pit on Sample 10, showing a significant amount of chlorine in the corrosion product. Each EDS spectrum has a number above the upper left corner which corresponds to the location indicated on the micrograph.

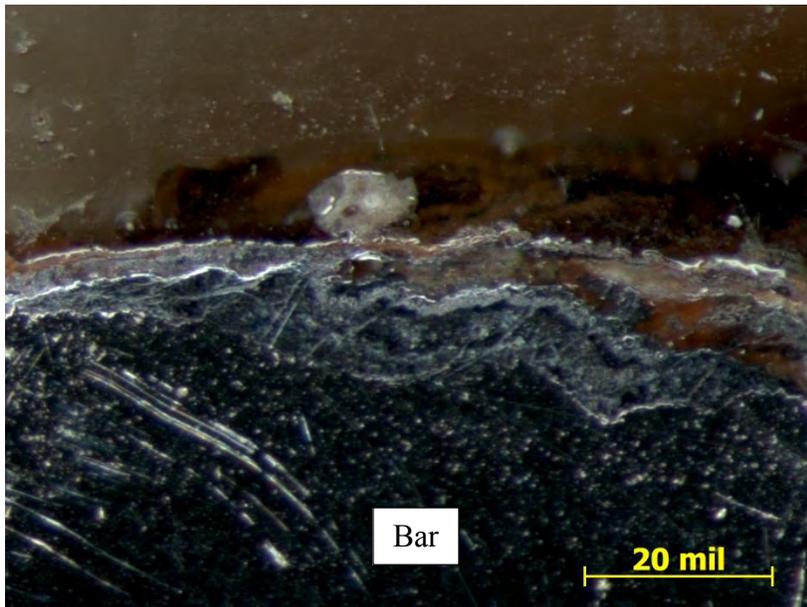
Figure 32. Cross-section of Sample 9, showing corroded bar.

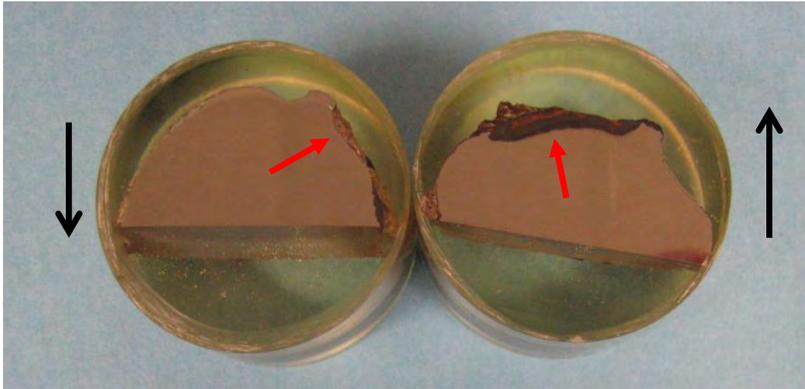
Figure 33. The polished cross-sections of Sample 10. The bar was cut in half so it could be placed into the epoxy molds. Arrows indicate which side was facing up in the slab. Significant pitting can be seen on the top surface of the right-hand specimen, and minor pitting can be seen on the bottom surface (red arrows).

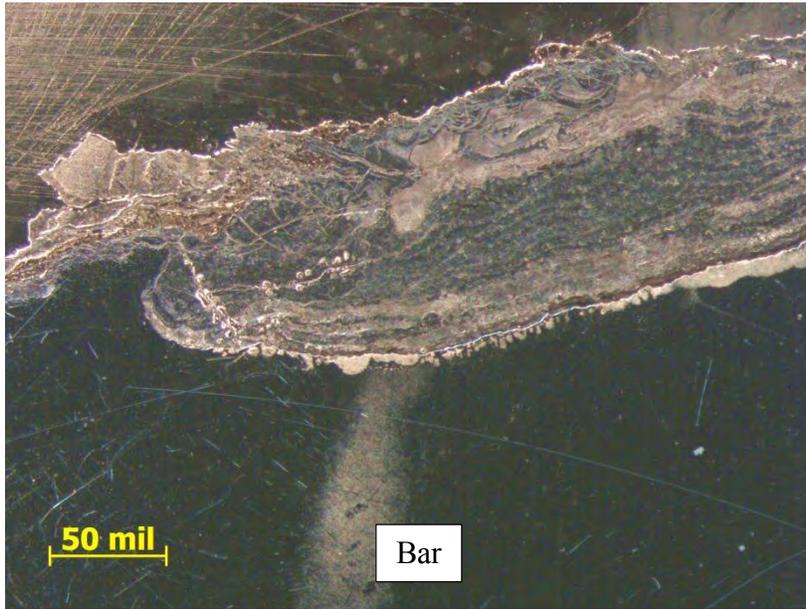
Figure 35. Cross-section of Sample 10, showing the corroded bar and pitting corrosion.

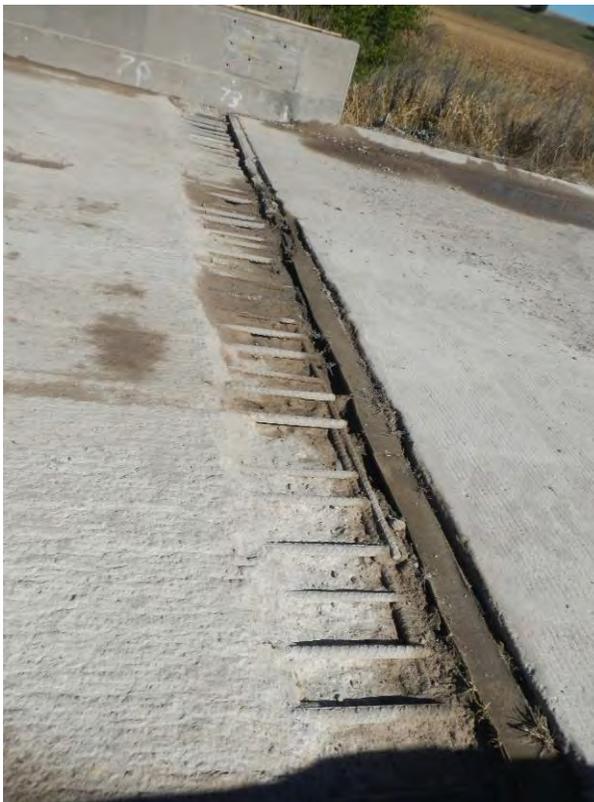
Figure E4. Deeper removal along end joint at westbound lanes

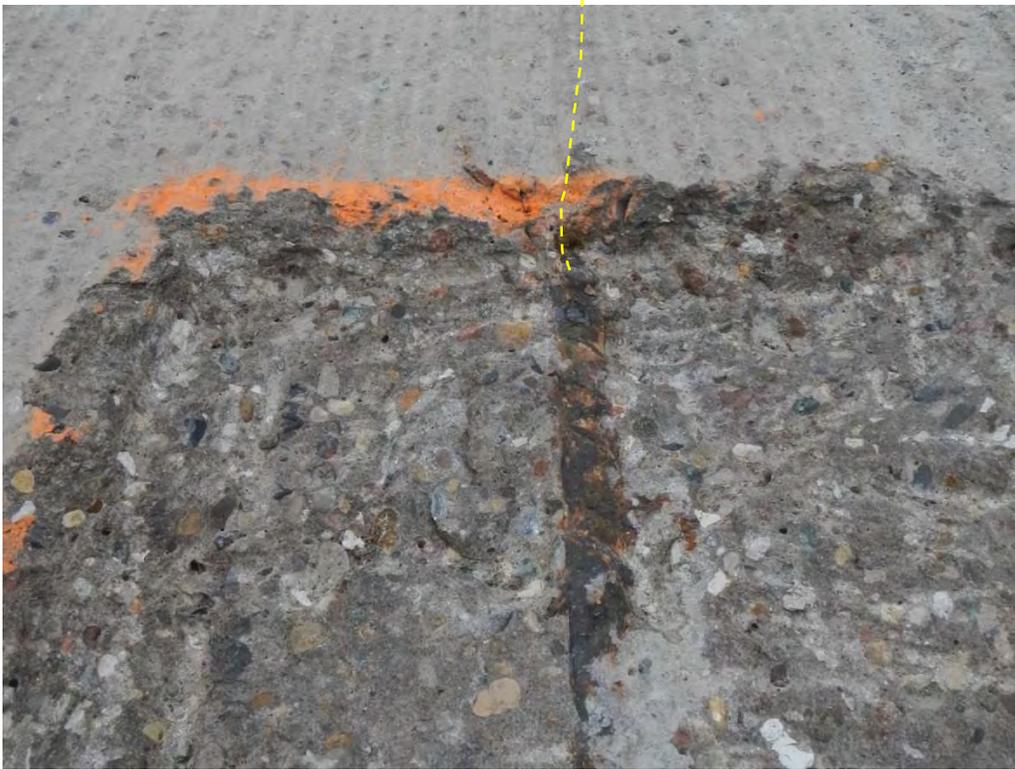
Figure E9. Corroding bar at crack (yellow line) in eastbound lanes.

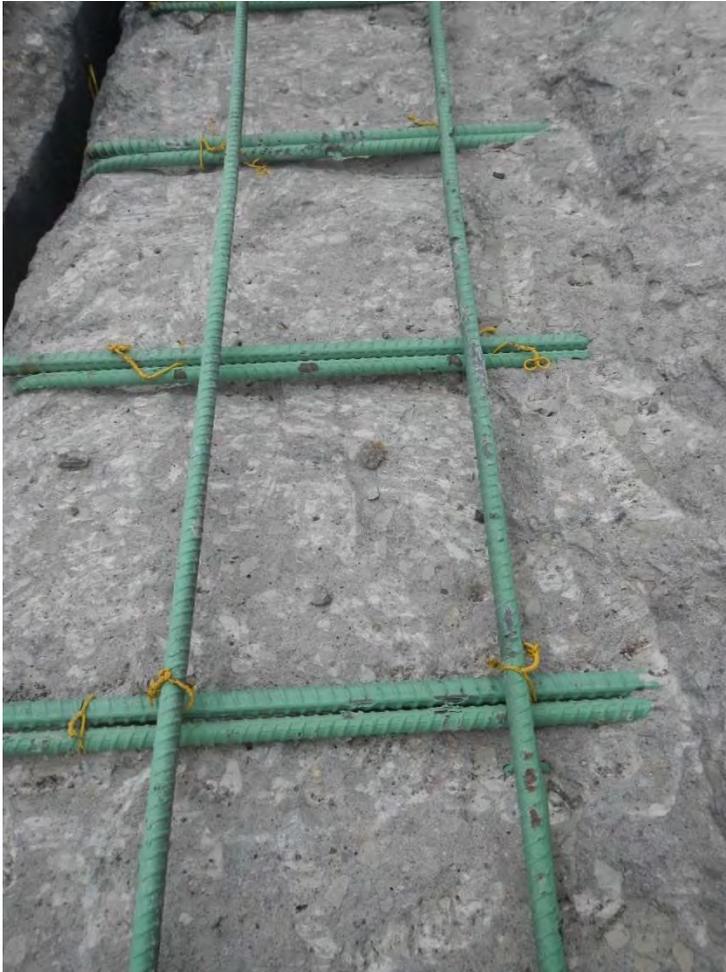
Figure E10. Damage to epoxy coating on bars in west approach slab in eastbound lanes

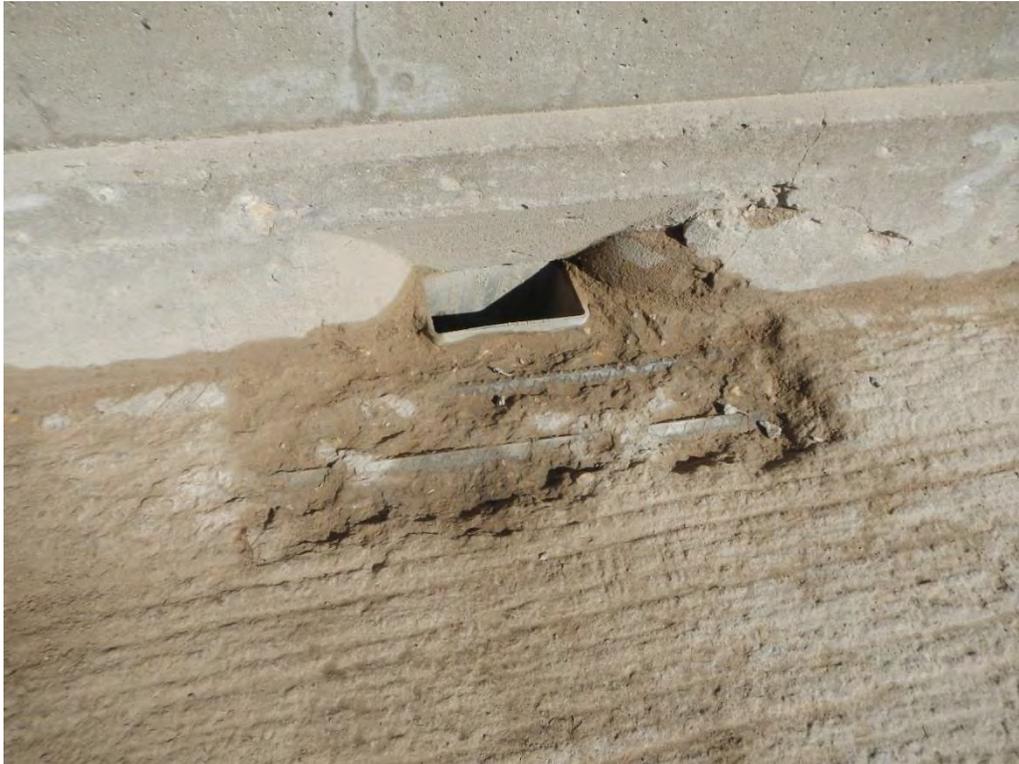
Figure E11. Concrete removal at scupper drain on westbound lane.

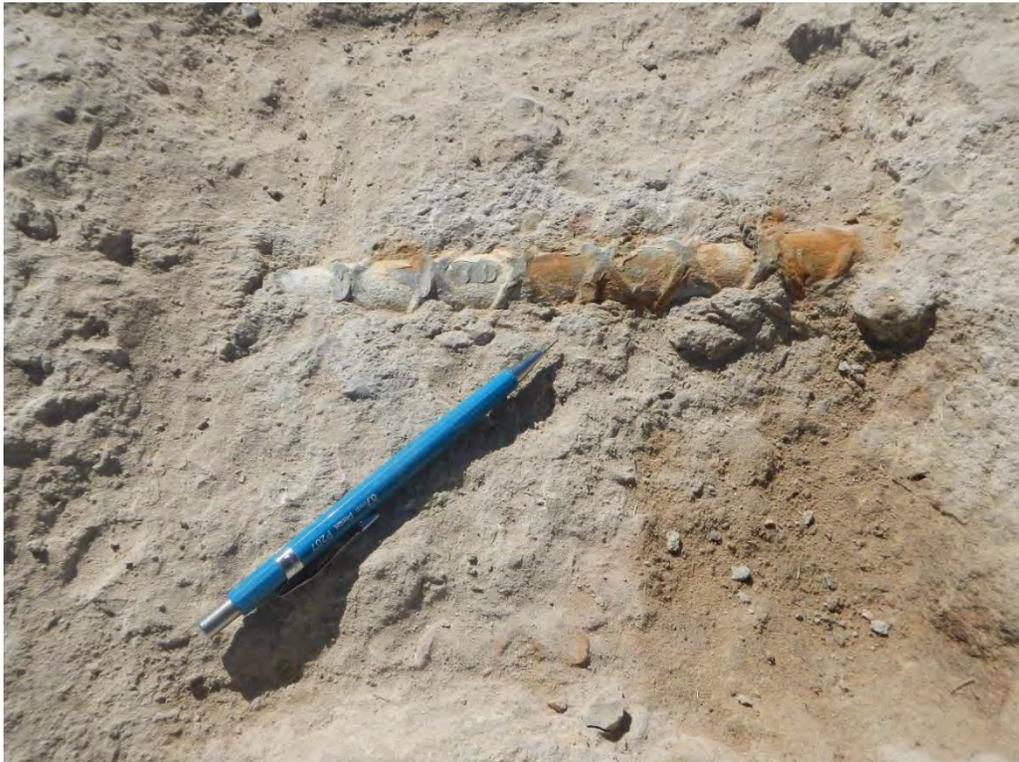
Figure E12. Close-up of corroded bar in westbound lanes.
