# Investigation and Evaluation of Iowa Department of Transportation Bridge Deck Epoxy Injection Process

**Final Report  
February 2019**

**Sponsored by**  
Iowa Department of Transportation  
(InTrans Project 10-381)

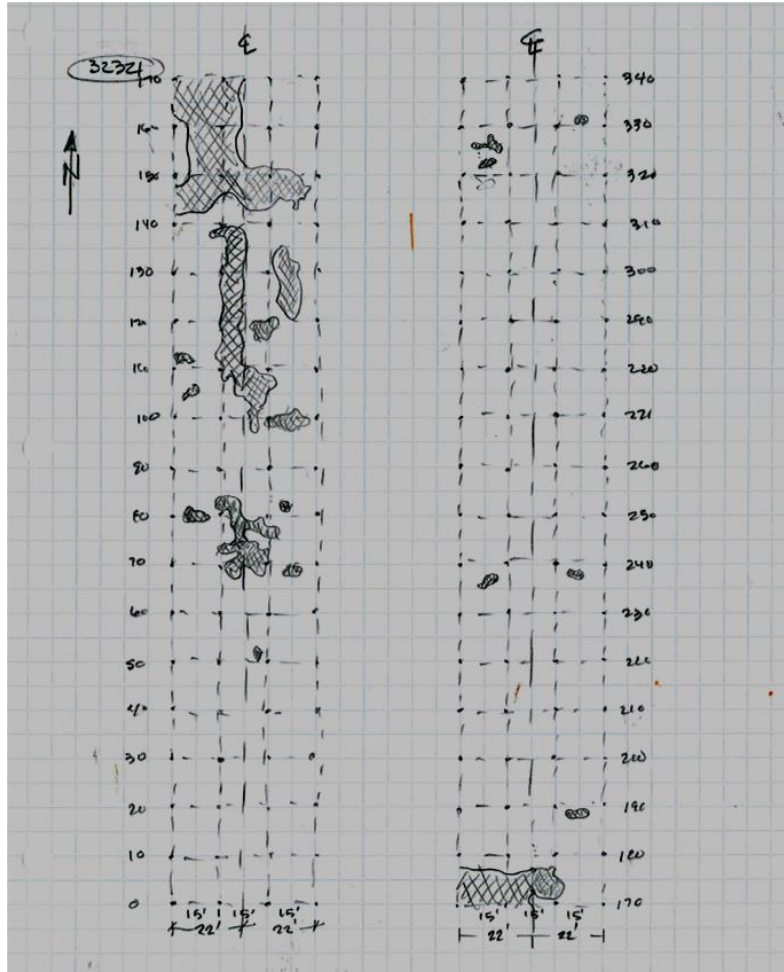
**Figure 3.3. Typical delamination map**

A map locating the delaminated portions of the overlay was generated upon completion of sounding. This was achieved by creating a grid of the entire bridge deck surface and transferring the located delaminations to the corresponding sectors of the map. The map shows the locations and sizes of delaminated portions of the overlay, and offers a snapshot of the overall health of the surface. From these maps, data were collected and used to analyze the group of bridges. An example of a delamination map is provided in Figure 3.3.

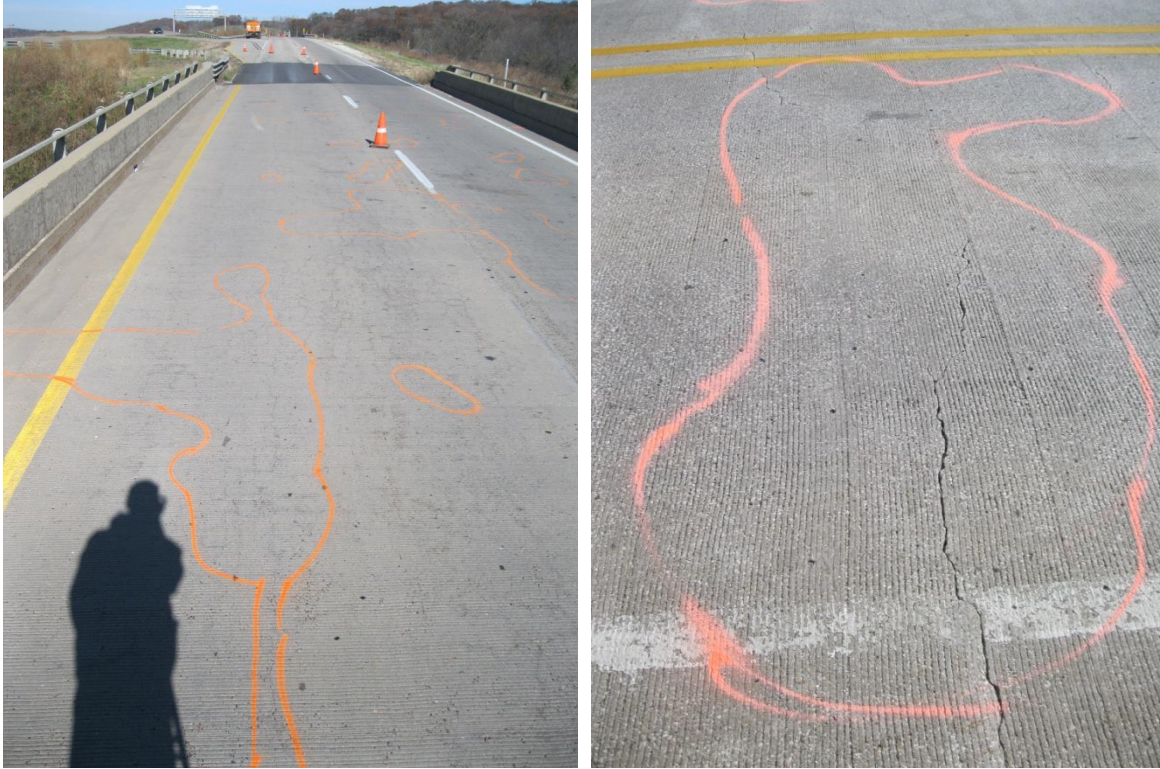
**Figure 3.4. Photographic documentation of delamination**

In addition to sounding the deck, photographs were taken to visually document the surface condition. Figure 3.4 shows an example of conditions seen at many of the bridges.

It was common to find delaminated portions of the overlay at or very near locations where both longitudinal and transverse surface cracking were present. It appeared that cracking often resulted in delamination and vice versa, as intuition would suggest. Additionally, delaminated portions of the deck often appeared to originate where cold joints were present, such as at the centerline of bridge. This agreed with the cases of cracking as cold joints are another port of entry for water and chloride ions. Additionally, the condition of the overlay was commonly the poorest where the bridge approach slab met the overlay. This may be due to several factors including: water entry at approach slab-overlay interface, snow plow impact, or magnified localized stresses attributable to thermal behavior (especially at acute angle portions of skewed decks).

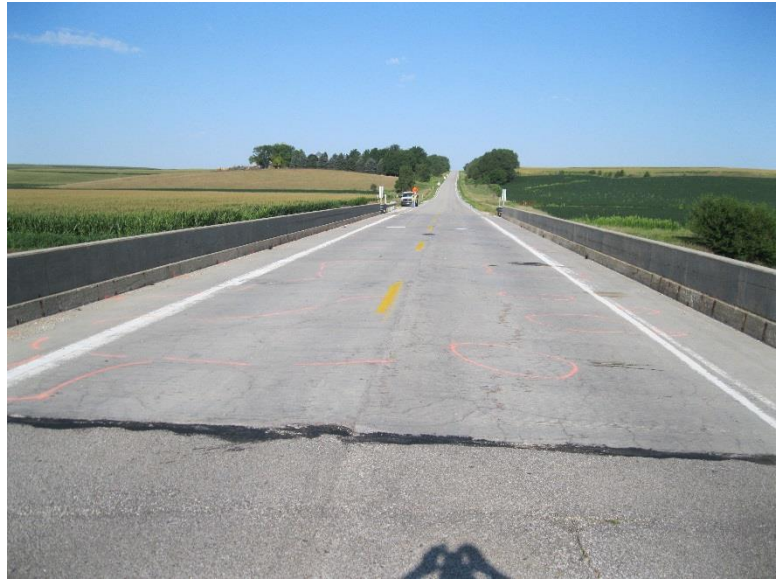
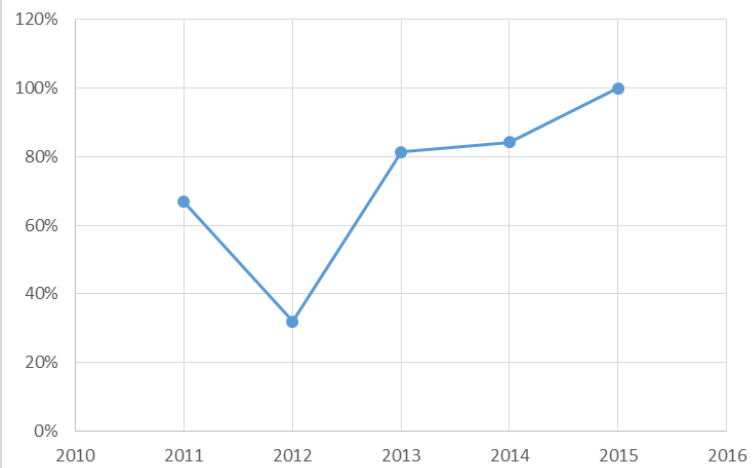
It is also worth highlighting that one of the bridges (FHWA #47860) had a delamination rate of 67 percent before epoxy injection. This delamination rate was reduced to 32 percent one year after injection, and had delamination rates of 81 percent and 84 percent, respectively, for the second and third years. The bridge deck was replaced in the fourth year. This observation may indicate that epoxy injection should not be applied to a bridge deck with a high delamination rate. However, due to the scope of this research, this observation needs to be further validated. When possible, a recommended delamination rate threshold should be established via future research work.

Due to the performance of bridge #47860 and its deviation from the other observed bridge performances, it was taken as an outlier and was removed from subsequent data analysis. In Table 6.3, the mean and standard deviation of the delamination rate were recalculated after excluding this bridge.

<b>Federal ID</b>	047860
<b>State ID</b>	8334.8S037
<b>County</b>	Shelby
<b>Location</b>	1.4 MI. West of JCT. IA 191
<b>Facility Carried</b>	IA 37
<b>Feature Crossed</b>	Moser Creek
<b>Iowa District</b>	4
<b>ADT</b>	640
<b>Year Built</b>	1961
<b>Sufficiency Rating</b>	85.4

Deck replaced in 2015
