Exploration of Ultrasound for the Evaluation and Preservation of Structures

**Final Report
January 2021**

Sponsored by
Iowa Highway Research Board
(IHRB Project TR-757)
Iowa Department of Transportation
(InTrans Project 18-671)

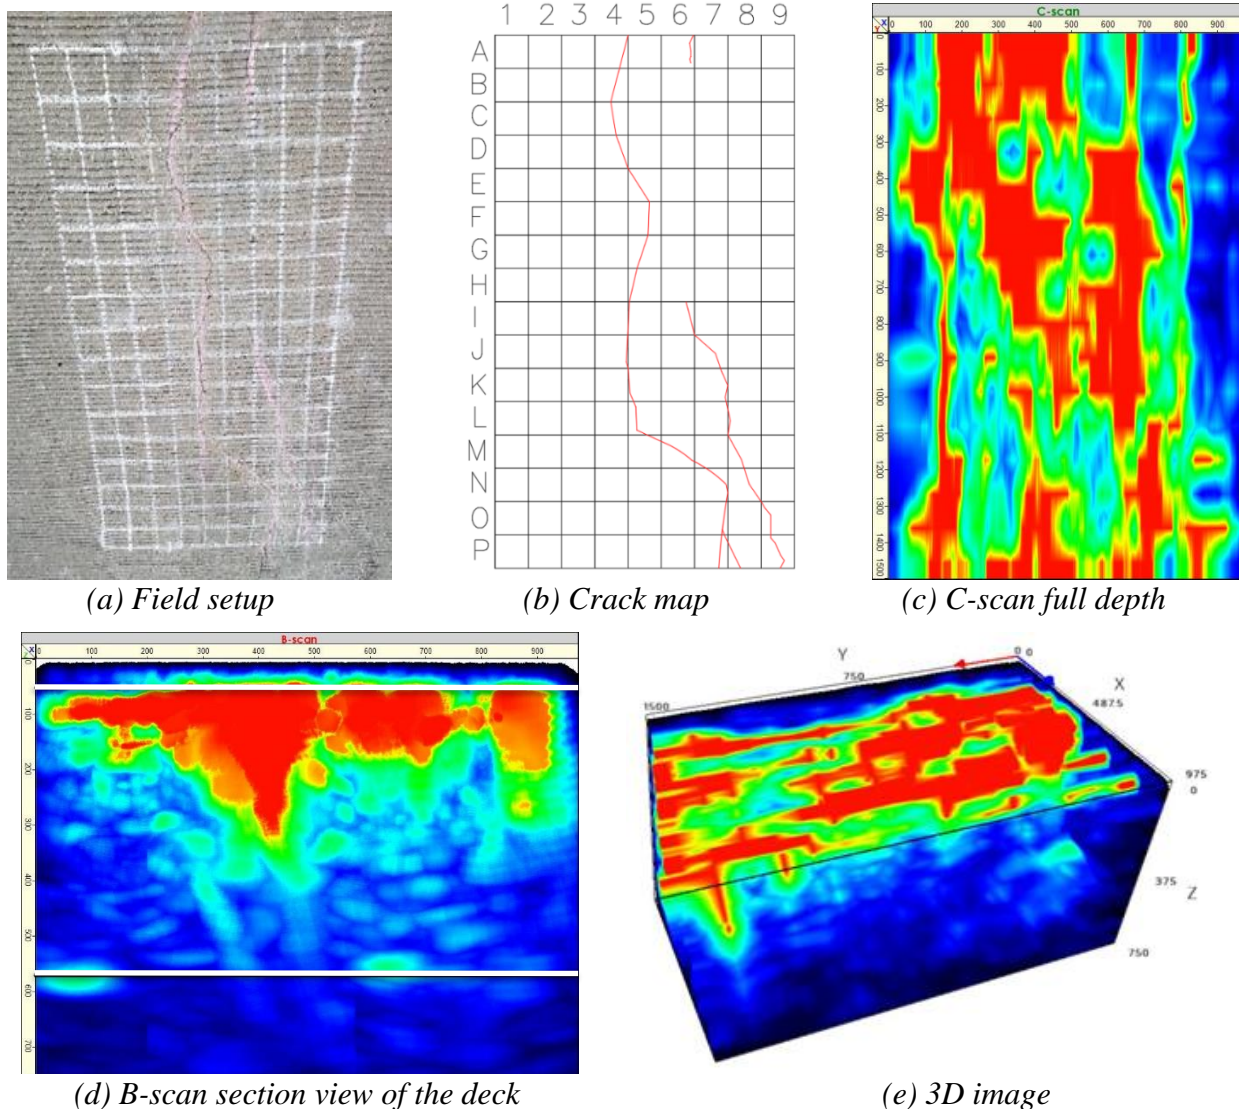
Figure 9. Test setup and results for Grid 1 on Mingo Bridge

This test location was over Pier 1, as shown in Figure 8, and included several cracks in the bridge deck, as shown in Figure 9b. Figure 9c and 9d show the C-scan and B-scan, respectively, and Figure 9e shows the 3D image for the scanned area. The original bridge plans show that rebar is present in the top layer of this test location (see Figure 7). Figure 9e shows that there are rebar-like shapes running along the y-axis. However, the configuration of each rebar is not clear in the scans.

Based on the information in the bridge plans, a white line marks the interface between the overlay and substrate in Figure 9d. The overlay is about 1.75 in. thick. Recall that MIRA's measurement range of the depth of the flaw location is from 2 to 16 in. This indicates that the cracks in the overlay cannot be accurately captured in the scans because the entire thickness of the overlay is within the first 2 in. of the concrete depth. As is evident from this scan, red shading extends from the rebar level to approximately the mid-depth of the slab. This demonstrates that

there are defects in the substrate beneath the overlay. The bottom surface of the deck is also marked with a white line in Figure 9d based on information in the bridge plans. However, the scans do not clearly capture this interface.

However, when the overlay exhibits significant cracking (as in Grid 1 and Grid 3), the scans show a large shaded area that extends from the level of the top rebar to the mid-depth of the deck. At these locations, it is impossible to identify the top and bottom layer reinforcement and the deck thickness.

According to the field inspection, the results of which are shown in Figure 9a and 9b to Figure 13a and 13b, Grids 1 and 3 had the worst cracking and were therefore rated as 5, while Grids 2 and 4 were in the best condition and were rated as 1. Grid 5 had minimal cracking (two visible

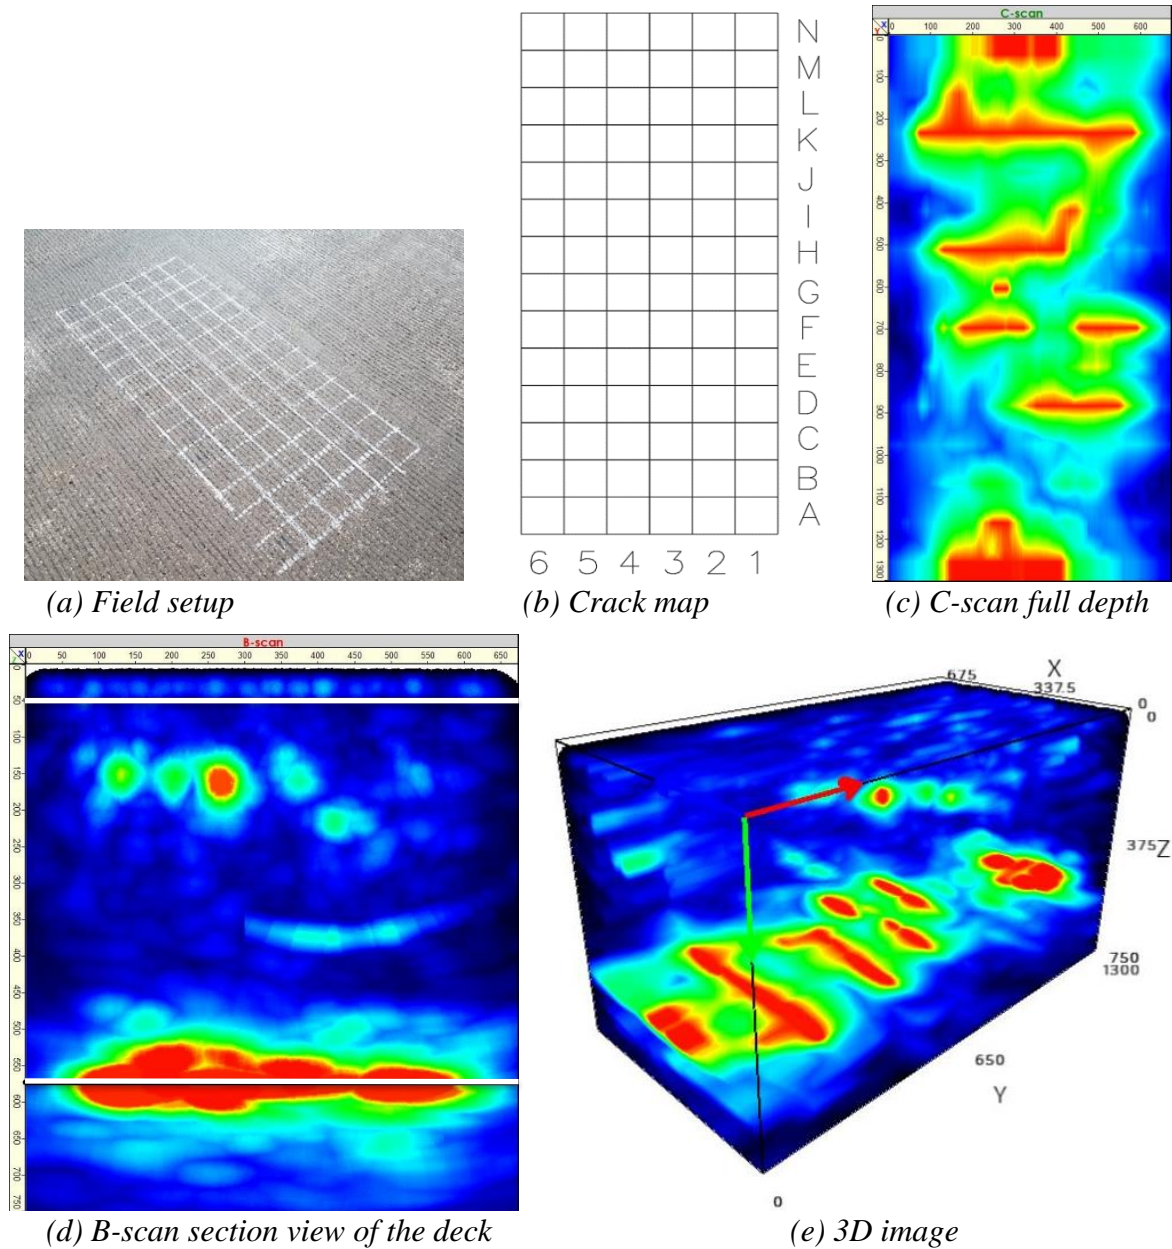
The second test setup was a 56 in. by 24 in. grid that contained no visible cracks in the bridge deck, as shown in Figure 10a and 10b.

Figure 10. Test setup and results for Grid 2 on Mingo Bridge

Figure 10c and 10d show the C-scan and B-scan, respectively, and Figure 10e shows the 3D image for the scanned area. Similar to the first location, white lines in Figure 10d mark the interface between the overlay and substrate and between the substrate and the bottom of the deck. It can be seen that the MIRA scans do not show the location of the interface between the overlay and substrate. However, a red area is visible at the bottom the deck. According to the bridge plans, the deck at this location has a depth of 22.5 in. (570 mm). In the MIRA scan, the red area is between 21.7 in. (550 mm) and 22.6 in. (575 mm) deep. In this case, MIRA was able to give a general range of the slab thickness. However, the intensities in the scan do not clearly distinguish between the bottom of the slab and the reinforcement. Additionally, this test was located near the abutment/mid-span, where the bridge plans indicate that no top reinforcement is present (see Figure 7). The scans confirm that no top reinforcement is present. Figure 10d and 10e show a red region located 6 in. (150 mm) below the surface that may indicate the location of a potential defect.

The results indicate that MIRA is good at detecting the location and relative size of the top layer reinforcement in the deck through a 1.75 in. overlay when the overlay is in good condition (see the results from Grid 2 and Grid 4).

It was also found that although the MIRA scans for Grid 2 and Grid 4 showed a large red area near the bottom of the deck (about 575 mm below the surface), it could not clearly distinguish between the bottom surface of the deck and the bottom layer reinforcement.

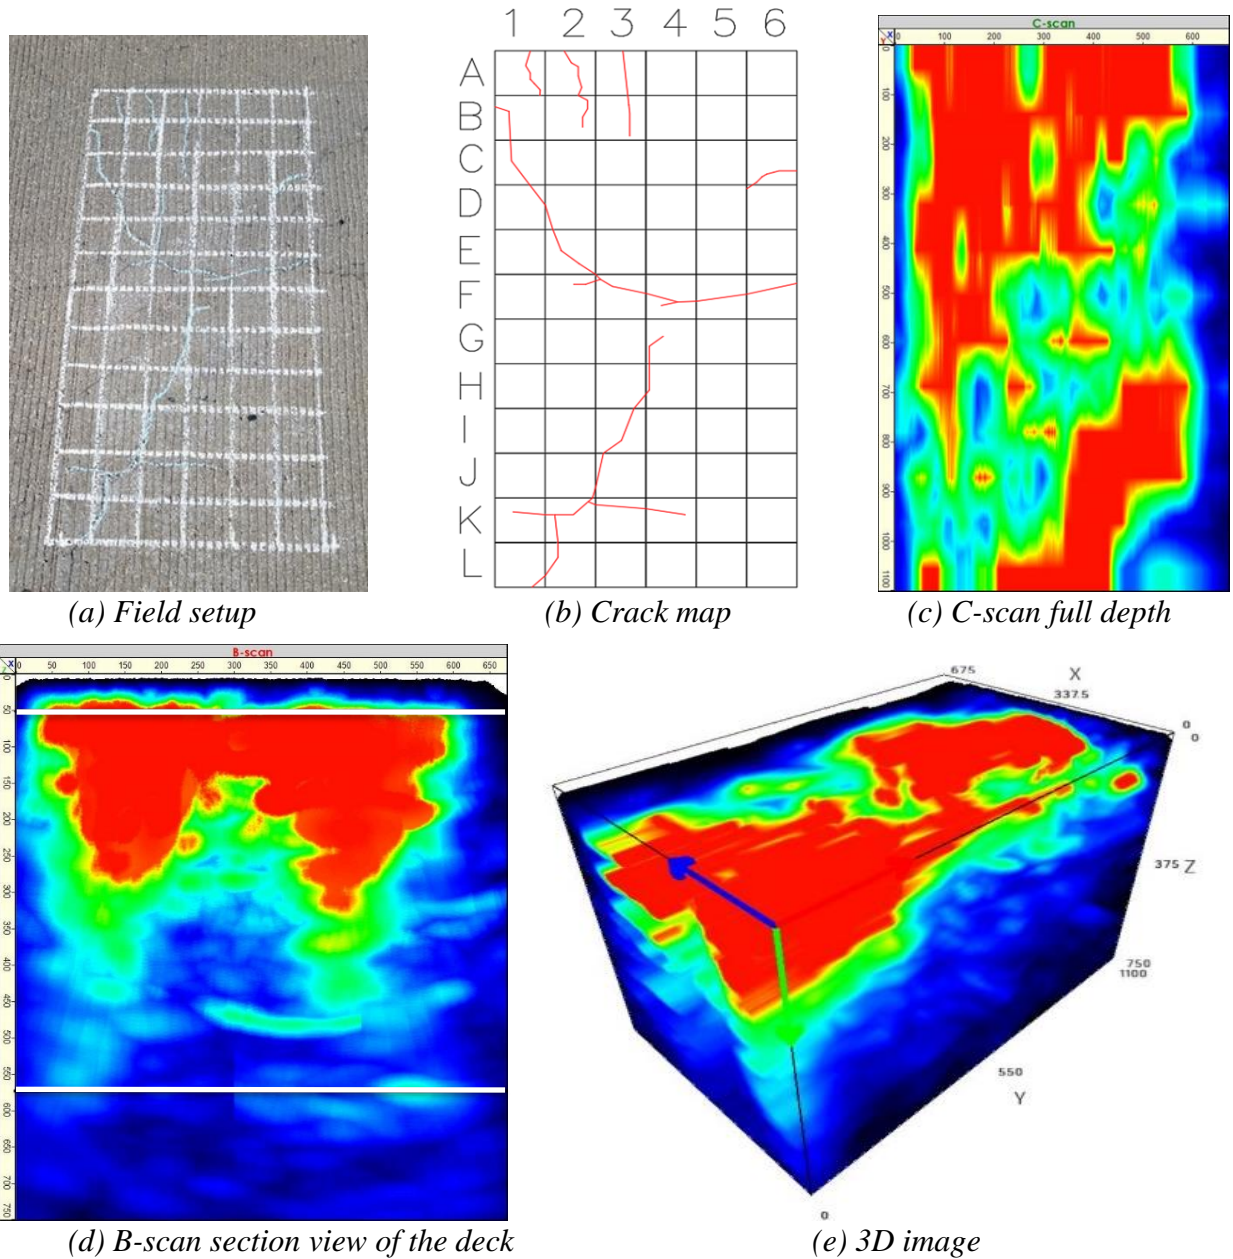
The third setup was a 48 in. by 24 in. grid that included several visible cracks in the bridge deck, as shown in Figure 11a and 11b.

Figure 11. Test setup and results for Grid 3 on Mingo Bridge

Similar to the scans for Grid 1, the scans for Grid 3 show a large red area at the level of the top rebar that extends down to the mid-depth of the deck, as shown in Figure 11c, 11d, and 11e. Since MIRA detected several defects in the top portion of the bridge deck, the bottom of the slab could not be detected. This low-depth attenuation, or the presence of damage, can be thought of as “noise” that is not allowing the waves to penetrate to the full depth of the deck. As the cases for Grids 1 and 3 illustrate, if significant low-depth damage is present, the depth of the deck cannot be accurately captured in the scans.

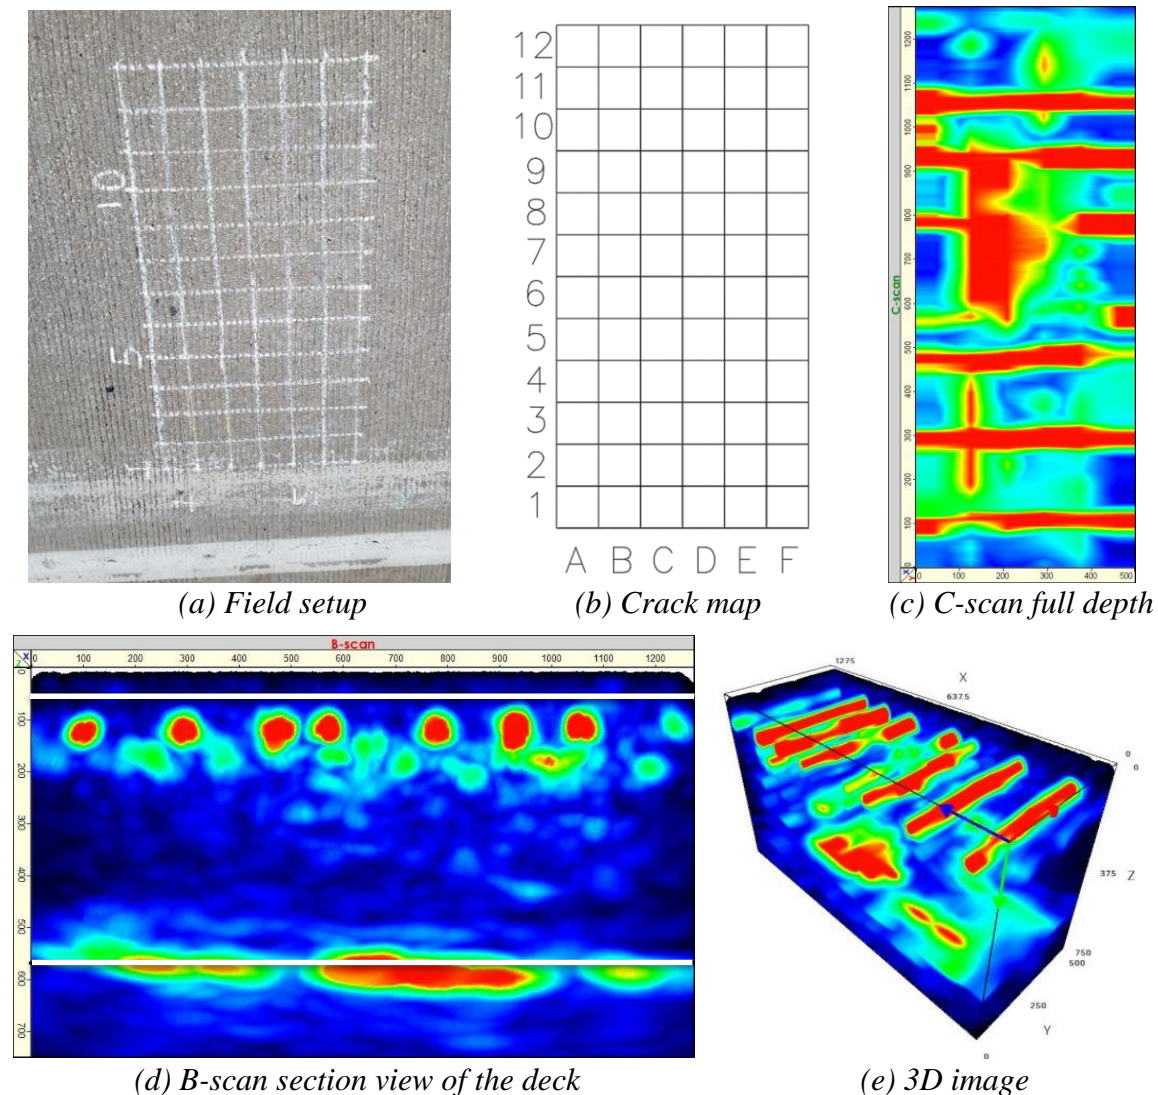
The fourth setup was a 48 in. by 24 in. grid that included no visible cracks in the bridge deck, as shown in Figure 12a and 12b.

Figure 12. Test setup and results for Grid 4 on Mingo Bridge

In this grid, the MIRA scans were able to locate the top layer of reinforcement, as shown in Figure 12c, 12d, and 12e. This grid was located over a pier, and the bridge plans confirm that top reinforcement is present at this location. The plans locate the reinforcement approximately 3.75 in. below the surface, which was confirmed by the MIRA scans. Moreover, the MIRA data show that the diameters of the red areas are around 1.5 in. (38.1 mm). The plans indicate that #11 rebar is located in this area, which has a diameter of 1.41 in. (35.8 mm). This indicates that MIRA has the ability to determine the location and relative size of rebar near the surface when extensive low-depth damage is not present. It is important to note, however, that the size of the area shown

in the scan is highly dependent upon threshold selection and can therefore be misleading. In addition, red shading is visible at a depth that coincides with the bottom of the deck, showing that MIRA can also identify the thickness of the deck when extensive damage is not present. The plans indicate that bottom reinforcement is located in this area, but because the top reinforcement blocked most of the shear waves, the bottom reinforcement could not be clearly scanned.

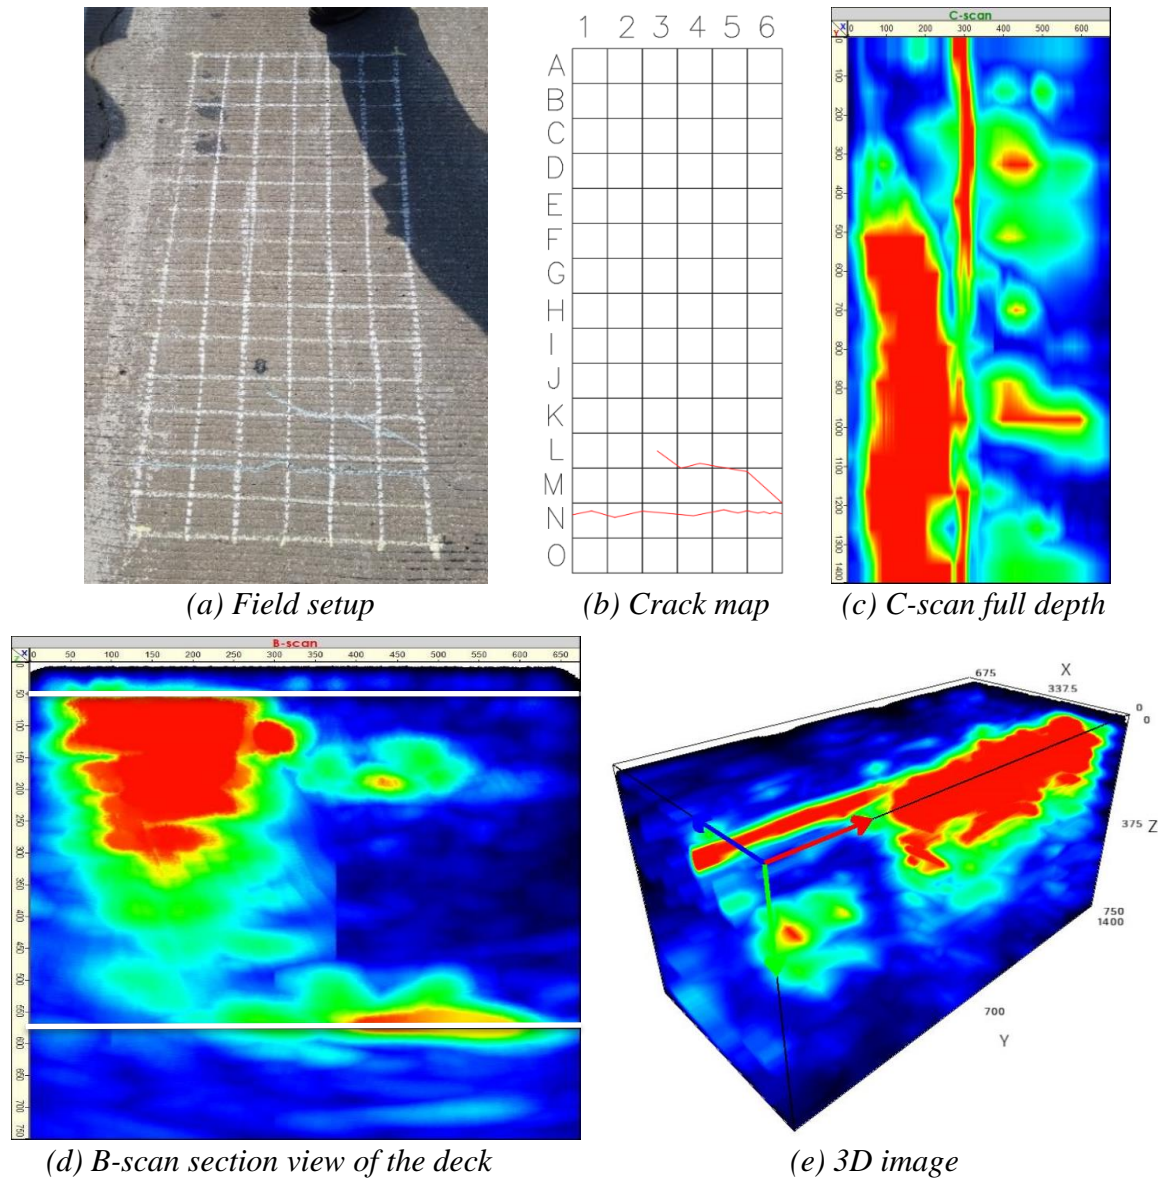
The fifth setup was a 60 in. by 24 in. grid that included some minor visible cracking on one side of the grid, as shown in Figure 13a and 13b.

Figure 13. Test setup and results for Grid 5 on Mingo Bridge

As shown in Figure 13c, the scans did show red areas in the bottom left corner of the grid. Figure 13d and 13e indicate that this red area extends from the top to the mid-depth of the deck. According to the bridge plans, no top reinforcement is present in this area. These scans appear to indicate that the damage seen at the surface, i.e., the two cracks, extends through the overlay and into the substrate. These scans could be useful for determining the extent of damage and could thus indicate the level of repair necessary.

cracks) and was rated as 3. These ratings are based solely on the external condition observed on the top surface of the bridge deck.

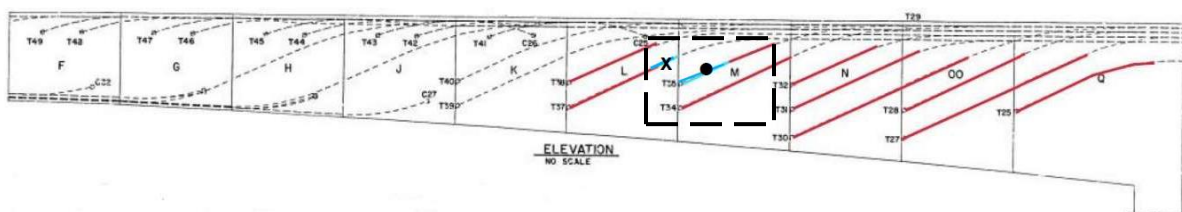
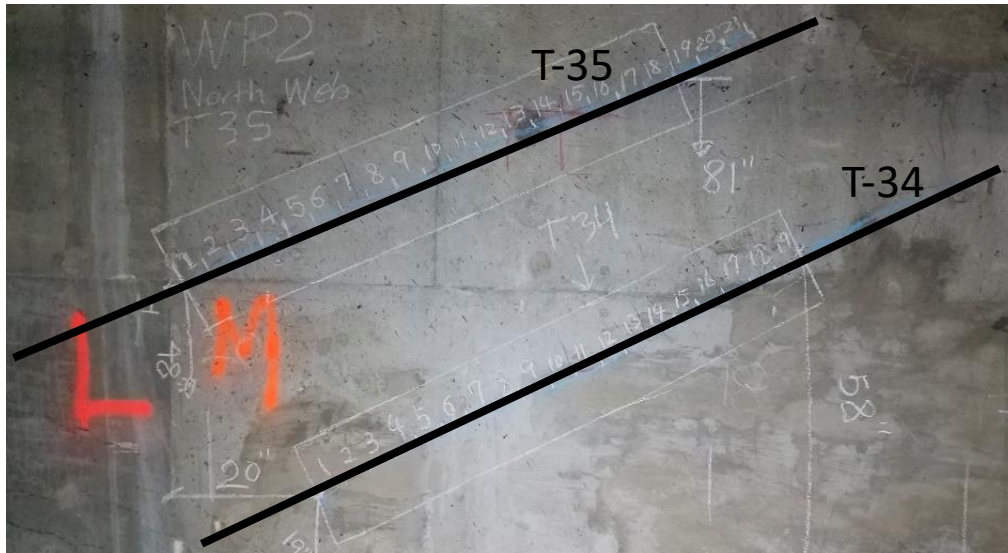
T-34 and T-35

Two tendons (T-34 and T-35) were located west of Pier 2 (Span 2) in the north web. The two web tendons tested are shown in Figure 15 and Figure 16.

VCS identified potential defects in T-35 using impact echo. The area of the defects is depicted in Figure 15 by the blue line. Moreover, to confirm that there was, in fact, a void at the identified location, a borescope inspection was conducted at the location shown by the black dot in Figure 15. In the results, a void was indeed identified. The impact echo testing did not identify defects in T-34.

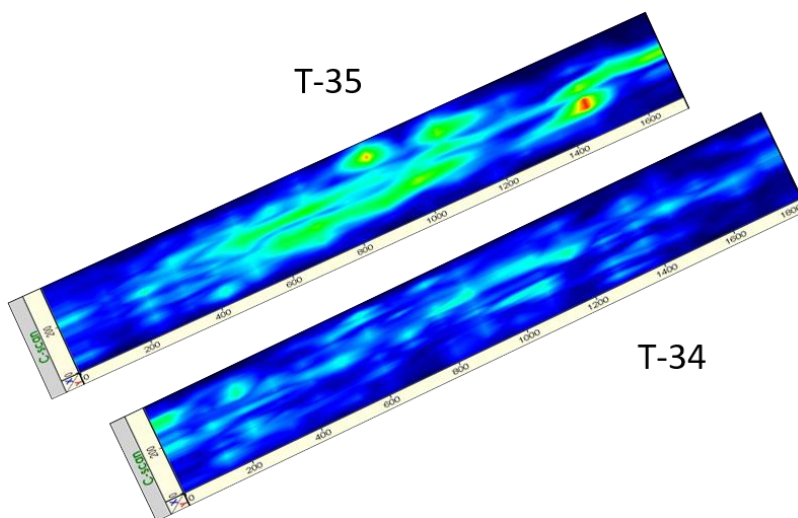
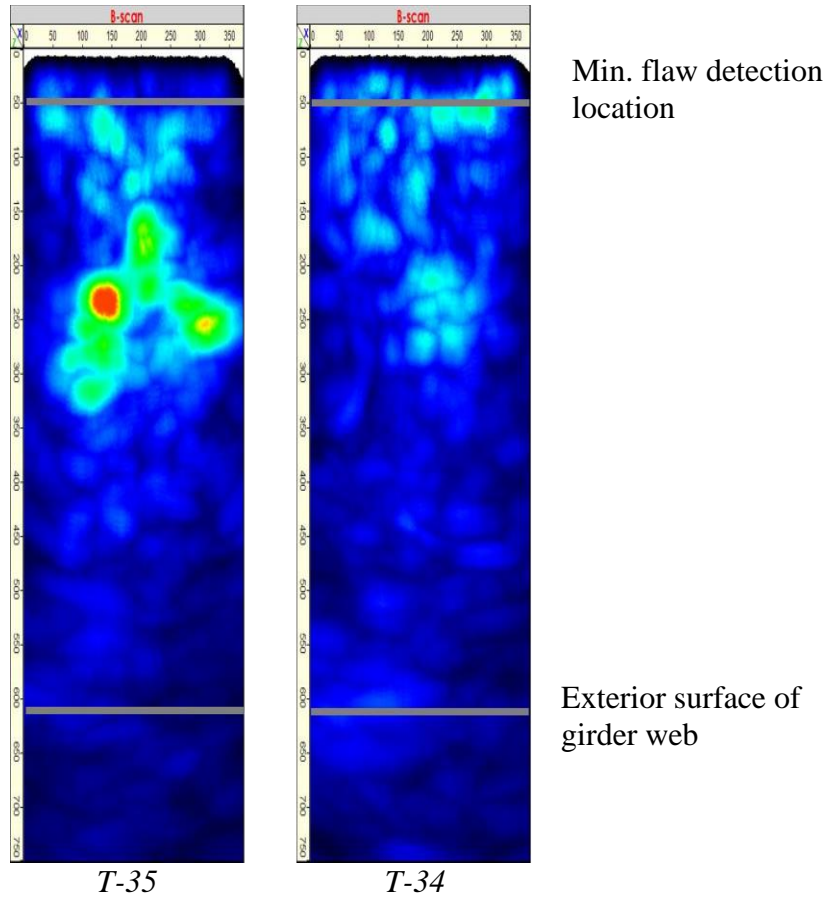
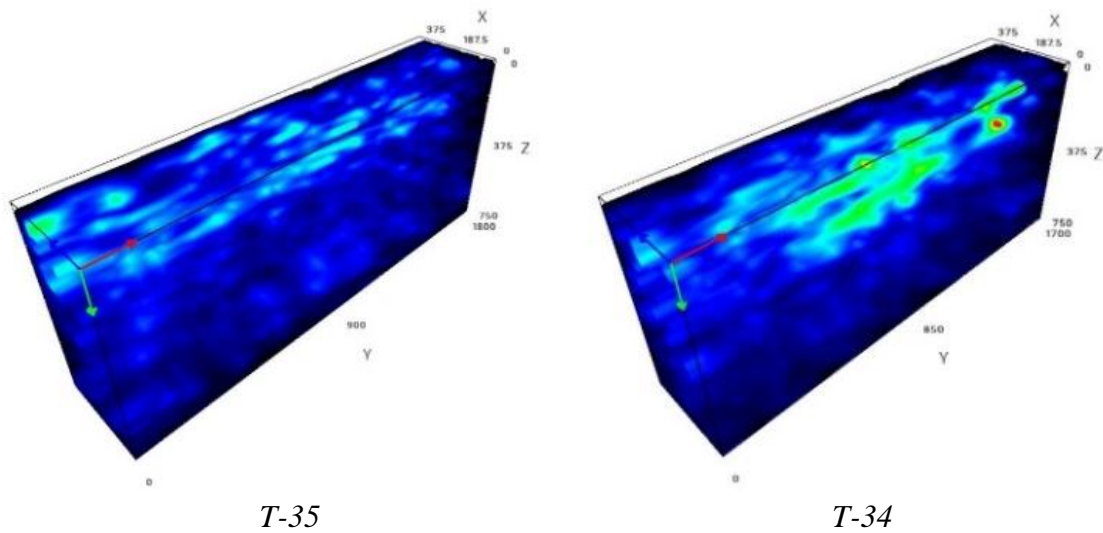
Figure 17. C-scans for T-34 and T-35

Figure 18. B-scans for T-34 and T-35

Figure 19. 3D images for T-34 and T-35

All MIRA scans showed a red area corresponding to the ducts for T-35, while no red area was found corresponding to the ducts for T-34. This result shows good agreement with the findings from the VCS inspection report, indicating that voids were present in duct T-35.

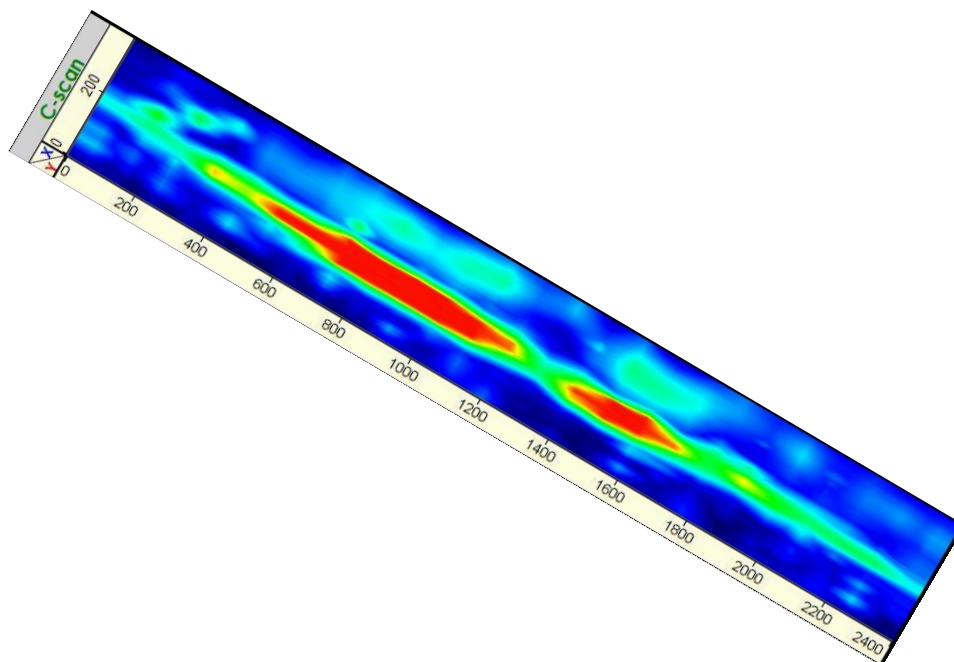
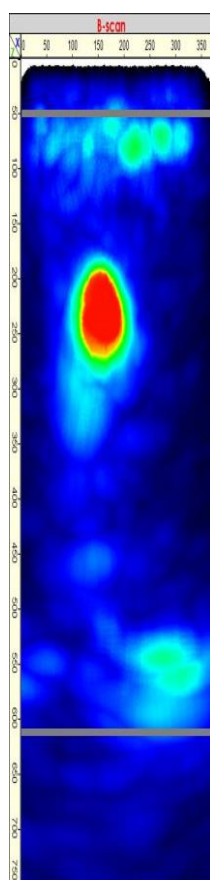
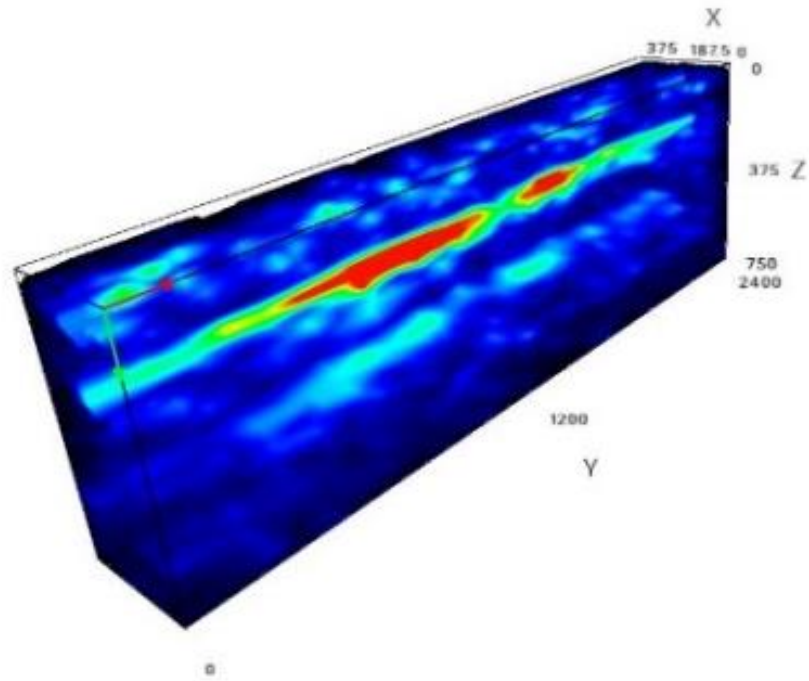
T-30 was the second void location determined by VCS. Figure 22, Figure 23, and Figure 24 show the C-scan, B-scan, and 3D image for T30, respectively.

Figure 22. C-scan for T-30

Figure 23. B-scan for T-30

Figure 24. 3D image for T-30

A red area is visible in the MIRA scans and confirms the void in the tendon duct.
