Utility Cut Repair Techniques— Investigation of Improved Cut Repair Techniques to Reduce Settlement in Repaired Areas

Final Report December 2005

the Iowa Highway Research Board (IHRB Project TR-503)

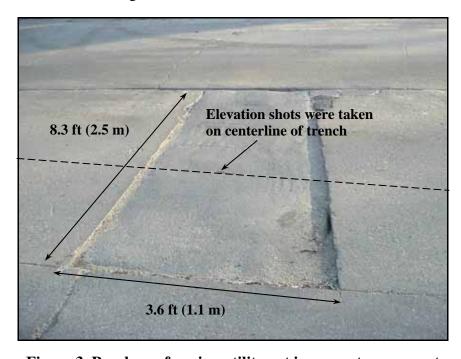
Figure 3. Poorly performing utility cut in concrete pavement

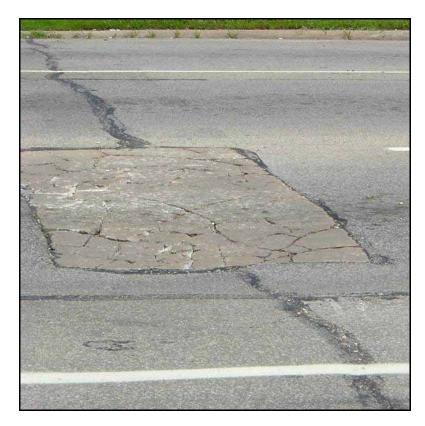
Utility cuts, specifically to repair water main breaks, are made throughout the year. Breaks that occur in the winter months are generally surfaced with a temporary cold patch installed until weather conditions improve for placing of a permanent pavement surface. Figure 5 shows an example of a utility cut constructed by a private contractor in the winter that has yet to receive a permanent asphalt surface. At the time this picture was taken, the patch was said to be three years old. With the deterioration of this temporary patch, visible map cracking can be observed in Figure 5.

Figure 5. Temporary cold patch in Cedar Rapids, with an estimated age of three years

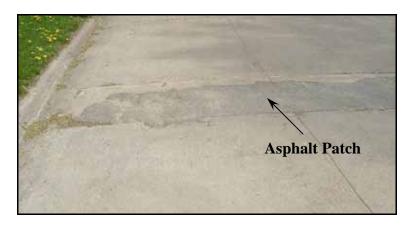
During the site visits, it was observed that in one city, utility cuts were repaired by placing asphalt near the edge of the concrete surfaced cut to compensate for the differential settlement. Applying this technique decreases the settlement impact felt by a driver; however it also decreases the aesthetic appearance of the existing roadway (see Figure 6).

Figure 6. Asphalt patch on top of concrete patch to "repair" the settlement problem

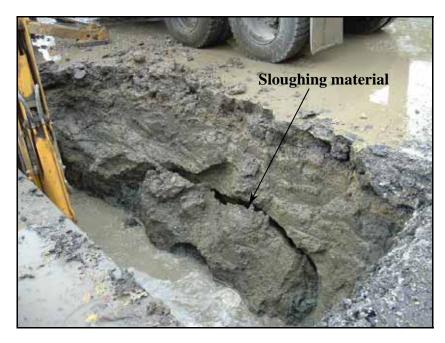
Natural factors play a role in the performance of a utility cut. For example, during an excavation of a water main break, adverse conditions occur such as that shown in Figure 7. As a result of the break, material becomes saturated and weak and begins to slough off. This in turn forms large voids underneath the existing material surrounding the cut, making adequate compaction difficult. Other problems that may arise during the reconstruction of the trench include large lift thicknesses, improper compaction, and lack of moisture control.

Figure 7. Material sloughing off the edges of the trench

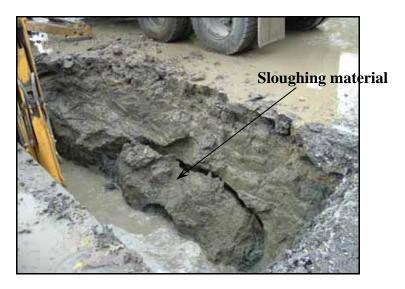
Figure 24. Material sloughing off in Ames site

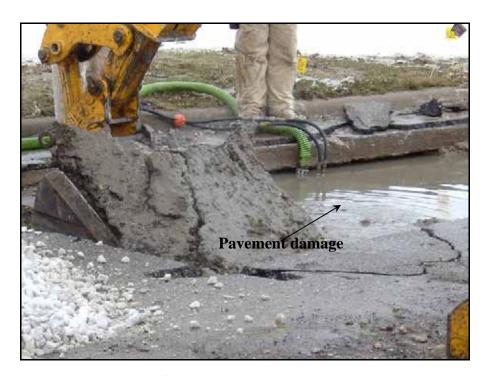
Figure 36. Saturated material being excavated

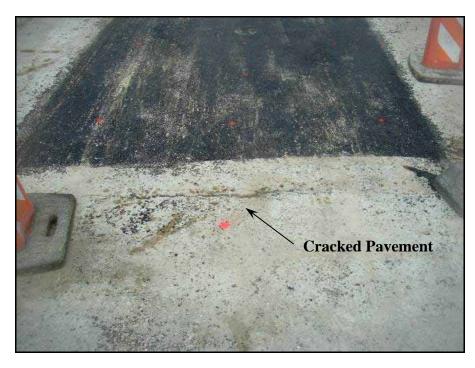
Figure 42. Visible pavement damage on utility edge

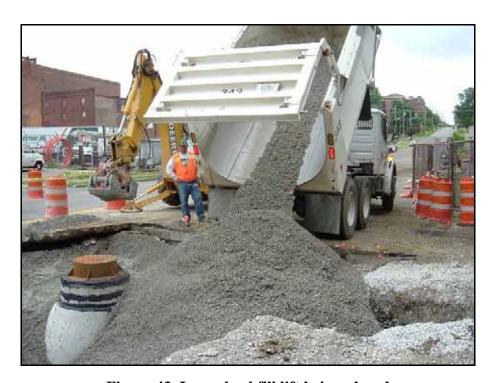
Figure 43. Large backfill lift being placed

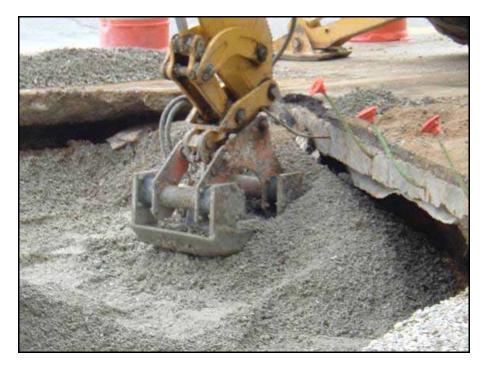
As a result of the cut, large cavities formed beneath the surrounding pavement of the trench. Figure 44 shows the large cavities and the attempt to compact this hard to reach area. These confined cavities underneath the pavement made compaction difficult using the vibrating plate on the end of a backhoe.

Figure 44. Large cavities forming beneath pavement

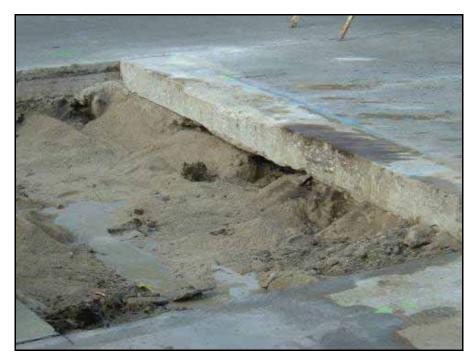
Figure 45. Backfill material caving in on trench edges
