An Experimental Validation of a Statistical-Based Damage Detection Approach

Final Report
January 2011

IOWA STATE UNIVERSITY
Institute for Transportation

Sponsored by
the Iowa Department of Transportation
(InTrans Project 08-336)

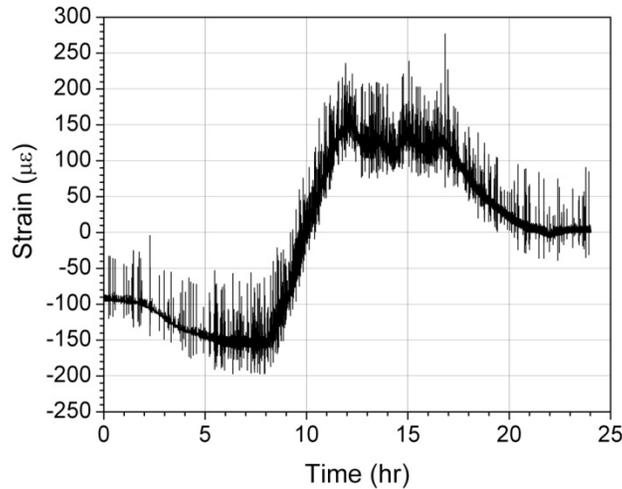
In a given 24-hour period, temperature variations create a cyclic strain response as is shown in Figure 1.1. The long rolling variation is the result of temperature fluctuations and the short vertical “spikes” are strains resulting from ambient traffic. It was found that if the data were split into approximately one-megabyte segments, corresponding to about 27 seconds, temperature variations do not exist. An average baseline can be determined for each 27-second data set. In a process called data zeroing, this average baseline is then subtracted from all data in the 27-second set, thereby creating a data set without temperature effects.

Figure 1.1 24 Hour Strain Record (Wipf, Phares, and Doornink 2007)

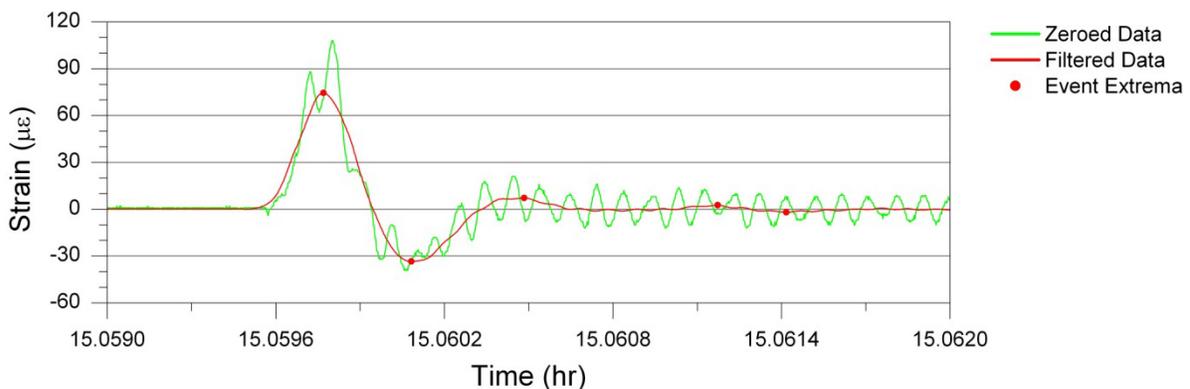
After data zeroing, the data set contains three components: random noise, the quasi-static vehicular response, and dynamic induced behaviors (Wipf, Phares, and Doornink 2007). A low-pass frequency filter is used to remove the noise and dynamic components from the data set, given that the frequencies of the quasi-static vehicular events are much lower than those of the dynamic responses and of the noise in the data file, leaving only the quasi-static response. After the zeroing and filtering is performed, vehicular events are identified within the strain data, based on a statistical and structural evaluation of the vehicular response relative to the location of a sensor. After event identification, maximum and minimum strain values, called event extrema, are identified for each event. An event after zeroing, filtering, and extrema identification is shown in Figure 1.2.

Figure 1.2 Zeroed, Filtered, and Event Extrema Identified Vehicular Event (Wipf, Phares, and Doornink 2007)

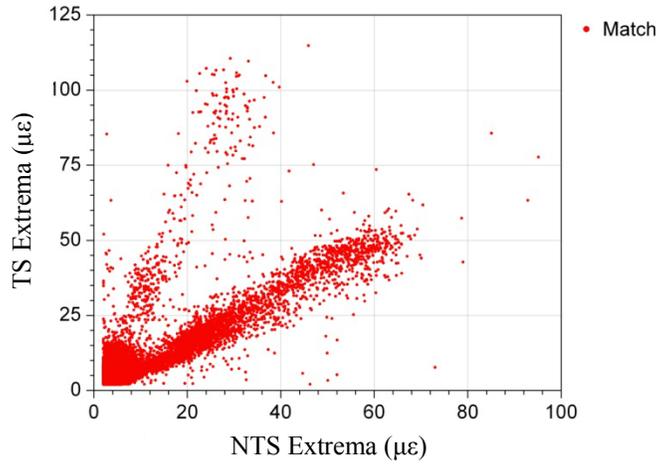
The event extrema from two sensors (one TS and one NTS) are matched to form x-y pairs that can be shown on a scatter plot (Figure 1.3). Initial data are collected during a “training” process, which defines the “normal” behavior. This process is completed for all applicable and desired sensor pairs. In some cases, up to four quadrants of pairs (maximum-maximum, maximum-minimum, minimum-maximum, and minimum-minimum) are present, depending on the sensitivity of the sensors to the longitudinal location of the vehicle. Once all scatter plots are created, limits for the data are manually set by an engineer. A typical scatter plot with defined limits is shown in Figure 1.4.

Figure 1.3 Matched Data Points from Two Sensors (Wipf, Phares, and Doornink 2007)

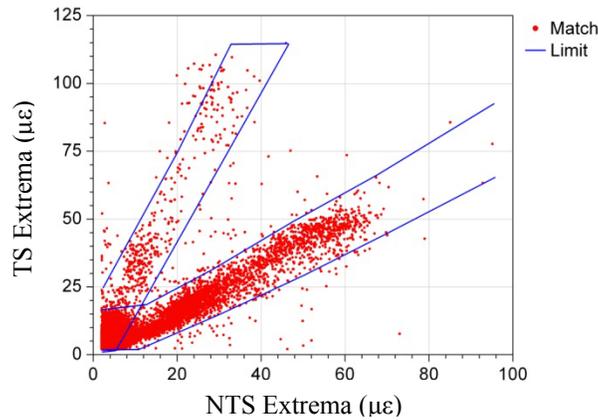
Figure 1.4 Matched Data Points with Applied Limits (Wipf, Phares, and Doornink 2007)

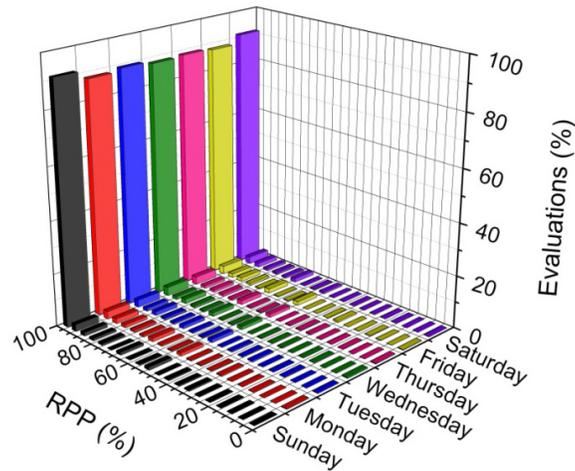
Numerous RPPs are calculated throughout the monitored time and histograms created. In the histograms from the initial bridge condition, a large grouping of assessments can be expected to have RPPs near the 100% mark as shown in Figure 1.5. If damage gradually occurs, the large grouping of RPPs can be expected to decrease from near 100% to 0% as time progresses, as illustrated in Figure 1.6. If damage occurs suddenly, the histograms can be expected to resemble Figure 1.7, where the RPP changes rapidly.

Figure 1.5 Initial Bridge Condition Daily Evaluation Histogram (Wipf, Phares, and Doornink 2007)

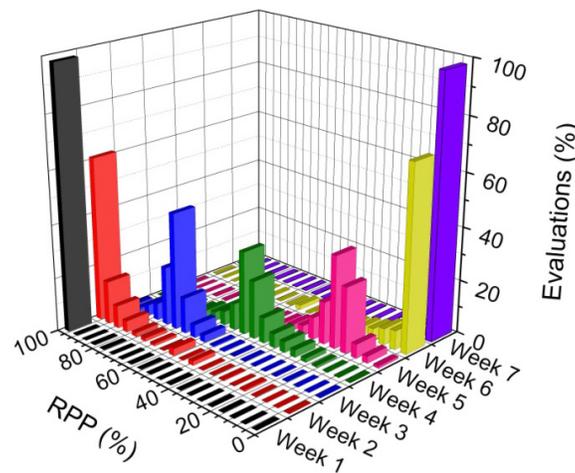
Figure 1.6 Gradually-Occurring Damage Daily Assessment Histogram (Wipf, Phares, and Doornink 2007)

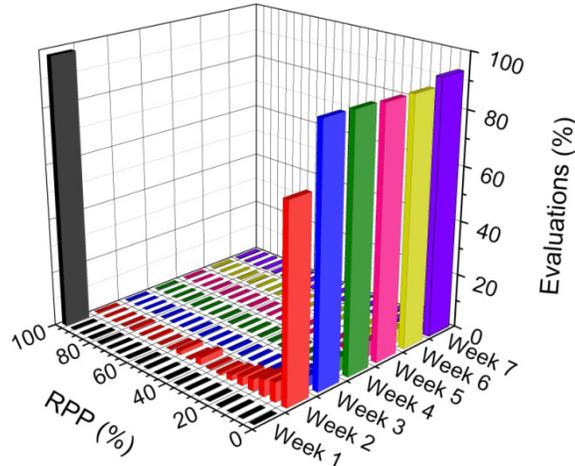
Figure 1.7 Suddenly-Ocurring Damage Daily Assessment Histogram (Wipf, Phares, and Doornink 2007)

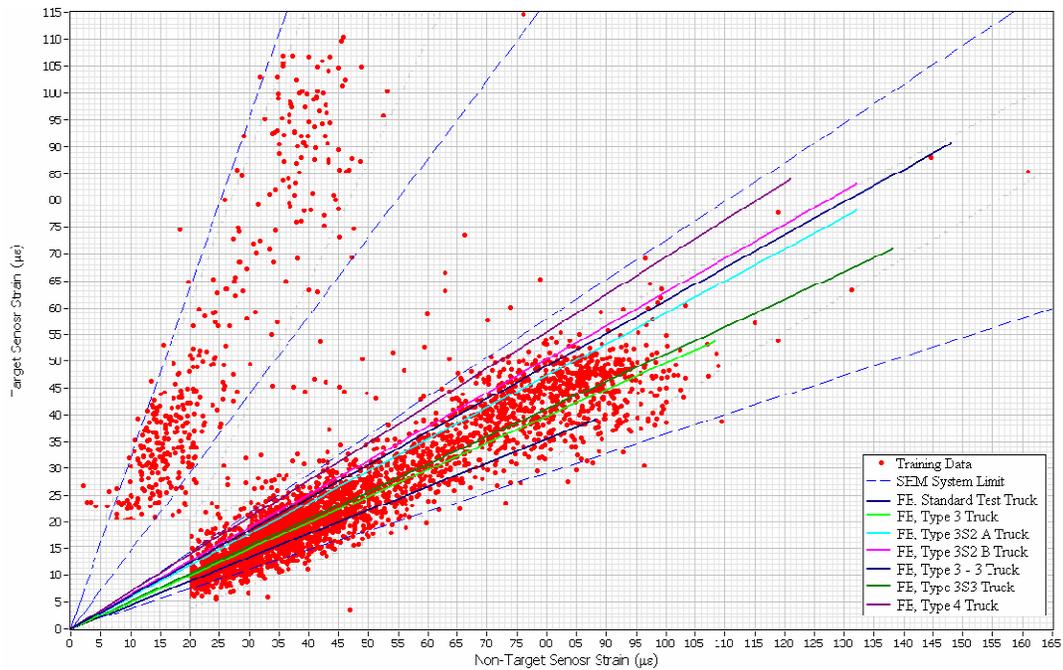
Using the FE model, Vis studied three variables impacting the TS-NTS relationships: transverse vehicle location, vehicle configuration, and damage in the bridge. The vehicle’s transverse location on the bridge can cause distinct groupings of data on the scatter plots, two of which are shown in Figure 1.8. These groupings of data can be represented by a straight line emanating from the origin of the scatter plot (Vis 2007). The straight lines were also used to represent different vehicular configurations. To show the effects of differing configurations, six truck configurations and loads were applied to the FE model. The lines representing the trucks on the scatter plot are shown in Figure 1.8, illustrating that vehicle configuration also has an effect on the TS-NTS relationship.

Figure 1.8 Sample Scatter Plot with Different Vehicular Configurations (Vis 2007)

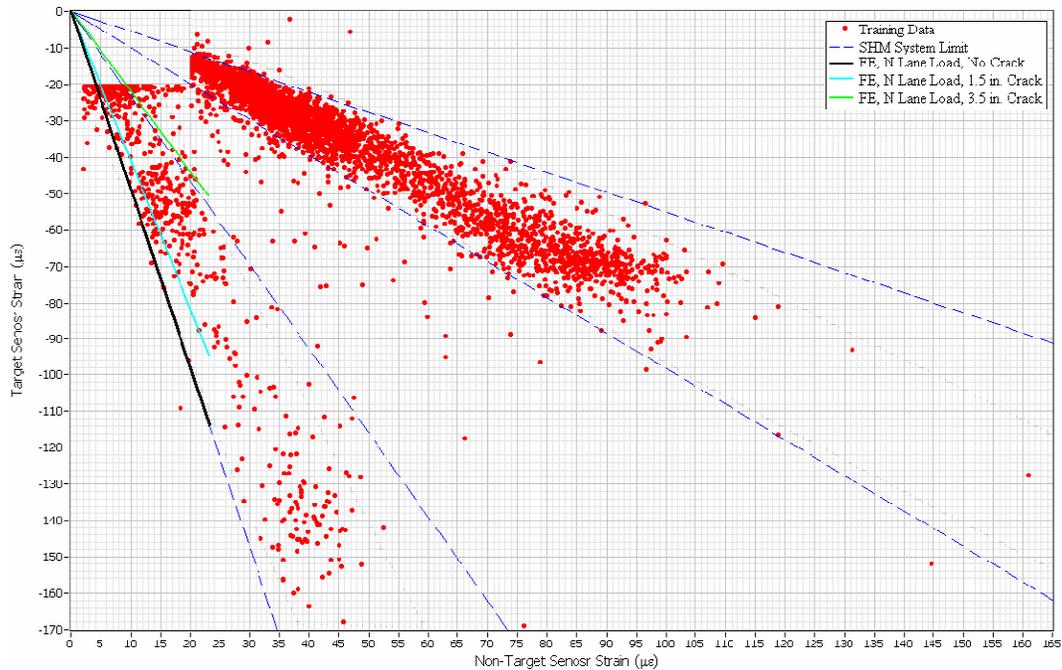
Cracks of different sizes were analytically introduced at a damage-sensitive location to determine the effects of the cracks on the TS-NTS relationship. As damage was introduced, the slope (i.e., TS-NTS ratio) of the lines changed as the crack length increased as shown in Figure 1.9. To recognize a change in the TS-NTS relationship indicative of damage Vis concluded that the TS-NTS ratio must pass beyond the range of ratios associated with both transverse vehicular location and different vehicular configurations (Vis 2007). Based on these results, it was concluded that the SHM system would likely be able to identify damage once a crack 1/16 in. in size has developed if a sensor is located near the crack.

Figure 1.9 Sample Scatter Plot with Damage Effects (Vis 2007)

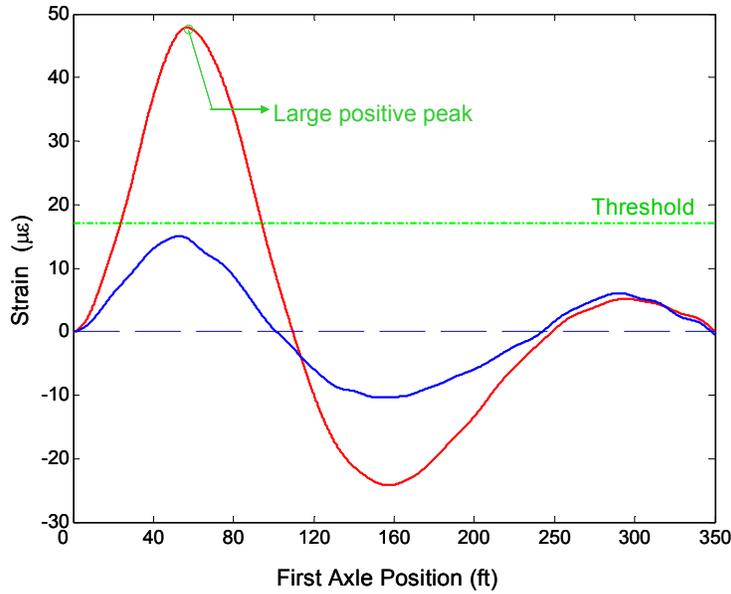
After verification by FE analysis and control tests, eight fiber-optic sensors (four sensors per transverse line in two different longitudinal locations) were installed on the deck bottom for integration into the long-term structural monitoring system. A good correlation existed between the strain peaks and truck axles, but in some cases, the truck axles were more difficult to detect than they were in the controlled load test. In these cases, a double checking algorithm was used to improve the axle detection capacity. By using the data from these sensors, other truck parameters, including speed and axle spacing, can be determined. It was found that the direct weight of each truck could not be calculated; however, the trucks could be sorted into two categories: heavy or light. In the work completed by Lu, only data from right-lane, five-axle heavy trucks were used in the damage-detection algorithm.

Figure 1.11 Truck Event Girder Bottom Strains (Lu 2008)

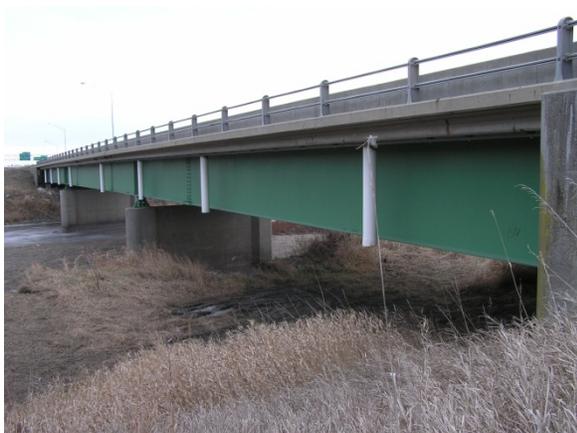
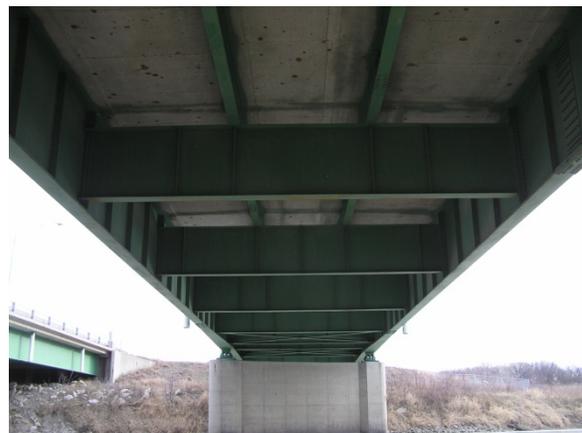
Figure 3.1 Photographs of the US 30 South Skunk Bridge (Lu 2008)

a. Side View

b. Bottom View

As with the related work preceding what’s described in this report, the bridge used for this project was the eastbound US 30 Bridge crossing the South Skunk River near Ames, Iowa (Figure 3.1). The US 30 Bridge has three spans with two equal outer spans (97.5 ft) and a longer middle span (125 ft), a width of 30 ft, and a skew of 20 degrees.

The superstructure consists of two continuous welded steel plate girders, 19 floor beams, and two stringers that support a 7.25 in. thick cast-in-place concrete deck. The bridge supports are pinned at the west pier and are roller-type supports at the east pier and at each of the abutments. The abutments are stub reinforced concrete and the piers are monolithic concrete (Lu 2008). The general bridge framing plan, along with general member dimensions, are shown in Figure 3.2.

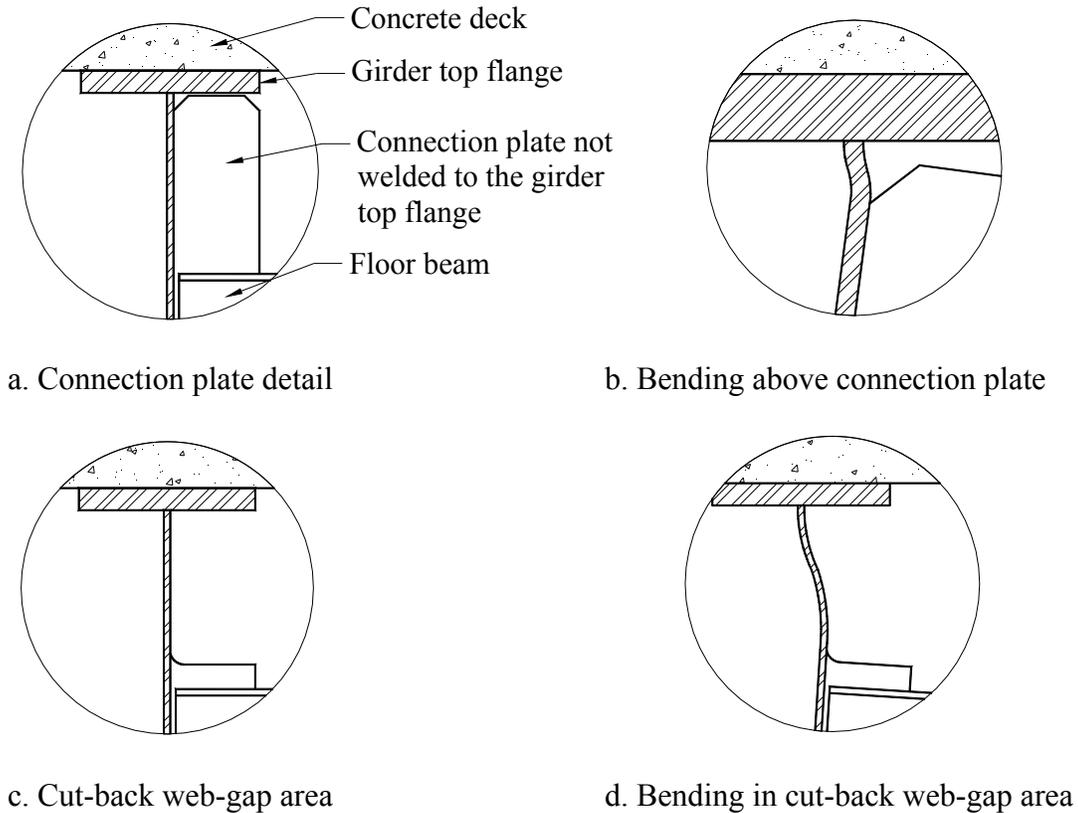
In previous research by Wipf et al., several fatigue-sensitive locations of the US 30 Bridge were instrumented with fiber-optic strain gauges. These locations are generally located at the connection between the floor beams and the web of the welded plate girders, as shown in Figure 3.3a.

Figure 3.3 Web-Gap Details and Out-of-Plane Bending Behavior (Lu 2008)

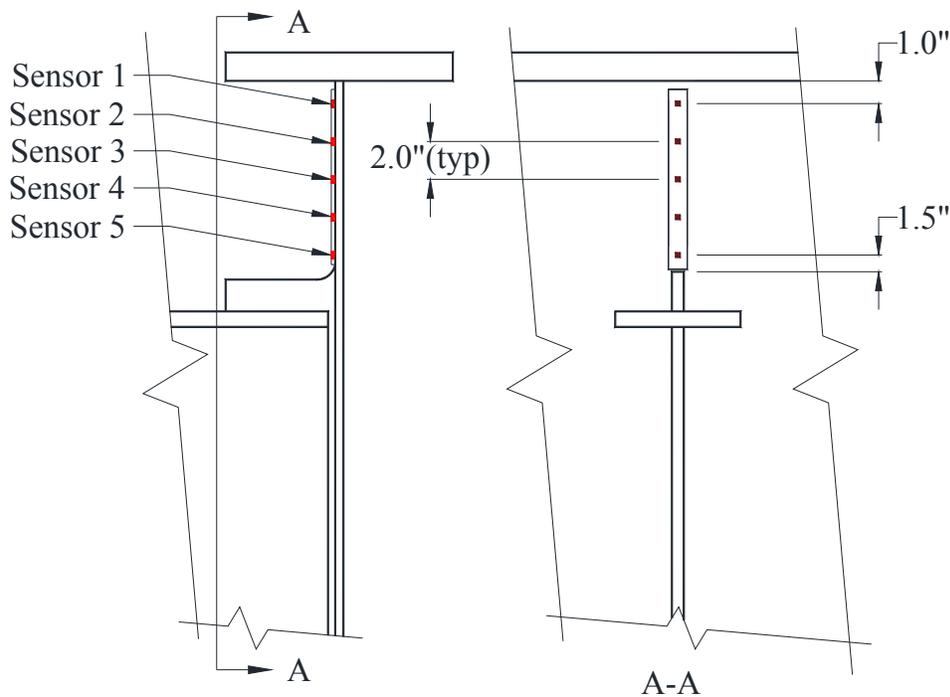
During previous work, 48 fiber-optic strain gauges were installed on the bridge. Numerous fiber-optic strain gauges were placed in the web cut-back regions to monitor the strain caused by live loads. Figure 3.4 shows the location of the five-sensor array at Section C, on the north girder, cut-back region (C-NG-CB), which is geometrically similar to all web gaps. Note that the sensor numbers shown in Figure 3.4 will be used elsewhere in this report.

Figure 3.4 Typical Instrumented Web-Gap

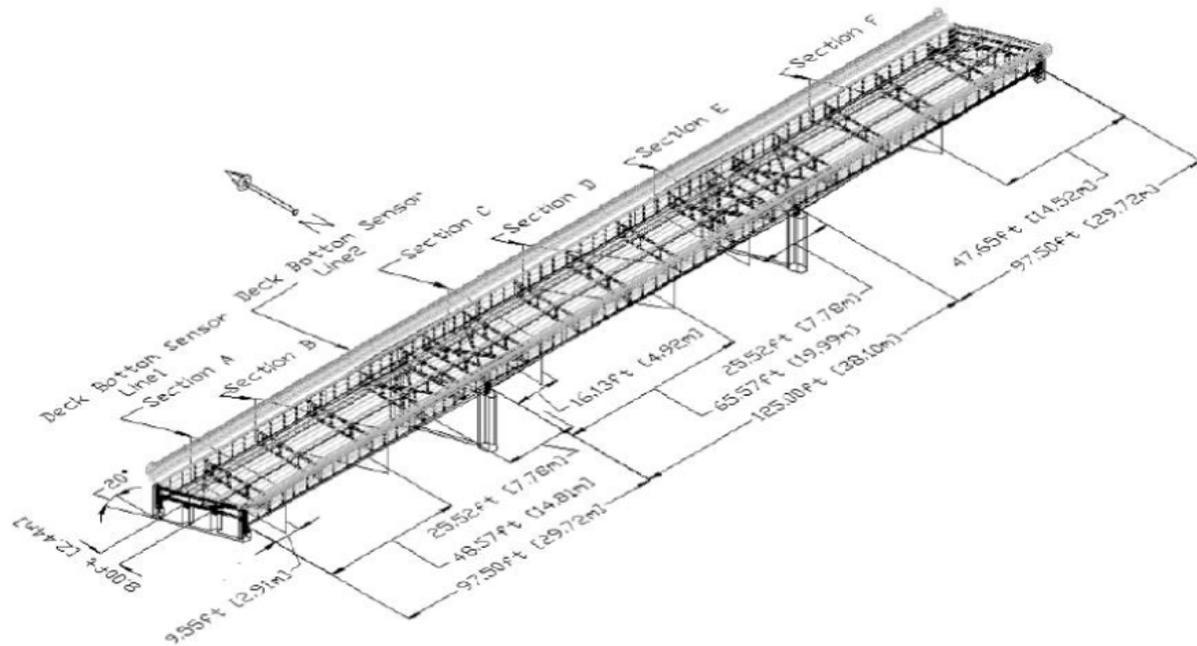
Sensors were also placed at numerous other locations on the US 30 Bridge. These sensors were distributed across six cross-sections (Figure 3.5) and are aligned in two orientations: vertical or horizontal. Sensors were installed on the bottom flanges of the two plate girders, the bottom flanges of multiple floor beams, the bottom flanges and webs of the stringers, and on the deck bottom. The distribution of the sensors across the different cross-sections (Sections A through F and Lines 1 and 2) is summarized in Figure 3.6.

Figure 3.5 Cross Sections of US 30 Bridge and Sensor Longitudinal Locations (Lu 2008)

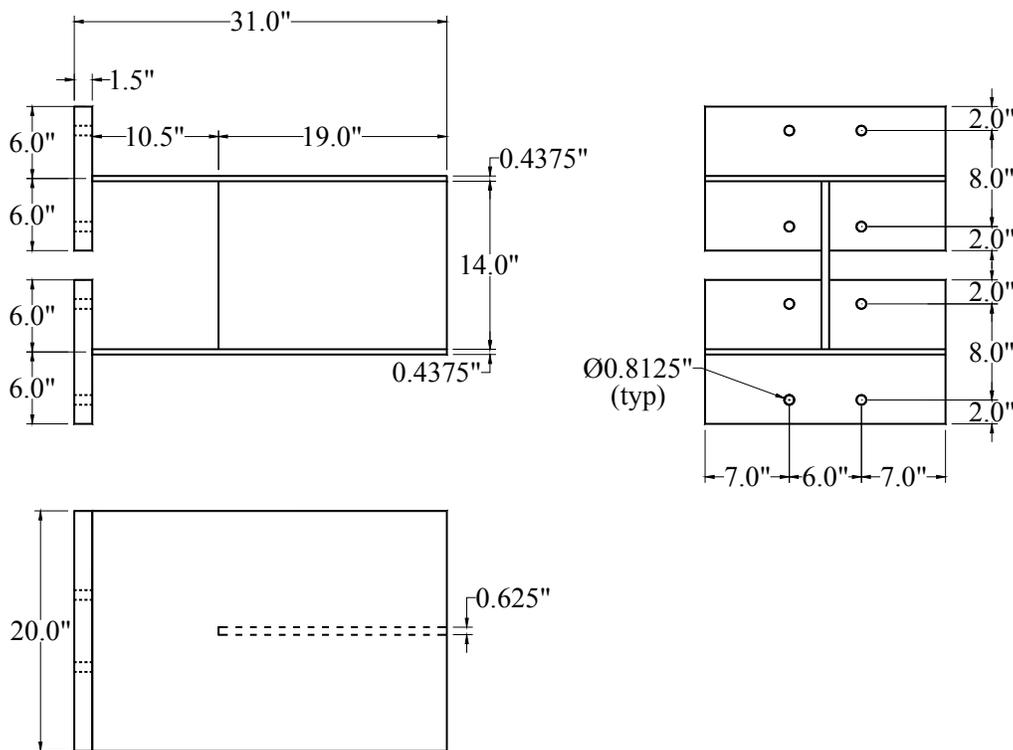
The sacrificial specimen details are shown in Figure 3.7 and a photograph is shown in Figure 3.8. To encourage similar strain levels and behaviors, the sacrificial specimen plate thicknesses and welds were designed to match those found on the US 30 Bridge.

Figure 3.7 Sacrificial Specimen Geometric Details

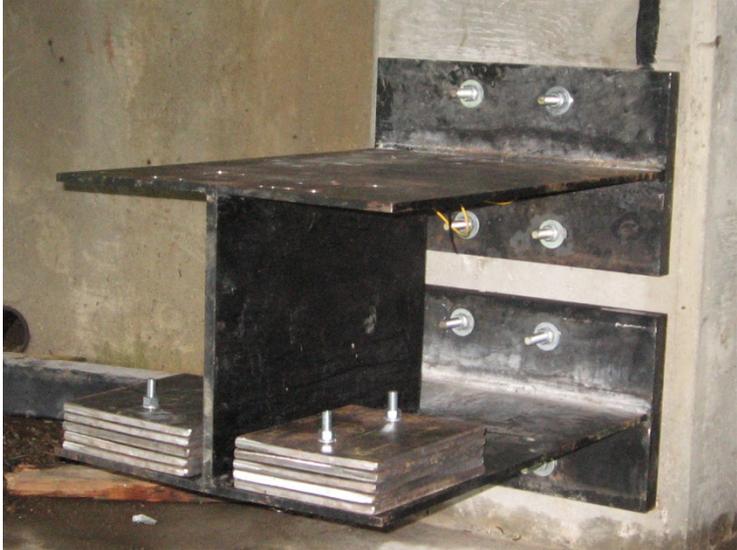
Figure 3.8 Photo of Sacrificial Specimen

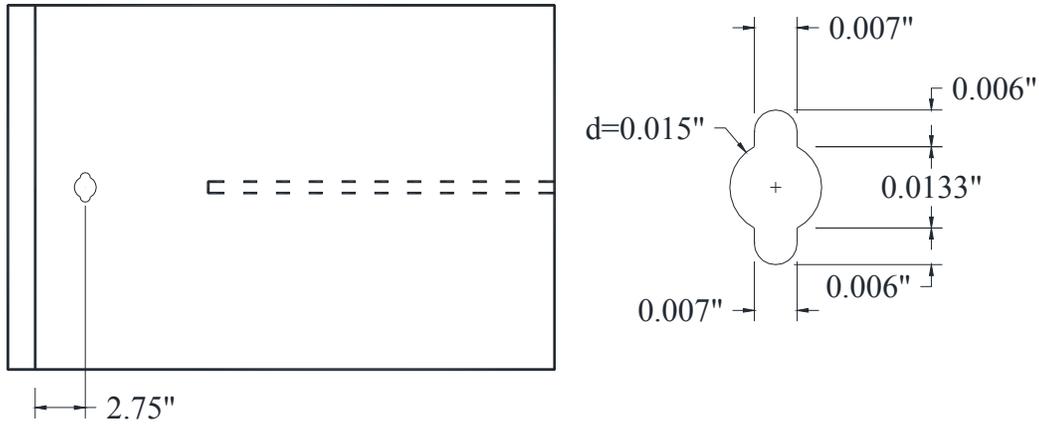
Sacrificial Specimen 1 modeled two web-gap areas connected together by a simulated connection plate, which in turn helps to transform the ambient traffic loads into double curvature bending of the simulated web-gaps. When subjected to high strains and a large number of cycles, a crack was expected to initiate at the EDM notch. Different damage levels were introduced in sacrificial Specimen 1 and are discussed in later paragraphs.

Figure 3.12 Dimensions and Location of Notch

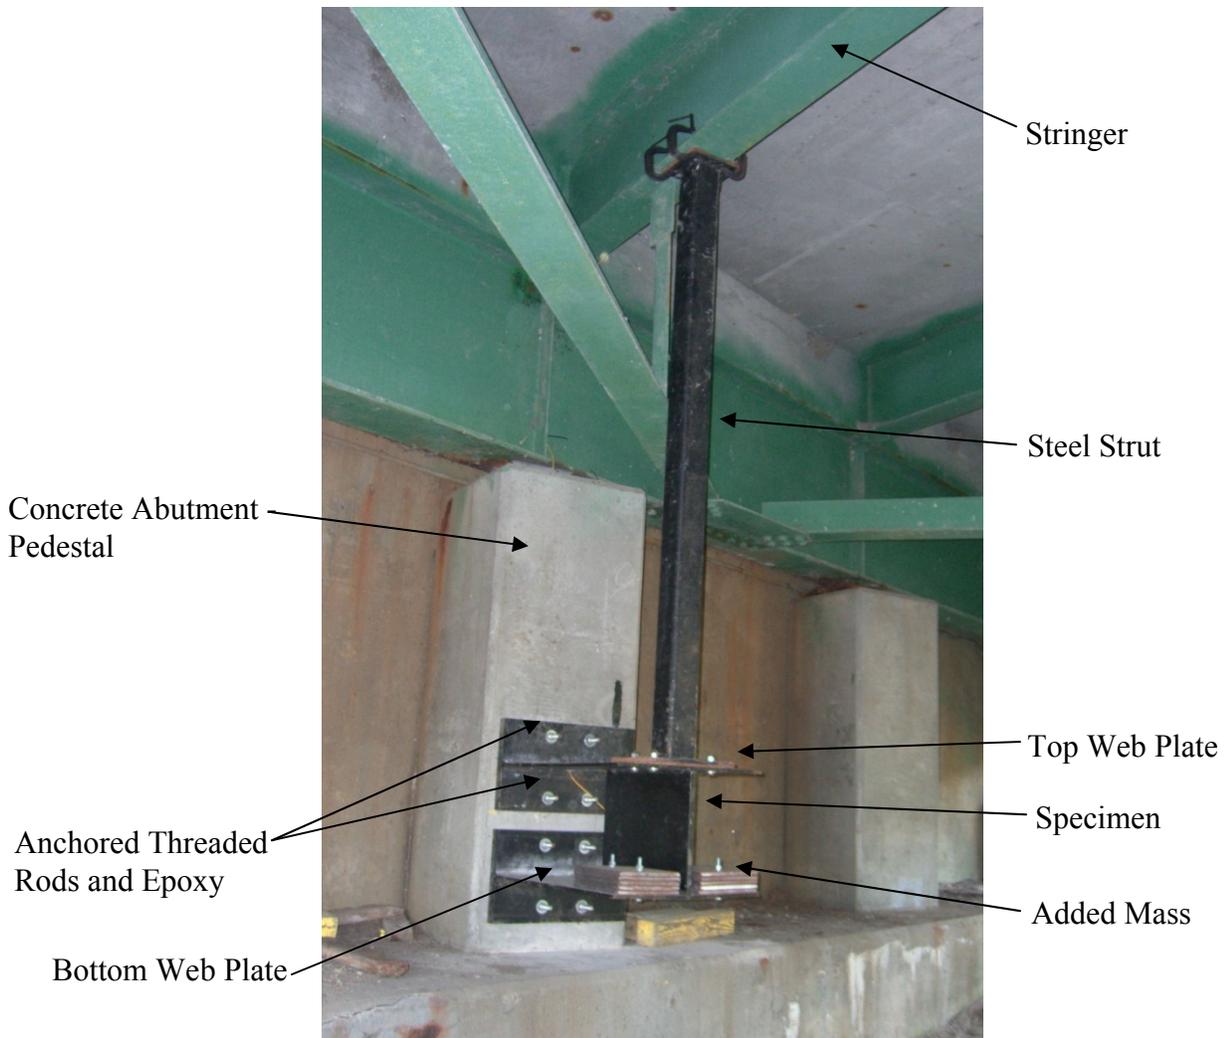
Figure 3.14 Photograph of Typical Installed Sacrificial Specimen

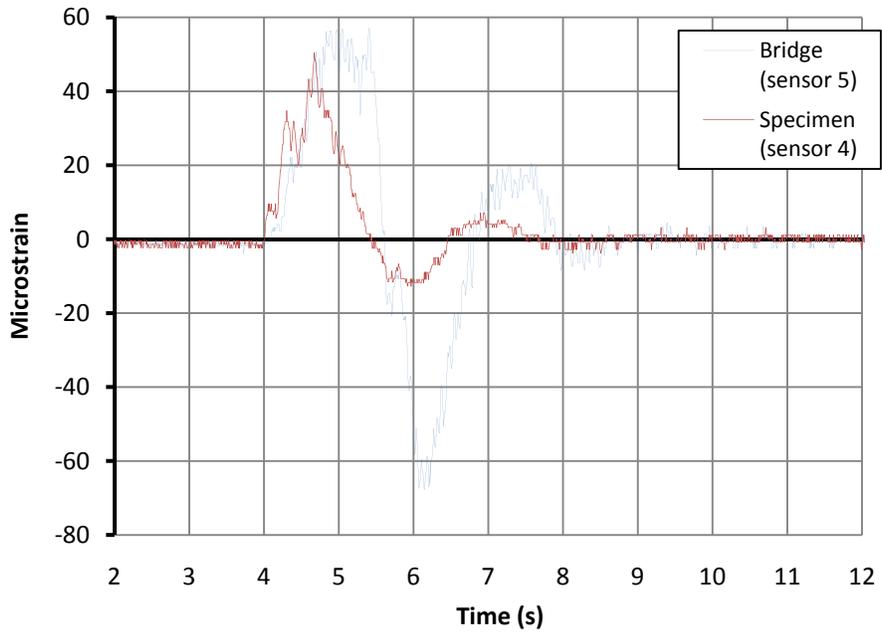
Typical strain vs. time curves for both the bridge and the sacrificial specimen web-gaps are shown in Figure 3.15. These data were produced by a single, five-axle truck driving across the bridge. Note that the strains for the sacrificial specimen web gap were collected using a four-sensor array, whereas strains in the bridge web gap were collected using a five-sensor array. As a result, the gauges were not measuring strain at exactly the same location in the web-gap.

Figure 3.15 Strain Response in Web-Gaps Due to Typical Five-Axle Truck

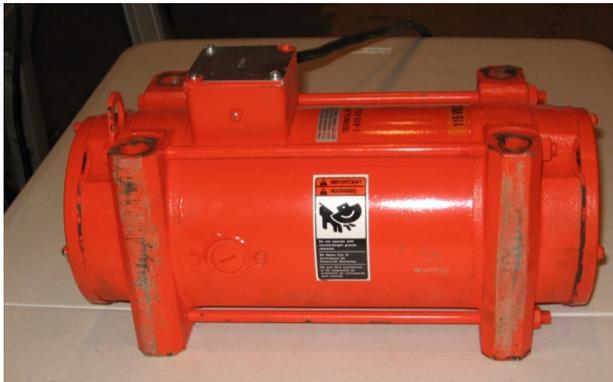
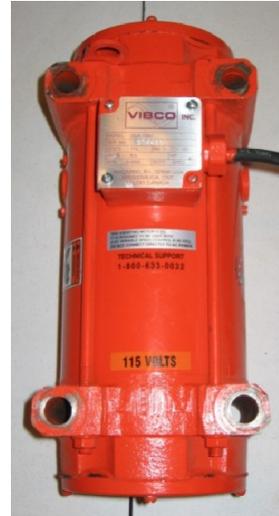
Figure 3.17 Photographs of Rotary Shaker

a. Side View

b. Top View

The first type of damage induced was fatigue cracking. Accelerated fatigue damage was created by subjecting the sacrificial specimen to many cycles of loading using the rotary shaker shown in Figure 3.17.

The rotary shaker is a motor with eccentric weights, which rotate at a user-specified frequency up to 100 Hz. The rotary shaker may be “dialed in” to the resonant frequency of the attached object to create very large strain values and number of cycles. To accumulate damage quickly, the shaker was bolted to the free end of the sacrificial specimen and then operated near the natural frequency of the sacrificial specimen. This induced high levels of strain at the high rate needed to create fatigue cracks in a relatively short time.

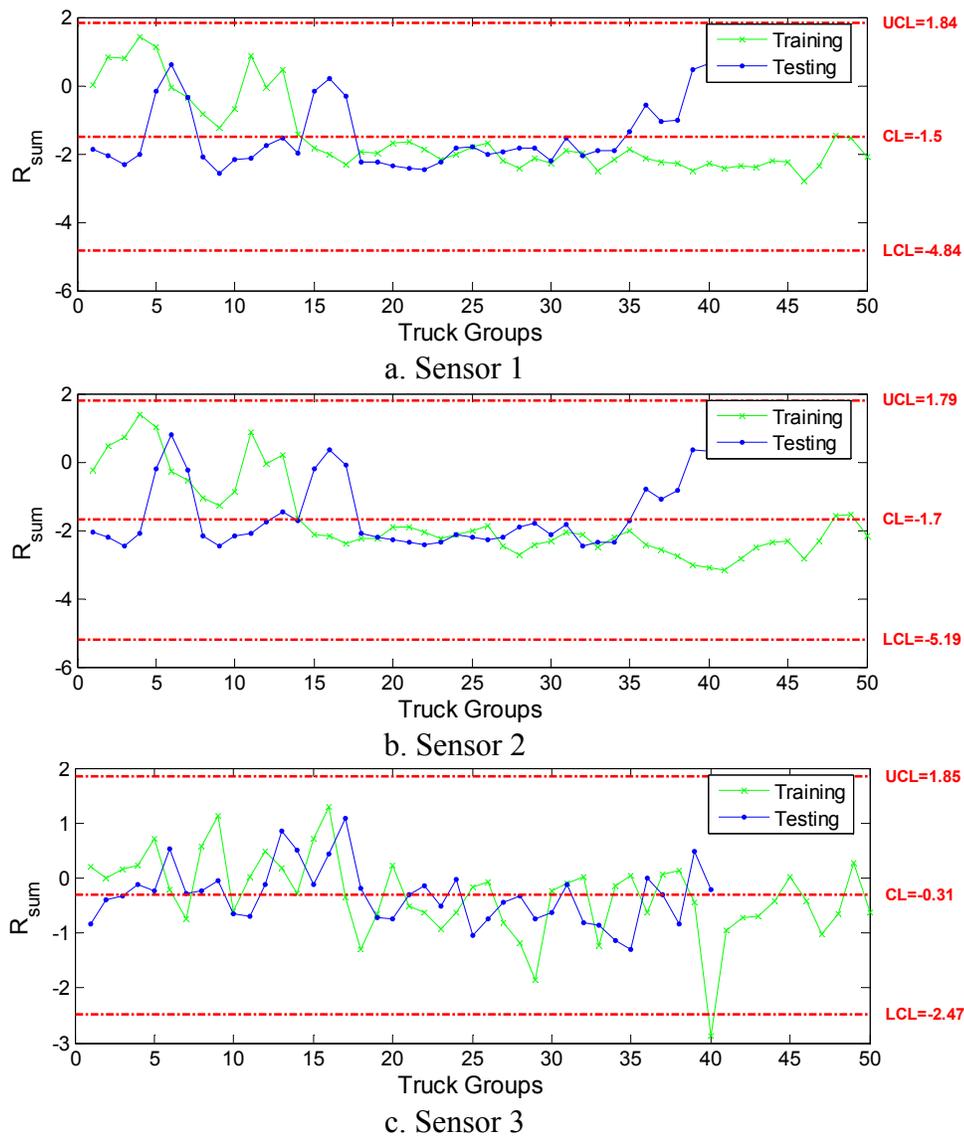
Figure 4.1 Undamaged Sacrificial Specimen 1 Control Charts

The control limits in each of the charts shown in Figure 4.3 match the control limits shown on the corresponding charts in Figure 4.1. For Sensors 2, 3, and 4, all of the R-sum values are outside of the control limits, indicating damage was detected. Because the damage is located closest to Sensor 4, it was expected that a large number of points would be outside the control limits; indeed, in Figure 4.3d all point are outside the control limits. Sensors 2 and 3, shown in Figure 4.3b and Figure 4.3c, respectively, also have every point outside the control limits. This fact may be an indication that the damage that occurred near Sensor 4 was quite severe (i.e., the farther away damage is detected from the source, the more severe the damage).

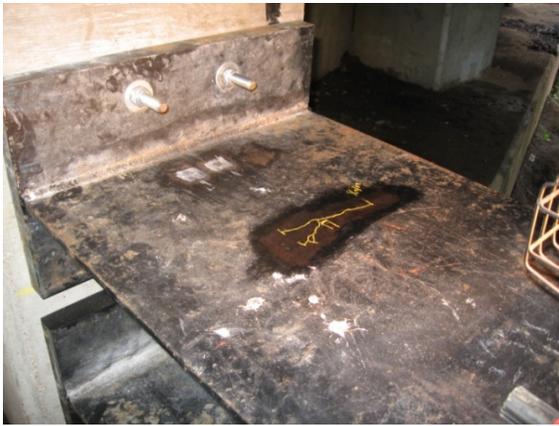
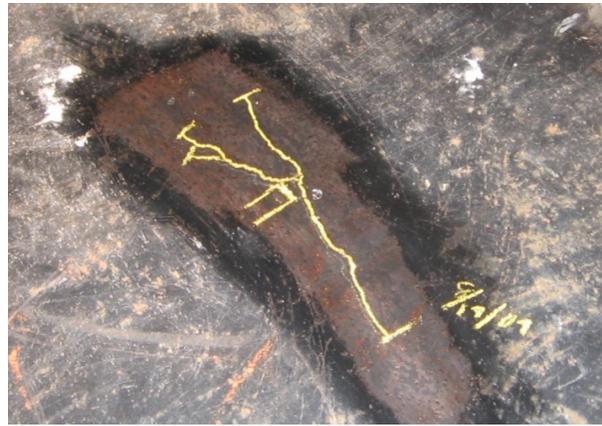
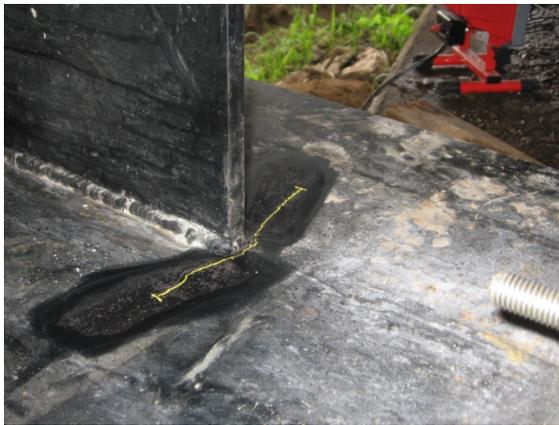
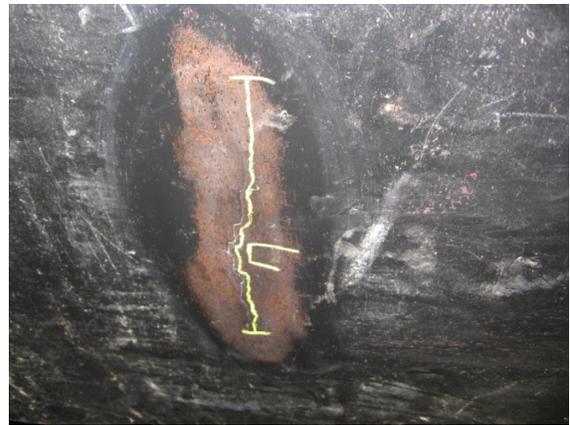
a. Top web plate cracking

b. Close-up of top web plate cracking

c. Bottom web plate cracking

d. Underside of bottom web plate cracking

Figure 4.2 Photographs of Sacrificial Specimen 1 Cracking

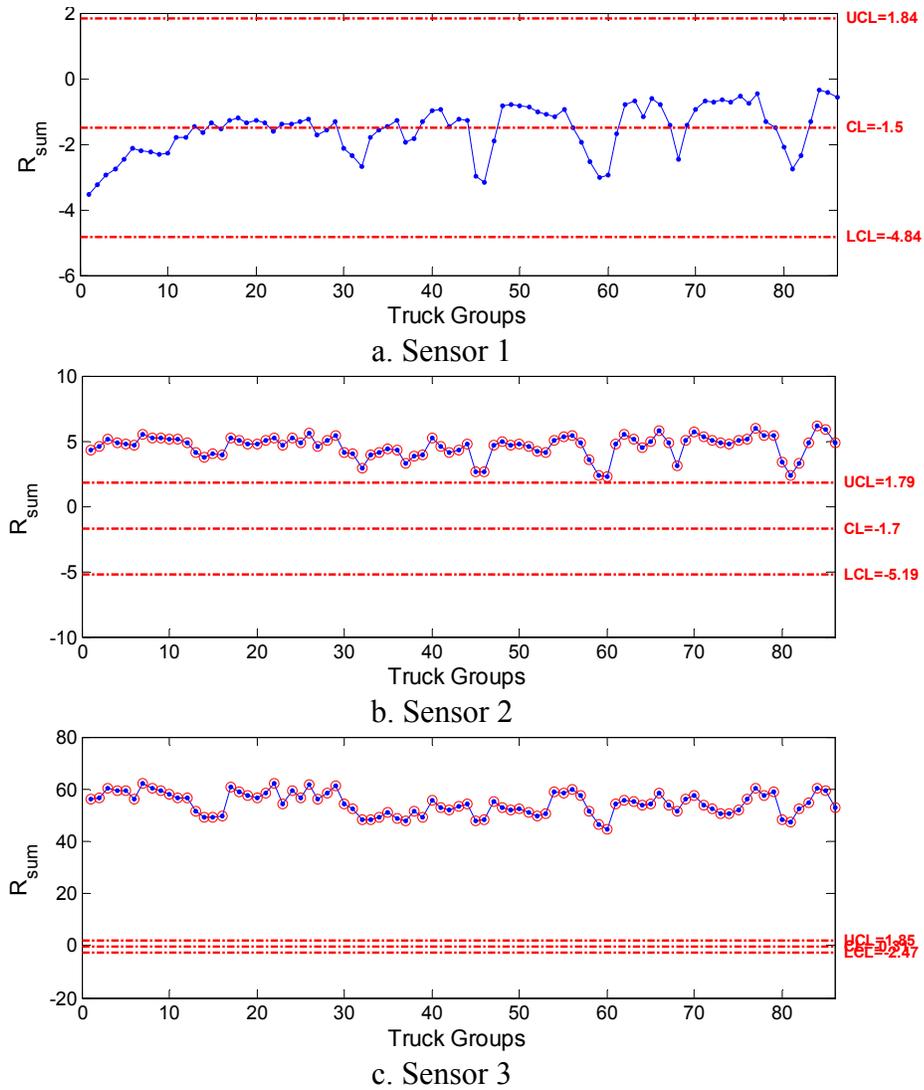
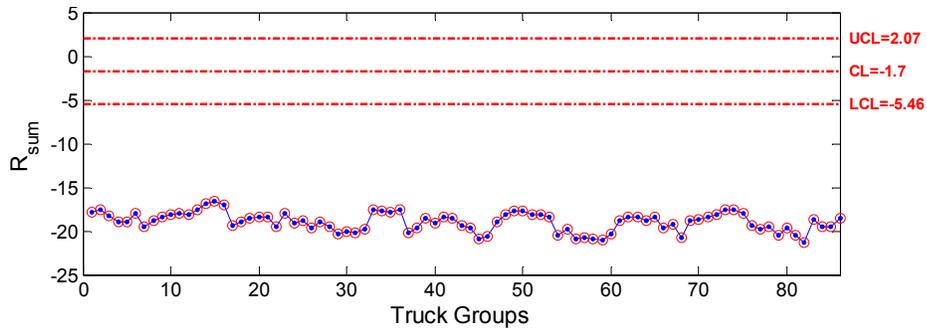
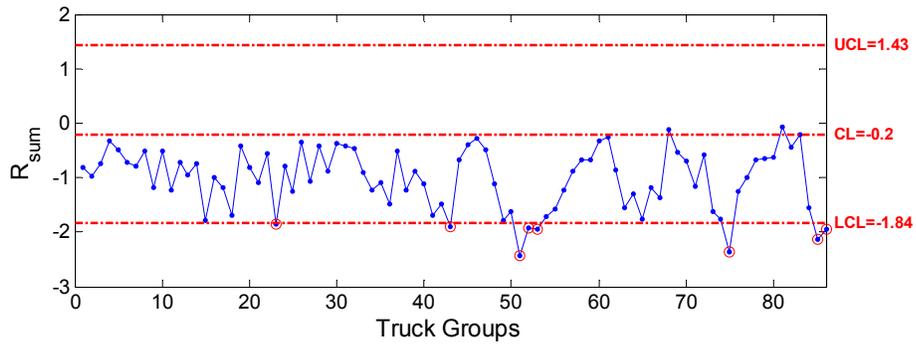
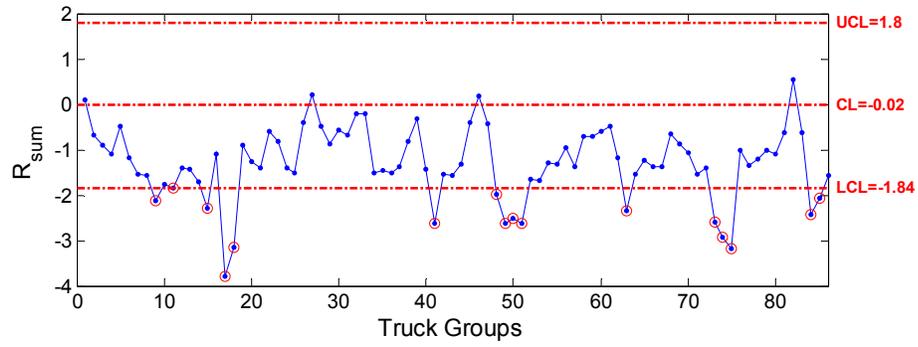
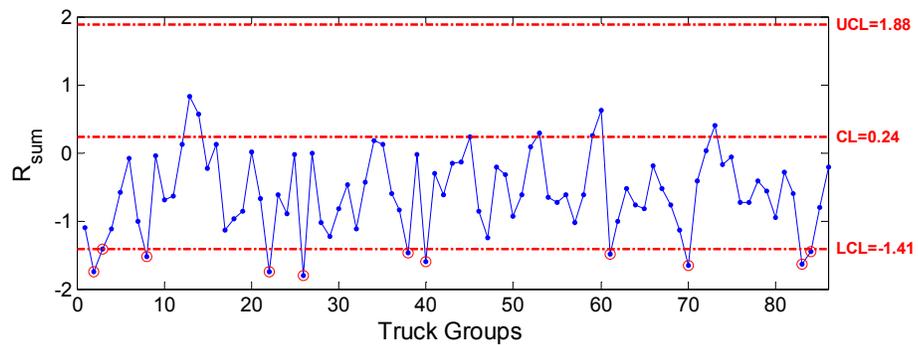
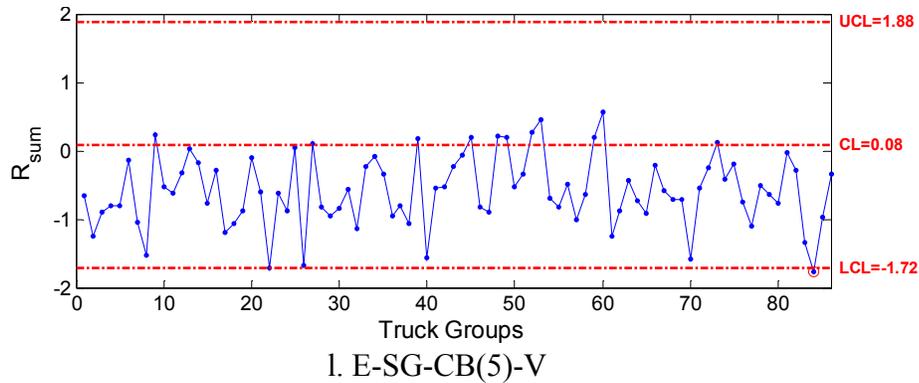
Data were collected from the damaged sacrificial Specimen 1 from August 25, 2009 to September 4, 2009. A total of 2,415 right-lane five-axle trucks were detected and, among them, 860 of the 2,415 were classified as heavy trucks. R-sum values for each sensor were calculated (using a truck group size of 10) and then plotted on the previously-constructed control charts (Figure 4.3).

Figure 4.3 Post-Damage Sacrificial Specimen 1 Control Charts

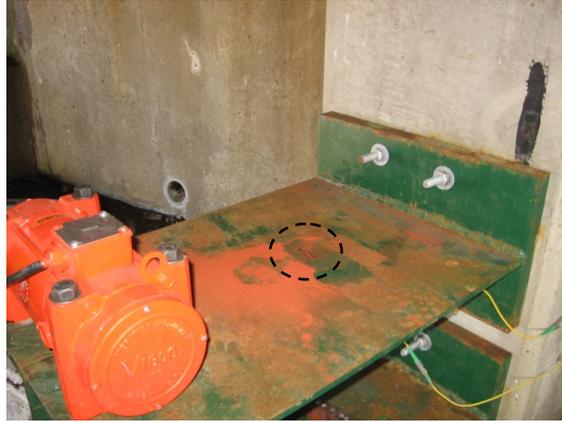
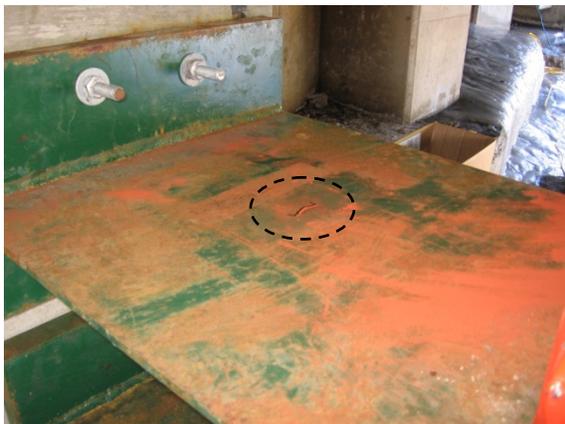
a. Overview of Top Web-Plate Cracking

b. Top Web-Plate Cracking

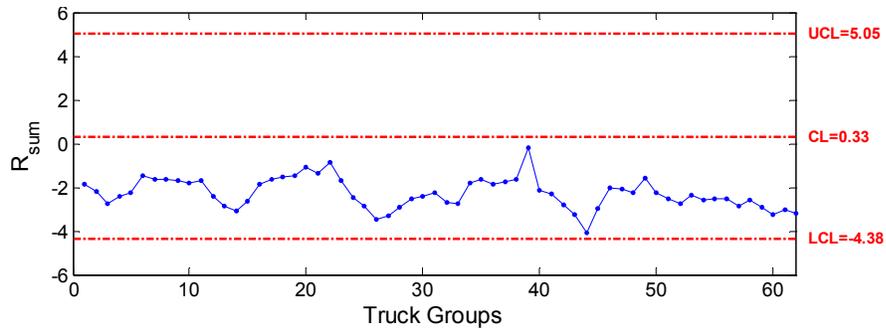
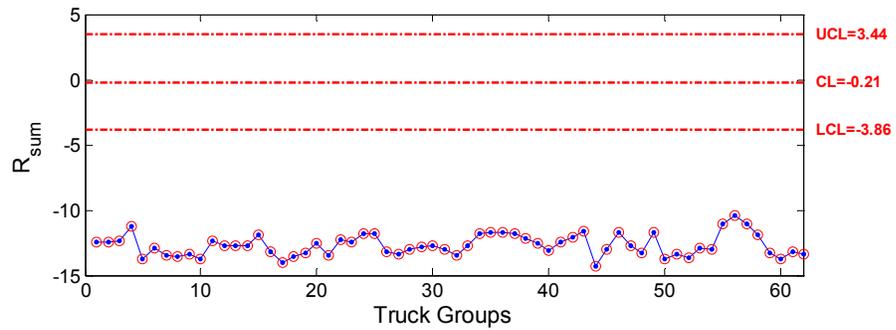
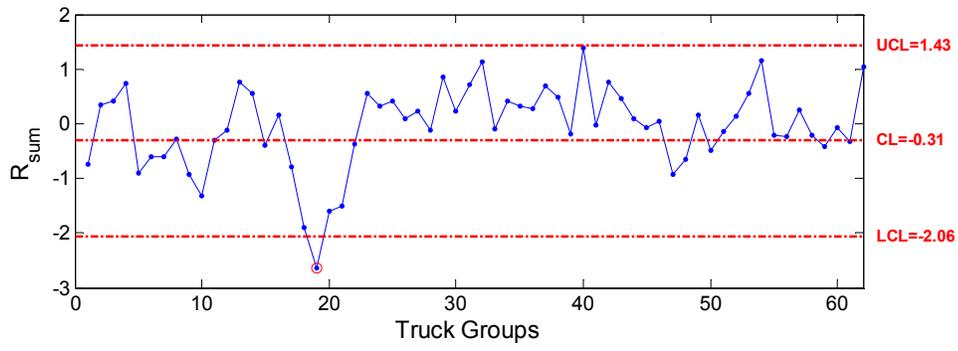
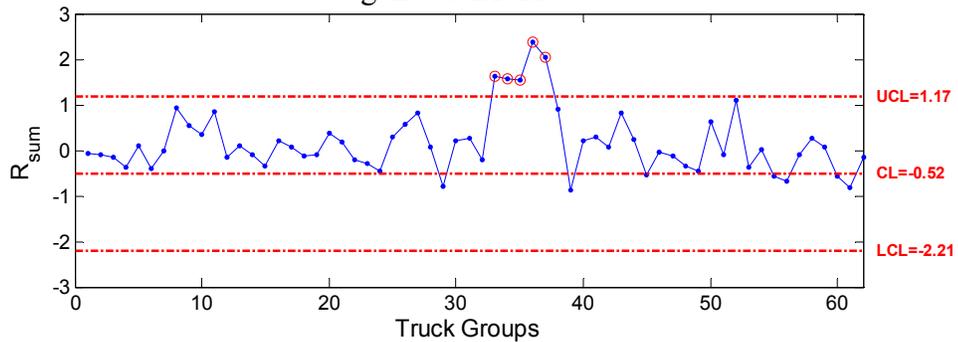
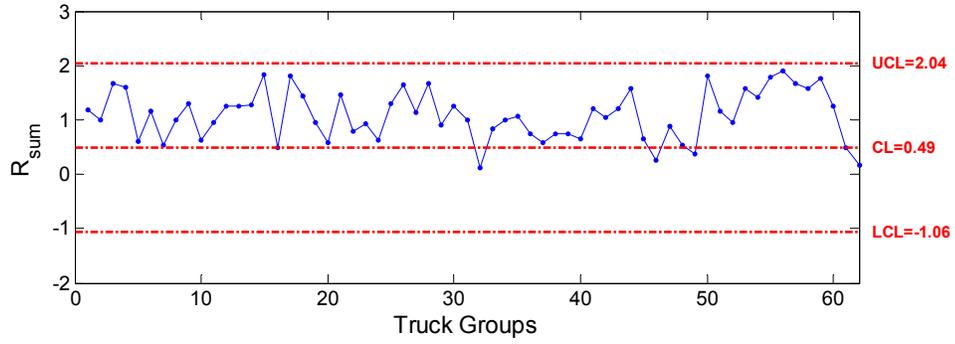
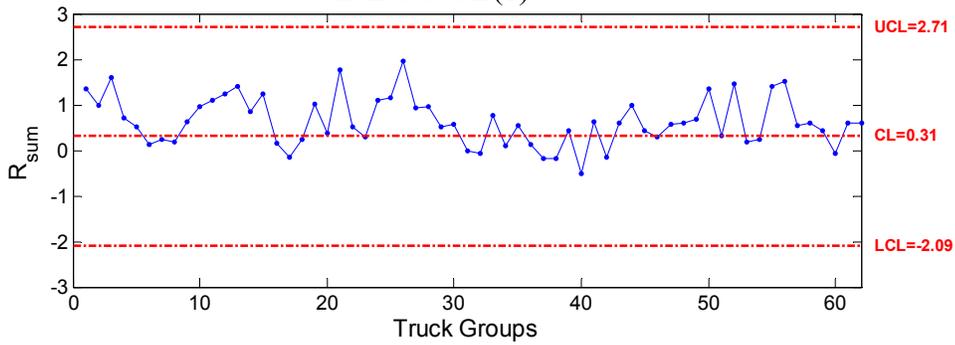
Also noticeable in Figure 4.6f and Figure 4.6h are the higher percentage of R-sum values outside of the control limits. In Figure 4.6f, 14.5% of the R-sum values are outside the control limits and in Figure 4.6h, 8.1% of the R-sum values are outside the control limits. As discussed earlier, this may be due to the large values provided by the sensors on Specimen 2, which may shift multiple R-sum values outside the control limits, even though damage may not be present at those other locations. The typical unidirectional shift in R-sum values was not observed for sensor D-SG-BF-H in Figure 4.6f. This figure shows multiple R-sum values outside both the upper and lower control limits. Even though a distinct shift in the R-sum values is not present, the cause of the R-sum values outside of the control limits may still be the inclusion of the larger-than-average Specimen 2 sensor residuals in the column- and row-sum calculations.

Figure 4.6 Post-Damage Sacrificial Specimen 2 Control Charts (1.25 in. crack)
