An Experimental Validation of a Statistical-Based Damage Detection Approach

Final Report
January 2011

IOWA STATE UNIVERSITY
Institute for Transportation

Sponsored by
the Iowa Department of Transportation
(InTrans Project 08-336)

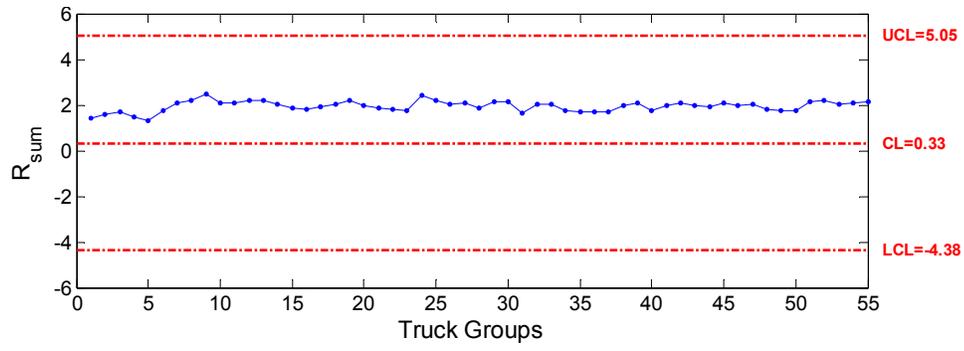
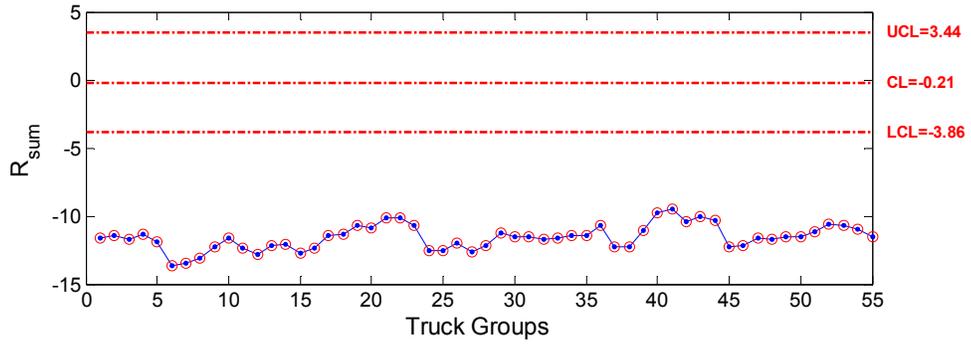
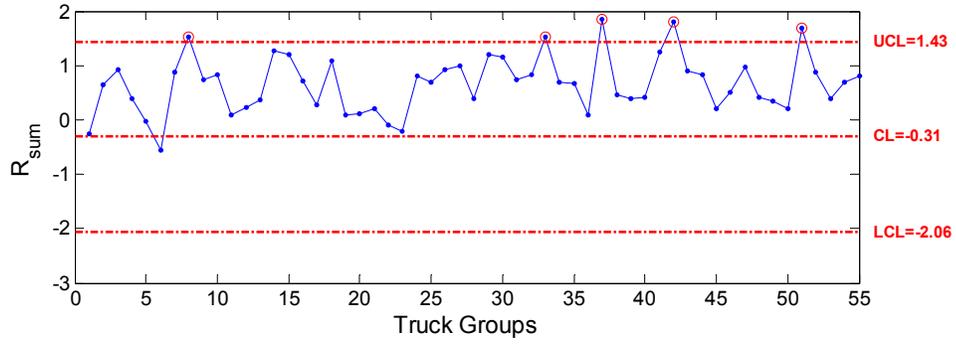
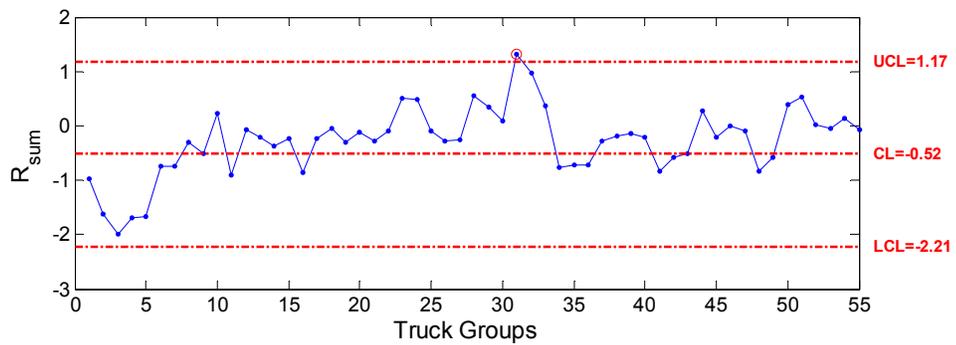
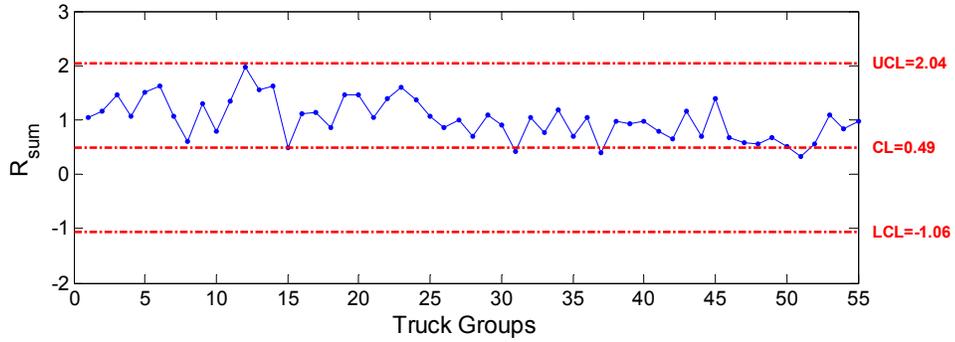
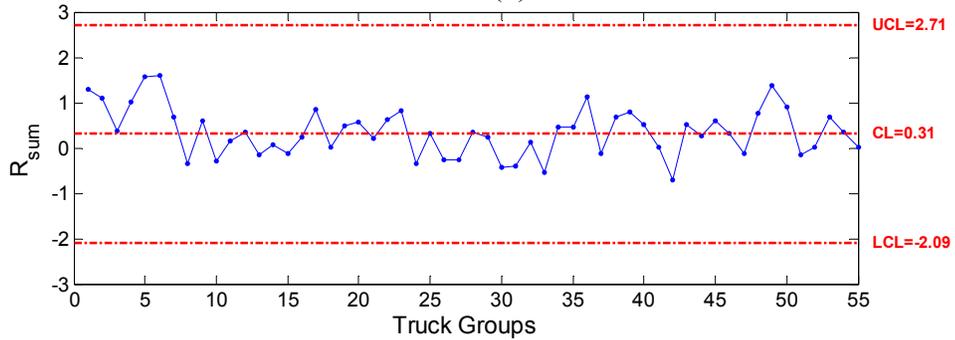
Figure 4.7 Post-Damage Sacrificial Specimen 2 Control Charts (1.50 in. crack)

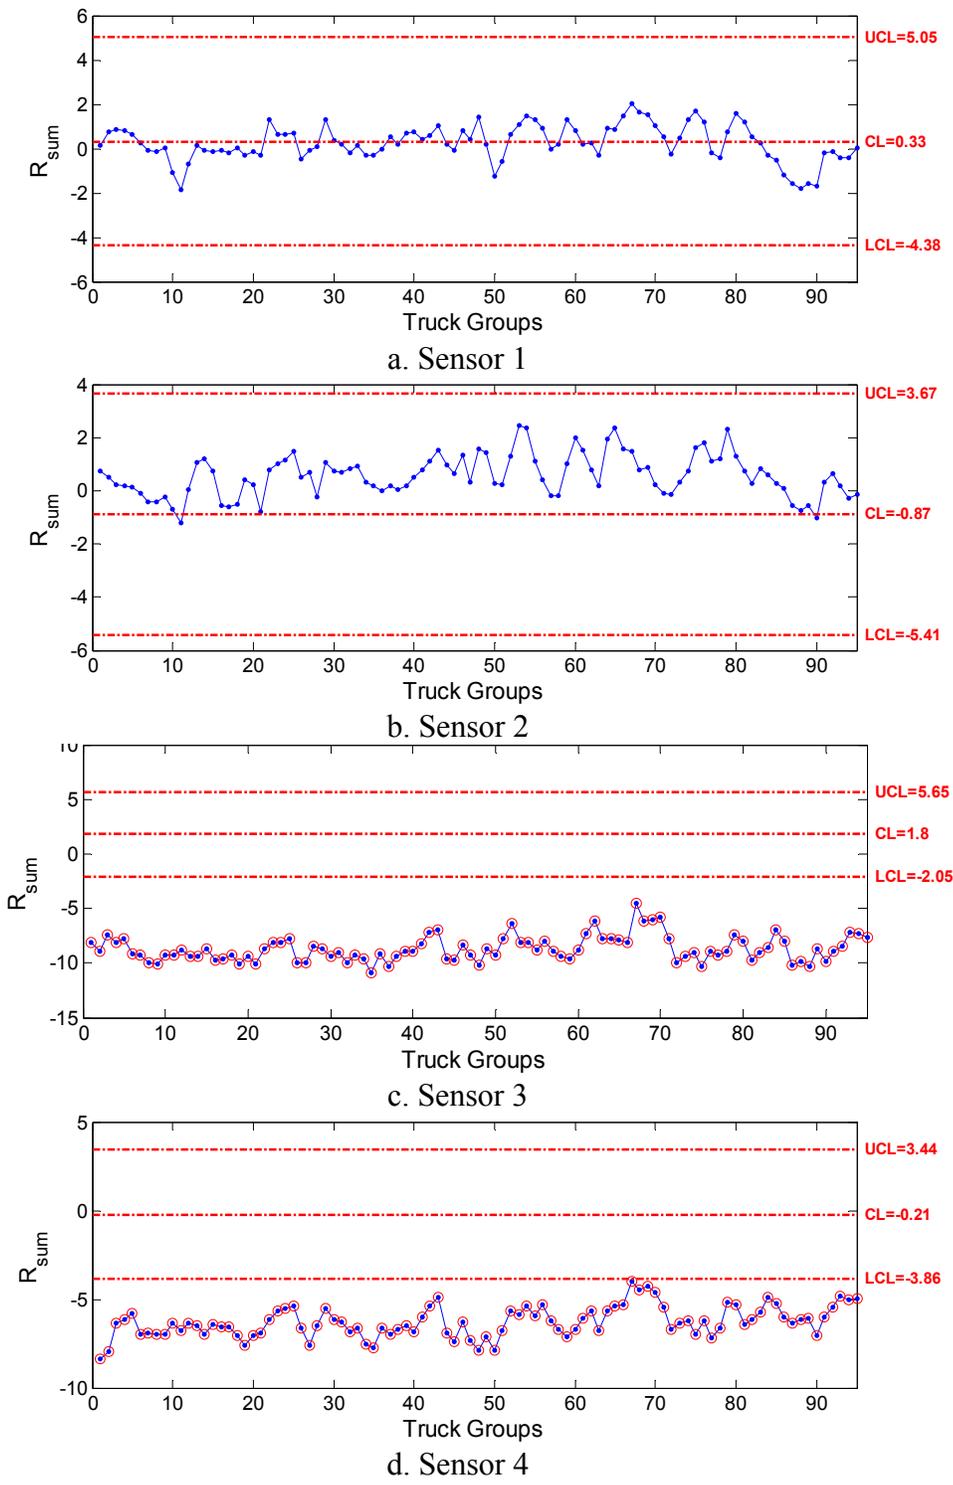
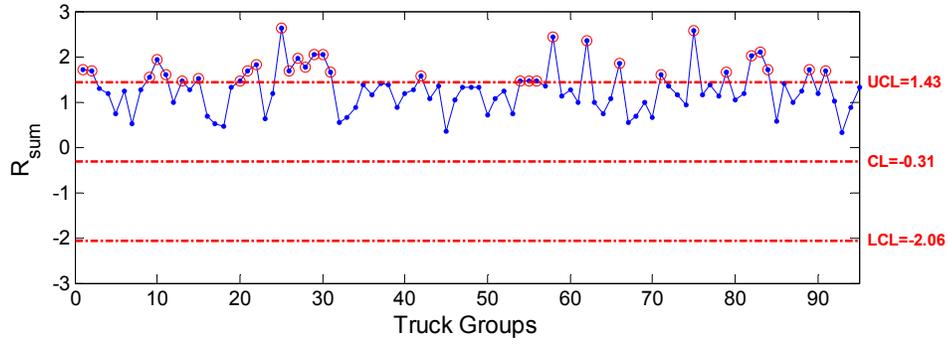
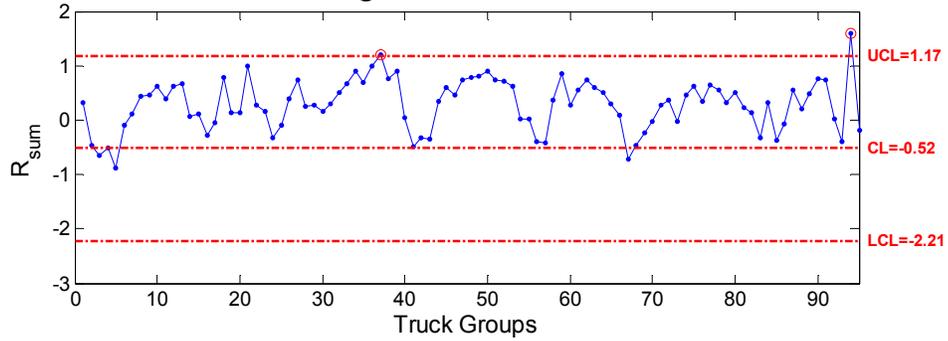
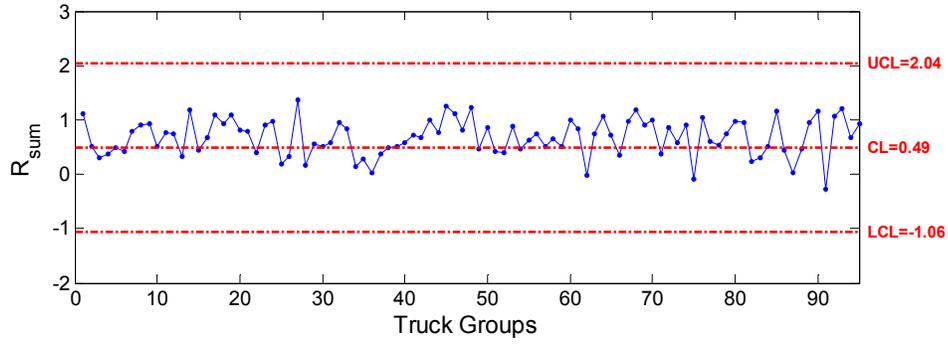
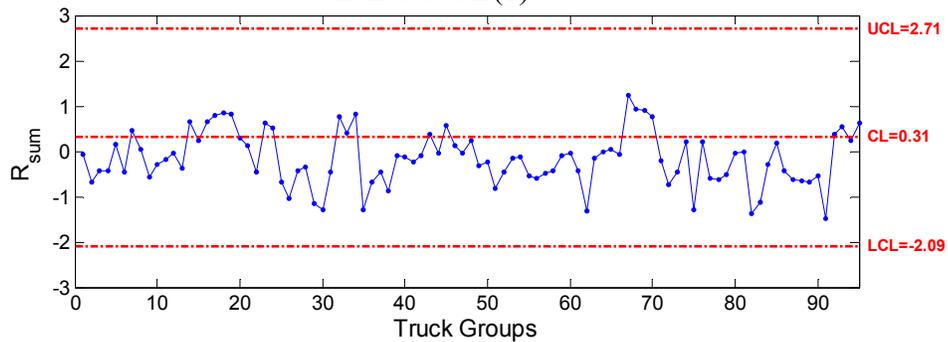
The control charts for the sensors not on Specimen 2 are shown in Figure 4.8e through Figure 4.8l. All of these control charts show an acceptable number of R-sum values outside the control limits except for sensors B-NG-BF-H and C-SG-CB(5)-V in Figure 4.8e and Figure 4.8i, respectively. Figure 4.8e shows a high percentage (33.7%) of R-sum values above the UCL and also shows an upward shift of the entire set of R-sum values. Figure 4.8i also shows a large percentage (60%) of R-sum values below the LCL, as well as a downward moving shift of the R-sum values. Again, the data in both of these cases were influenced by the residual values from the sensors on Specimen 2 in the column- and row-sum calculations. Further modifications to the damage-detection algorithm are needed to address the high false-positive rate.

Figure 4.8 Post-Damage Sacrificial Specimen 2 Control Charts (1.75 in. crack)

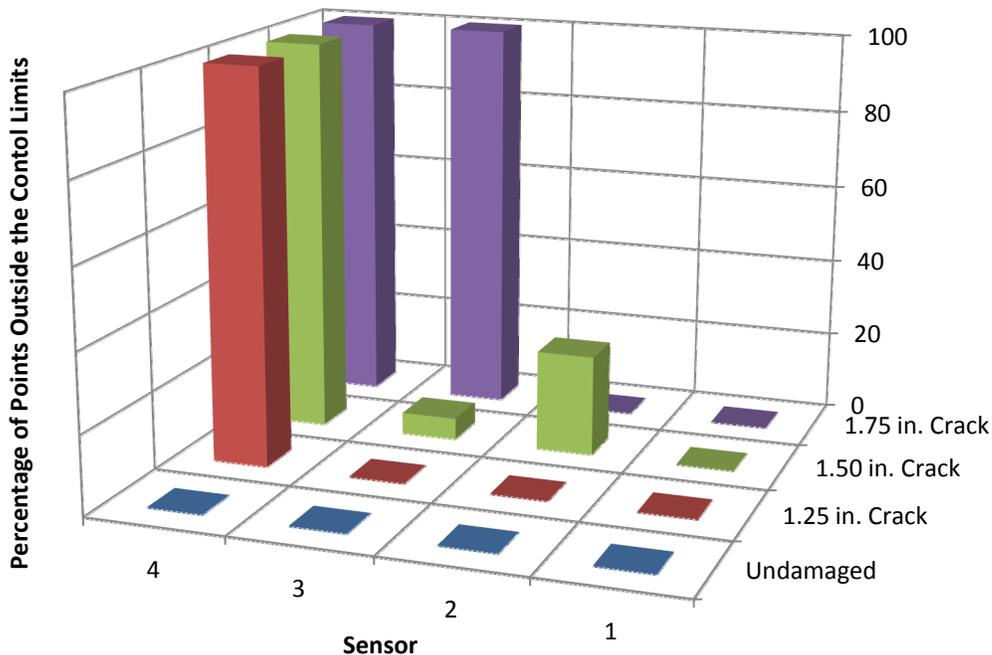
The cracking in sacrificial Specimen 2 occurred nearest to Sensor 4 and is displayed in Figure 4.9 as the bars nearing 100% of the points outside the control limits. As the size of the crack increases to 1.75 in., the percentage of points outside the control limits of Sensor 3 also starts to increase, as was expected. This increase in points outside of the control limits of Sensor 3 for the 1.75 in. crack again confirms that more severe damage can be detected by sensors farther away from the damage. The location of the damage, though, may be more difficult to detect as it becomes more severe.

Figure 4.9 Percentage of Points Outside the Control Limits: Sacrificial Specimen 2 Cracking

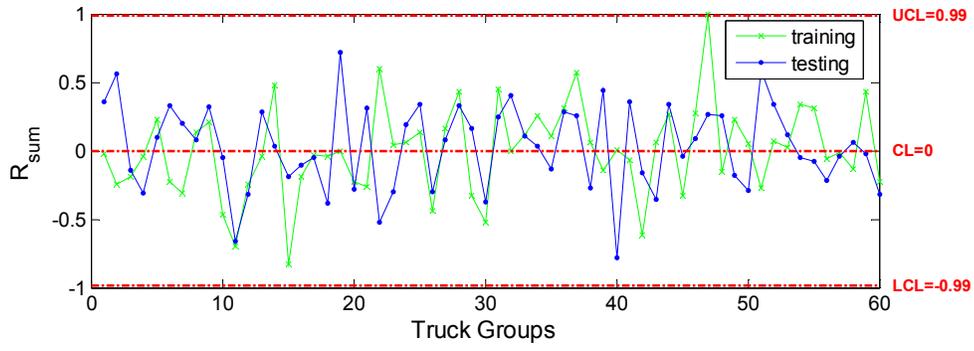
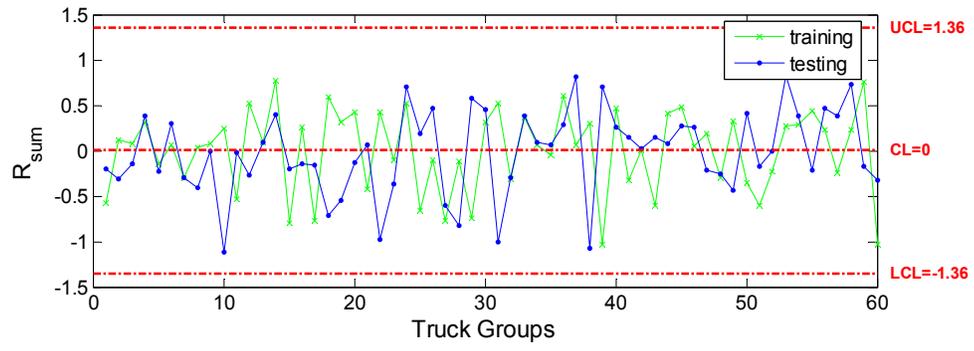
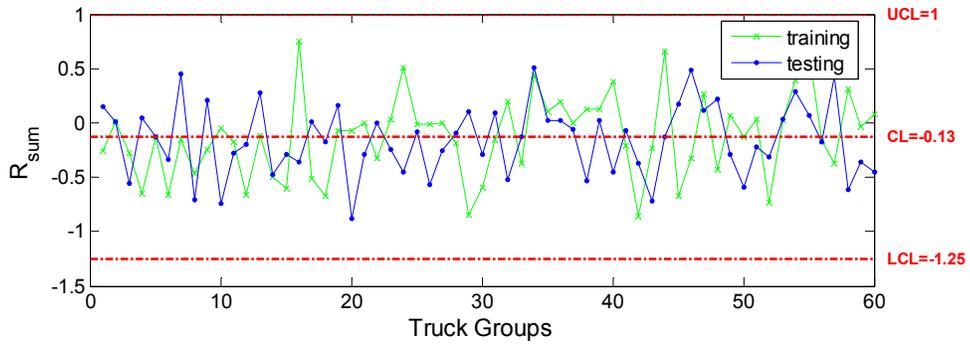
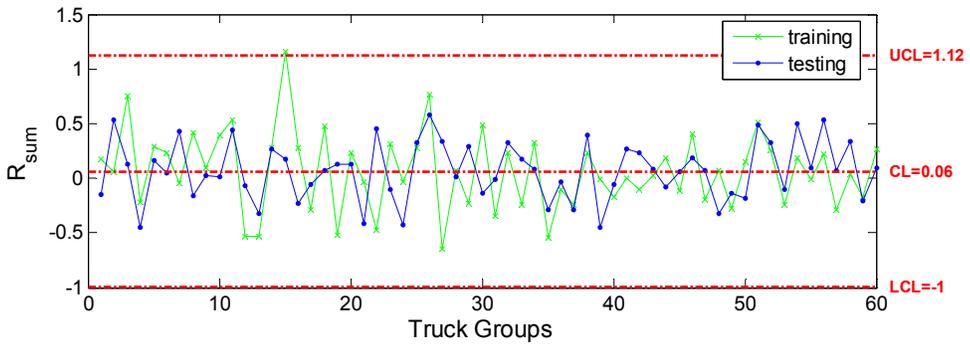
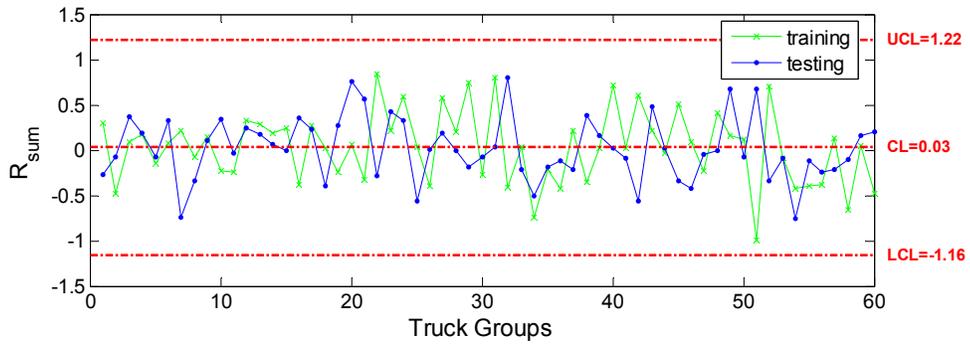
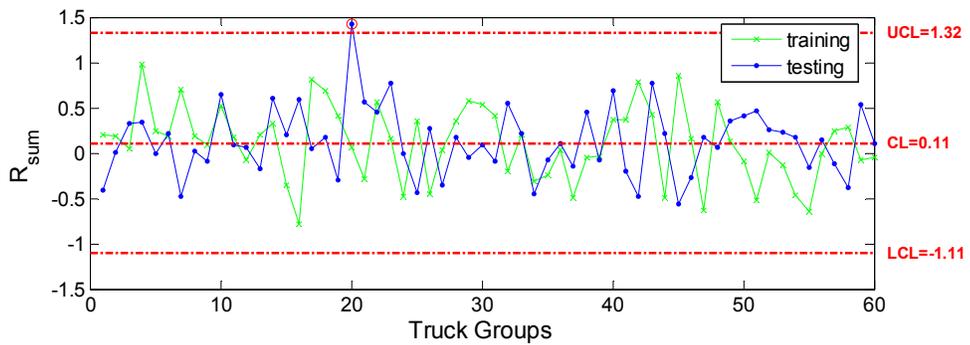
Figure 4.10 Sacrificial Specimen 2 Corrosion Control Charts

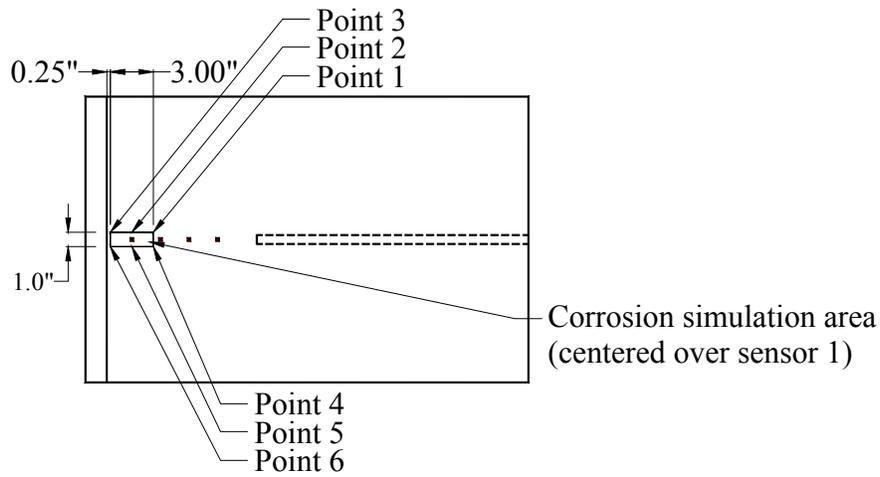
Following the collection of the training data, roughly 5% of the total plate thickness in a 1 in. by 3 in. section centered over Sensor 1 was removed. The location was centered over Sensor 1 to determine the effects of the corrosion when directly over a sensor and when in close proximity to other sensors. The locations of the simulated corrosion area and measurement points are shown in Figure 4.11. To measure the decrease in plate thickness, an additional steel plate was placed over each point and the distance from the top to the top plate was recorded. After grinding, this process was repeated and the percent decrease was calculated for each measurement point, as shown in Table 4.1

Figure 4.11 Corrosion Simulation Area Details

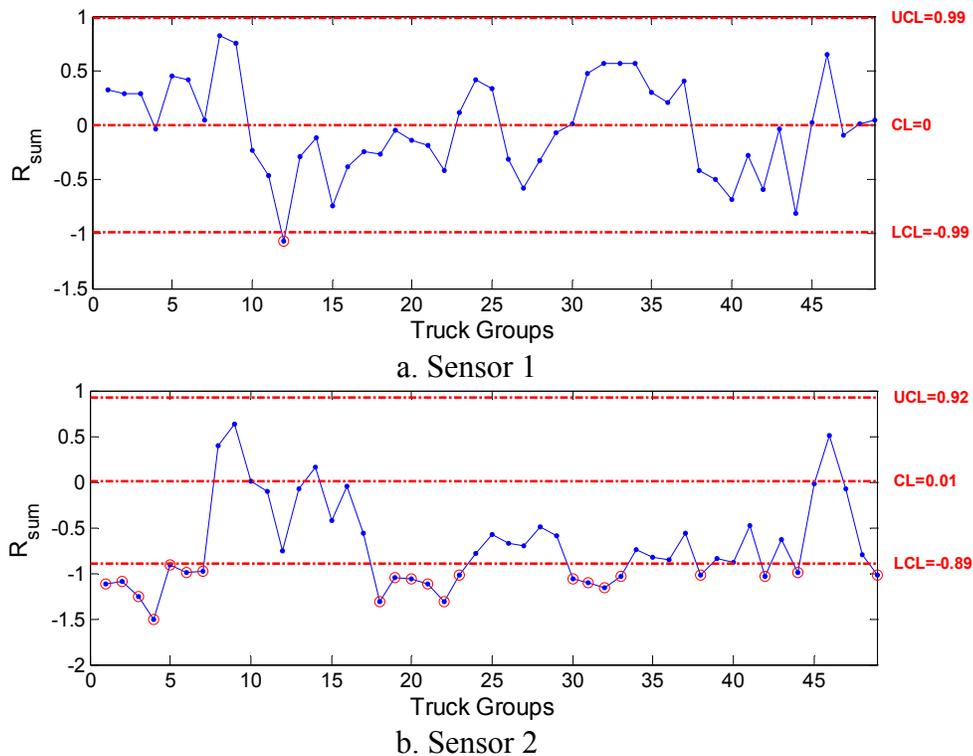
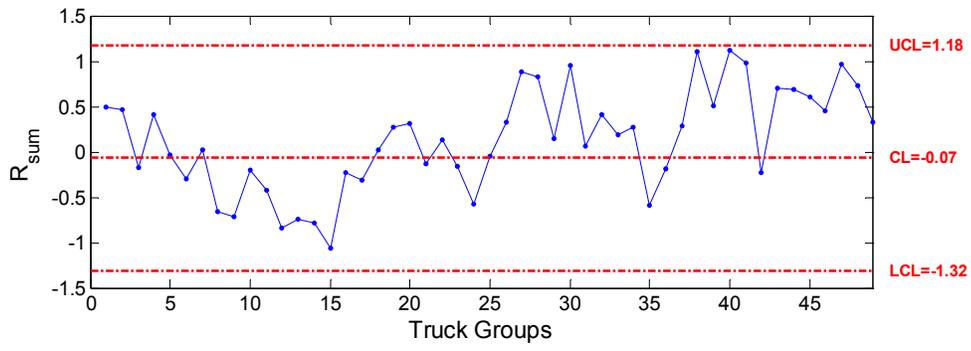
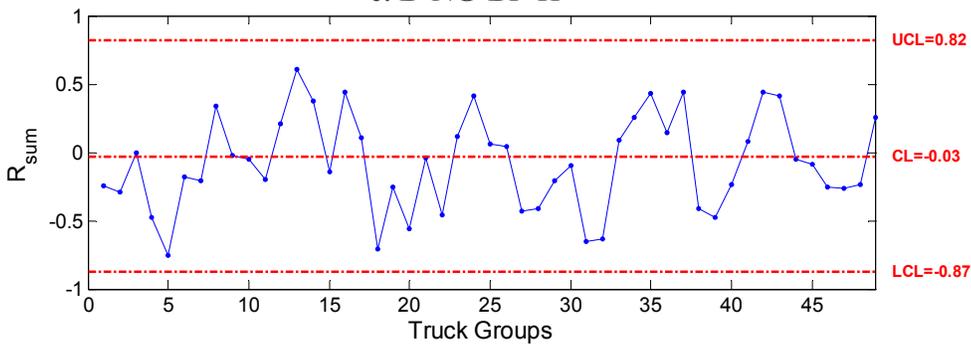
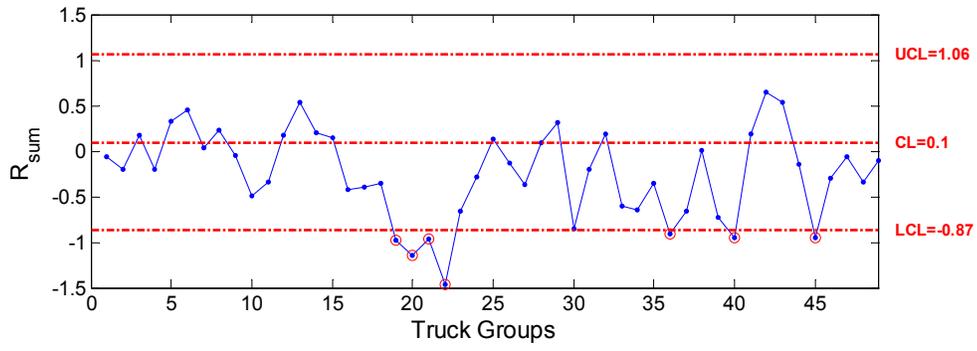
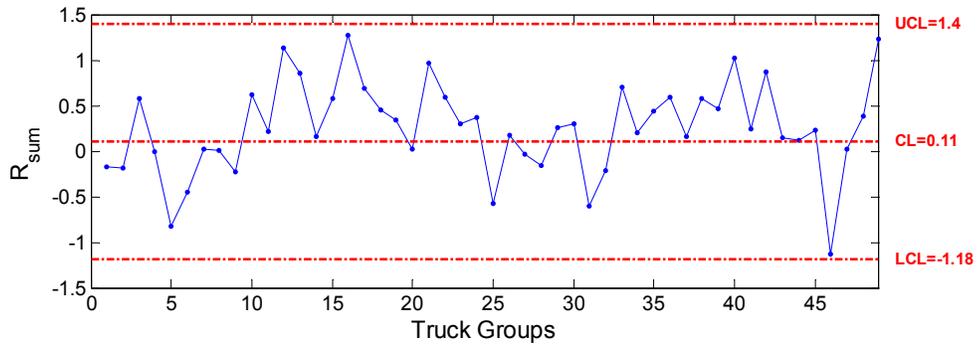
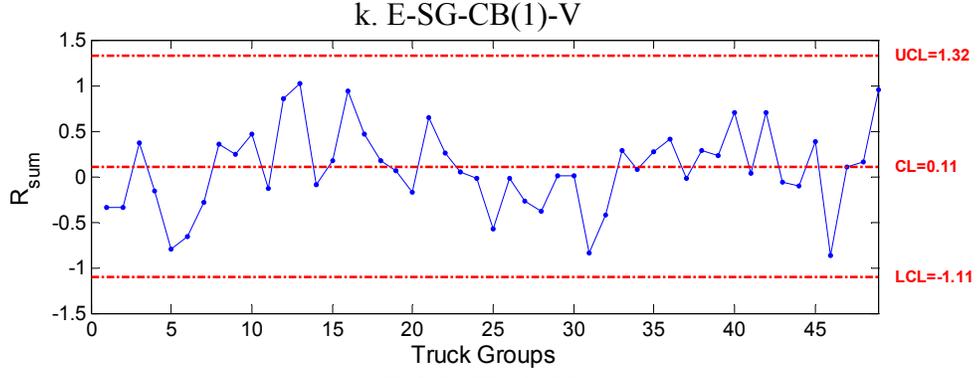
The control charts for sensors not on Specimen 2 are shown in Figure 4.12e through Figure 4.12i and show very few R-sum values outside of the control limits. Because the damage to Specimen 2 was small in this case, there are no large adverse effects to the R-sum values in the control charts for the sensors not on Specimen 2, as previously discussed.

Figure 4.12 Post-Corrosion Sacrificial Specimen 2 Control Charts

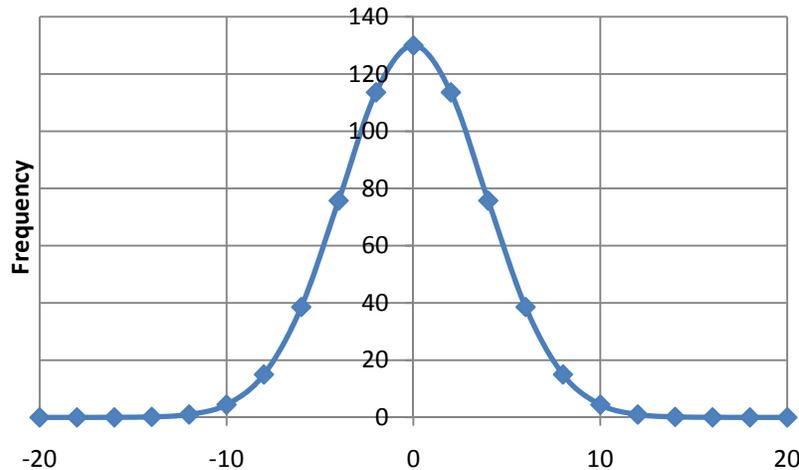
where x and μ are the mean and standard deviation of the sample, respectively. The assumption of normally-distributed data is critical to how the control charts are constructed. Specifically, the control limits were set to achieve a specific false-positive rate, based on known characteristics of normal distributions related to the mean and multiples of the standard deviations.

Figure 5.2 Sample Normal Distribution

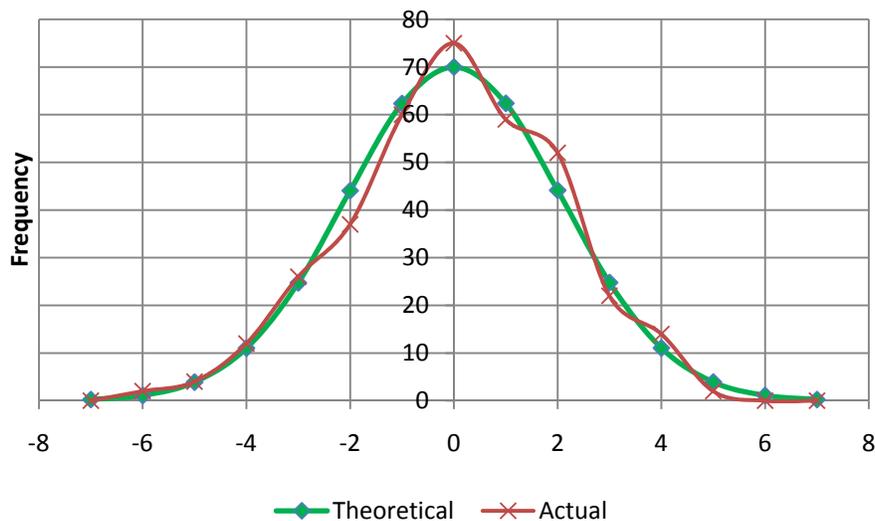
In Figure 5.3 an actual distribution is graphically compared to a theoretical normal distribution. Through the χ^2 Test, the calculated significance level is 0.98, which for this project supports the null hypothesis that the actual data are obtained from a population that is normally distributed. It can be seen that even though the actual distribution does not exactly match the theoretical distribution, the actual data supports the null hypothesis.

Figure 5.3 Sample Distribution Comparison with 0.98 Significance Level

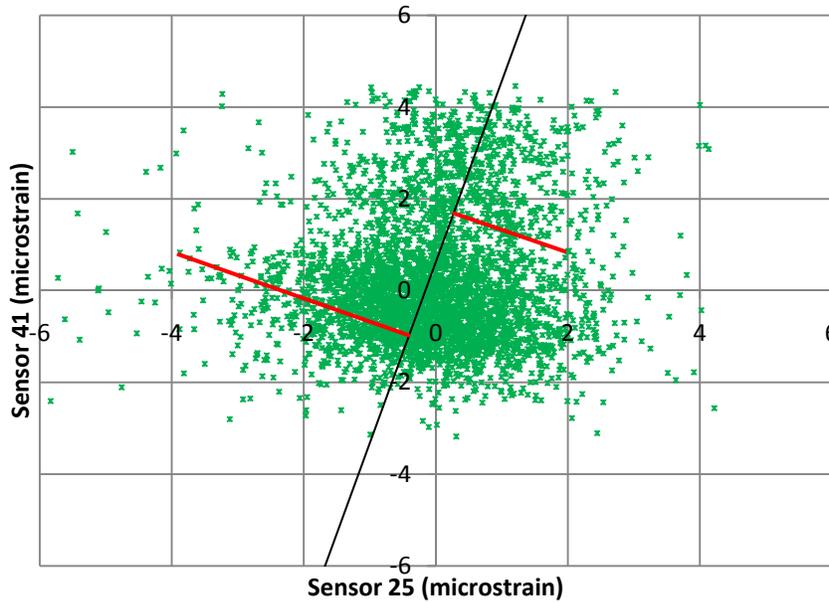
An orthogonal regression is appropriate when there is no natural distinction between predictor and response variables (MathWorks 2010). As it turns out, by using orthogonal regression, the residual matrix becomes symmetric, because the two equations for one sensor pair are inversely related and therefore the same residuals are calculated. This, albeit unintended, attribute reduces the computation time associated with the damage-detection approach.

Figure 5.5 Sample Orthogonal Regression

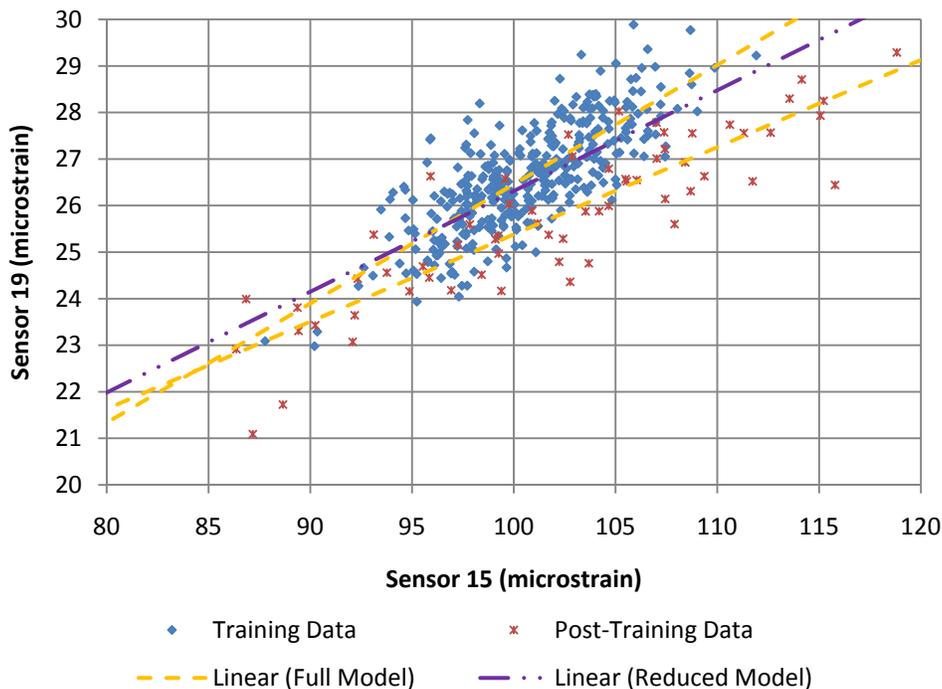
The reduced model is shown as the dot-dot-dashed lines in Figure 5.6 and Figure 5.7. It can be observed in Figure 5.6 that the reduced model is similar to the full model, leading to the conclusion that no damage has occurred at those two sensor locations. On the contrary, Figure 5.7 shows that the reduced model is drastically different from the full model. This would indicate that damage has been detected.

Figure 5.6 Sample Training Full and Reduced Model

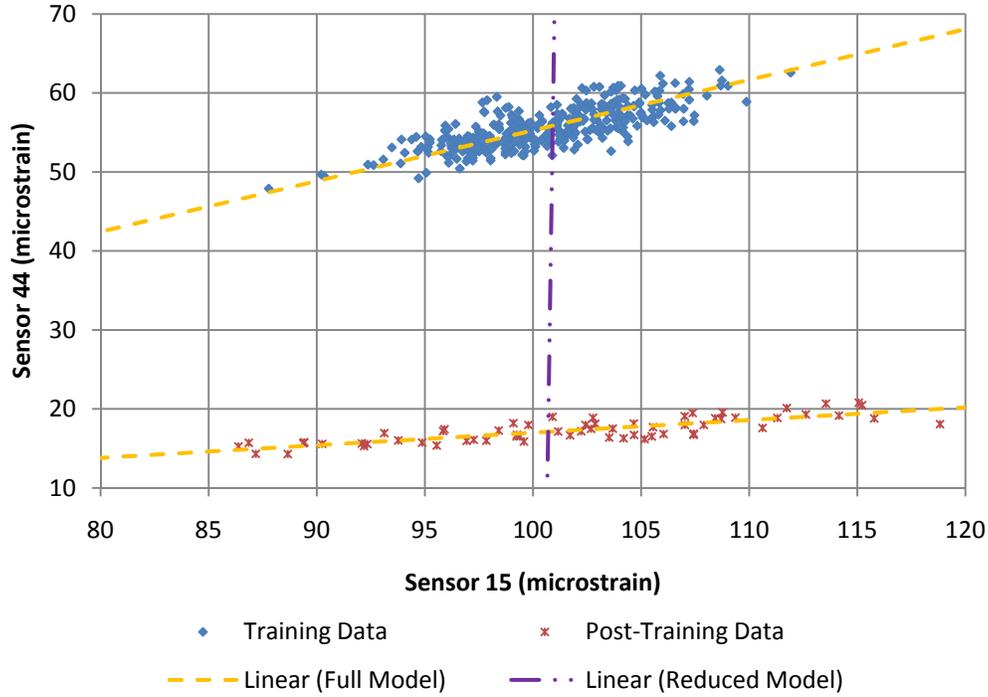
Figure 5.7 Sample Damaged Full and Reduced Model

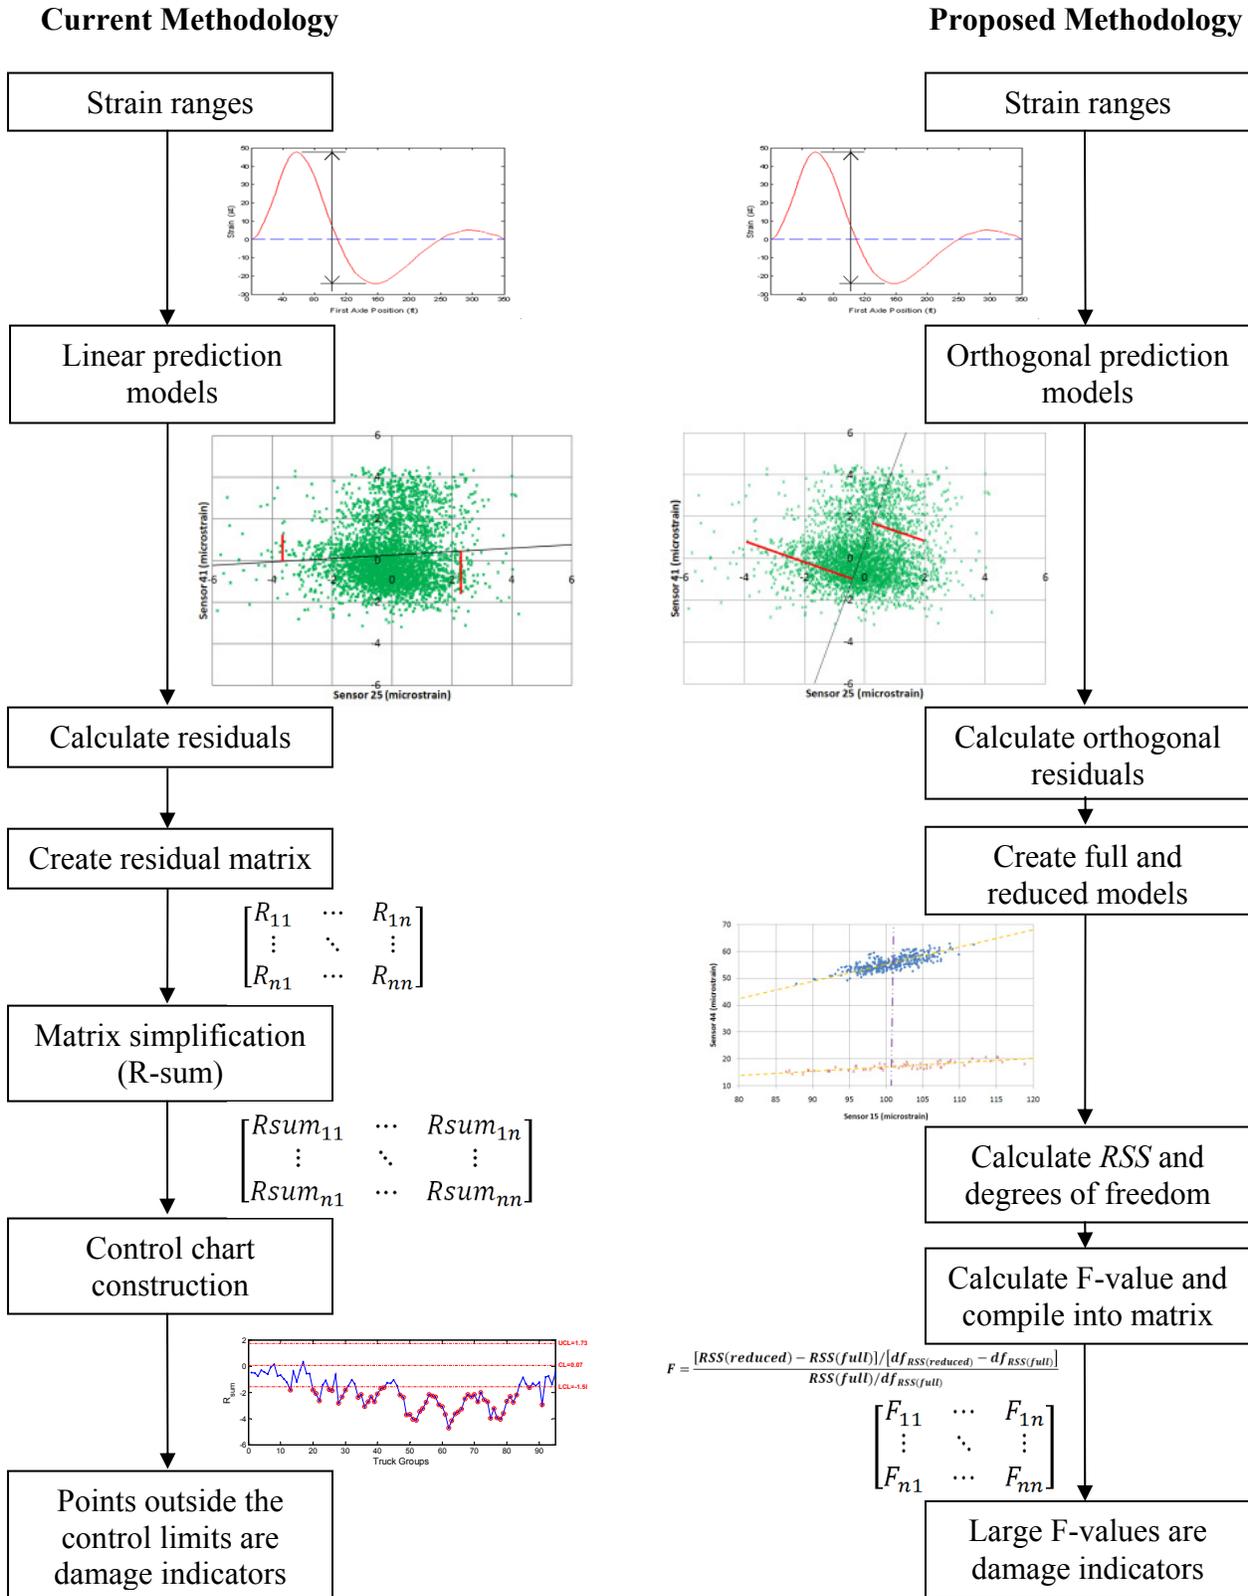
where RSS stands for residual sum of squares and df is the degrees of freedom associated with an RSS value (Caragea 2007). The alternative hypothesis states that the reduced model is too simple and that the more complex full model is more appropriate (Caragea 2007). F-values can be calculated and a significance level can be found using the F distribution. A significance level can then be set to either accept or reject the null hypothesis. A flow chart comparing the current method of damage detection to the proposed method is shown in Figure 5.8.

Figure 5.8 Flow Chart Comparison of the Two Damage-Detection Methods
