# **Early Entry Sawed Portland Cement Concrete Transverse Joint Ends**

**Final Report  
For  
MLR-97-05**

**April 2003**

**Iowa Department  
Of Transportation**

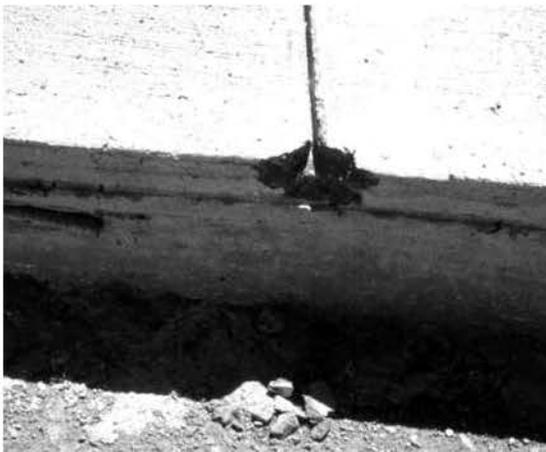
The conventional method of early sawing of PCC was cutting a 1 1/8 inch deep joint with the saw blade passing completely out through the edge of the slab. This practice, in “green” concrete, often resulted in an immediate large spall at the joint end or caused hairline cracks which result in corner breaks or spalls later (See Figure 1). A logical cause for this spalling was the saw blade being forced toward the unsupported slab edge. In addition, sawing completely out to the shoulder resulted in weakening of the joint ends leading to potential additional damage or corner spalls from roadway construction and maintenance equipment operating or scraping along the shoulder’s edge (See Figure 2).

Figure 1  
Joint End Corner Spall

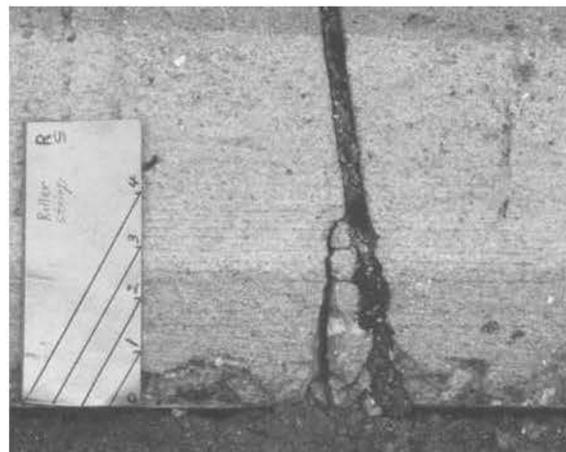
Figure 2  
Joint End Corner Spall

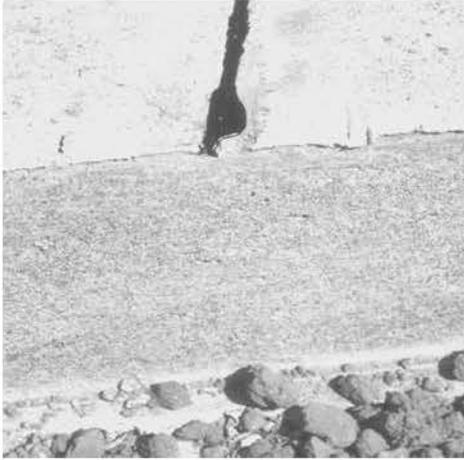
Reduction of the joint end spalling is the primary objective of this research (See Appendix A). In order to do this, a southbound lane test section of one day’s paving on highway US 65 bypass southeast of Des Moines has been evaluated using non-conventional methods. This procedure involved early sawing of the transverse contraction joints at the conventional depth of 1 1/8 inches up until approximately 1/2 to 3/4 inch before the leading edge of the blade reaches the end of the slab. Stopping the saw at that point created a “short joint”. In addition to preventing end spalls, this method will decrease costs of labor by leaving a concrete “dam” to contain hot pour sealant from flowing out over the end of the joint (See Figure 3). Currently, materials and labor are used to create a duct tape dam at the end of each joint. The tape dam has a high rate of adhesion failure due to the curing compound coating on the PCC (See Figure 4).

**Figure 3**  
**"Short Cut" creates a sealant dam.**

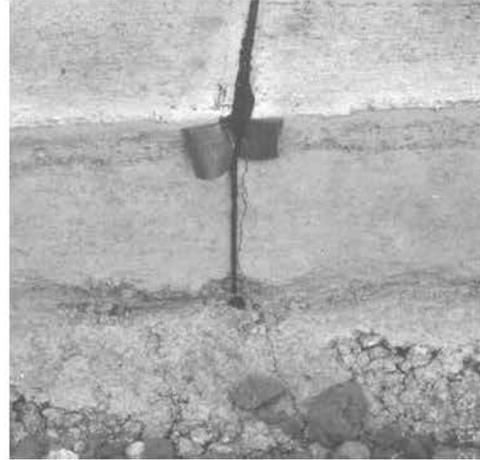
**Figure 4**  
**Adhesion failure of duct tape and sealant leakage.**

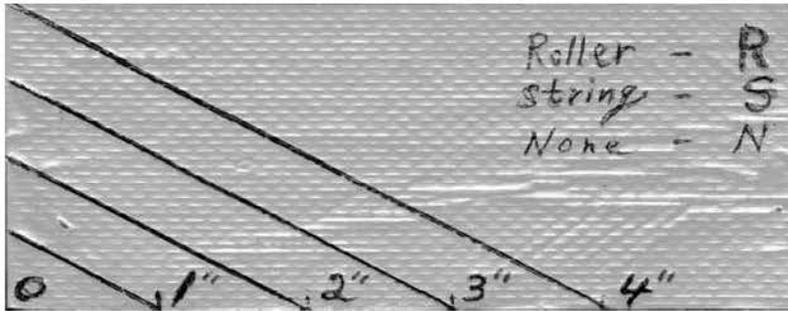
Measurements to determine corner spall lengths were made (in inches) using a special gauge (See Figure 5). Contraction joint crack width was measured in inches using a crack comparator (See Figure 6).

Figure 5  
Corner Spall Gauge  
(Not to scale)

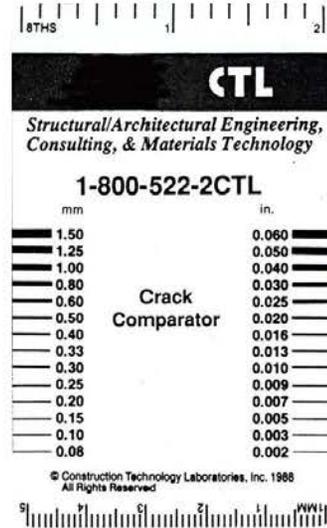
Figure 6  
Crack Comparator  
(Not to scale)

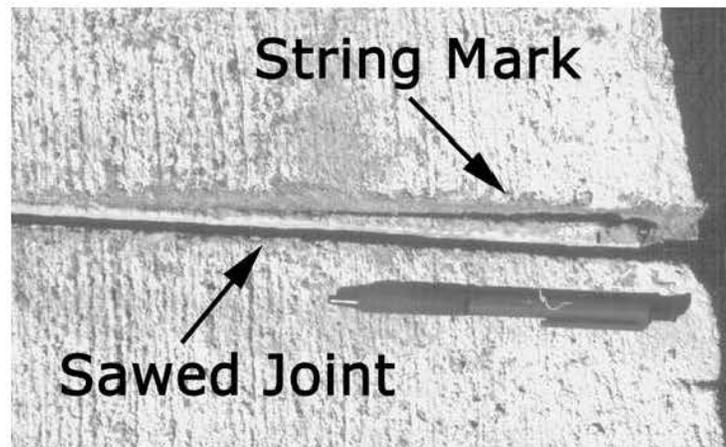
- The saw did not always follow, exactly, the mark left by the contractors' joint marking string. The string marking action on the plastic concrete over the center of the dowel basket, often created a deep groove near the shoulder, simulating a shallow joint (See Figure 7). That groove created a secondary-like joint and provided a path for the hot liquid sealant to escape over the shoulder's edge. It can eliminate the benefit of the dam left by the "short joint".

Figure 7  
String mark seen beside  
sawed joint.

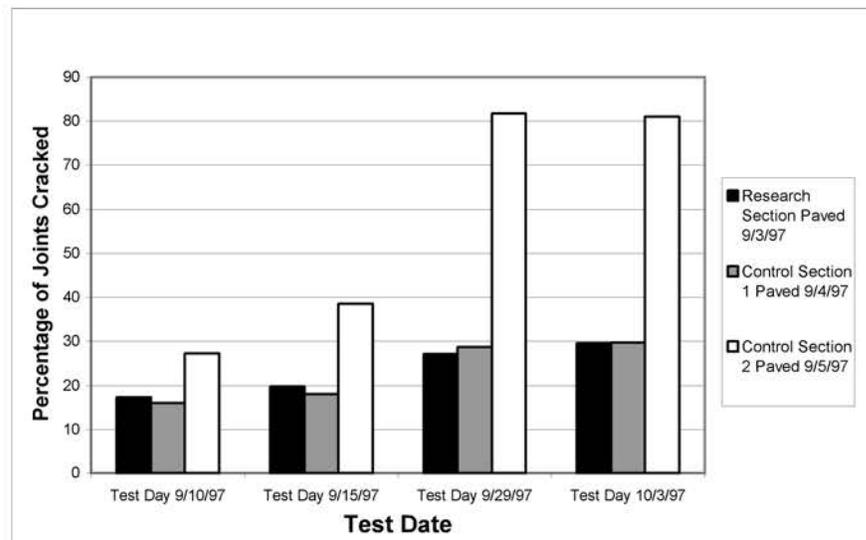
The development of shrinkage cracks below the sawed joints was observed along the shoulder’s edge and recorded progressively on 4 different dates before shouldering work covered the edge of the slab. The data is given in Appendix D. It is interesting to note the rate of concrete joint shrinkage crack development over time. The research section and control section #1 each acted in a similar way, but control section #2 had an unusually high rate of joint cracking. Over the 3 sections, the percent of joints cracked at approximately 1 week of age was 17.3, 16.0 and 27.3 respectively and at 4 weeks of age was 29.6, 29.8 and 81.8 respectively (See Graph 1).

**Graph 1  
Percentages of  
Contraction  
Joints Cracked**

Analysis of paving and weather data over that time period did not show any significant changes which would influence the high cracking rate for control section #2, as shown in the data on page 20 near the end of Appendix D. It is interesting to note that the number of contraction joint cracks in control section #2 were much higher (82%) than in control section #1 (30%). It is also interesting to note that the crack width for control section #2 was about half as wide (0.028 inches) as control section #1 (0.056 inches) and in the research section (0.050 inches). (See Graph 2) The cause for the difference in joint cracking rate was not determined.

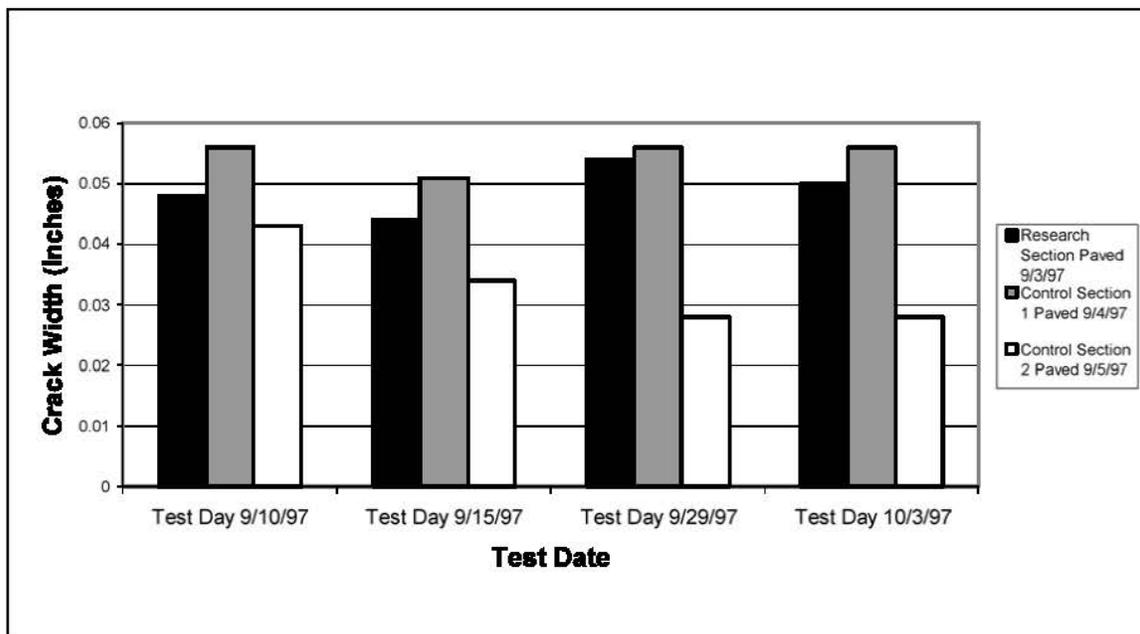
Graph 2  
Average Crack Width

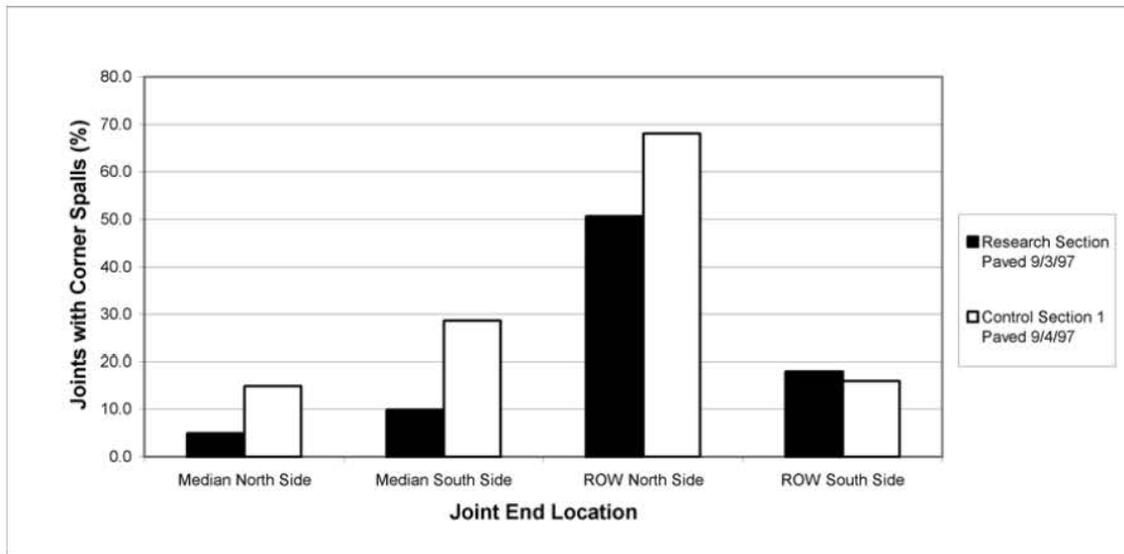
The test section ROW end of the joint contains even more damage (See Graph 3). The test section shows damage on 17.9% of the joint ends on the south side and 50.6% on the north side. Similarly, control section 1 showed 16.0% of the joint ends damaged on the south side and 68.1% on the north side. Control section 2 showed 9.1% of joints damaged on the south side and 47.7% on the north side (See page 20 in Appendix B). Test section joints have spalls averaging 1.9 inches on the north side and 1.5 inches on the south side (See Graph 4). The control corner spalls average 2.5 inches on the north side of joint ends and 1.7 inches on the south side (See Appendix B).

**Graph 3**  
**Joint End Corner Spalls**

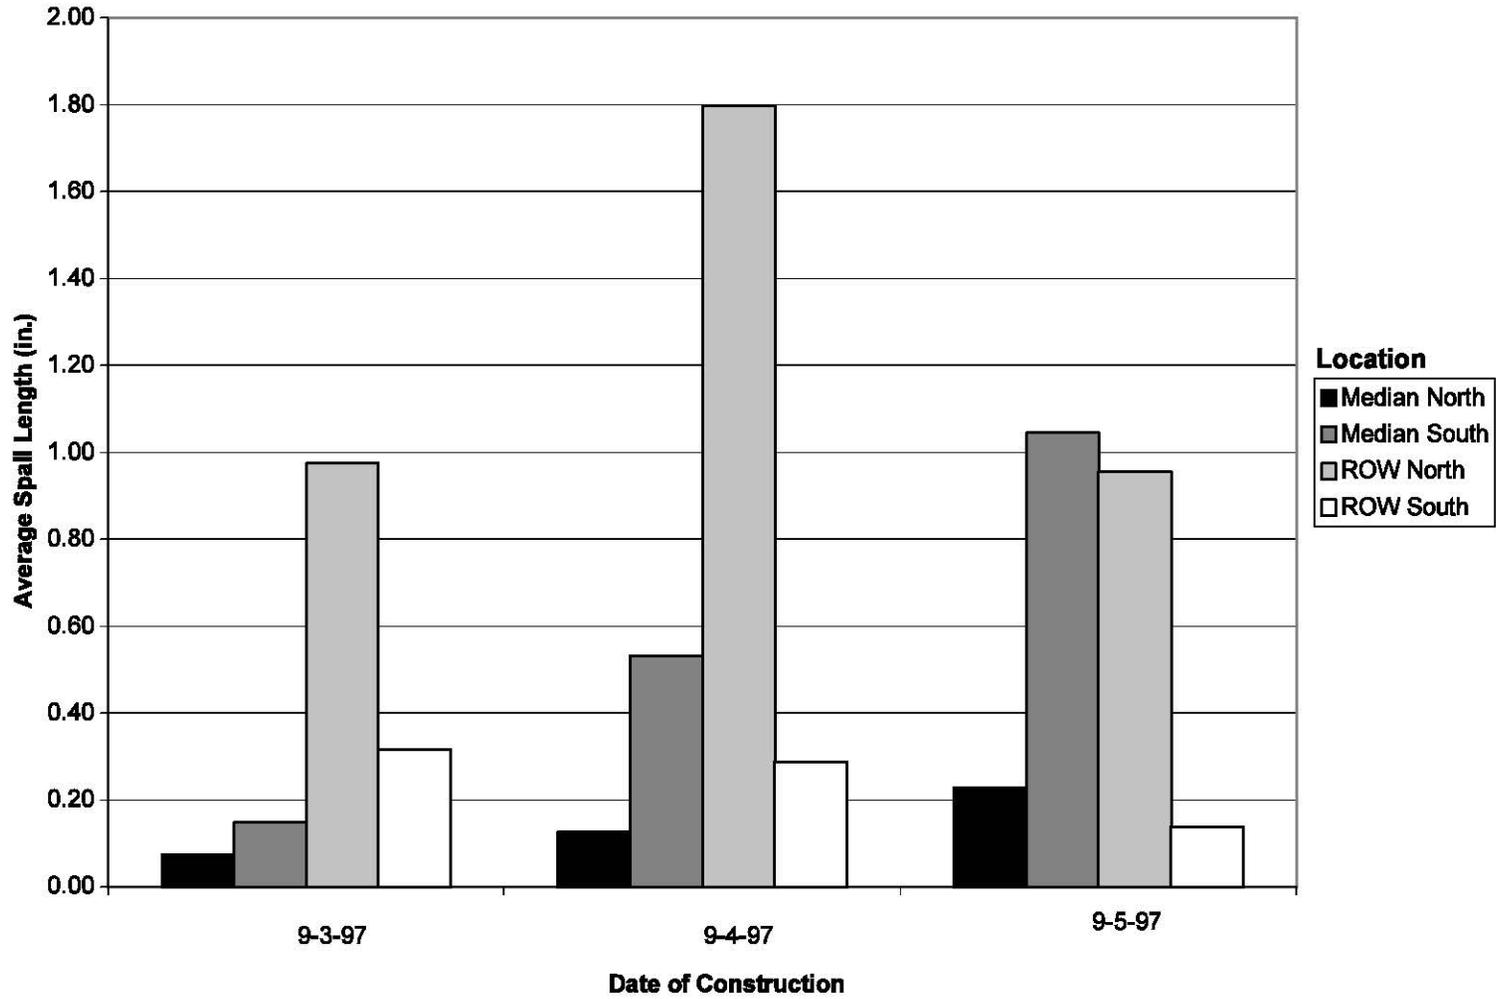
Graph B-1: Average Joint End Spall Length For All Joints.

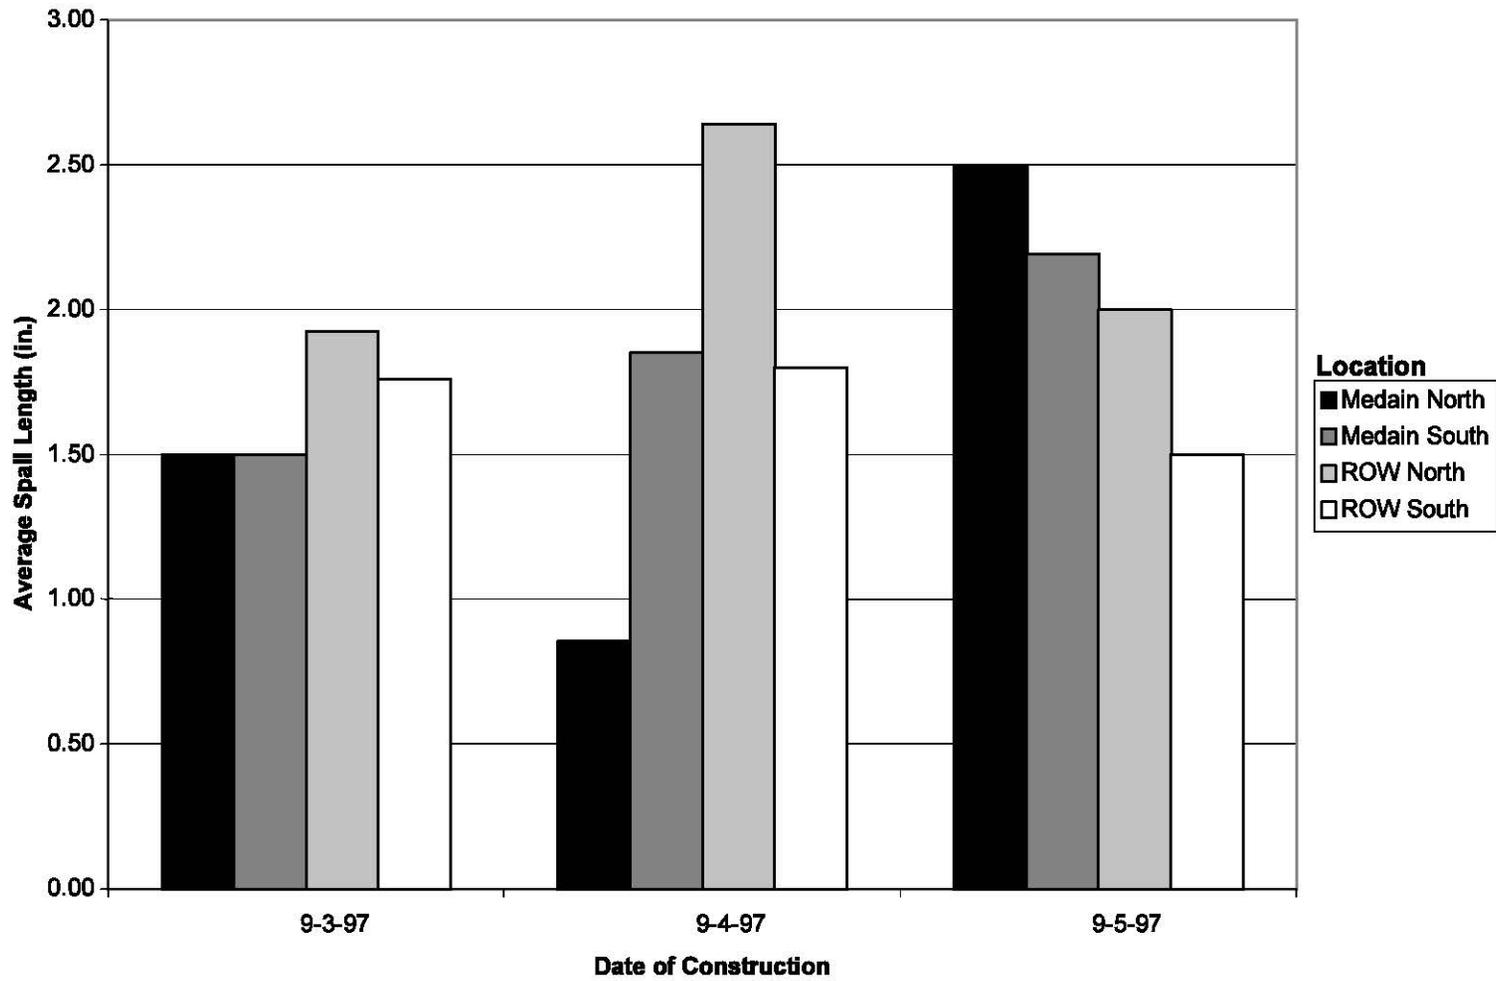
**Graph B-2: Average Joint End Spall Length For Spalled Joints.**

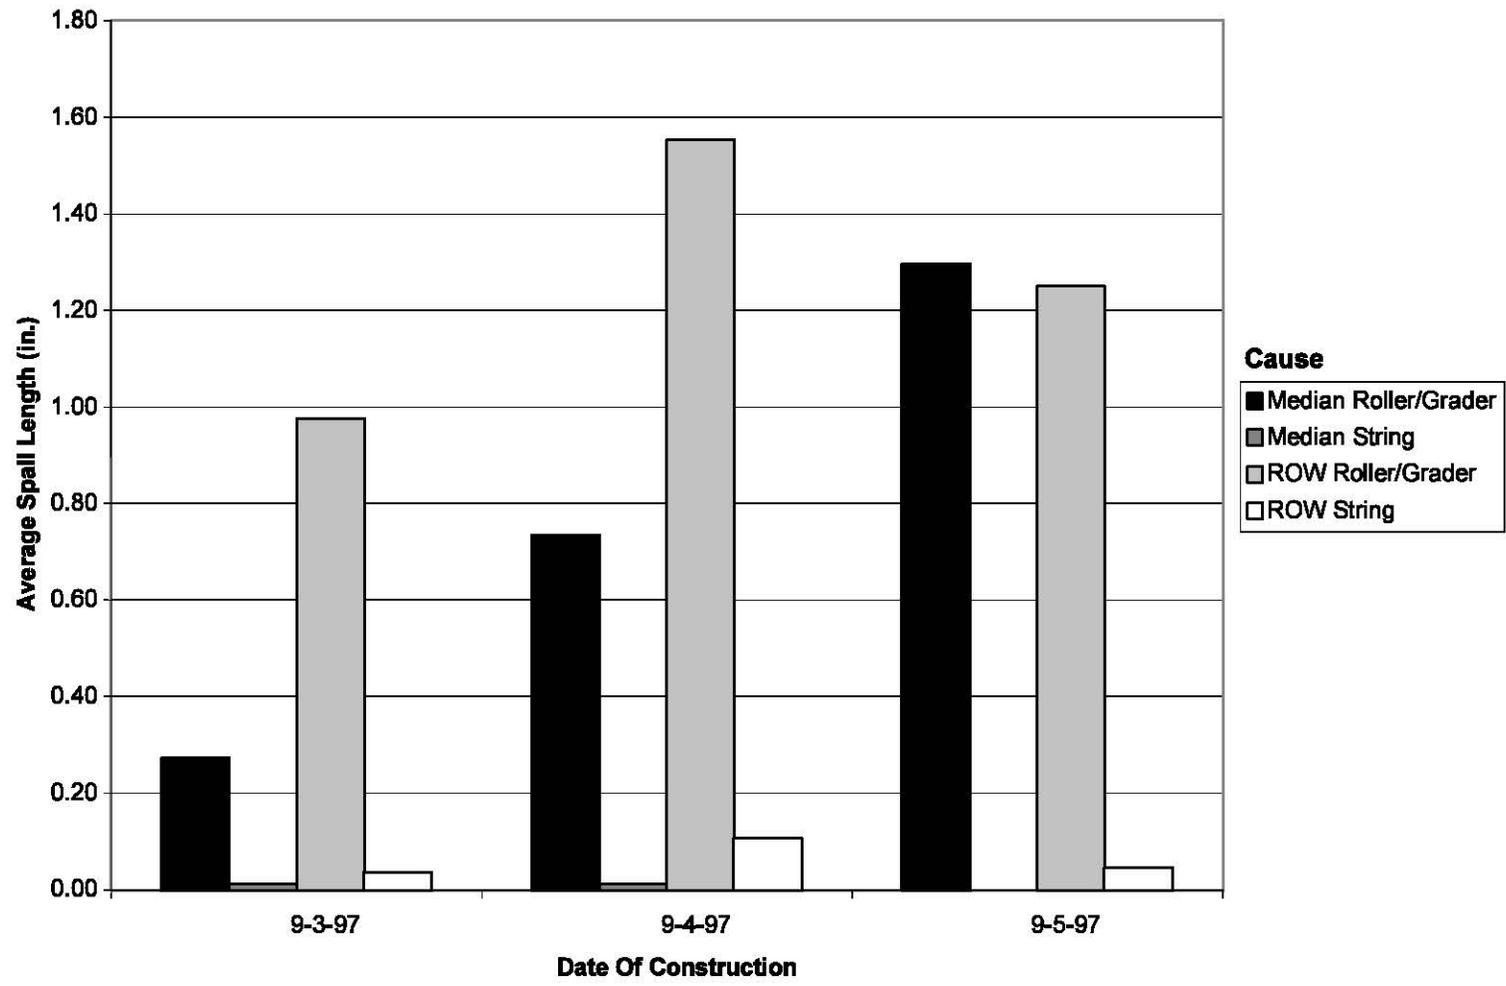
Graph C-1: Average Joint End Spall Length For All Joints.

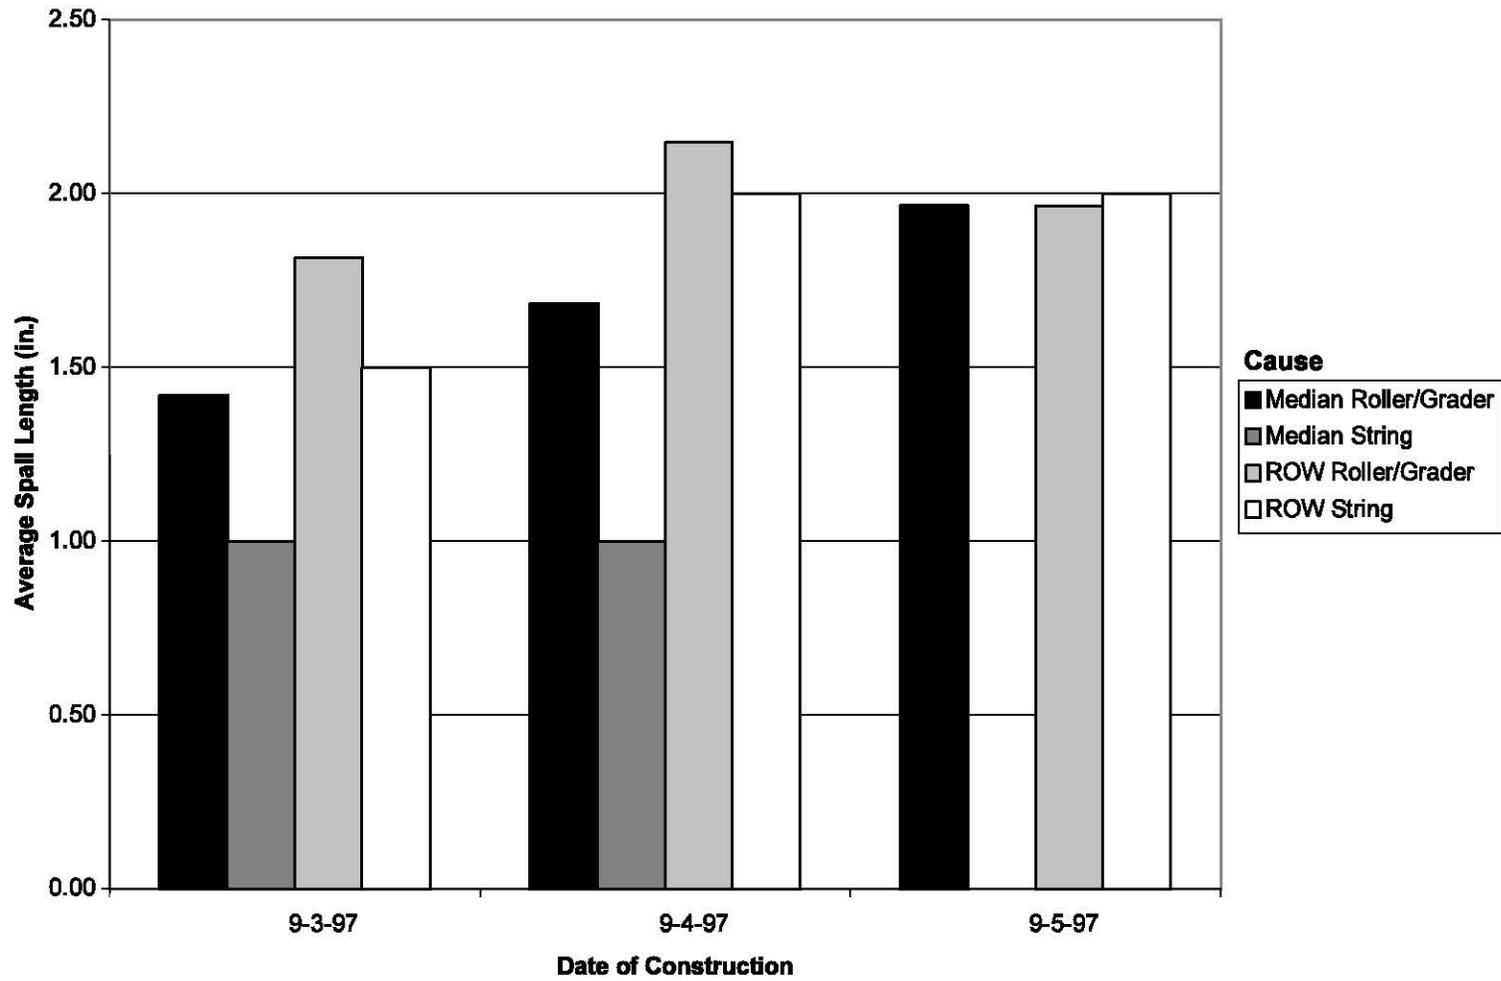
**Graph C-2: Average Joint End Spall Length For Spalled Joints.**

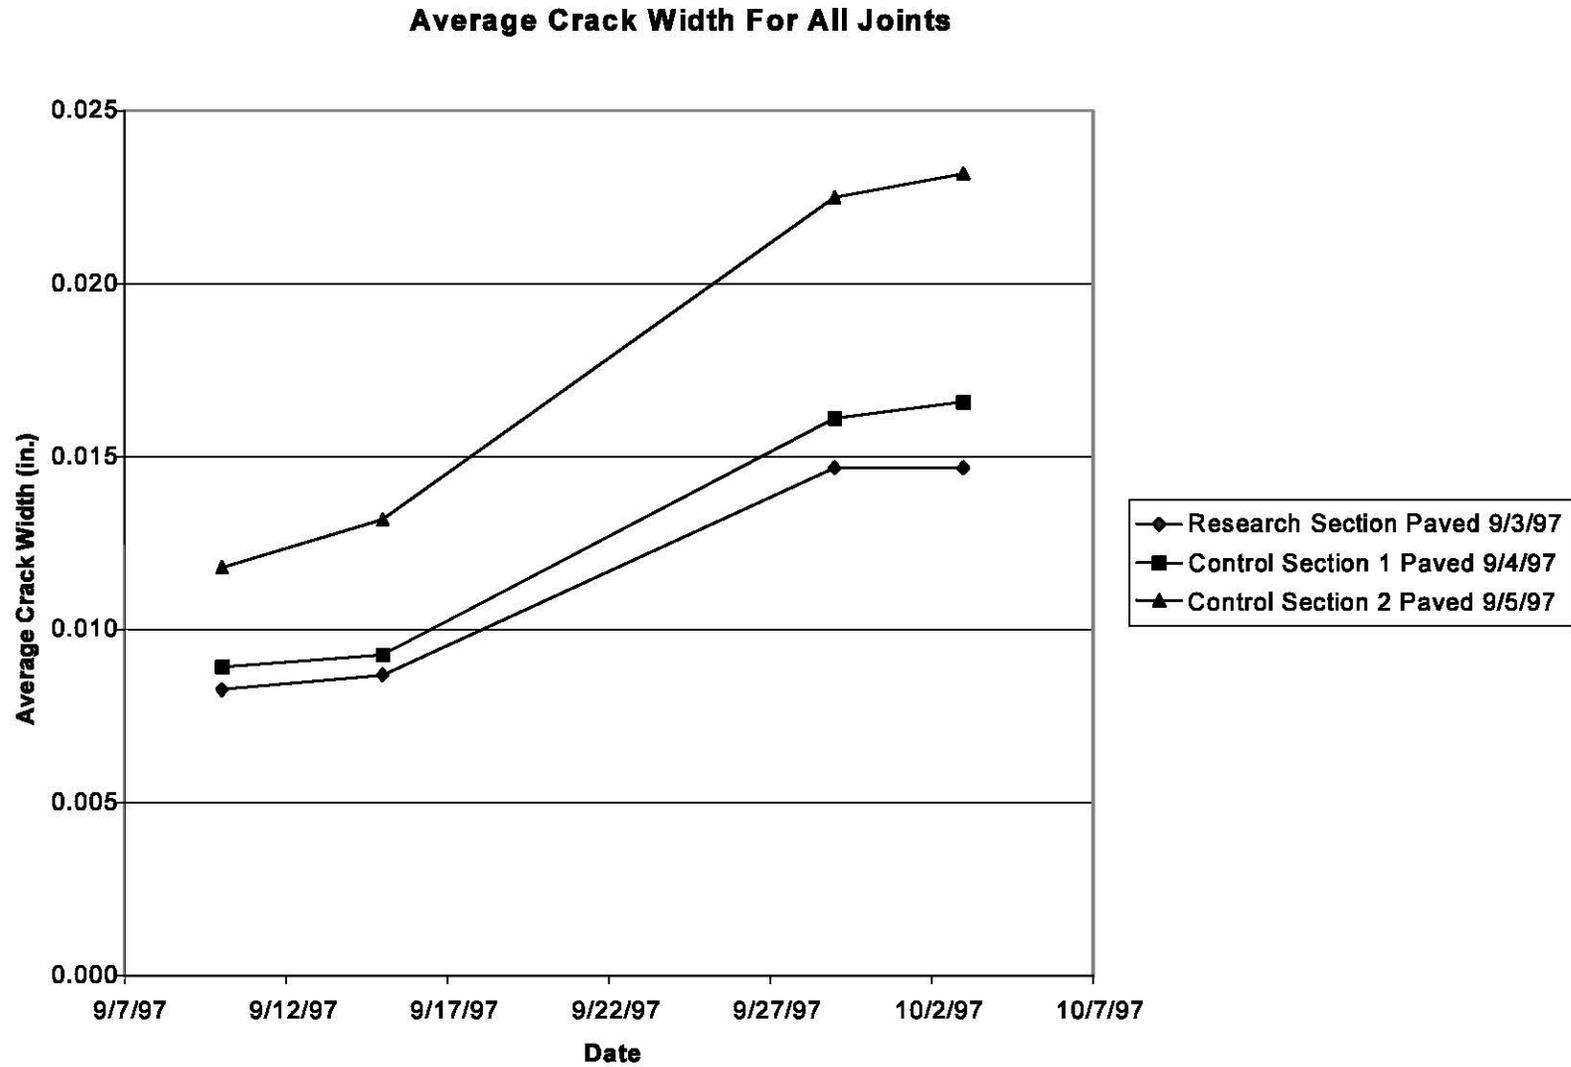
**Graph D-1: Average Crack Width For All Joints.**

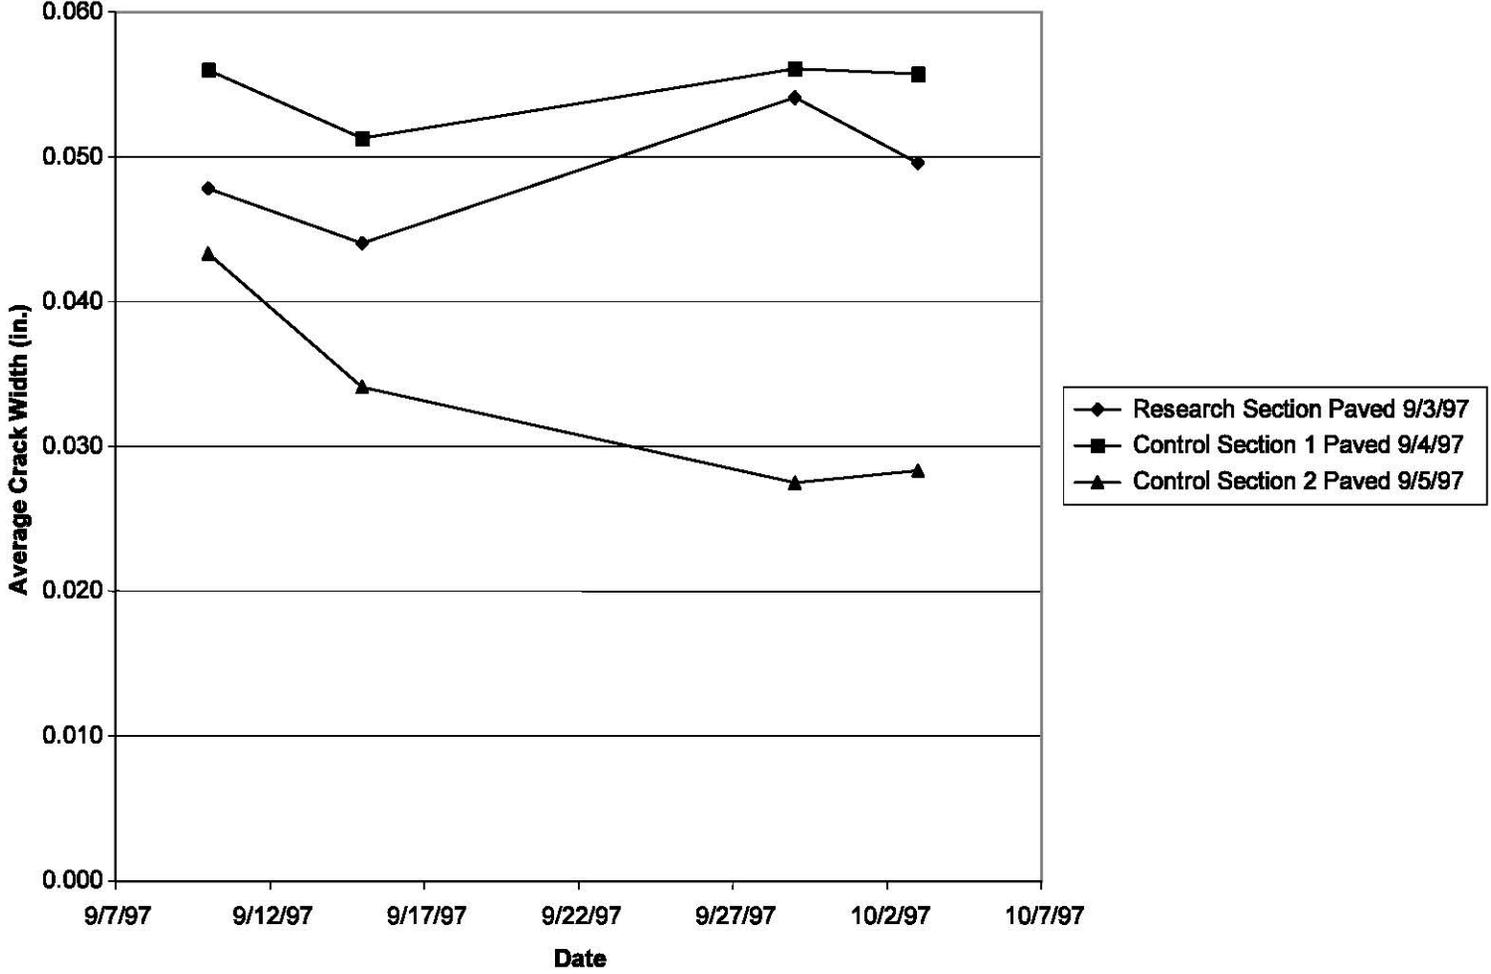
**Graph D-2: Average Crack Width For Cracked Joint**
