# **HEAT DISSIPATION AND CRACK CONTROL IN MASSIVE CONCRETE AT THE BURLINGTON BRIDGE**

**Final Report  
Iowa Highway Research Board  
Project MLR-94-1**

**Iowa Department  
of Transportation**

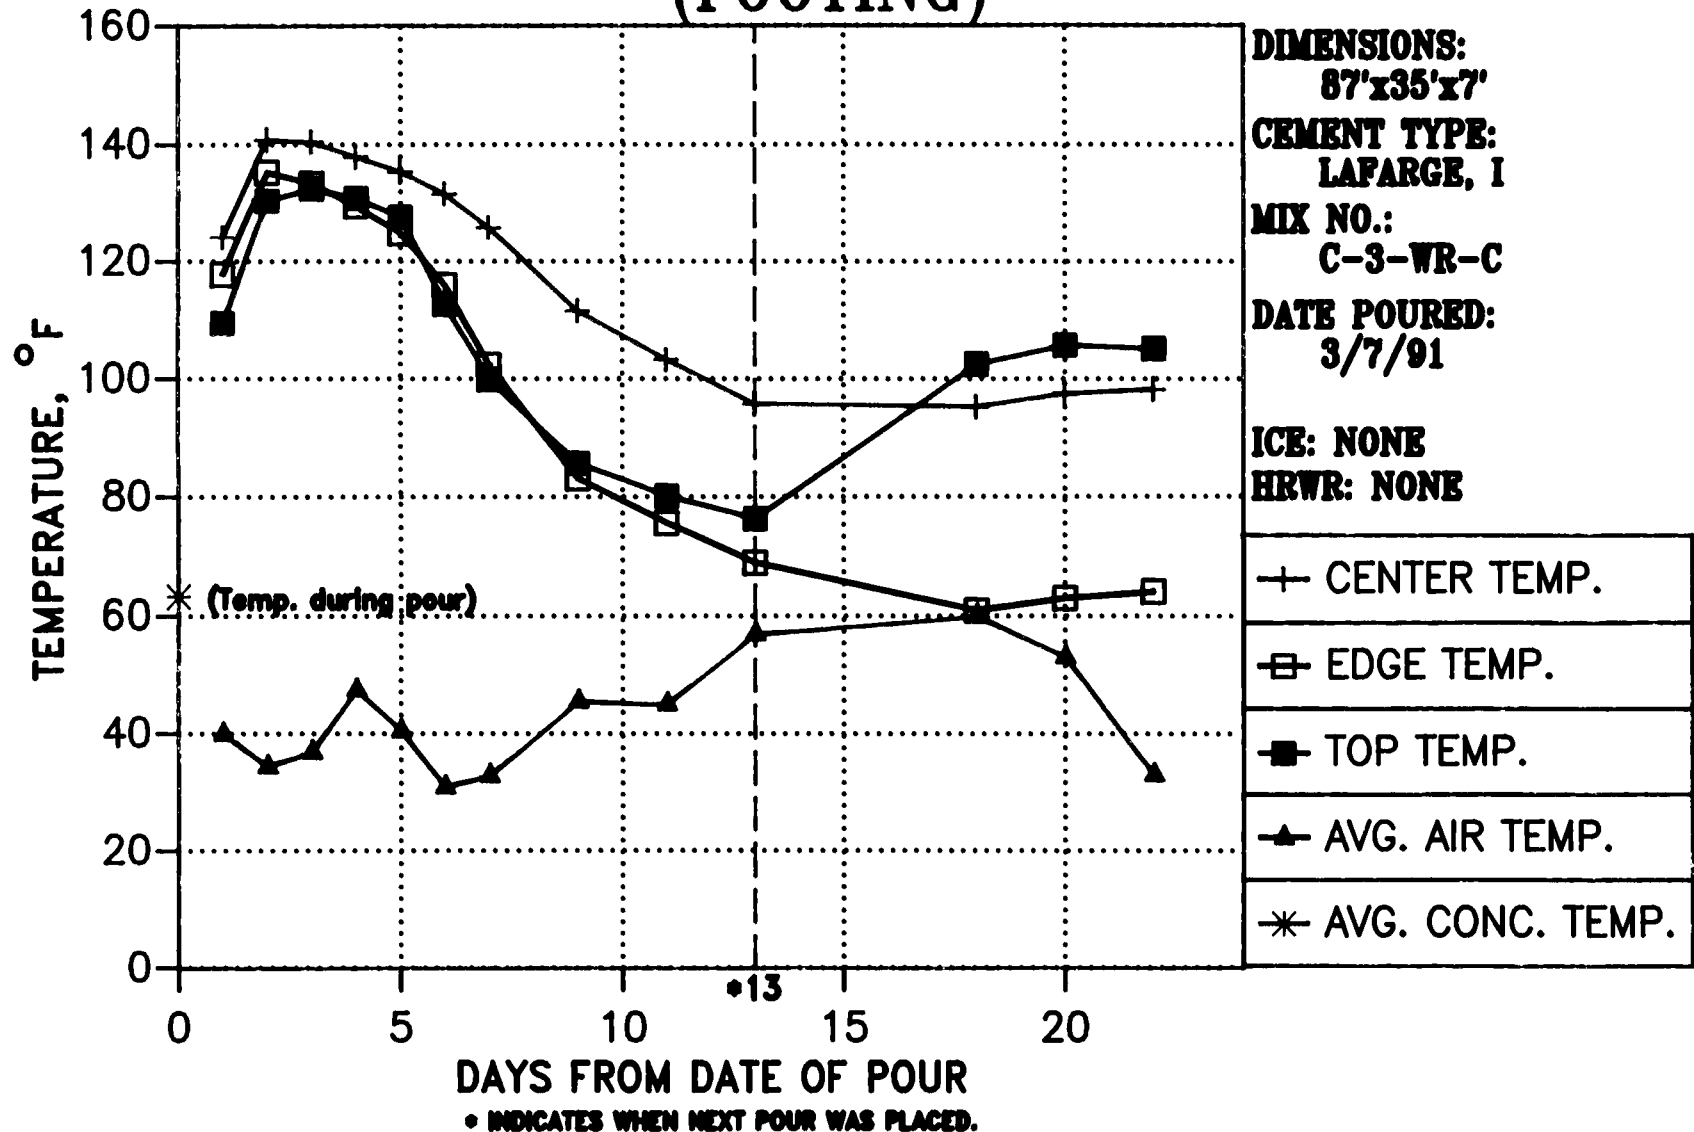
# TEMPERATURE VS. TIME MS-1F (FOOTING)

faster than the center. During the time the placement was being monitored, the temperature differentials never exceeded the 35°F specification; it is, however, difficult to tell whether they would have, since the differentials were still rising when monitoring ceased on the ninth day after the date of placement (Figures 4 and 5).

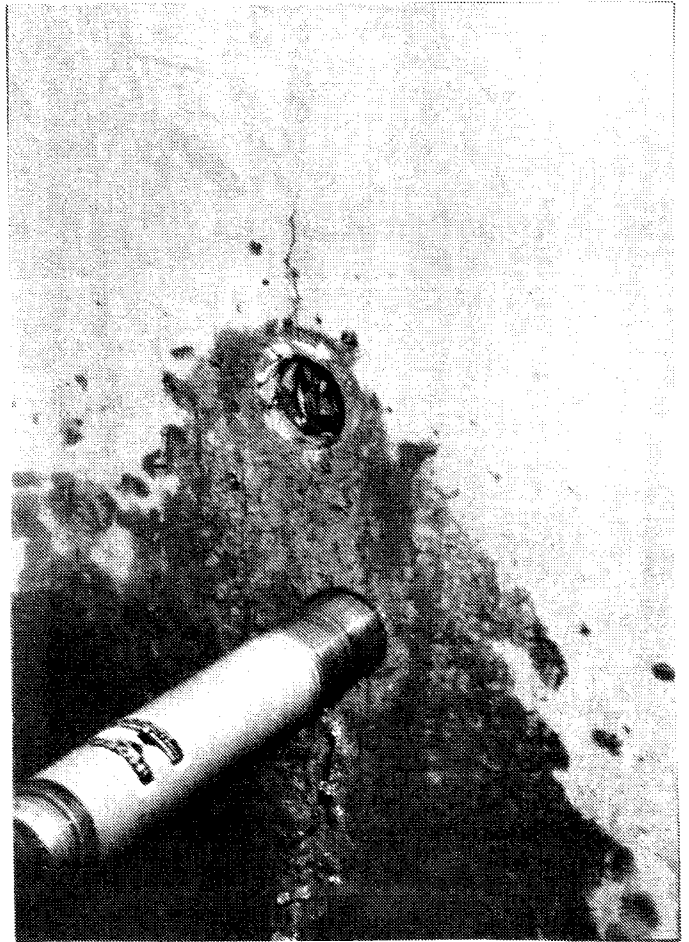
Photo 5 - A longitudinal crack  
in the substructure of pier MS-2

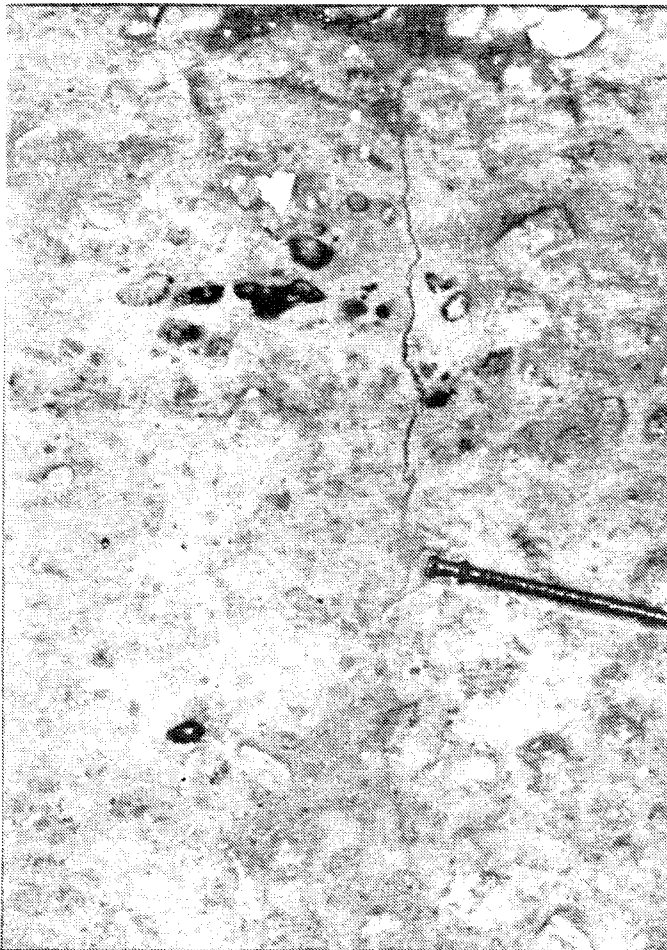
Photo 6 - Drilling cores in pier  
MS-2

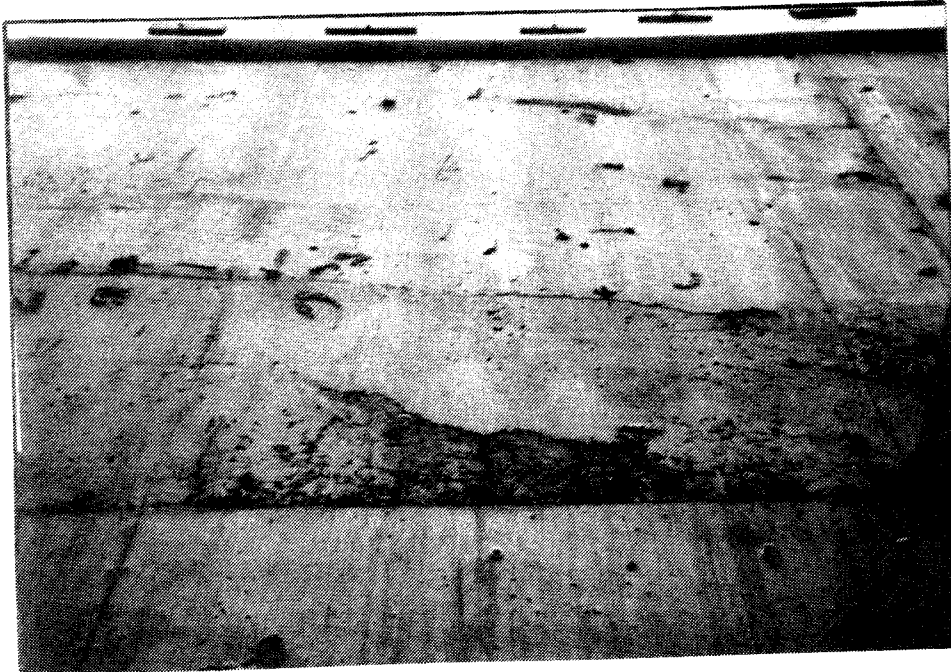
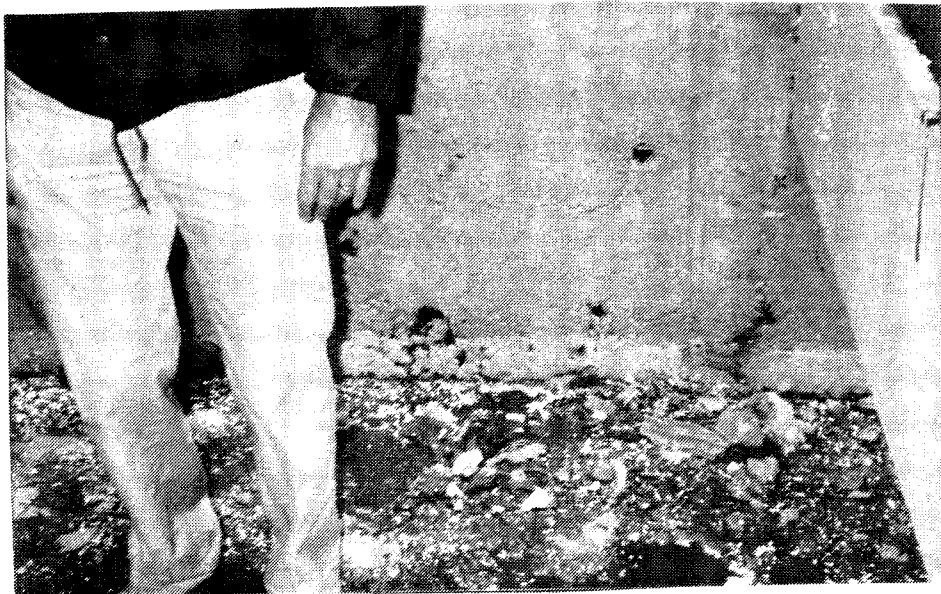
Photos 8, 9, 10

Honeycombing in the substructure of pier MS-2 (pours MS-2-1 and MS-2-2). Probably to inadequate vibration and low rate of placement.

In addition to the cracking, honeycombing and cold joints were noticed in MS-2-1. These were believed to be caused by inadequate vibration of the concrete during the placement and a low rate of concrete placement. It seems that the contractor had a tendency not to vibrate the leading side or toe of the individual layers (so the concrete would not "run"). The low placement rate necessitated

having to build-up the concrete on one end of the lift before depositing any on the other end. The placement was essentially in a "hopscotch" pattern, jumping back and forth in order to prevent a cold joint. To try to reduce the honeycombing and cold joints, the contractor tried smaller lifts. To repair the honeycombing and cold joints that were larger than 3/4 inch, the contractor had to remove the bad spots and fill the holes with a 50/50 sand-cement grout.
