# Ultrathin Portland Cement Concrete Overlay Extended Evaluation

Construction Report  
July 2000

Iowa DOT Project TR-432

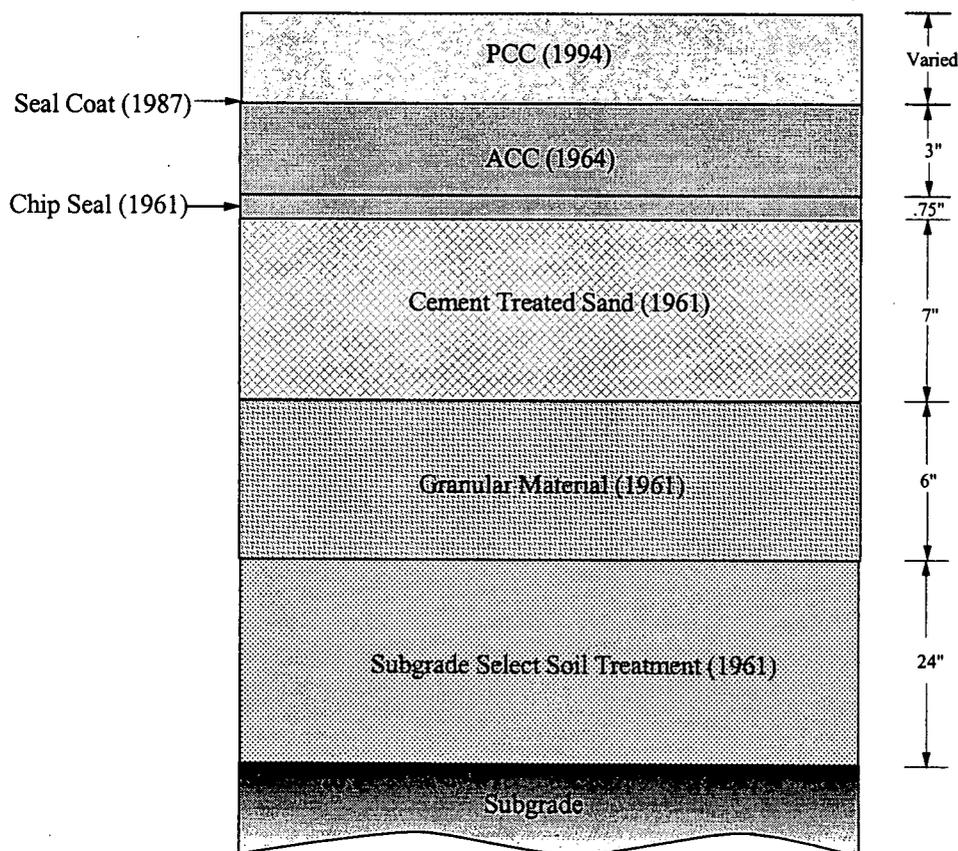
Figure 2: Pavement layers and the dates of their construction

with six inches of granular material, seven inches of cement treated sand (CTS), and 0.75 inches of chip seal. The 9-foot granular shoulders were also constructed at this time. The chip seal was used as the driving surface until 1964, when three inches of type B asphalt cement concrete (ACC) were placed over it. In 1987, a seal coat of negligible thickness was applied to the ACC surface. Ultra-thin whitetopping was placed on the ACC in 1994. All pavement layers were designed and placed according to effective Iowa State Highway Commission (ISHC) or Iowa DOT specifications at the time of contract letting. Figure 2 shows the pavement layers and the dates of their construction [1].

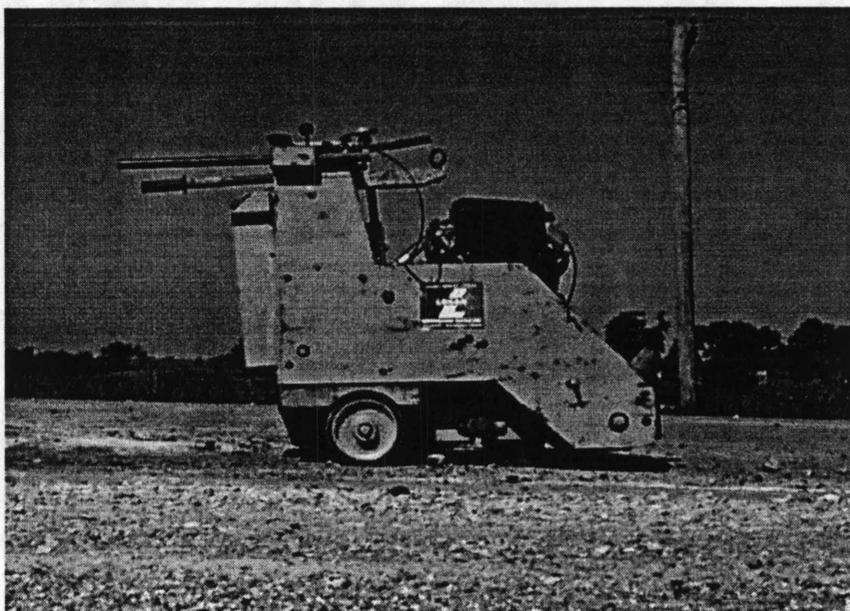
Figure 3: Portable scarifier

Rehabilitation sections underwent preparation prior to placing PCC. Following the removal of PCC panels, portions of remaining underlying ACC were removed through the use of shovels, pick axes, and air-powered chipping hammers. Remaining ACC was removed from the perimeters of removal areas through the use of a demolition saw (a hand-held portable saw) when necessary. The ACC base was then scarified or chipped to increase bonding with the new PCC that was to be placed. Scarification and chipping were also used to attain the minimum PCC depth of three inches if the requirement had not already been satisfied. Use of a portable scarifier was the most popular scarification technique. The portable scarifier is shown in figure 3. Scarification was also achieved through the use of a demolition saw. In these instances, transverse and longitudinal lines were cut in the ACC base. The lines were approximately 1/8 inch deep and spaced between 0.5 and 1.0 inches apart. Following scarification, removal areas were cleaned of debris by using a high-pressure air hose.

Other problems regarding the construction process were minor in nature. Equipment breakdowns produced only slight delays. These consisted of a damaged hose linking a joint saw to the water supply and the repair of the portable scarifier. In addition, adverse weather conditions resulted in the postponement of construction for several days.

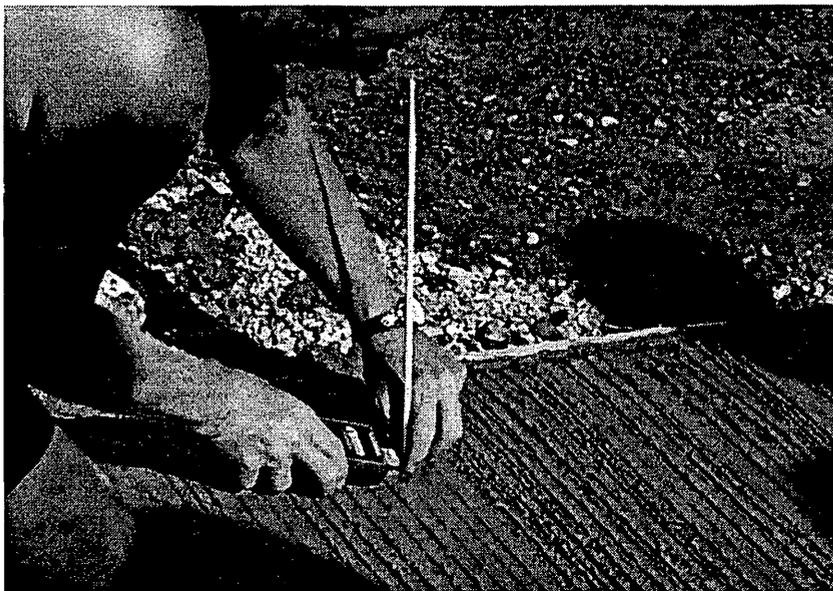
Figure 4: Maturity probe insertion into newly placed PCC

11 displays various characteristics of the PCC at locations of maturity probe placement when the pavement was reopened to traffic.

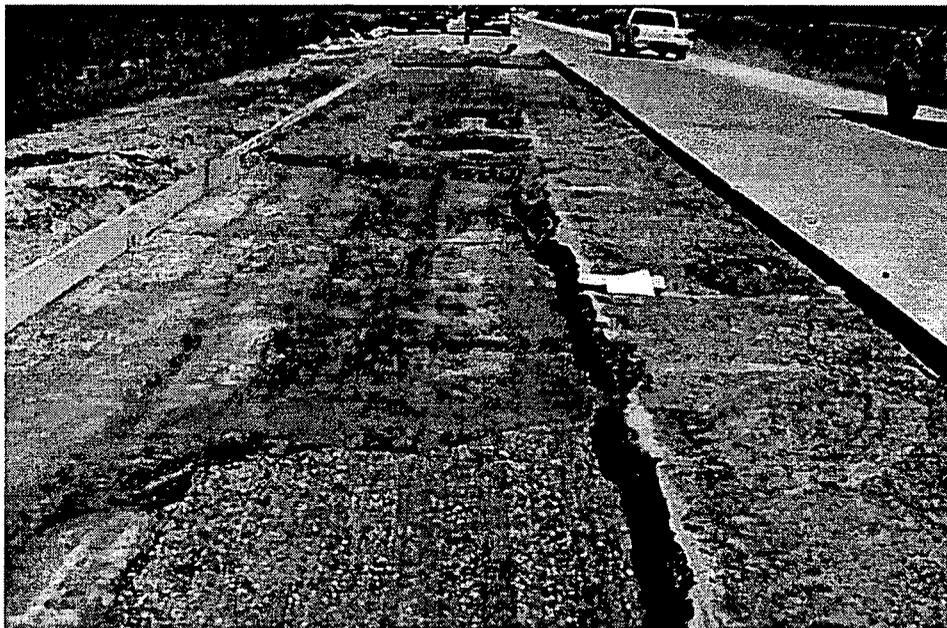
ACC crumbled apart if it required removal by backhoe. The same ACC/bonding condition was evident throughout this section.

Figure 5: Characteristics of a full-lane rehabilitation section (station 2697 + 50 - 2698 + 20) where ACC was partially removed

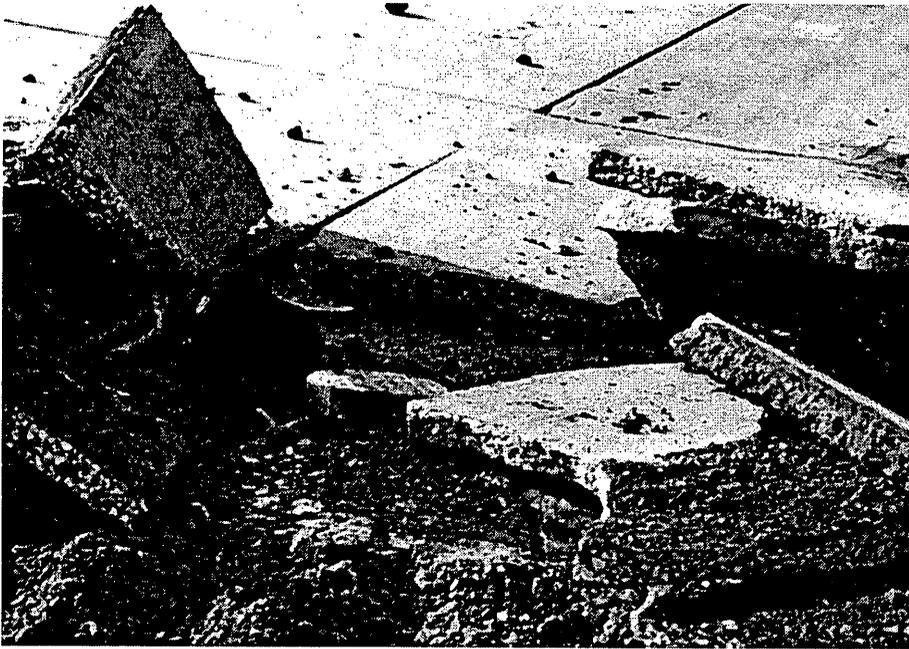
The rehabilitation of 204 feet of pavement occurred on August 19. The ACC crumbled when disturbed by the backhoe. Overall, the ACC appeared to be brittle and in poor condition. The PCC thickness was observed to be 1.5 - 2 inches in the outer 4 - 5 feet of the lane, beginning at station 2693 + 00. Badly cracked (epoxied) panels began at station 2693 + 42 and ended at 2692 + 42 (working from North to South). The severe level of distress in these panels is most likely attributed to the thinness of the PCC. Figure 6 shows the condition of the ACC and interface bonding that was typical along this 204-foot length of rehabilitation.

Figure 6: ACC and interface bonding conditions at station 2693 + 50
