Final Report on Phases II and III

Evaluation of Control Structures for Stabilizing Degrading Stream Channels in Western Iowa

July 1985

Iowa DOT HR-208A
Project 1502
ISU-ERI-Ames-86050

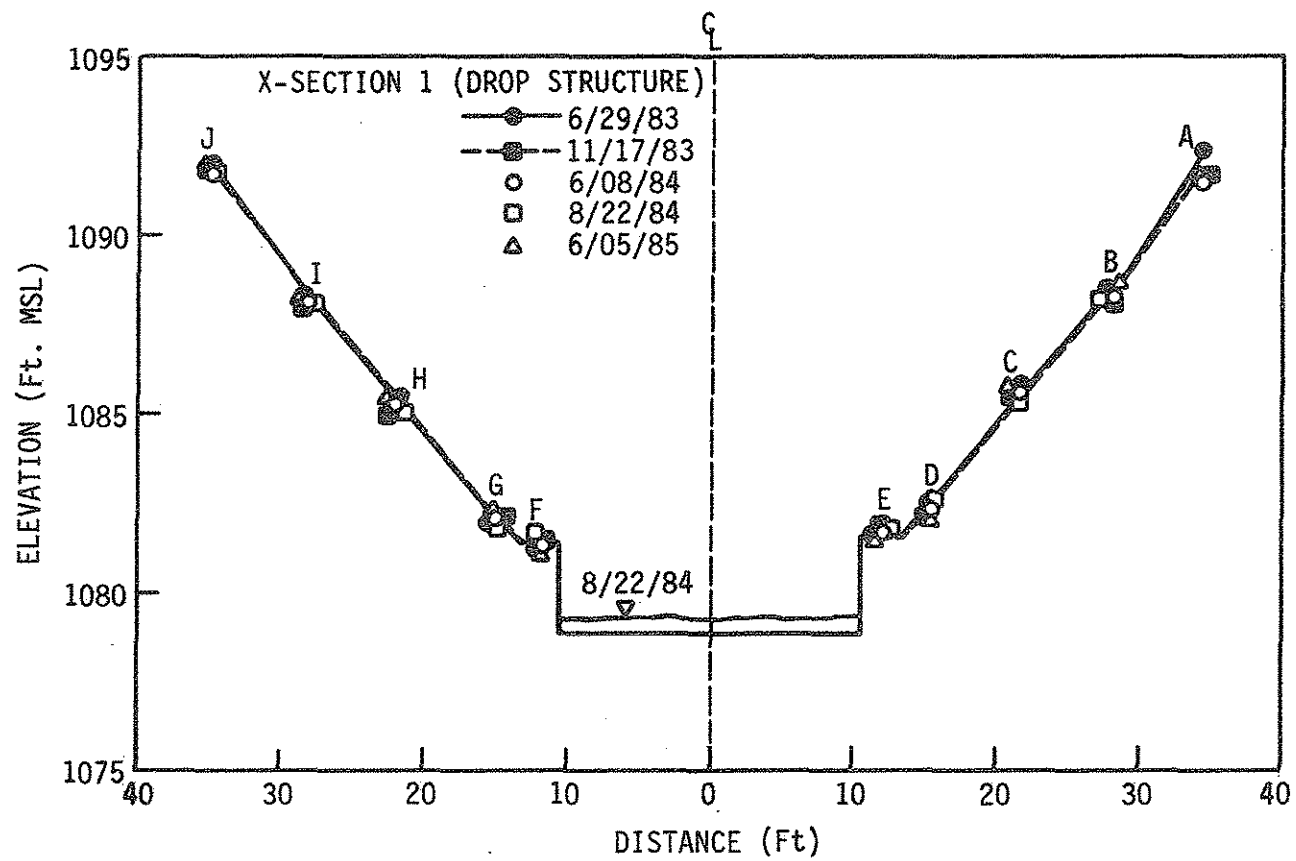
In order to monitor the differential movement of the structure, concrete monuments were placed on the surface as shown in Fig. 1. Elevations of the monuments were measured at five different times: 6/29/83, 11/7/83, 6/8/84, 8/22/84, and 6/5/85. The elevation data were used to plot all of the transverse cross sections at the various dates. These plots revealed that virtually no differential settlement has occurred within the structure throughout the course of the investigation. Figure 2 is a typical cross section, and Fig. 3 shows the cross section that exhibited the maximum amount of settlement. In Fig. 3

Figure 2. Cross section at top of structure. Note differential movement at monument A. This is the only measurable movement observed in the structure.

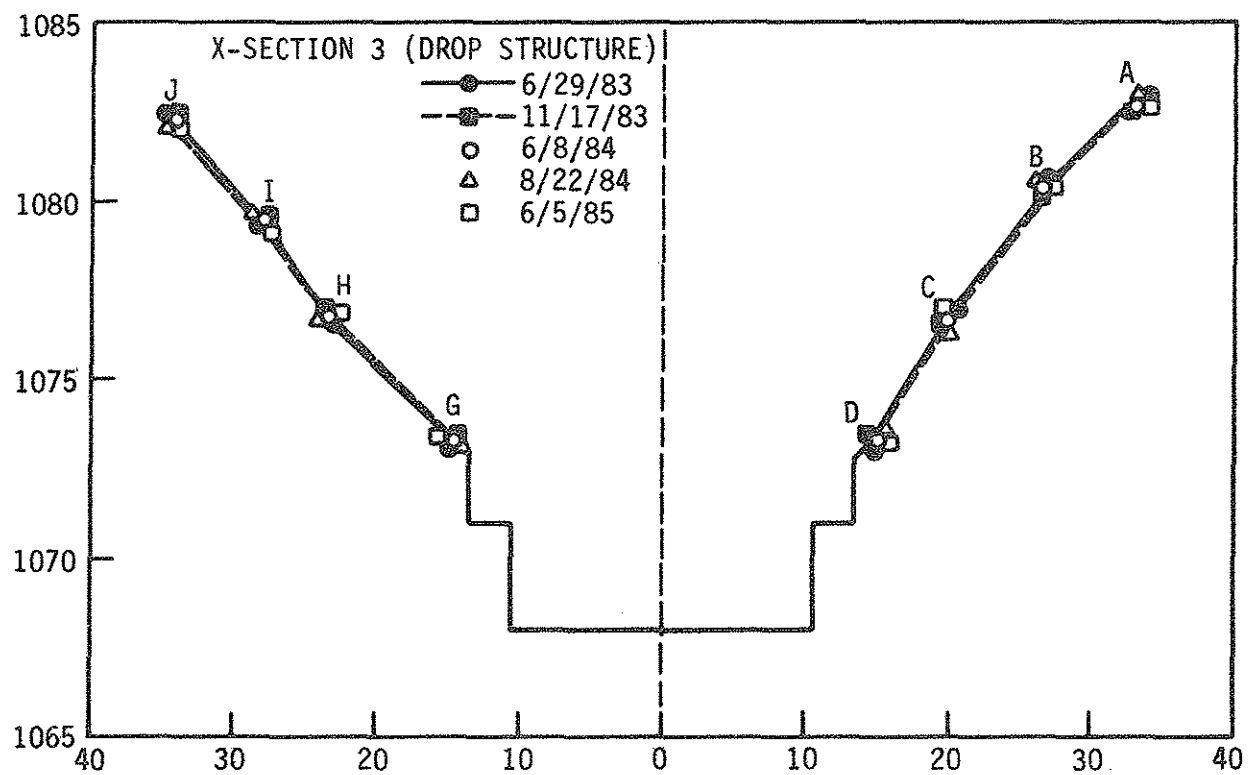
Figure 3. Cross section at about middle of structure. Virtually no differential movement is observed, which is typical of all 5 cross sections.

the monument 1A, at the top of the sideslope immediately downstream from the crest, settled about four inches between the first two observation dates. No differential movement has been observed since 11/7/83; thus, it has been concluded that differential settlement is not a problem. Because soil consolidation occurs most rapidly soon after loading, it appears settlement will not be a problem.

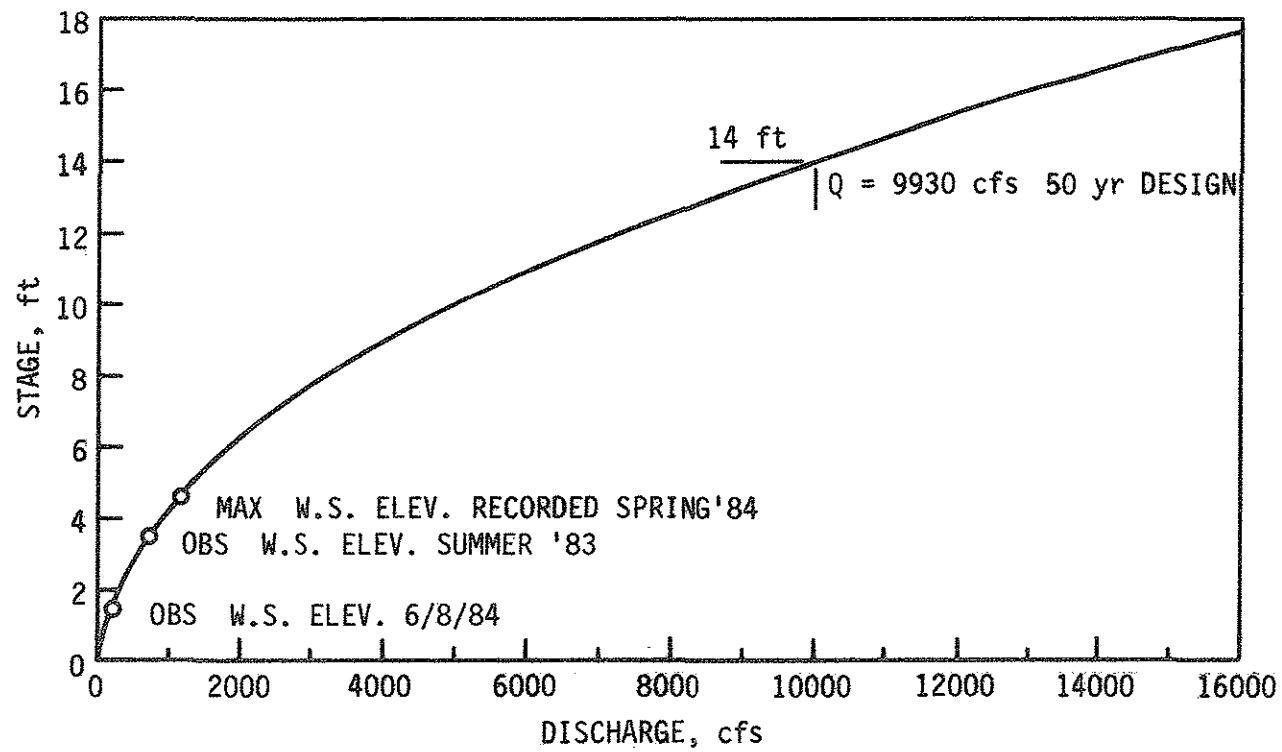
Figure 4. Stage-discharge relationship for drop structure at its crest. Crest elevation is 1079 ft MSL.

was used, and it estimated the flow depth at 13.5. The data shown in Fig. 4 give good agreement with the design estimates.

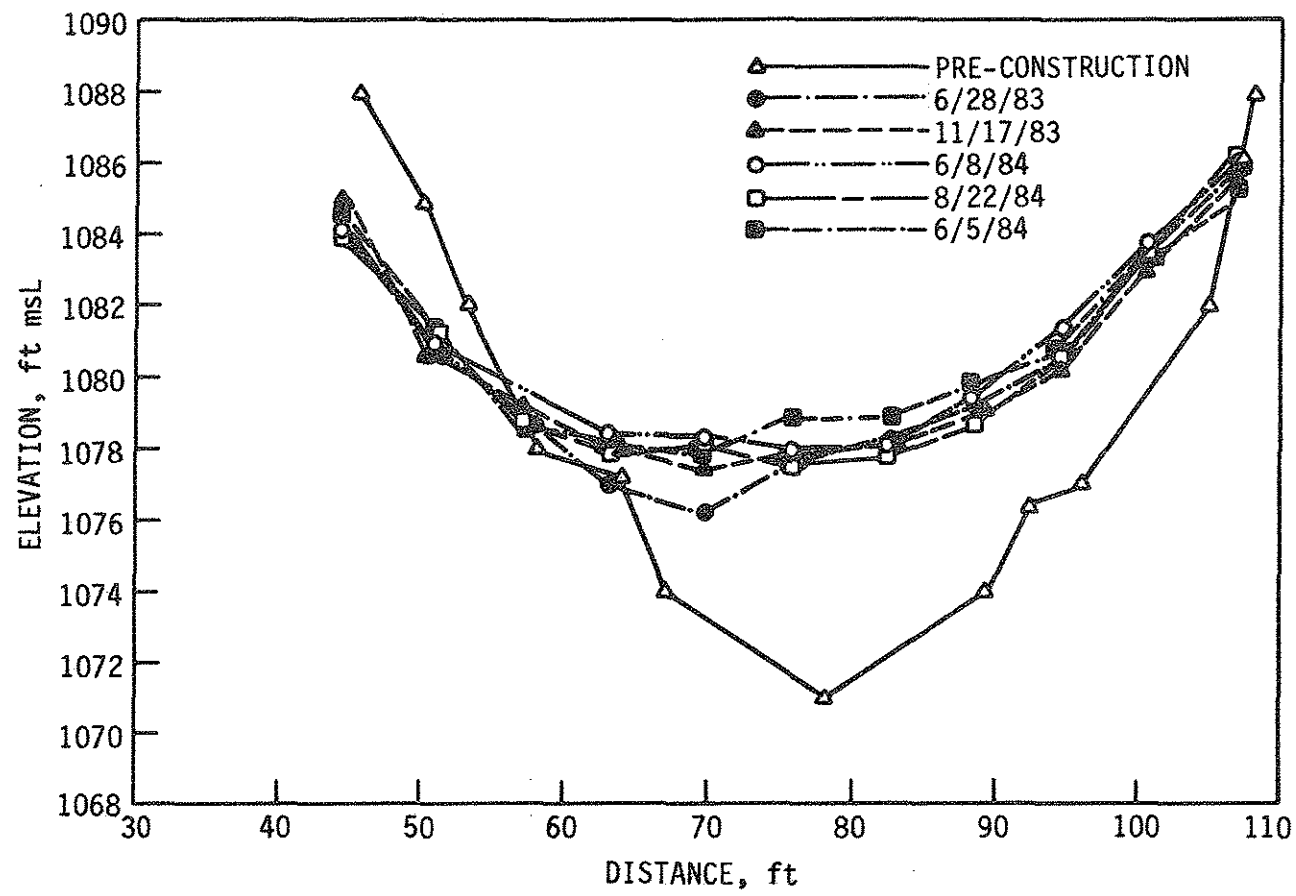
Changes in the upstream channel geometry caused by sedimentation have been monitored by surveying transverse profiles at the bridge and at 500-ft intervals upstream to a distance of 5,000 ft. Transverse profiles at the bridge were measured on 11/12/83, 6/28/83, 6/8/84, 8/22/84, and 6/5/85. A set of transverse profiles is shown in Fig. 6. These sections show that sedimentation to a depth of 6 ft had occurred prior to 6/28/83, but little change has been noticed since that date.

Figure 6. Transverse cross sections of channel bottom for various dates.

This indicates that the major amount of sedimentation above the crest occurred during construction and that the 1,200 cfs event since construction has had little effect on deposition.

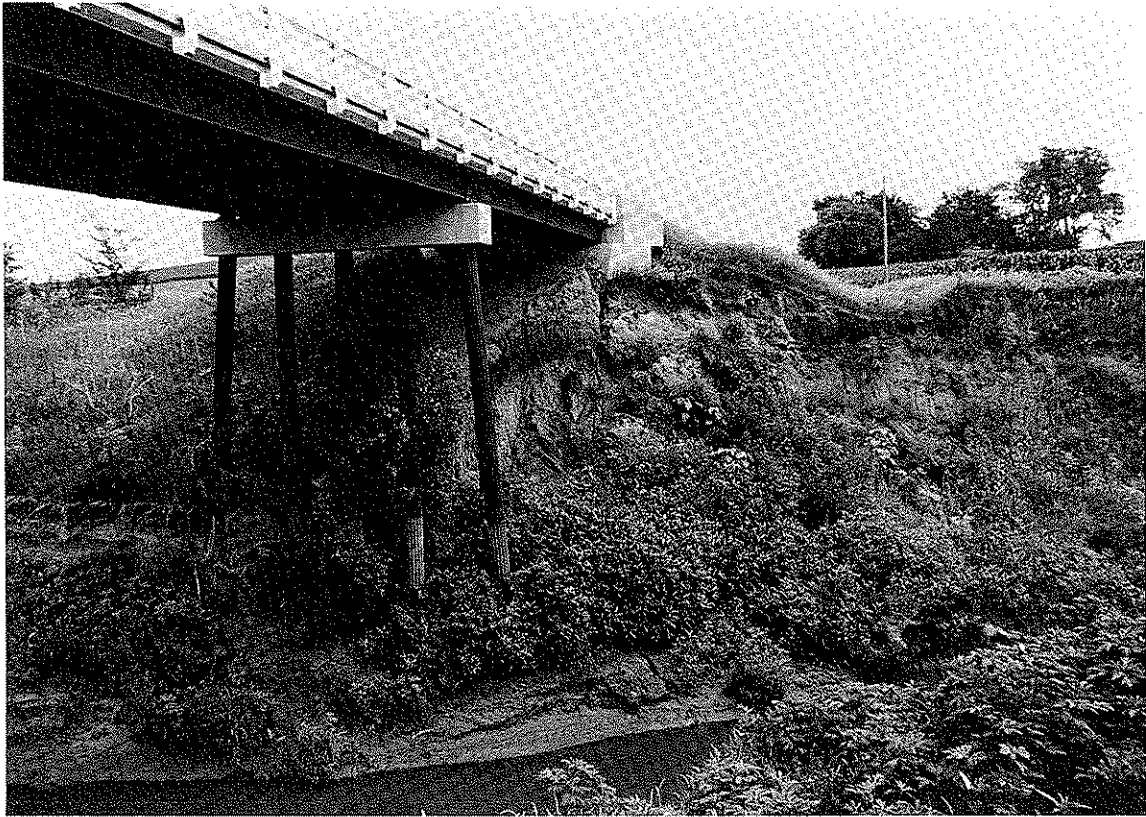
The sedimentation beneath the bridge has been sufficient to cover the piles to their original depth of soil cover and to stabilize the slope beneath the abutment. This is illustrated by comparing Photoplates 4 and 5. Photoplate 4 was photographed in 1979 when erosion had exposed about 6 ft of previously buried piling and pulled soil away from the abutment. Photoplate 5 was taken in June, 1985 and shows that the piles have been covered to their original depth.

Plate 4. East end of bridge showing exposed piling and soil slide away from abutment. Light colored portion of the bottom of piles indicates where soil formerly covered piles, July 1979.

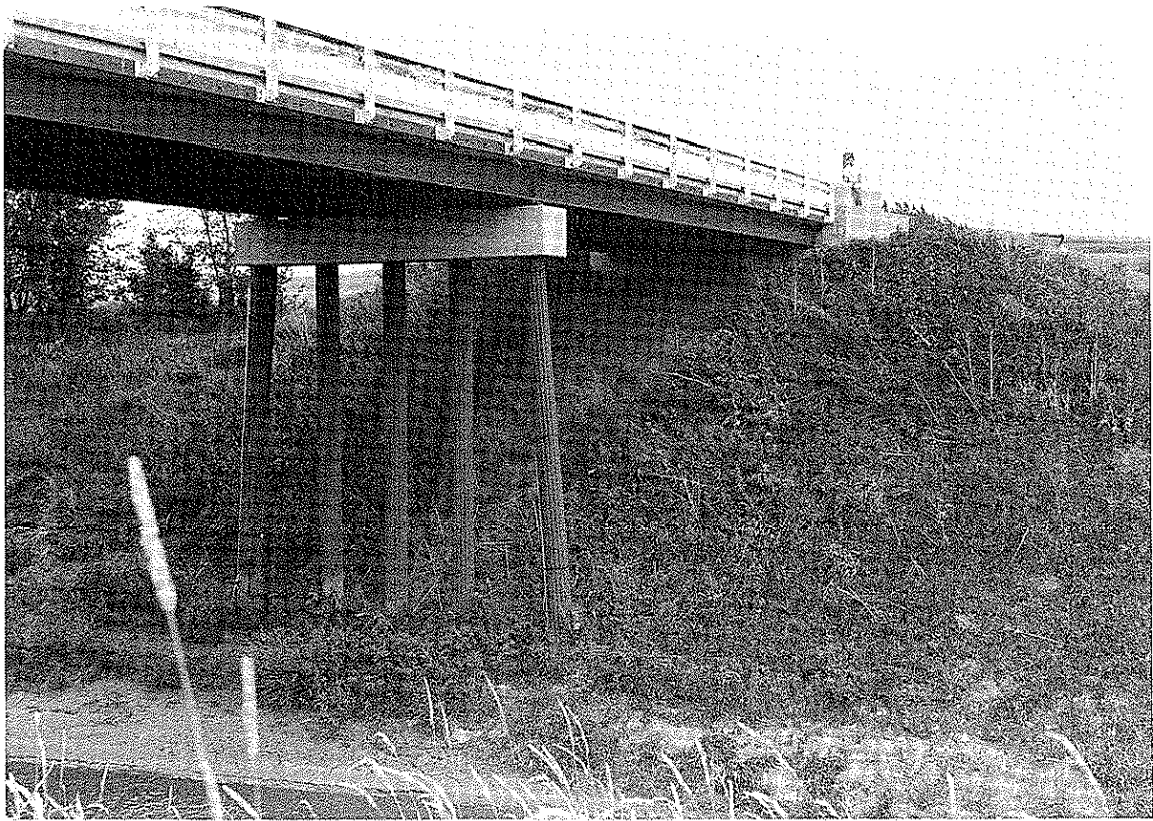
Plate 5. East end of bridge showing piling once again covered by soil and stable soil slope beneath abutment, June 1985.

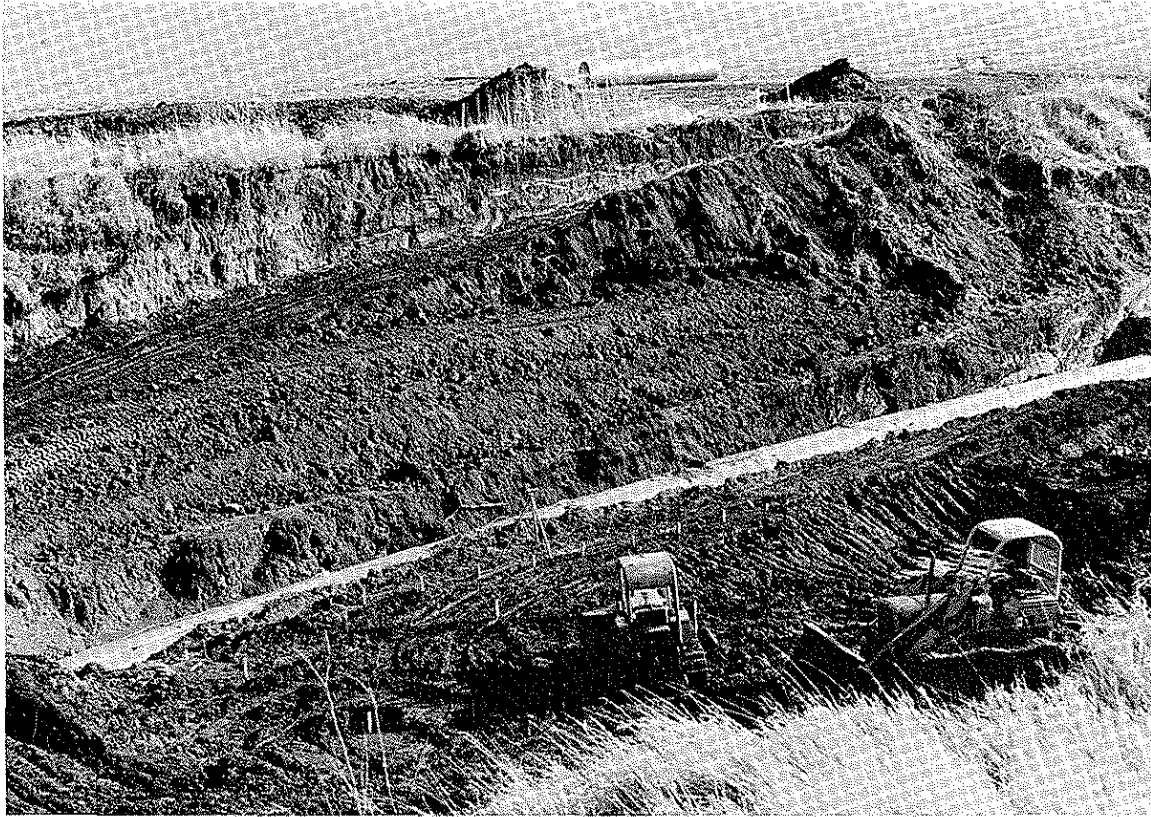
Plate A-1. Excavation and grading of side slopes, Dec. 18, 1982.

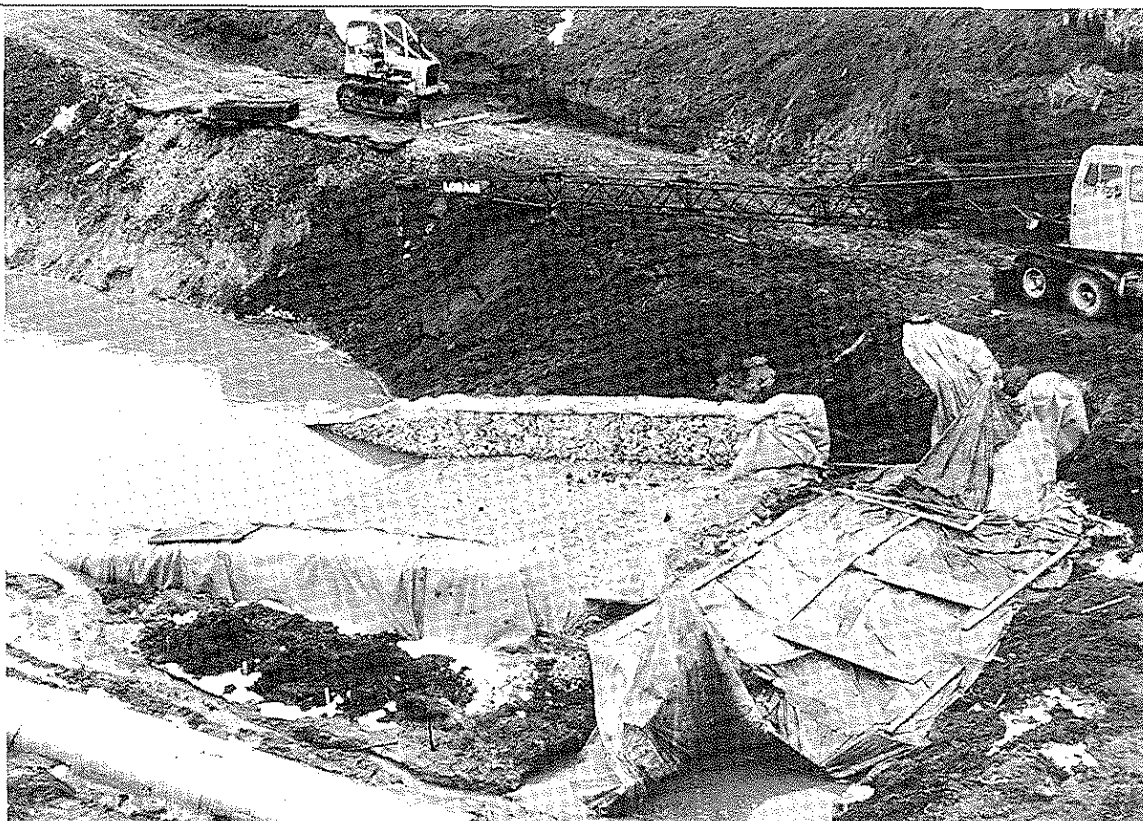
Plate A-2. Gabion spillway in place, Feb. 10, 1983.

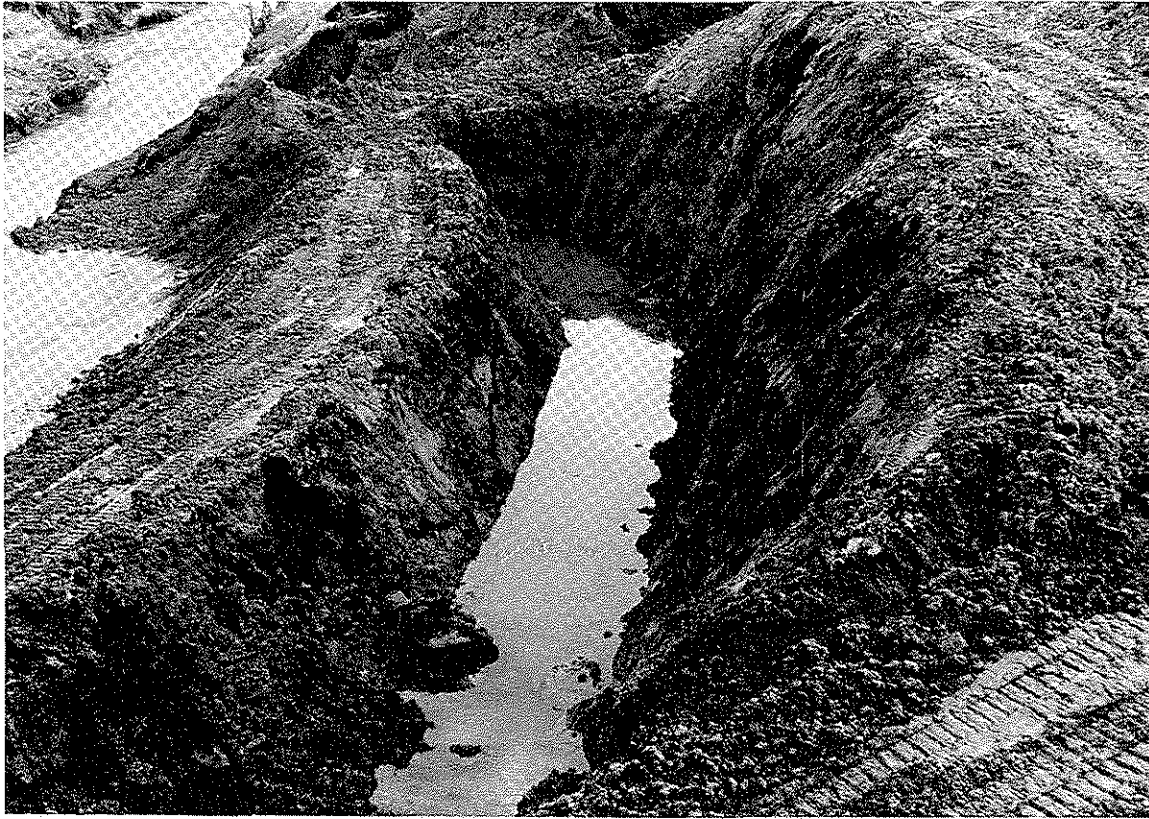
Plate A-3. Diversion channel excavated on west side of natural channel, Apr. 9, 1983.

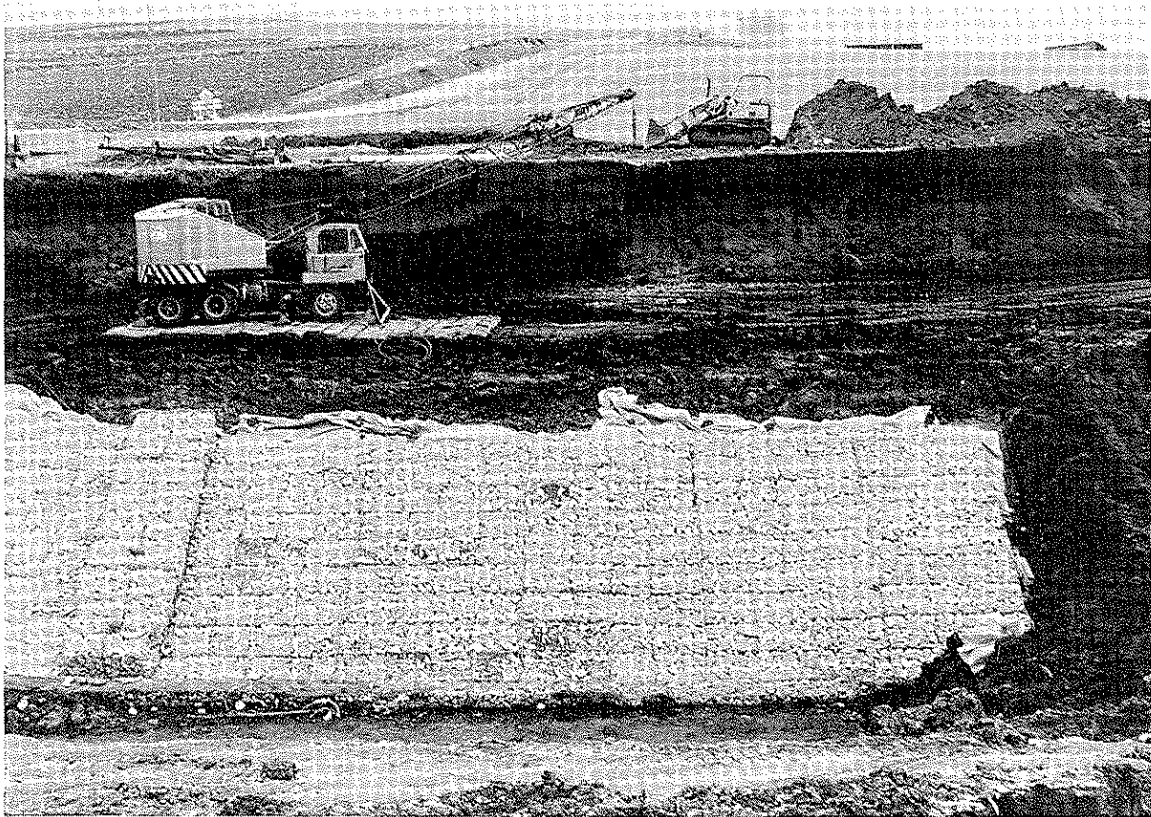
Plate A-4. Gabions in place on east side of spillway, Apr. 27, 1983.

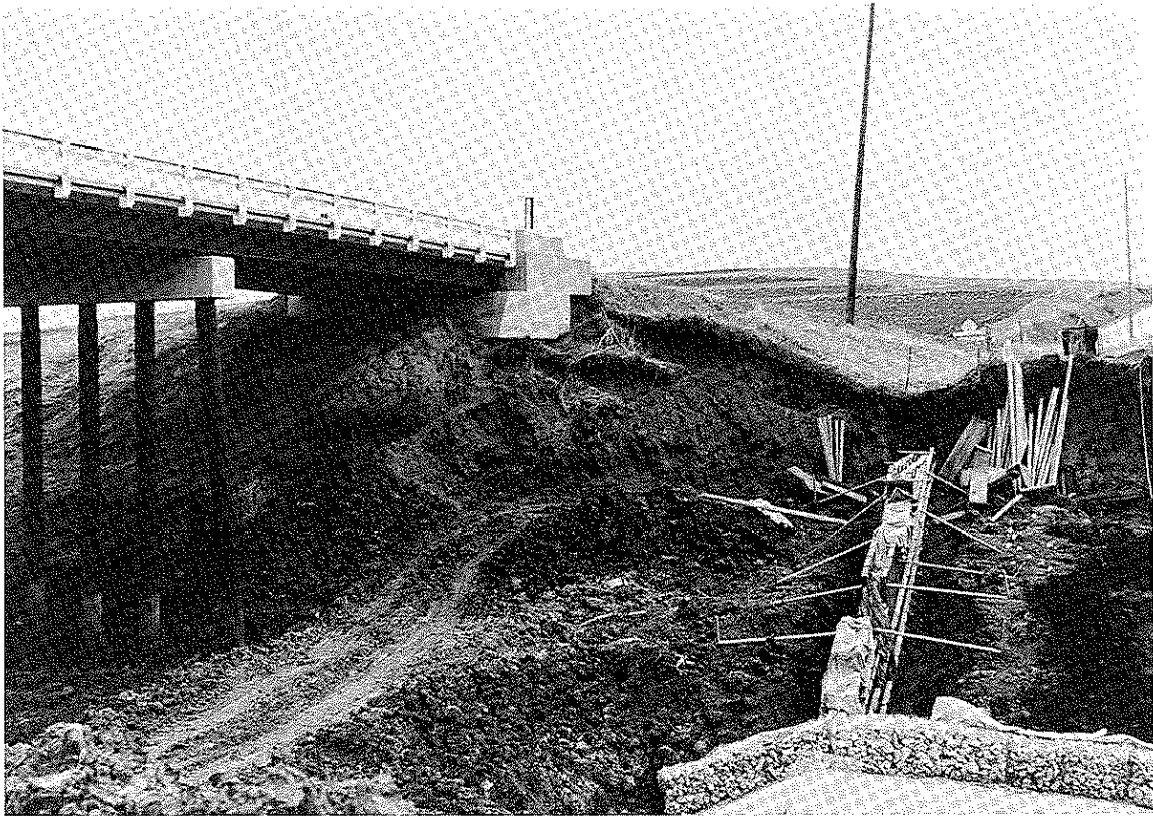
Plate A-5. Concrete cutoff wall at crest of structure, Apr. 27, 1983.
