Iowa Highway Research Board

Project HR-87

SUBGRADE INSULATION

Final Report  
December 1965

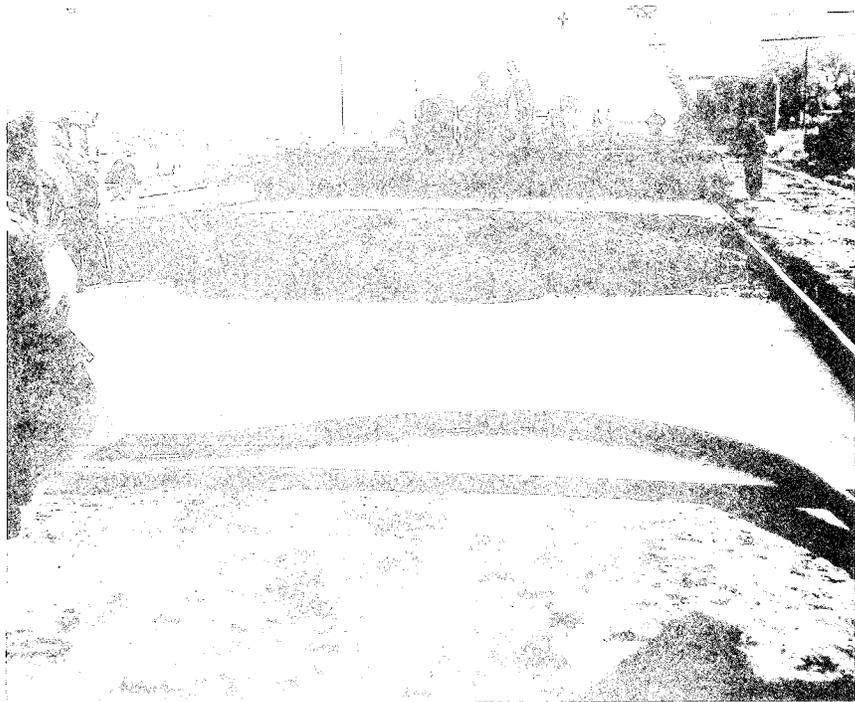
Photo 5: Concrete being placed on the Styrofoam.

Nine inches of Portland cement concrete pavement was then placed directly on the Styrofoam (or polyethelene). The thermocouples used to measure the temperature of the concrete pavement were held in position by frames during placing of the concrete.

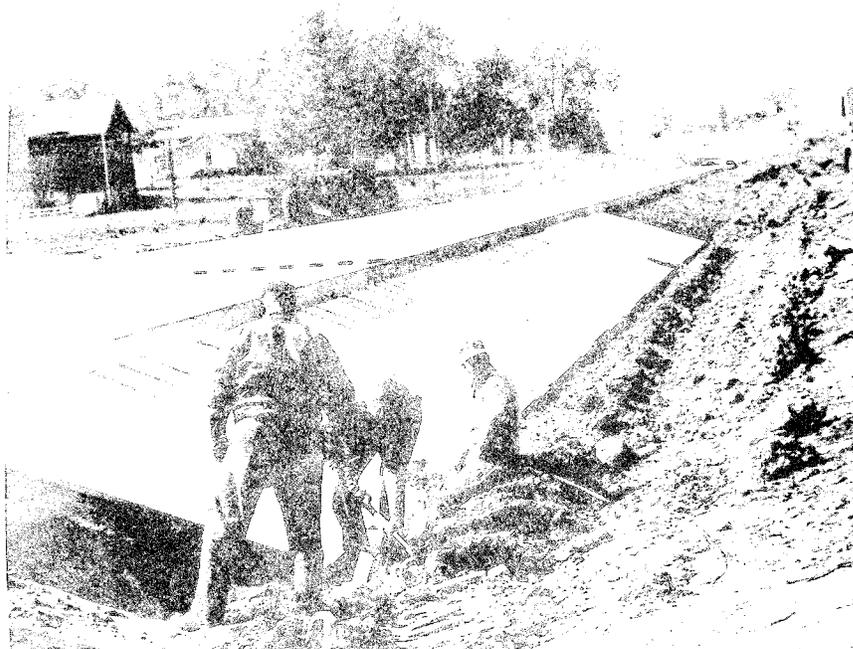
Photo 7: Styrofoam being placed on the 2:1 Slope in the Shoulder.

placed along the slope and the shoulder was constructed. Thermocouples were placed in the shoulder at various depths in the soil below and above the Styrofoam.

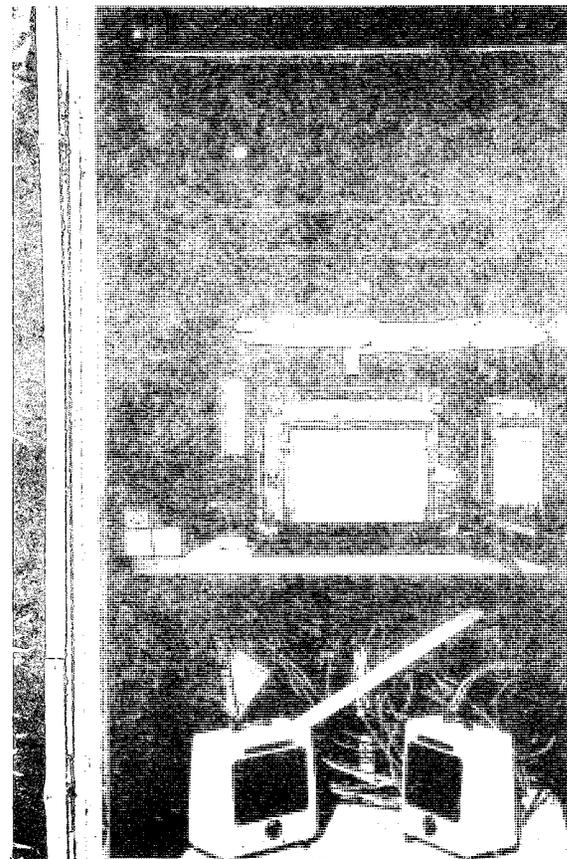
Photo 9: Interior of temperature recording installation. Recording potentiometer above, two electrical heaters below.

The thermocouple wires terminated in a 5 foot by 5 foot by 6 foot building located near the right of way line. This building was well insulated and a temperature above 50<sup>o</sup>F was easily maintained during the winter months by use of two electric heaters.

The temperatures obtained by the thermocouples were indicated by an automatic recording potentiometer which was capable of recording, in sequence, the temperatures in 24 separate locations. It was timed so that the temperatures at the 24 locations were recorded once every two hours. The recorder contained two instrument boards consisting of 24 terminals each. Either board could be connected, making it possible to obtain temperatures from 24 alternate locations if desired. The layout of the thermocouples at Station 602+00 and at Station 604+50 is shown in Figures 3 and 4.

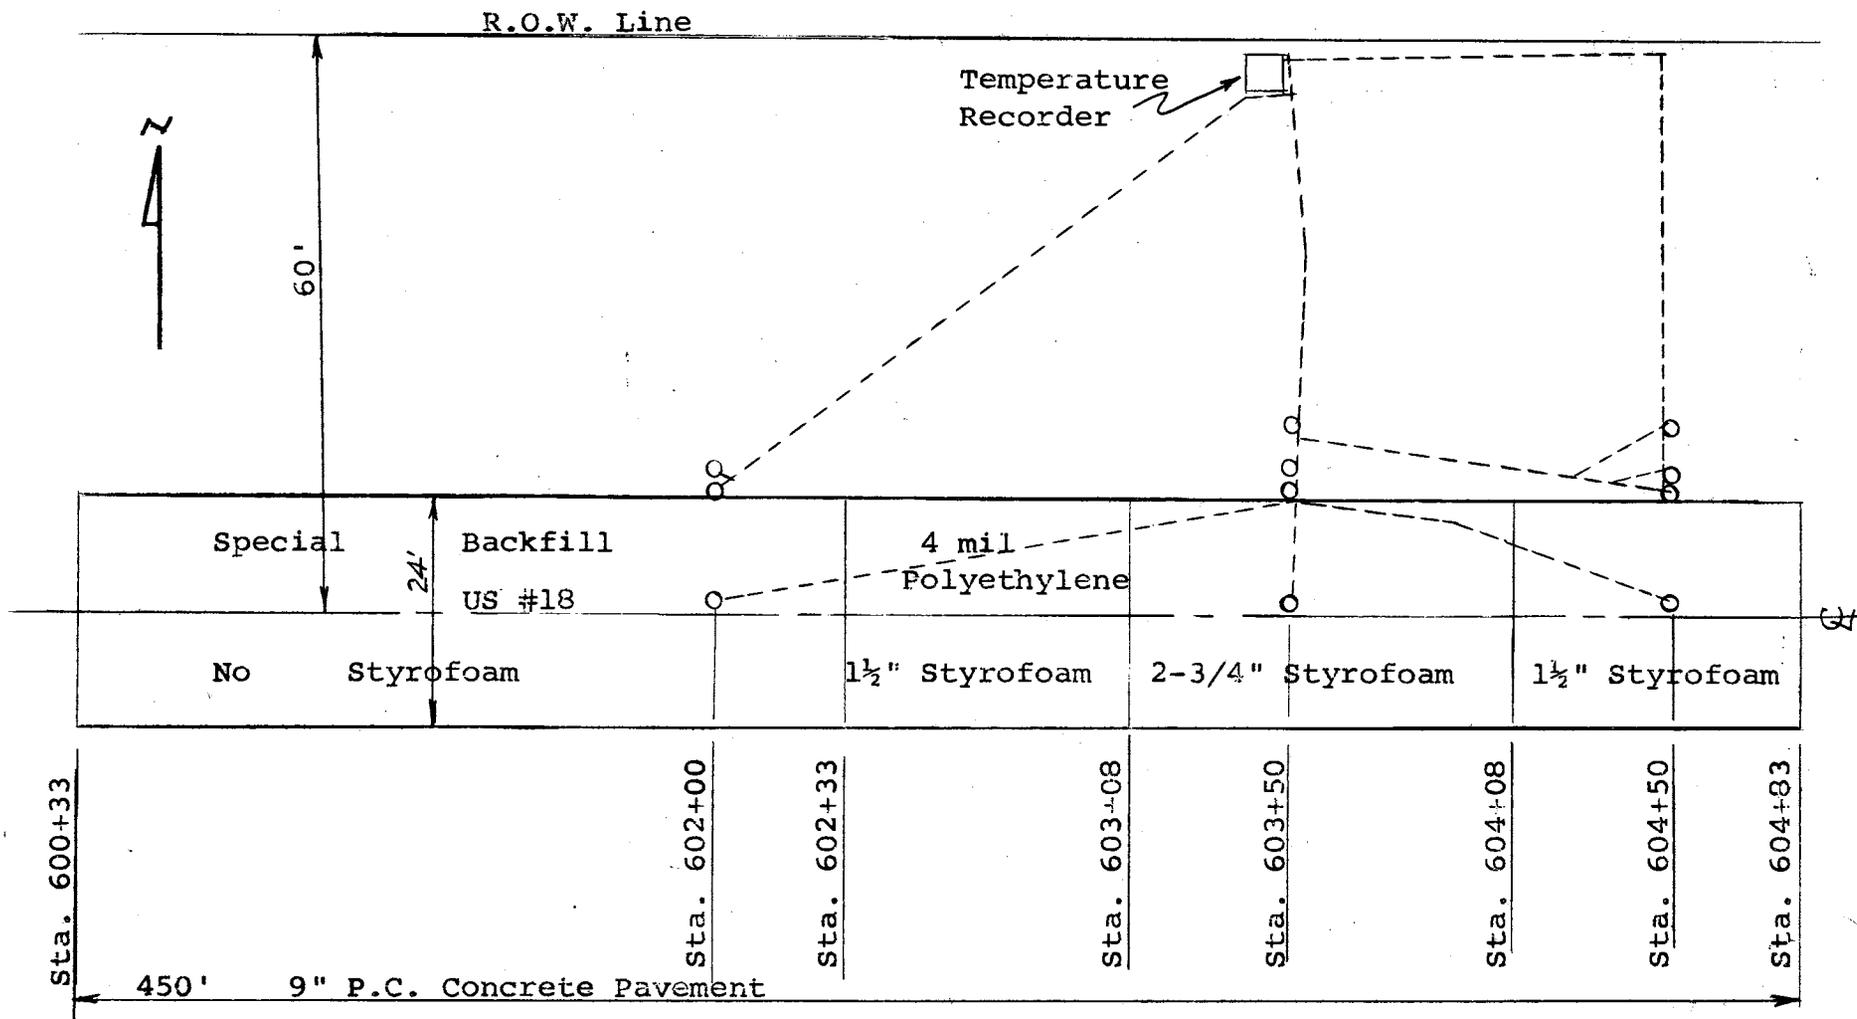
Figure 2

The 250 foot test area was divided into three sections. In the east section, 75 feet in length, one layer of Styrofoam one and one-half inches thick was placed. In the middle section, 100 feet in length, two layers of Styrofoam, each three-fourths inch thick, were placed. In the west section, 75 feet in length, one layer of Styrofoam one and one-half inches thick was placed. In this section the Styrofoam was covered with a sheet of four mil polyethelene. A layout of the test area is shown in Figure 2.

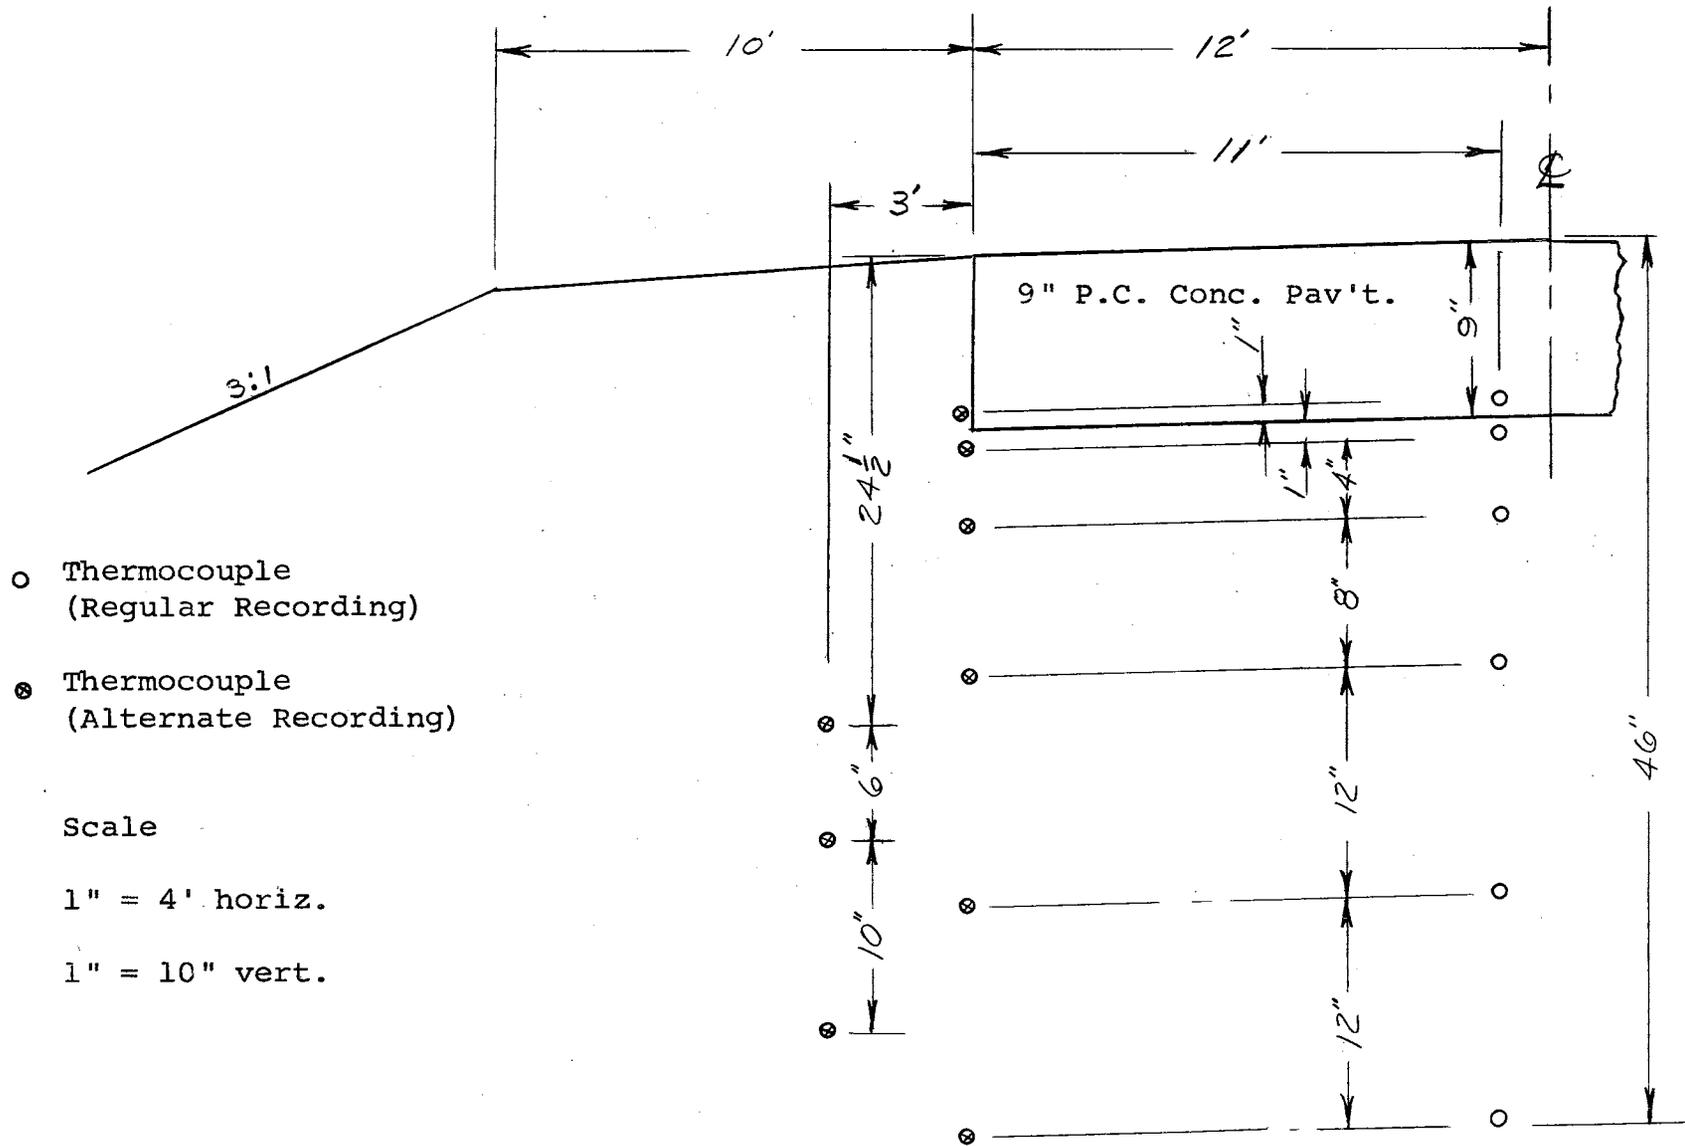
Figure 3

Thermocouple Locations

Sta. 602+00

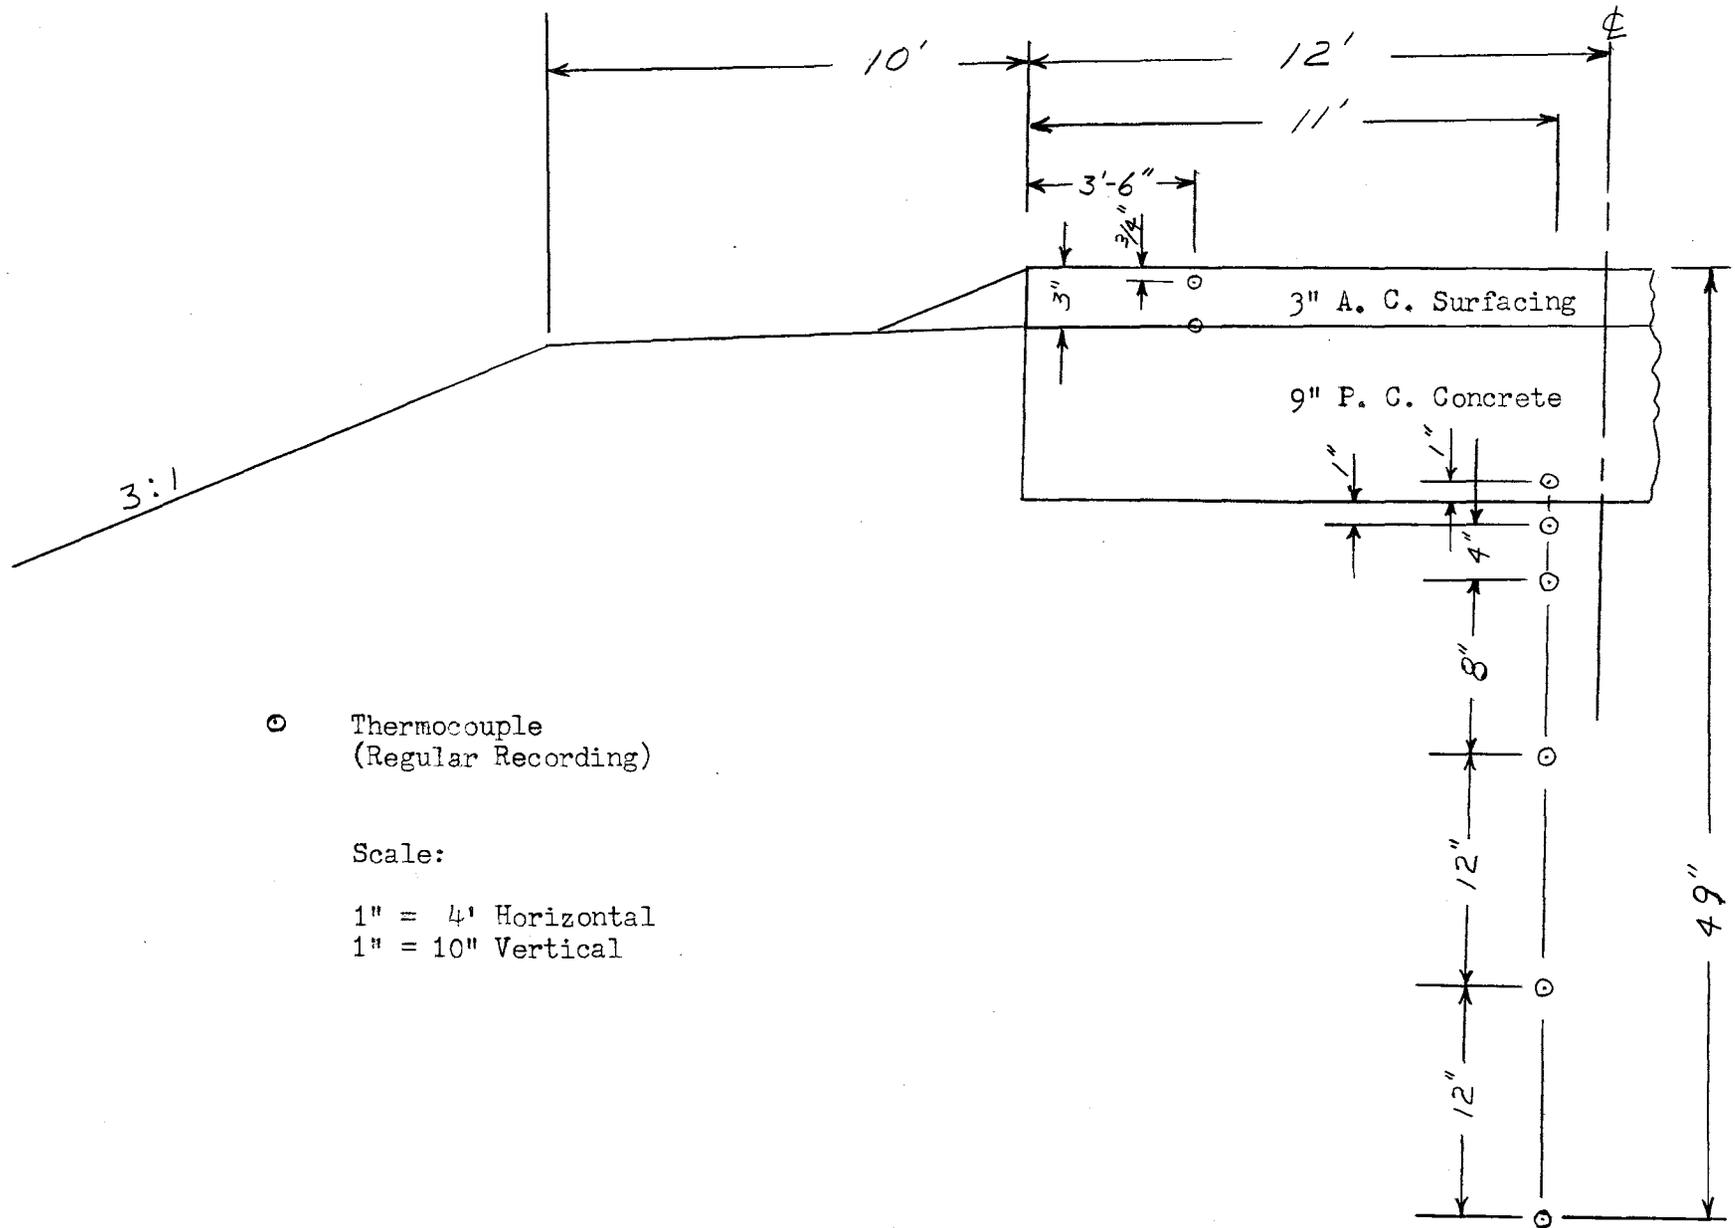
Figure 5: Thermocouple Locations Sta. 602 + 00 - Effective 5-7-65

Figures 5 and 6 show the thermocouple locations at the same stations after the asphaltic concrete resurfacing had been completed. The remaining thermocouples were placed in the concrete and subgrade at Station 603+50 but were not installed in the resurfacing at that particular location.

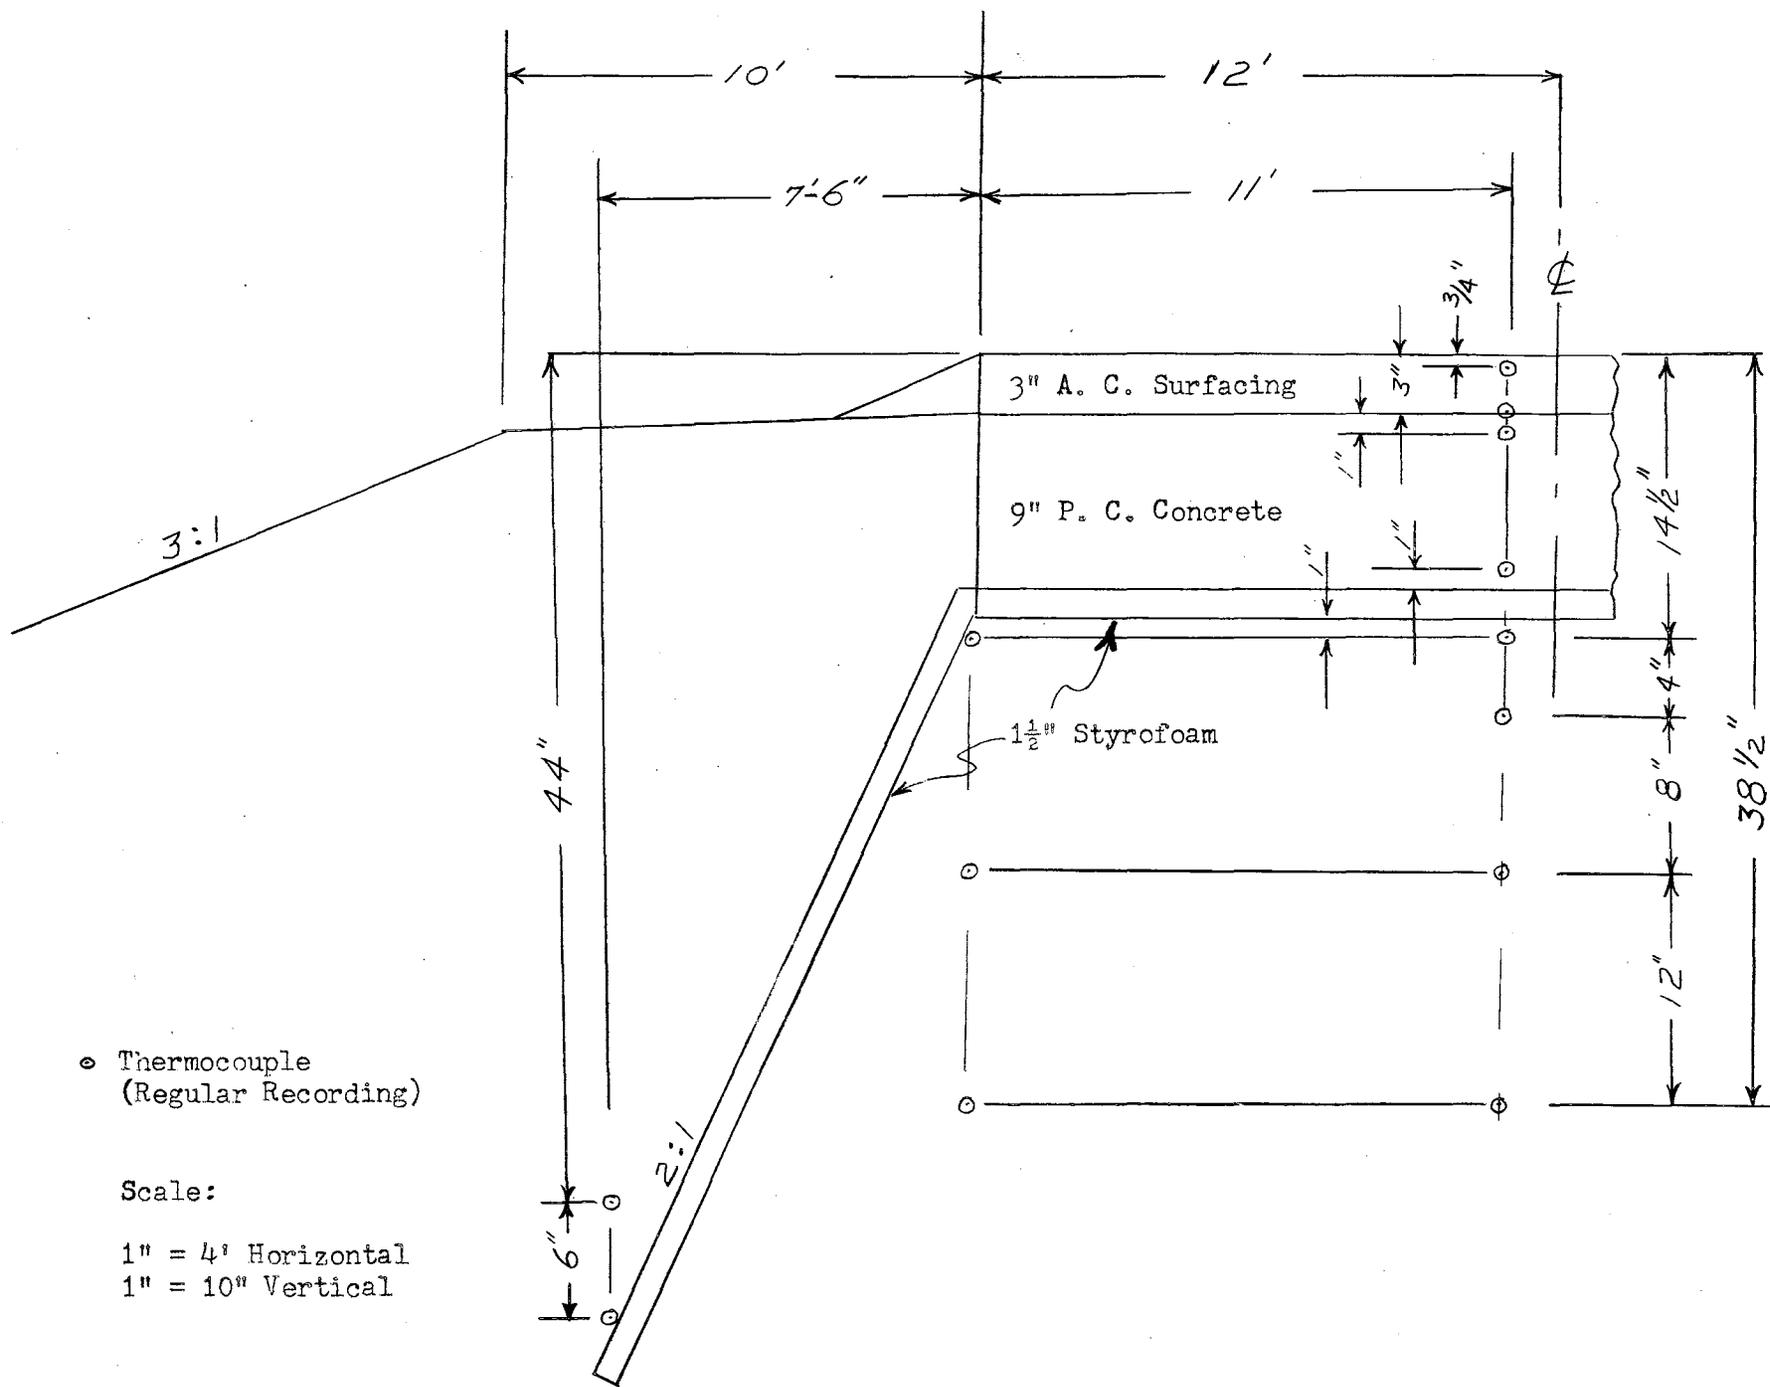
Figure 6: Thermocouple Locations Sta. 604 + 50 - Effective 5-7-65

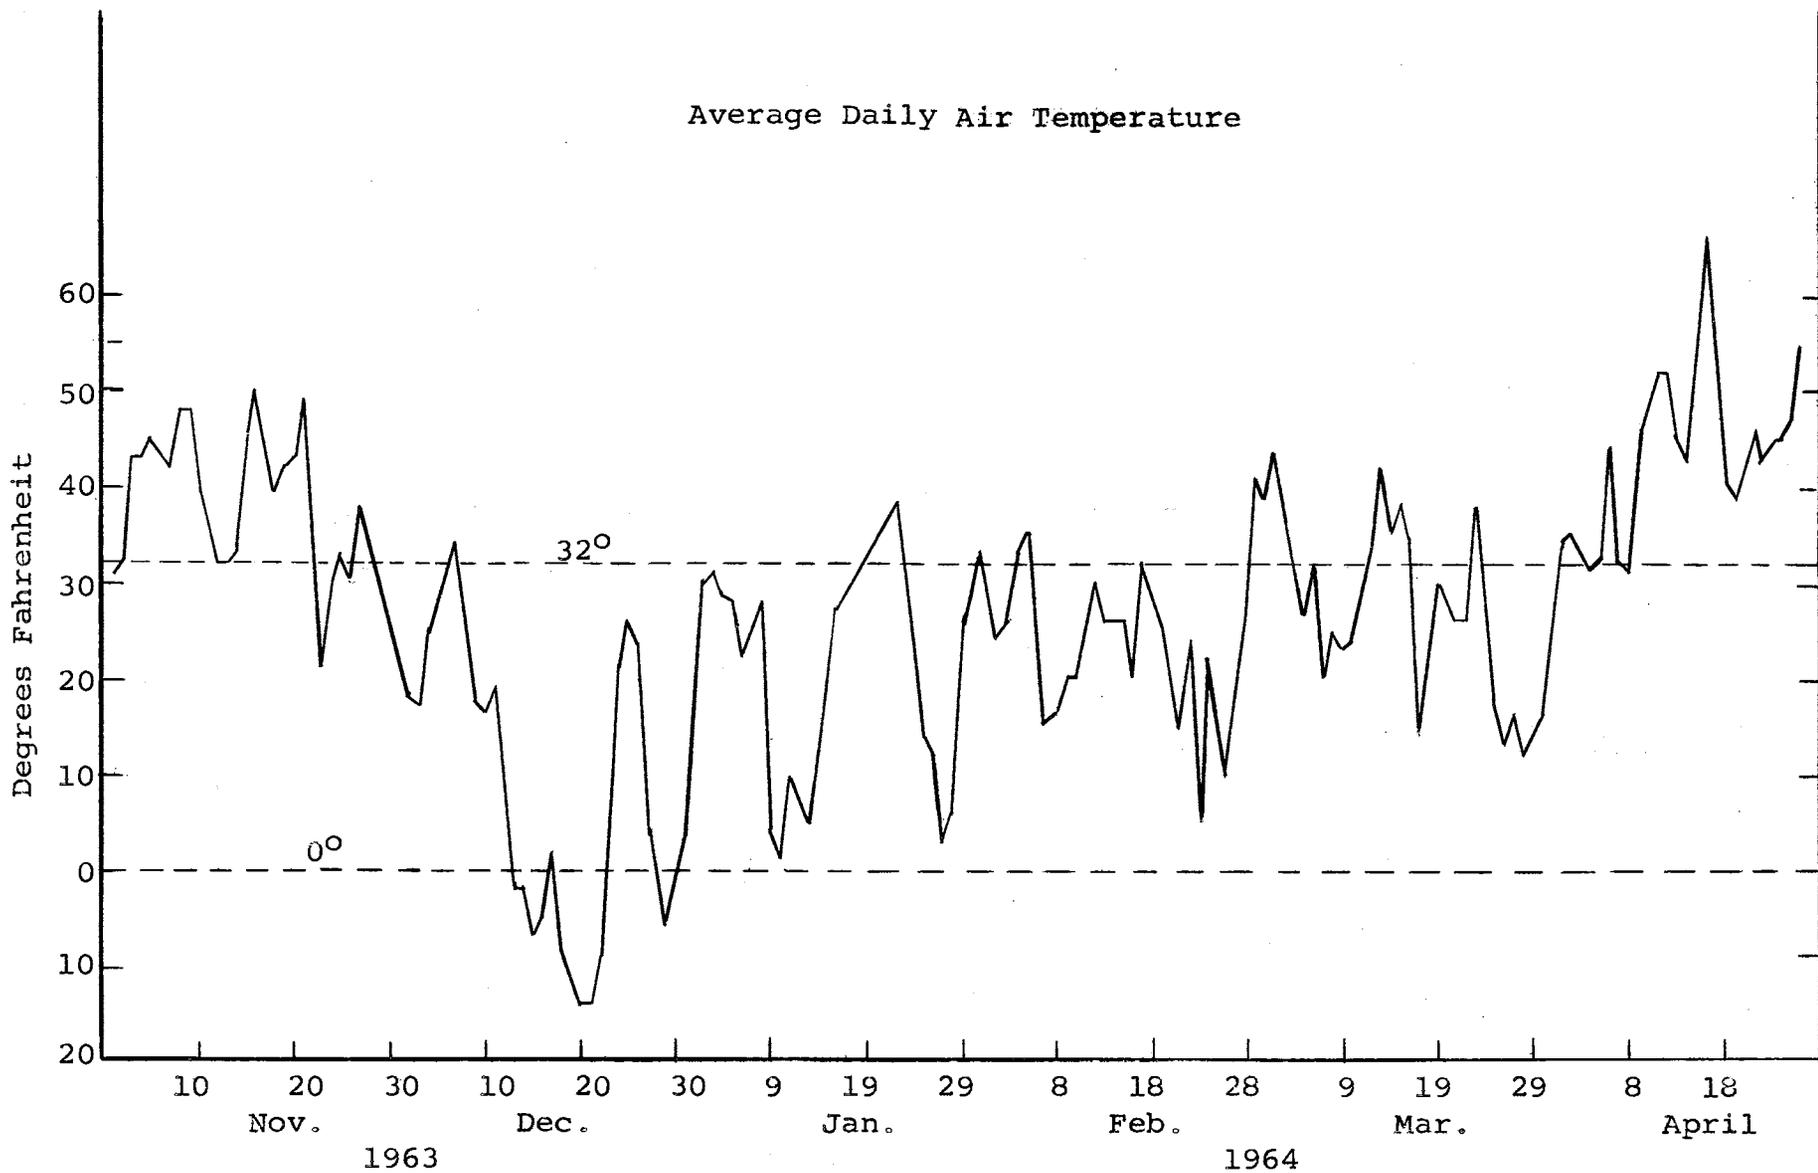
Figure 7

Figures 7 and 8 show the average daily air temperatures during the freezing seasons of 1963-1964 and 1964-1965.

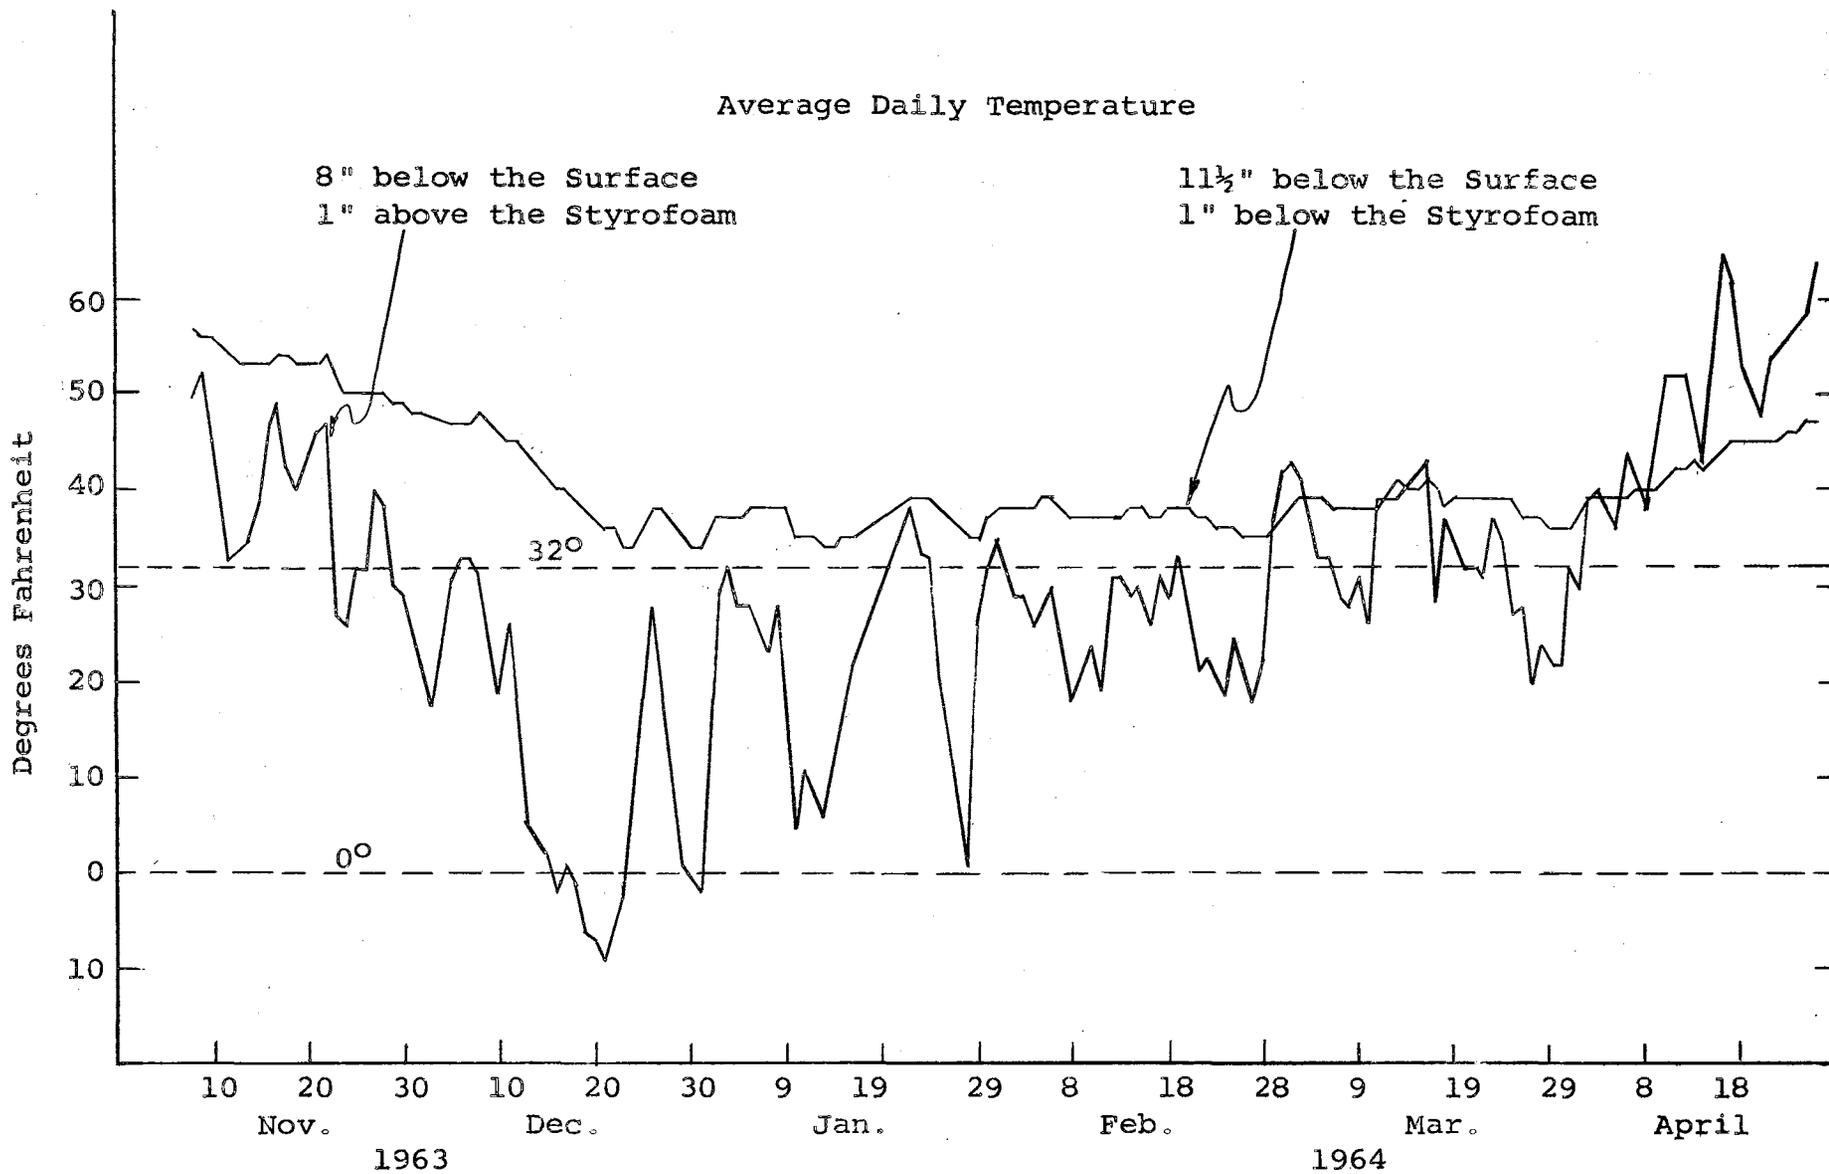
Figures 9 and 10 compare the temperatures above and below the Styrofoam insulation. Figure 9 shows these comparative temperatures for the 1963-1964 freezing season (before resurfacing) and Figure 10 shows them for the 1964-1965 freezing season (after resurfacing).

Average Daily Temperature

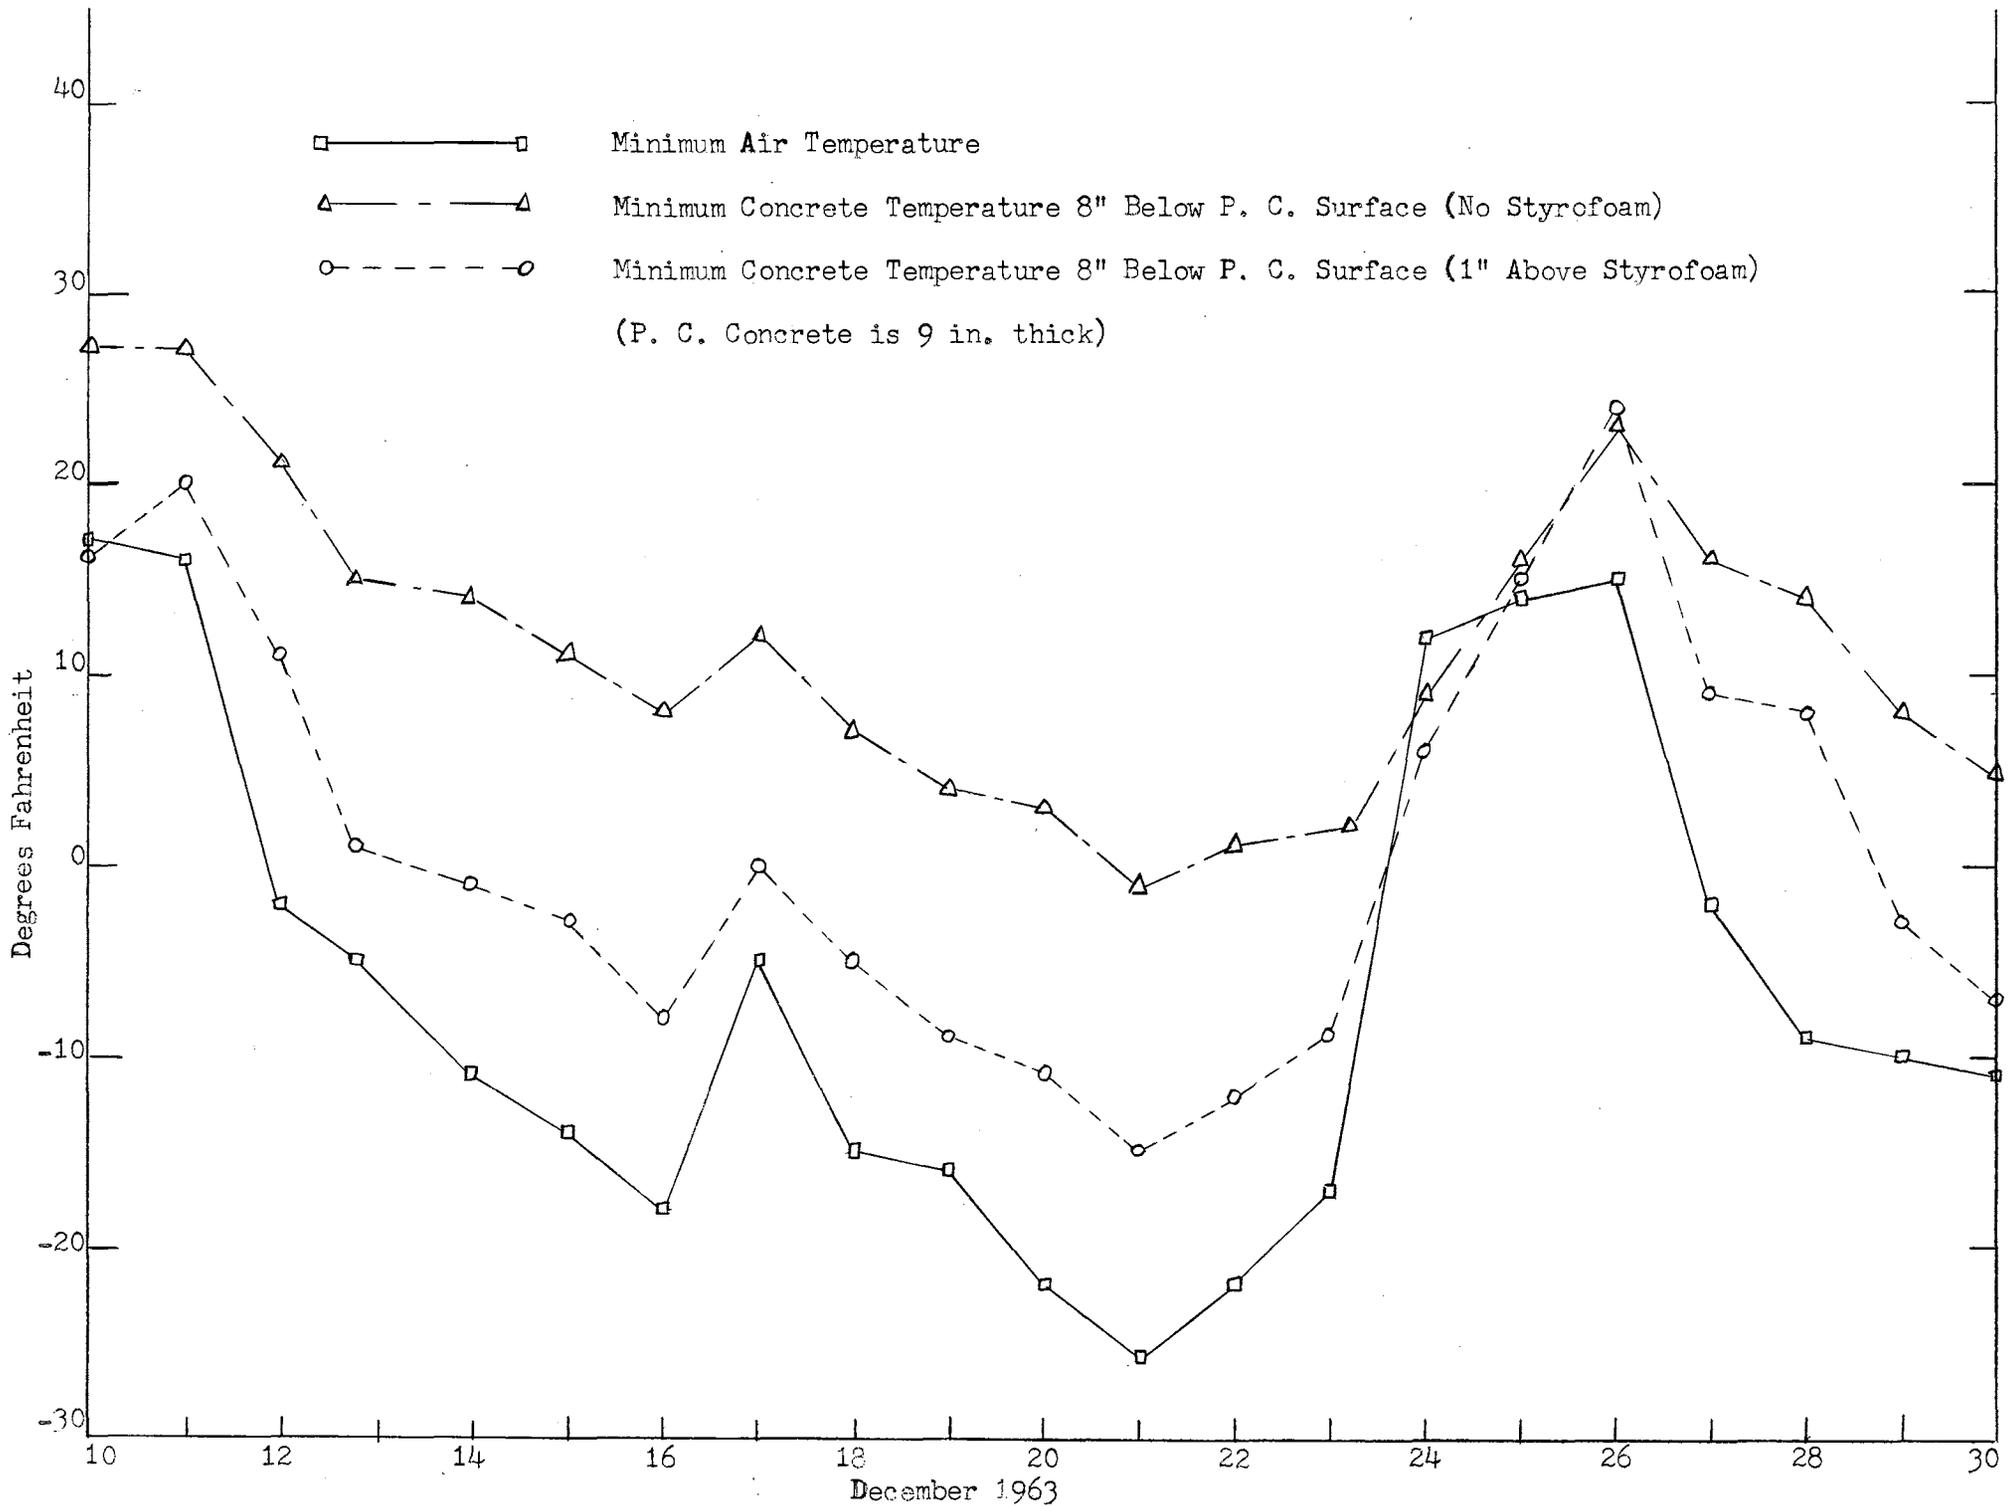
Figure 11: Concrete temperatures as affected by insulation - Winter 1963 - 1964

Figures 11 and 12 compare minimum temperatures in the concrete one inch above the bottom of the slab, as affected by insulation below the slab. These graphs are included primarily to show that while the Styrofoam insulates the subgrade from freezing temperatures, it also prevents the concrete from receiving heat from the subgrade. Figures 13 and 14 show maximum temperatures at the same locations during the warmest summer months. In this case the Styrofoam reduces the amount of cooling from the subgrade. The temperatures shown in Figure 11 are those before the asphaltic concrete was applied and those in Figures 12, 13, and 14 are after the three inch resurfacing.

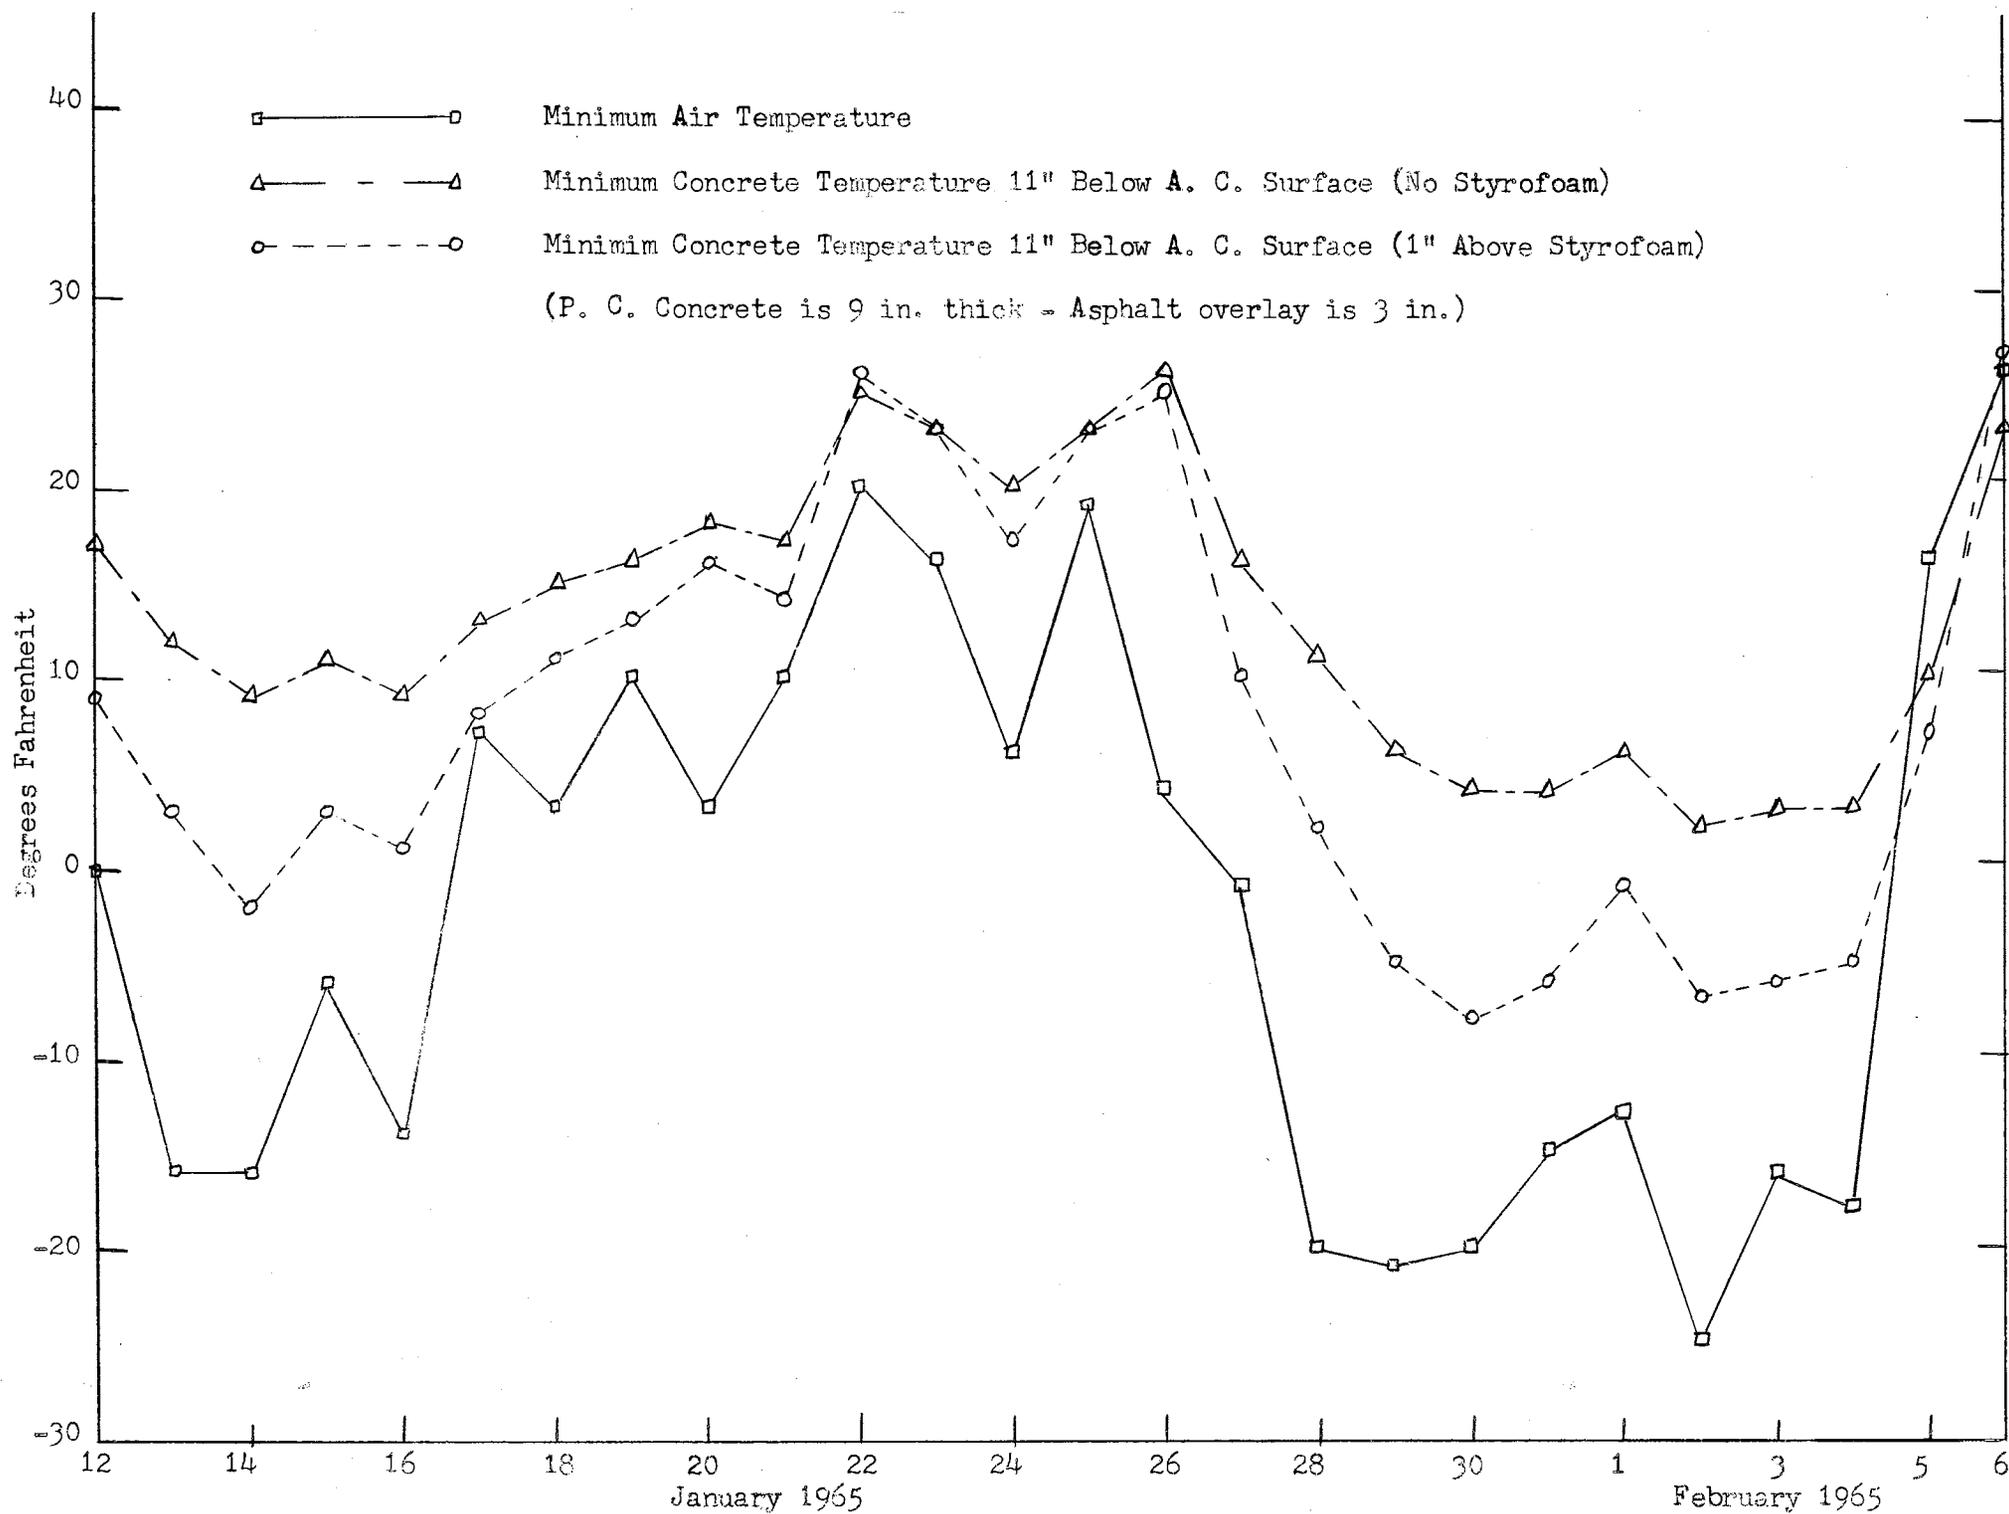
Figure 12: Concrete temperatures as affected by insulation - Winter 1964 - 1965
