Iowa Highway Research Board

Project HR-87

SUBGRADE INSULATION

Final Report  
December 1965

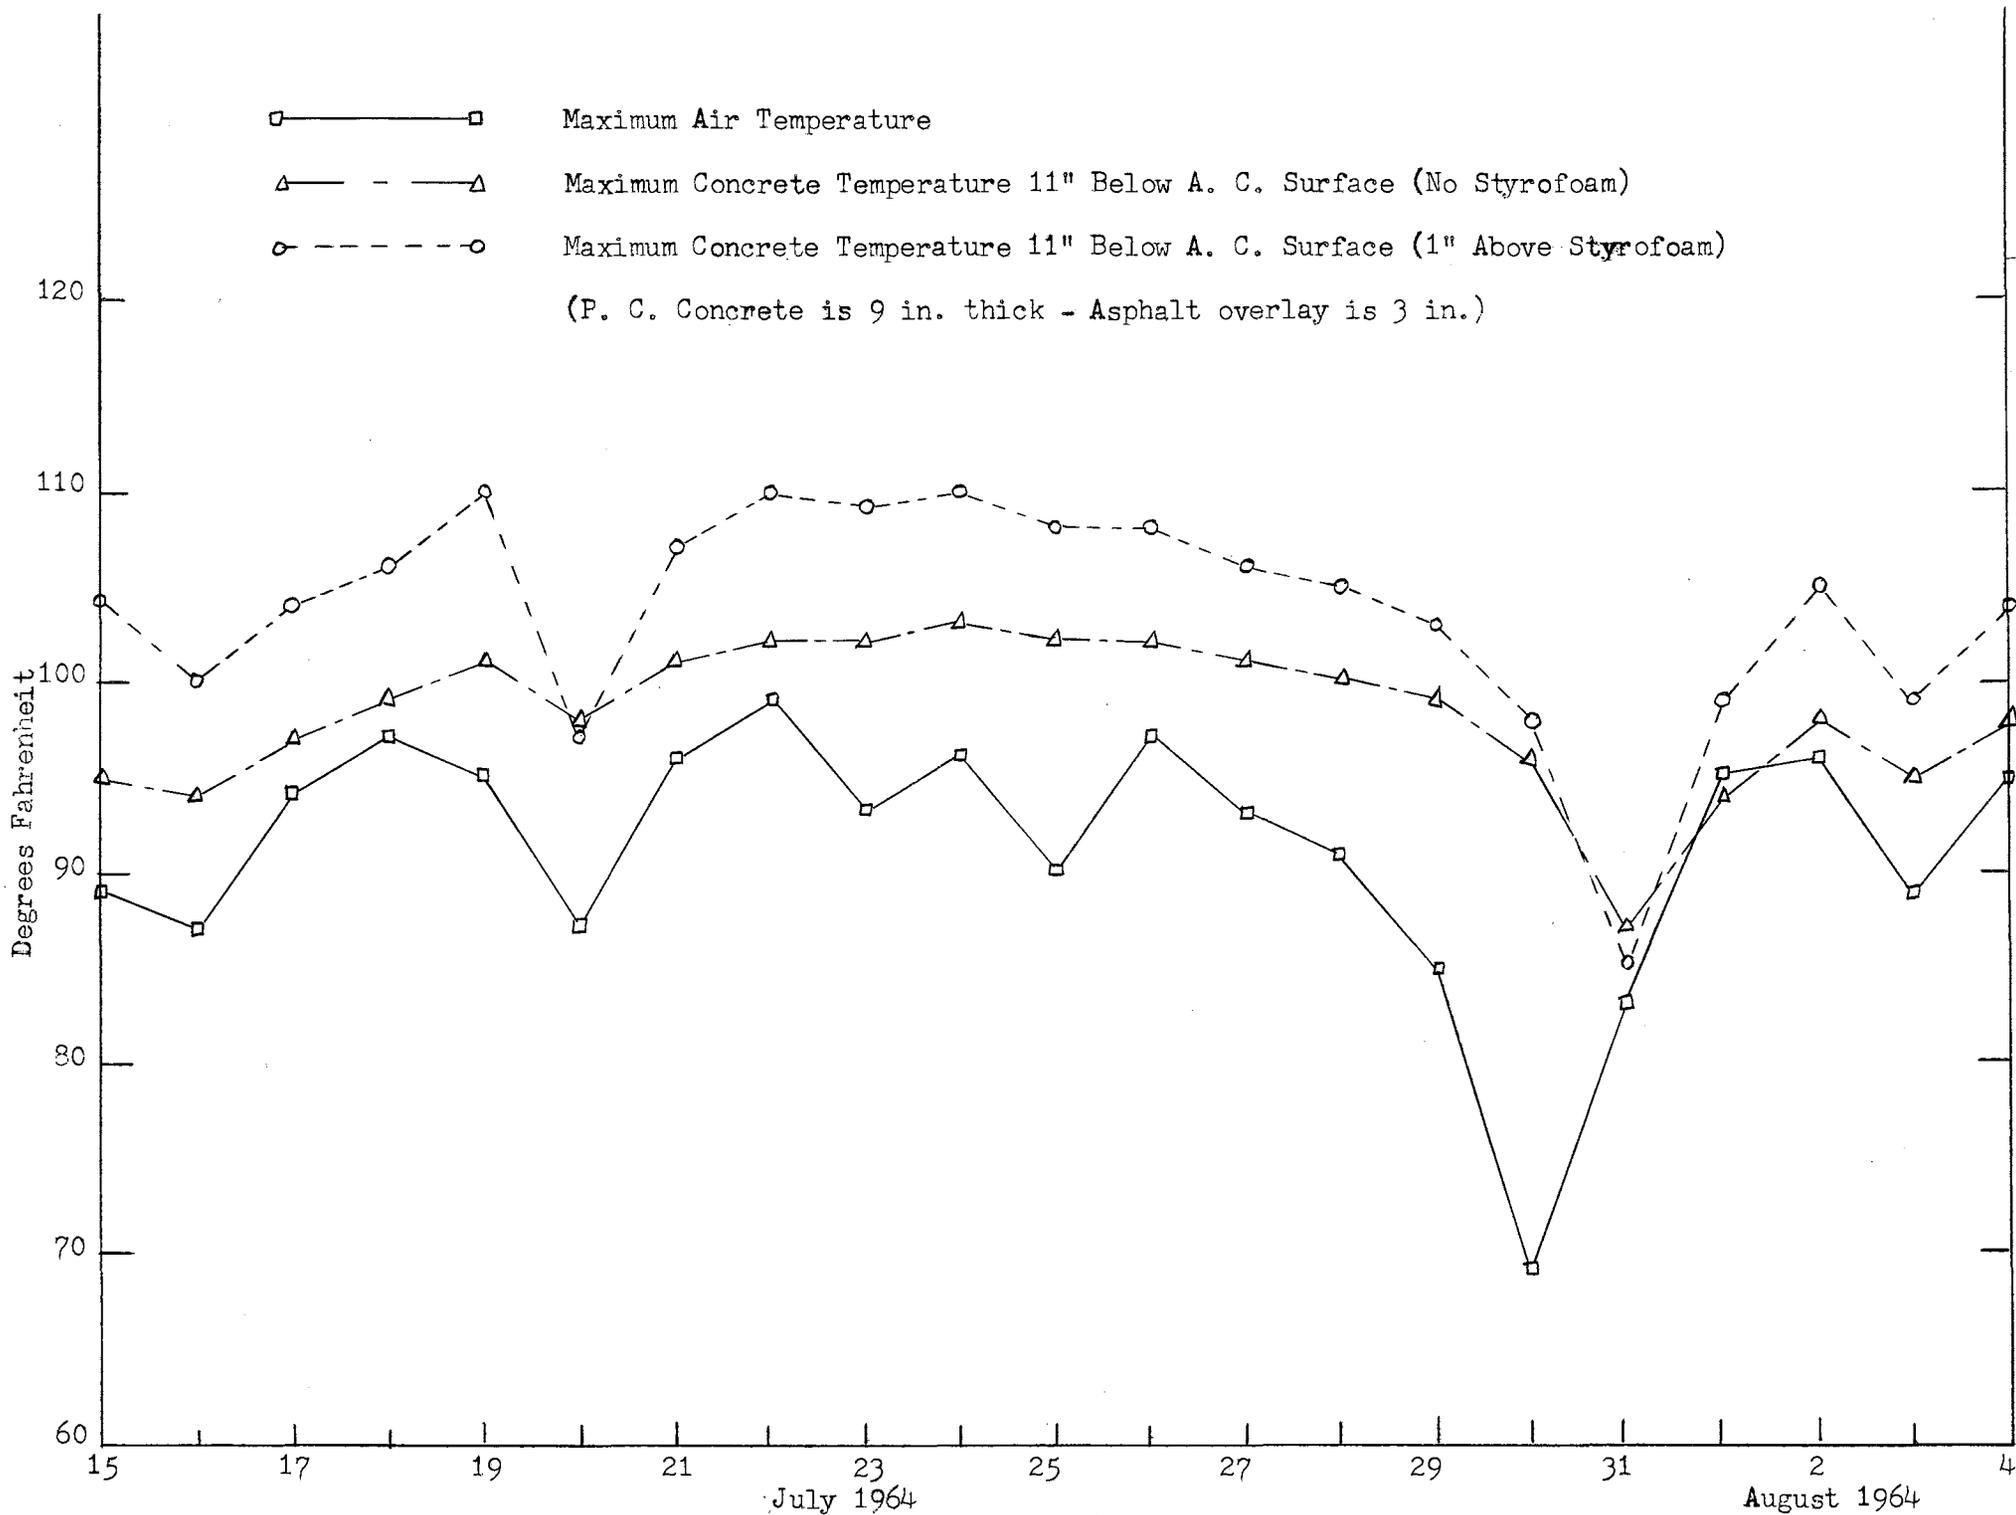
Figure 13: Concrete temperatures as affected by insulation - Summer 1964

Figures 11 and 12 compare minimum temperatures in the concrete one inch above the bottom of the slab, as affected by insulation below the slab. These graphs are included primarily to show that while the Styrofoam insulates the subgrade from freezing temperatures, it also prevents the concrete from receiving heat from the subgrade. Figures 13 and 14 show maximum temperatures at the same locations during the warmest summer months. In this case the Styrofoam reduces the amount of cooling from the subgrade. The temperatures shown in Figure 11 are those before the asphaltic concrete was applied and those in Figures 12, 13, and 14 are after the three inch resurfacing.

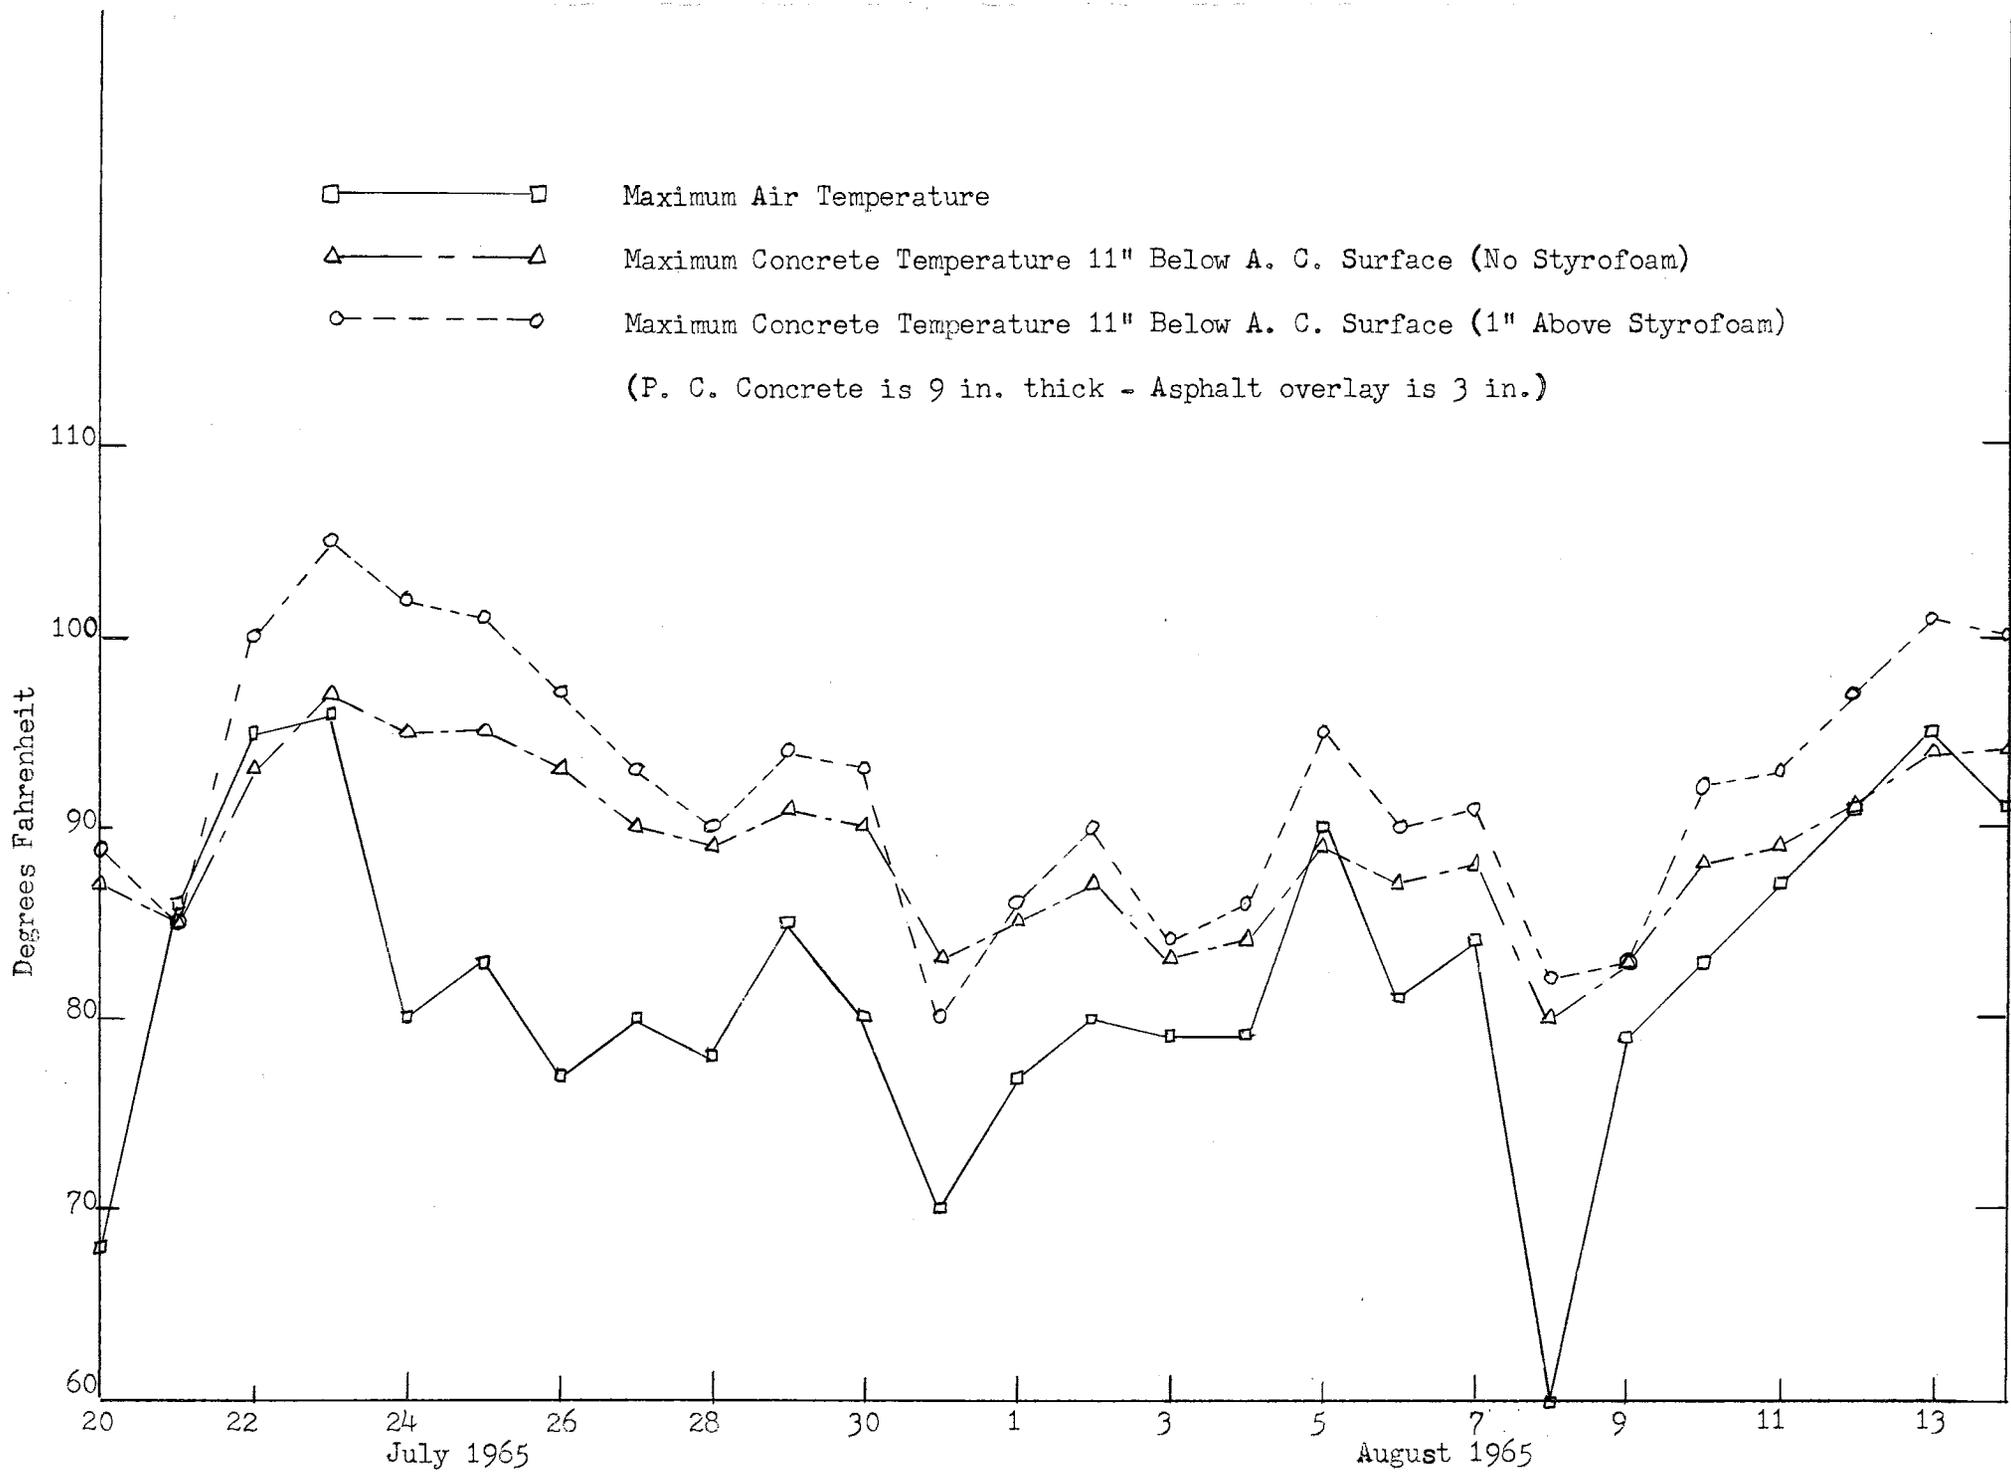
Figure 14: Concrete temperatures as affected by insulation - Summer 1965

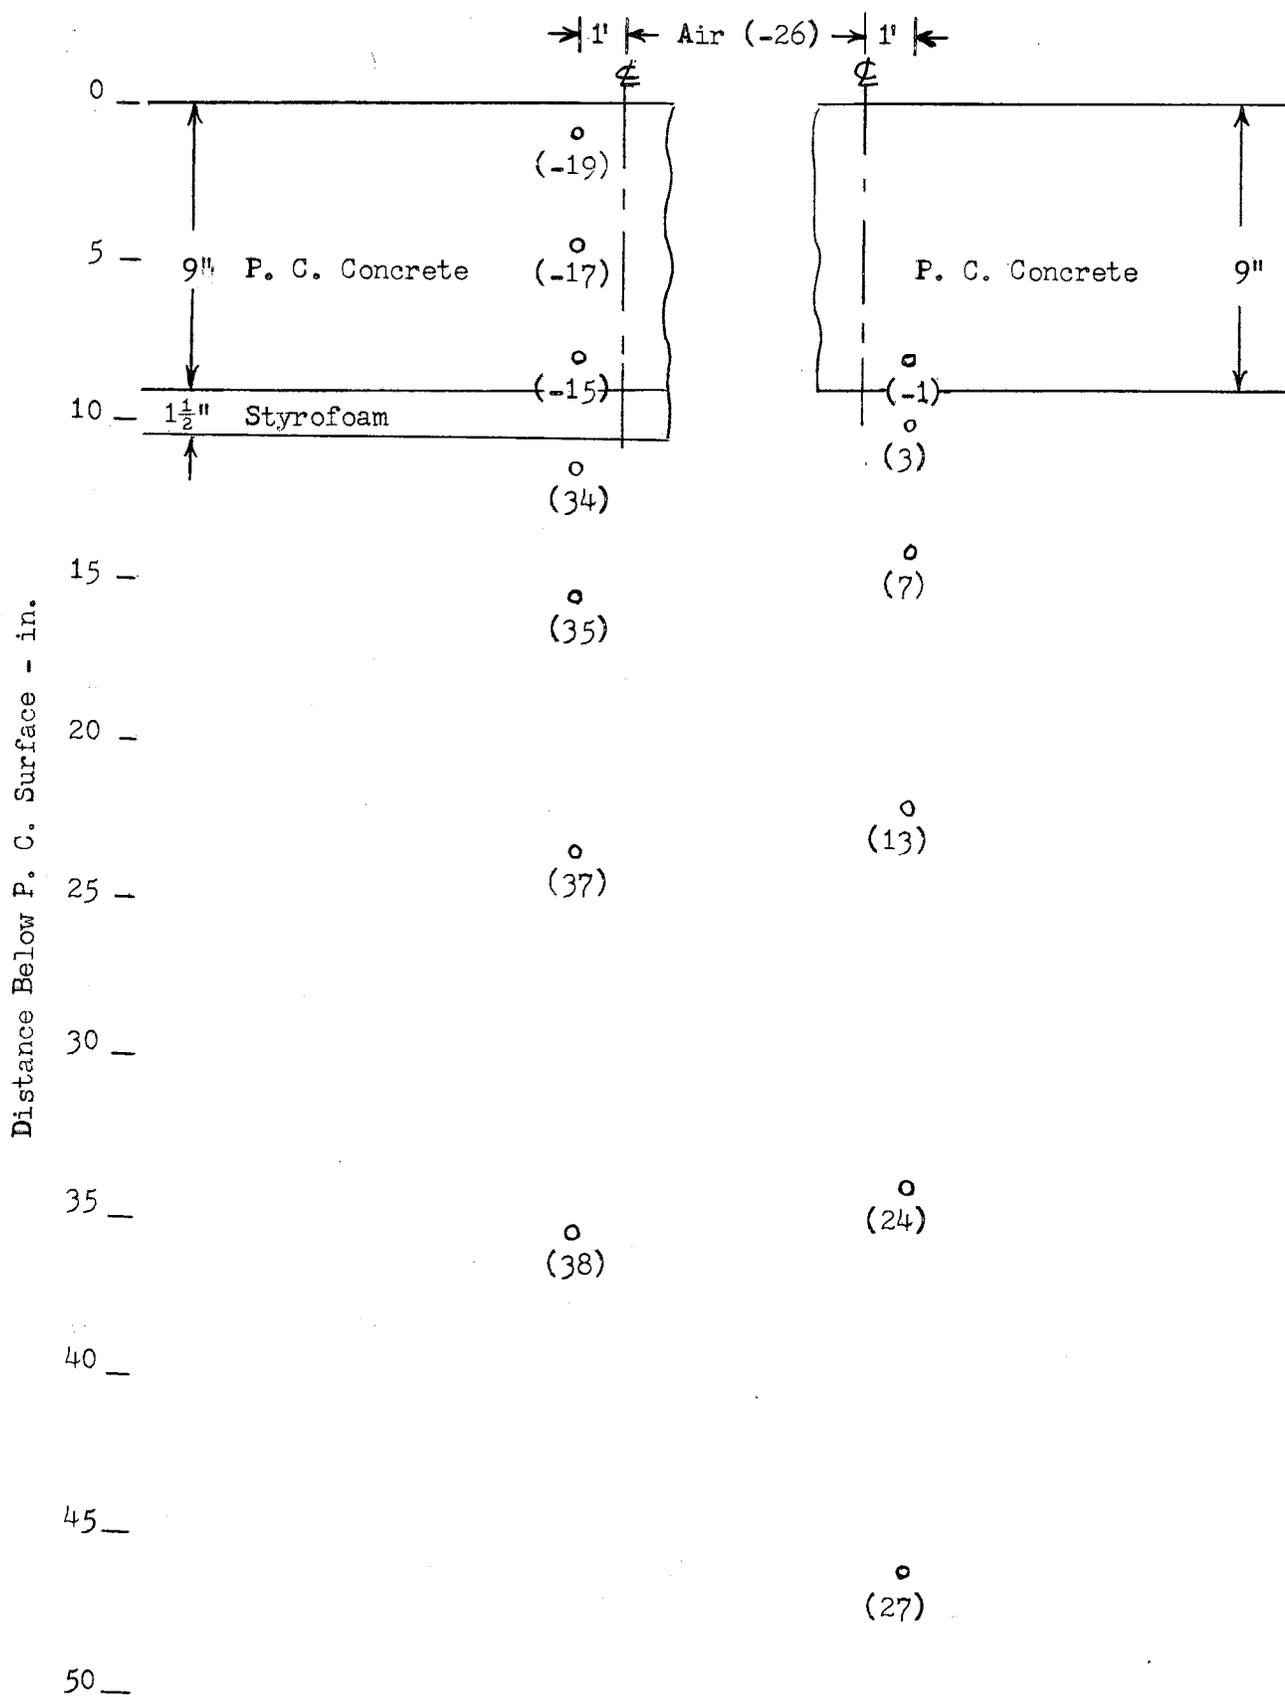
Figure 15: Minimum Temperatures °F - November 1963 - June 1964

Figures 15, 16, 17, and 18 show minimum and maximum temperatures at various depths below the surface with and without the Styrofoam insulation. It should be noted that during the winter of 1963-1964 the minimum temperature one inch above the Styrofoam was  $-15^{\circ}\text{F}$  while the minimum temperature

one inch below the styrofoam was  $34^{\circ}\text{F}$ . During the winter of 1964-1965, however, the minimum temperature one inch above the Styrofoam was  $-8^{\circ}\text{F}$  and the minimum temperature one inch below the styrofoam dropped to  $30^{\circ}\text{F}$ . During the 1964-1965 winter the subgrade temperature five inches below the styrofoam dropped below  $32^{\circ}\text{F}$  for a period of five days.

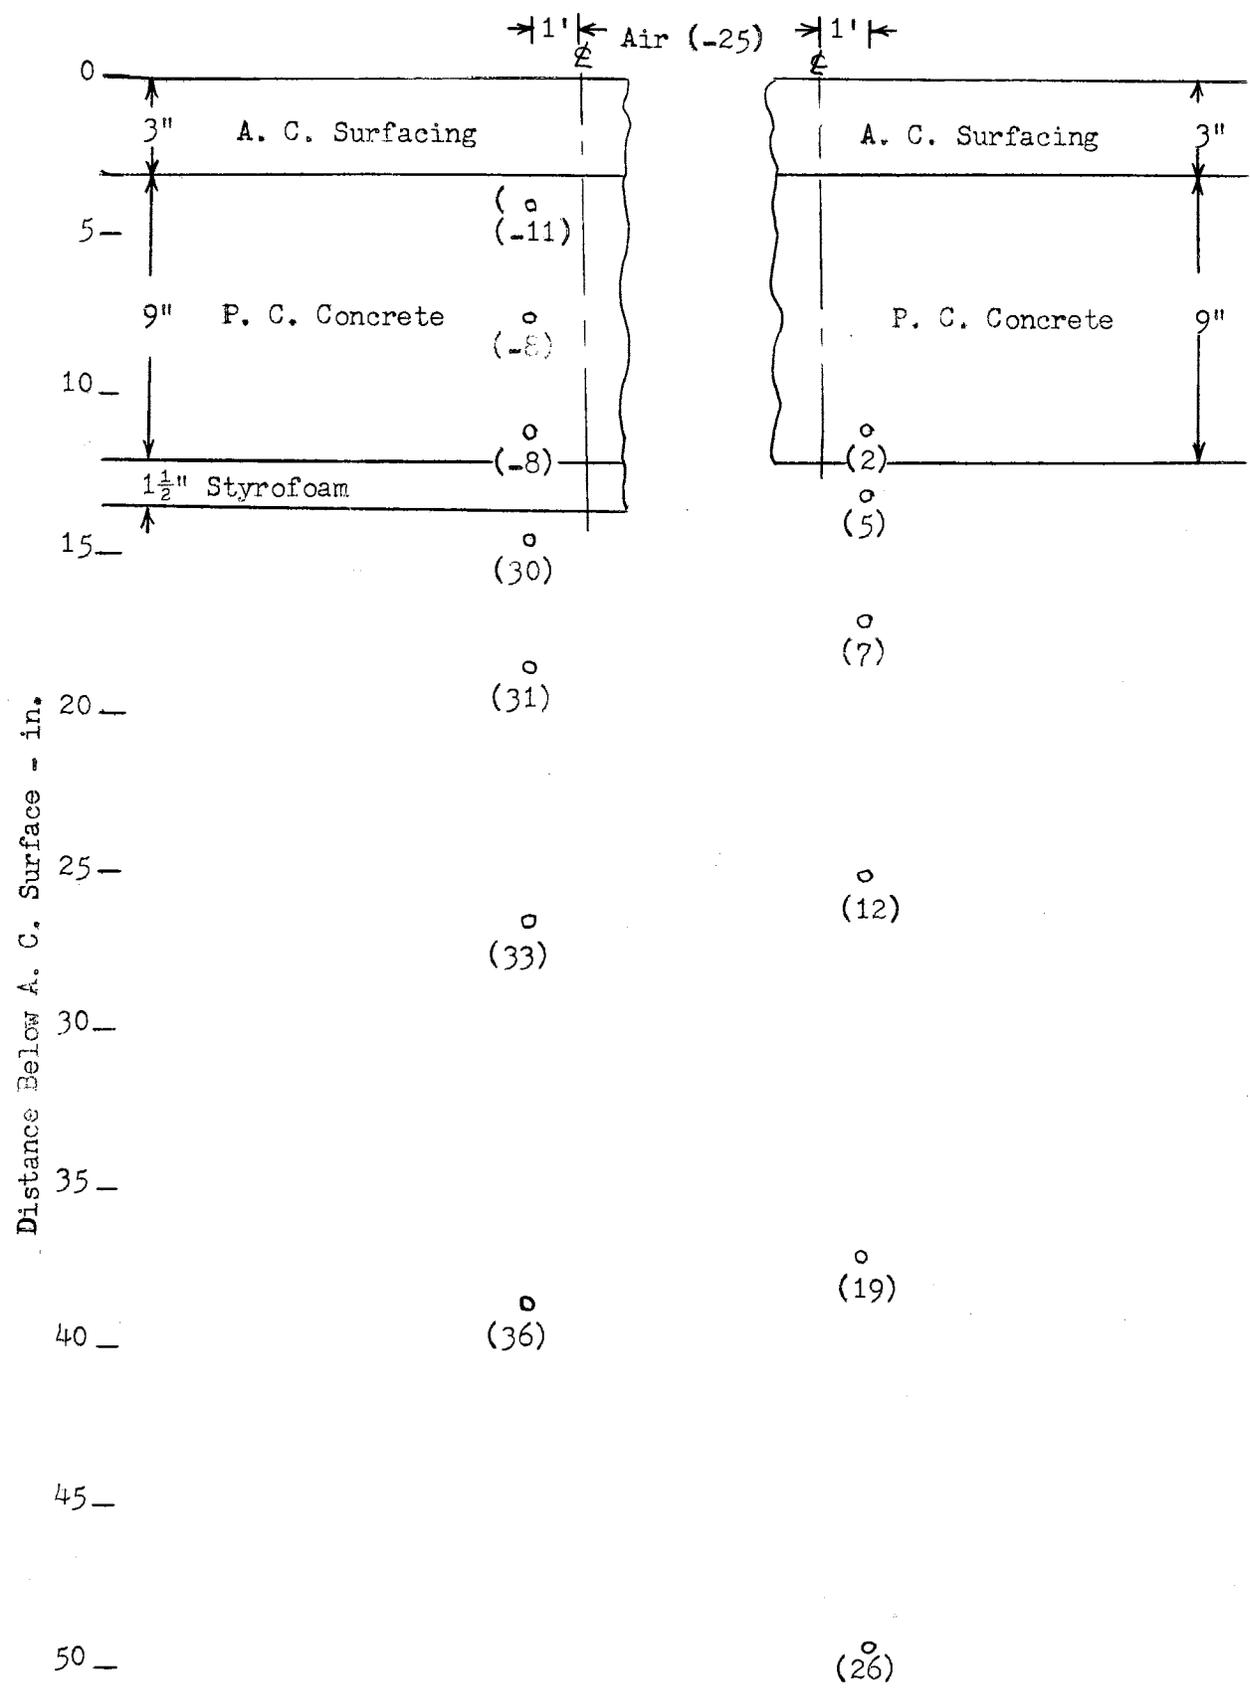
Figure 16: Minimum Temperatures °F November 1964 - May 1965

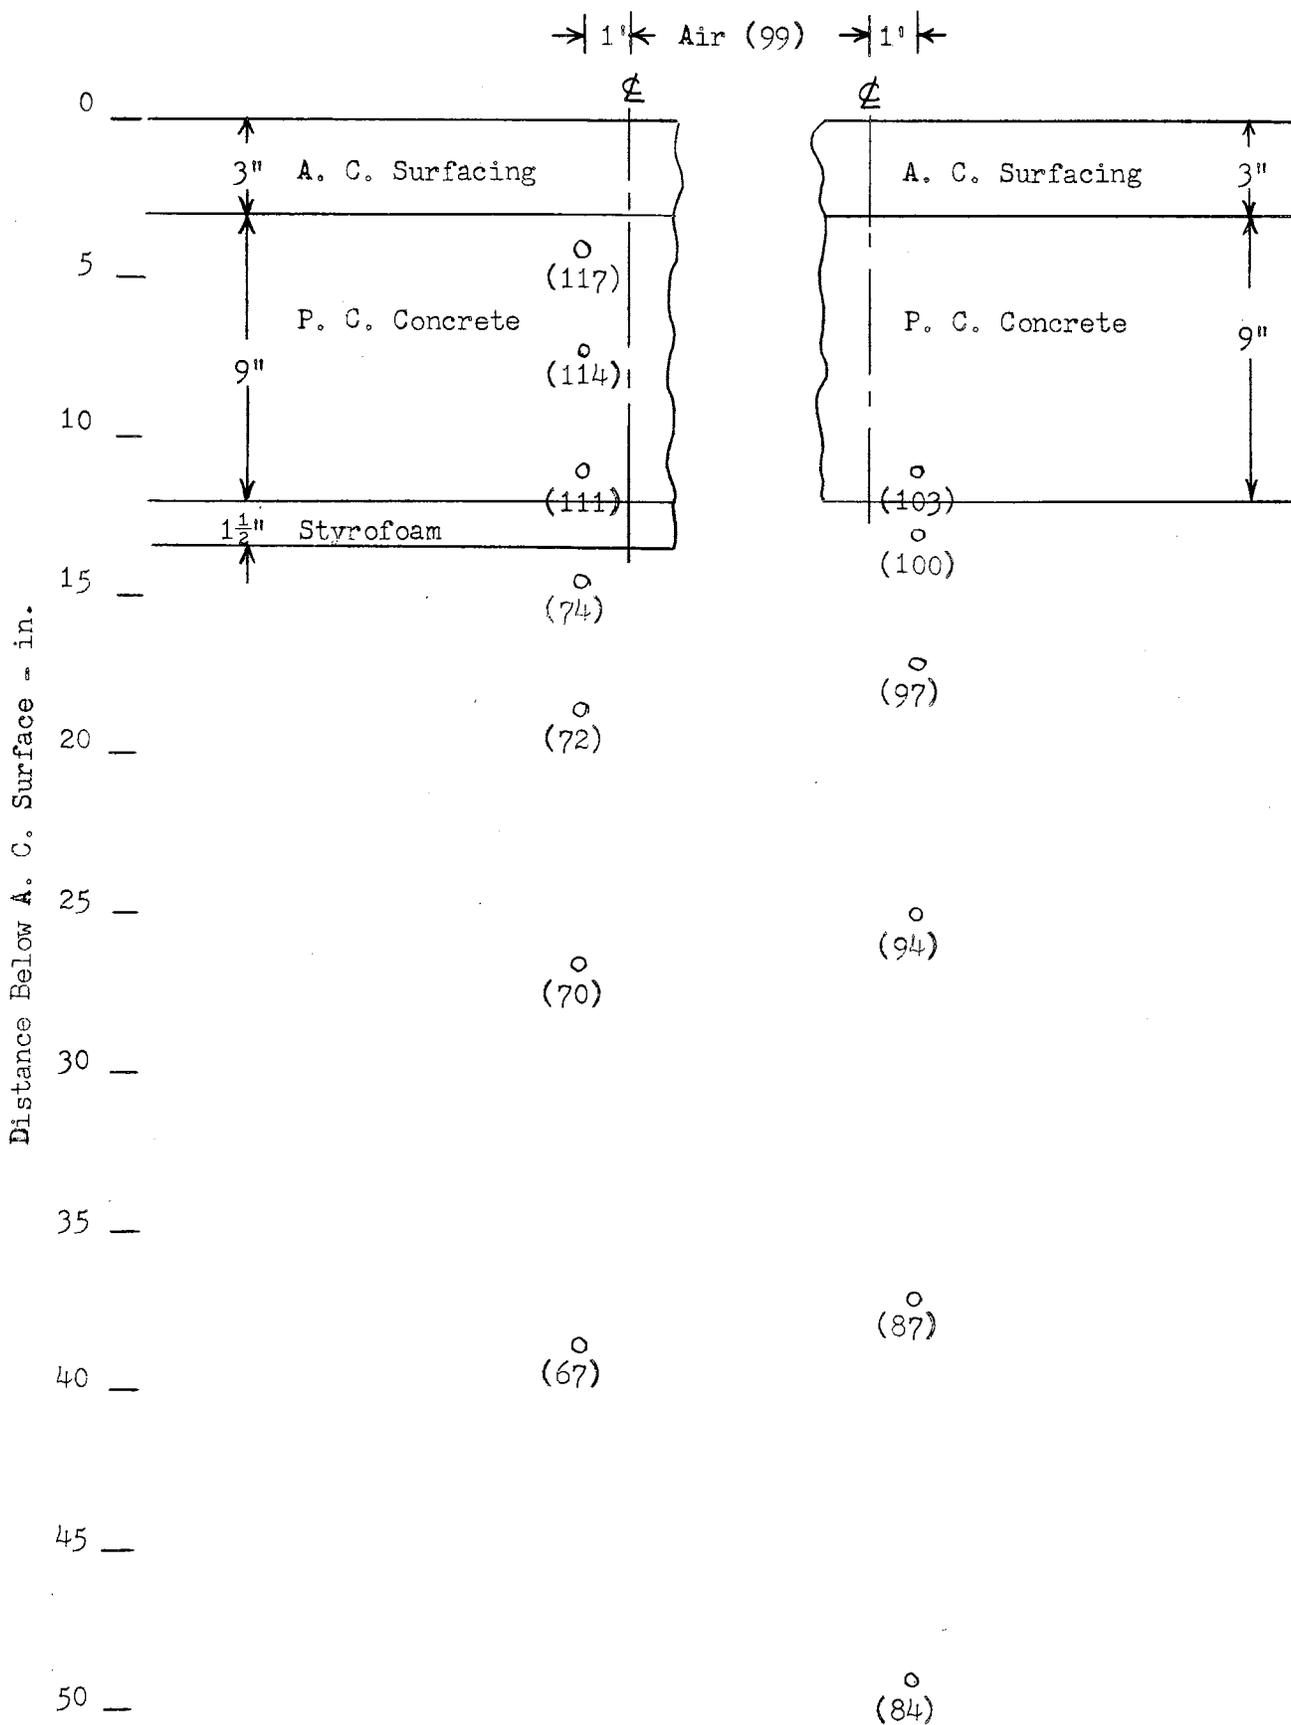
Figure 17: Maximum Temperatures °F - June 1964 - November 1964

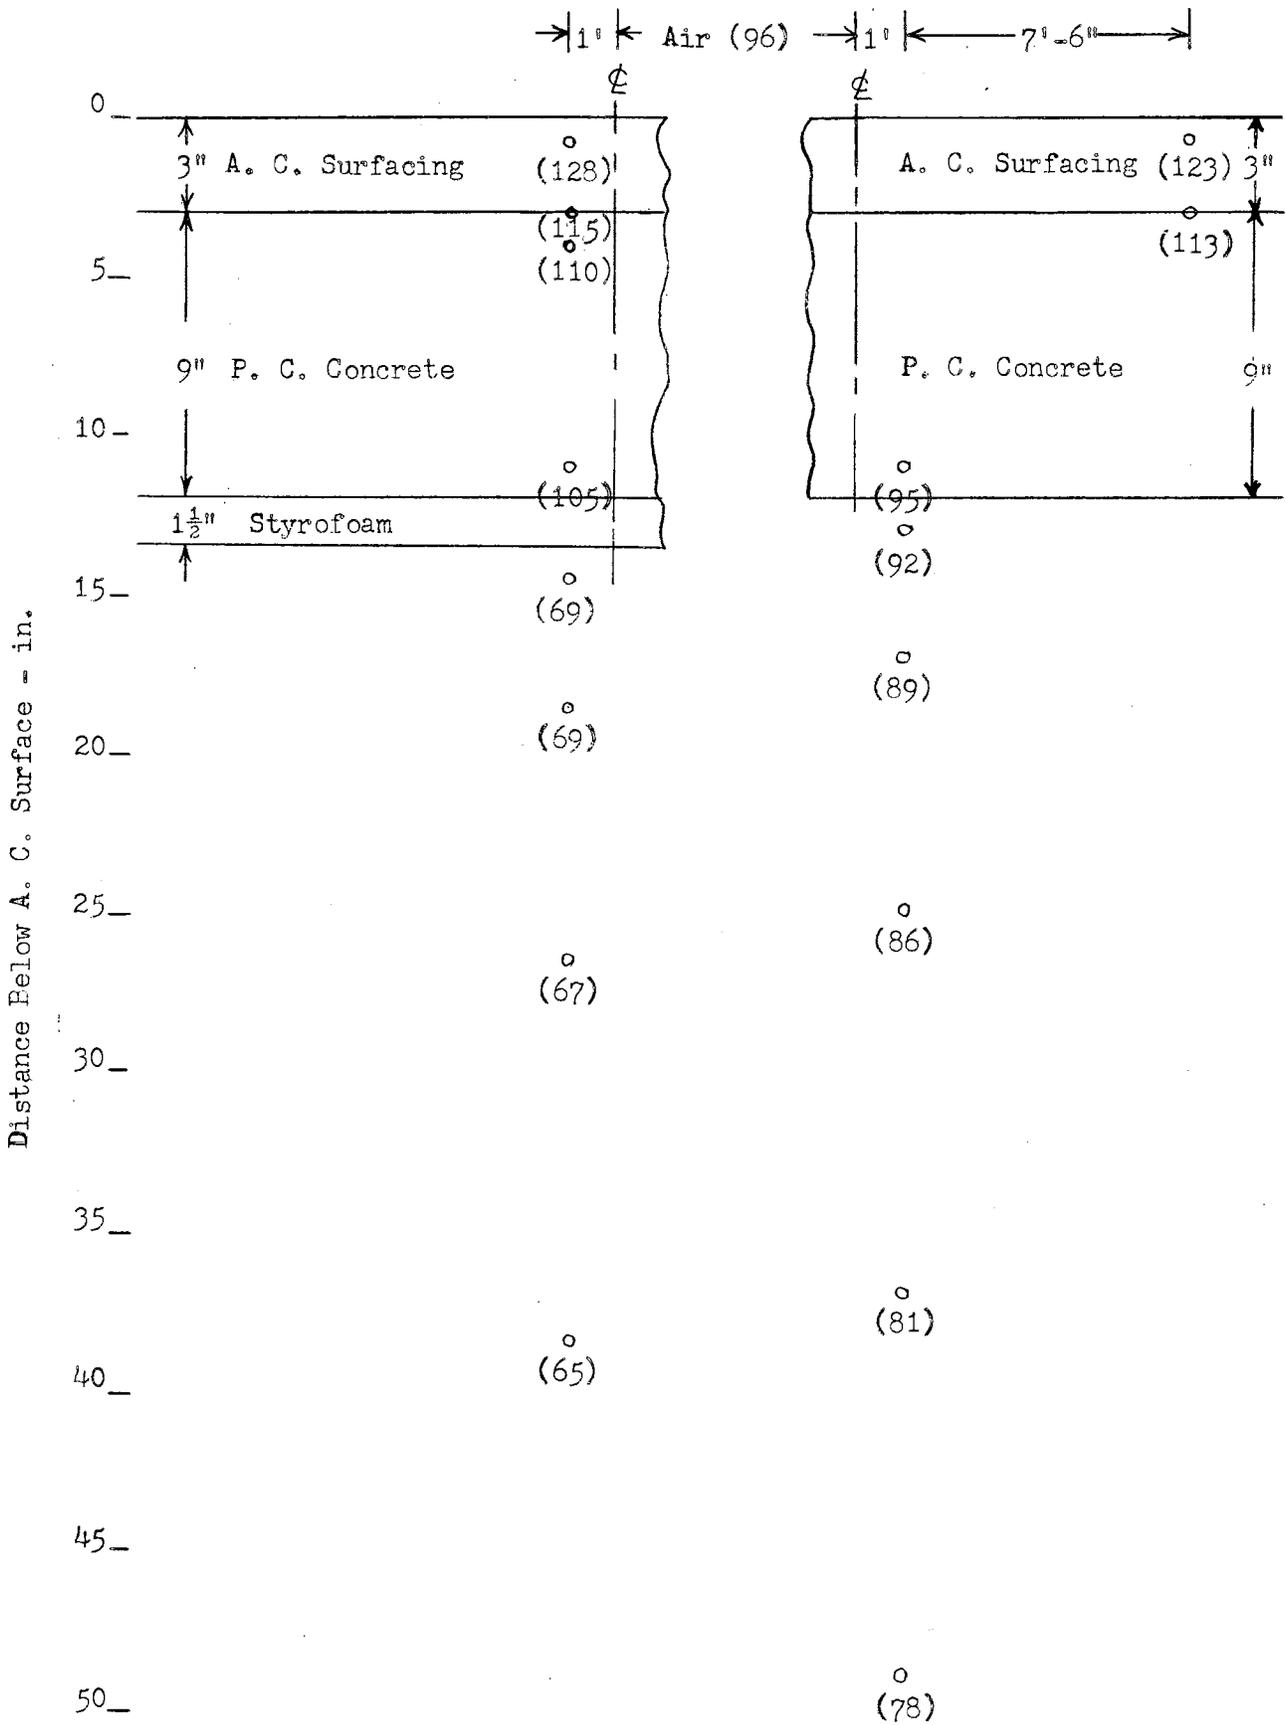
Figure 18: Maximum Temperatures °F - May 1965 - August 1965

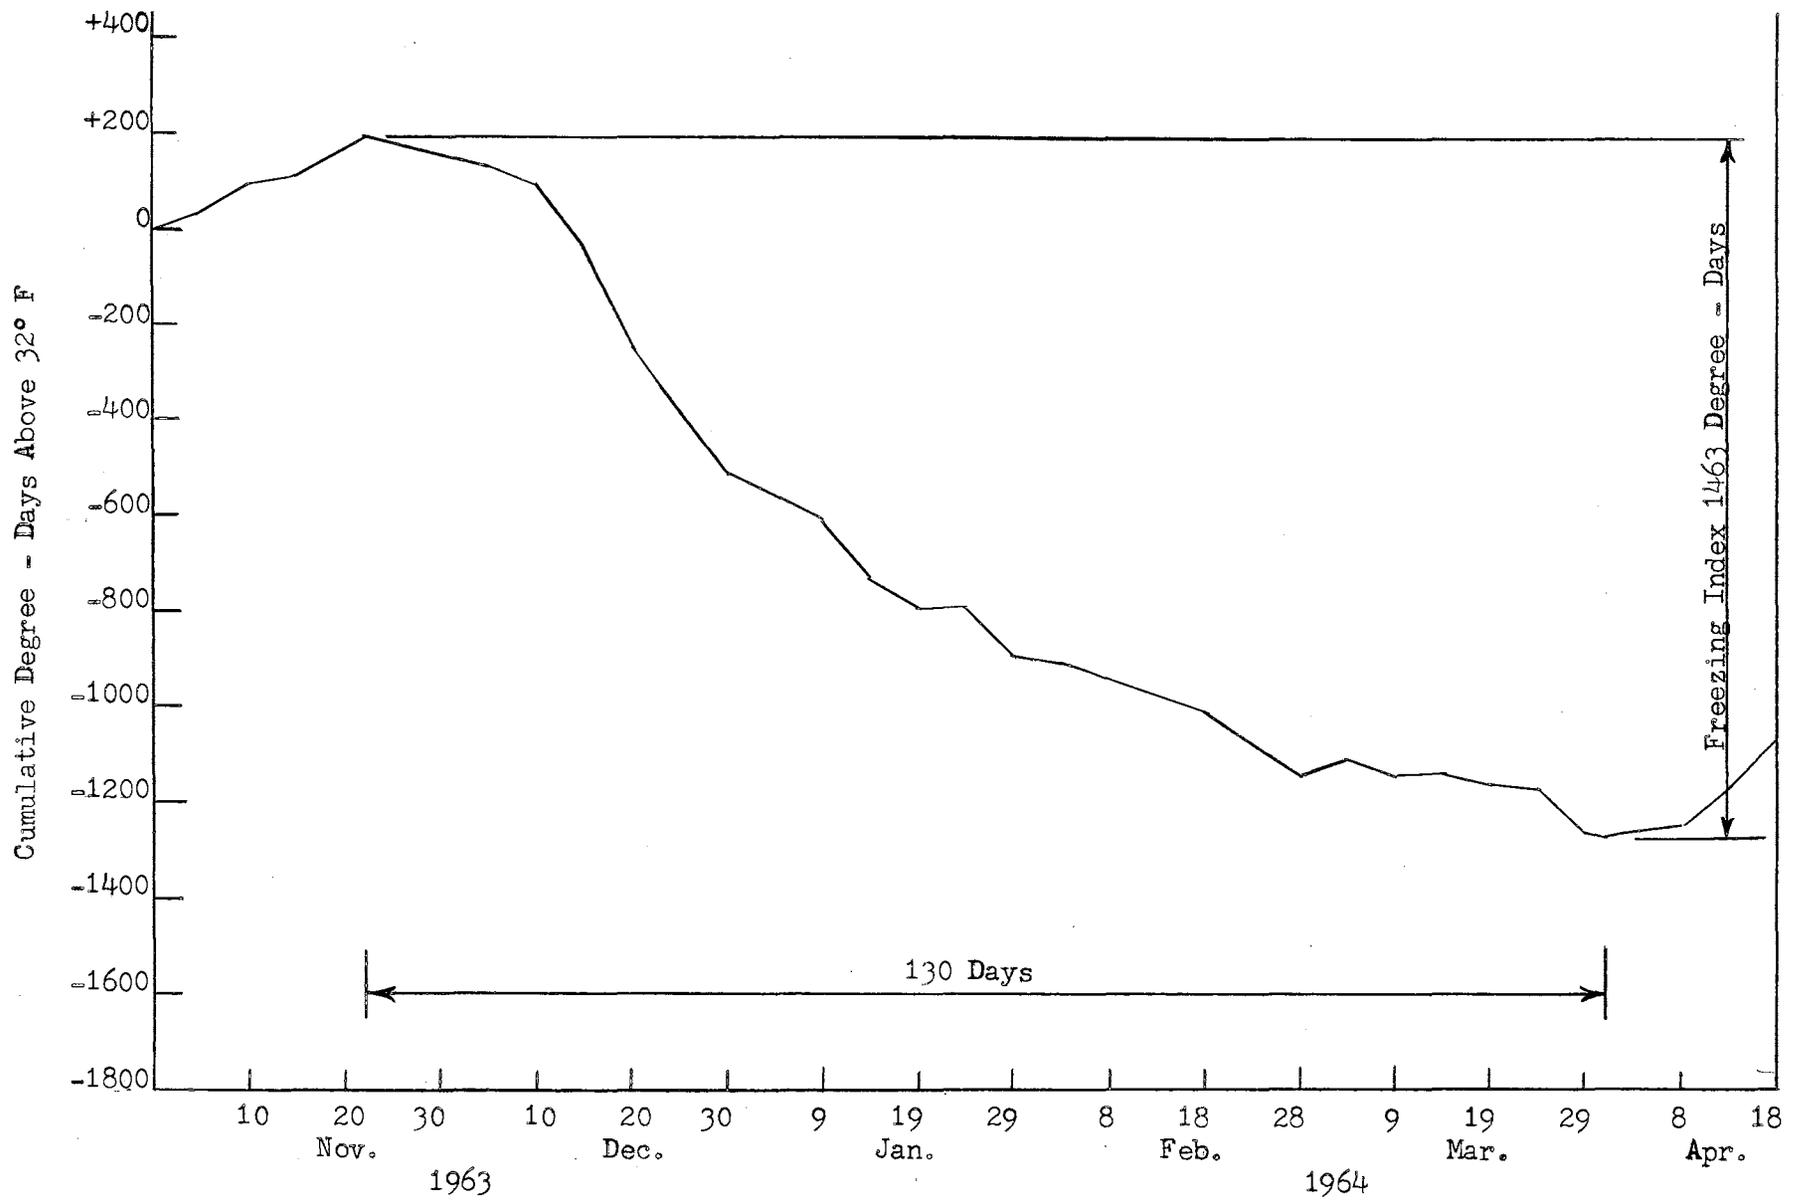
Figure 19: Determination of Freezing Index

Figure 19 shows the freezing index to be 1463 degree-days for the 1963-1964 freezing season. Figure 20 shows the freezing index for the 1964-1965 freezing season has a value of 2035 degree-days. The mean freezing index for this part of the state as determined by the U.S. Army Corps of Engineers is 1100 degree-days over a 105 day period and the design freezing index is 1700 degree-days. From these figures it can be seen that the 1963-1964 winter was somewhat colder than average for this area, and the 1964-1965 winter was very severe. Mr. Paul J. Waite, Weather Bureau State Climatologist, speaking of the

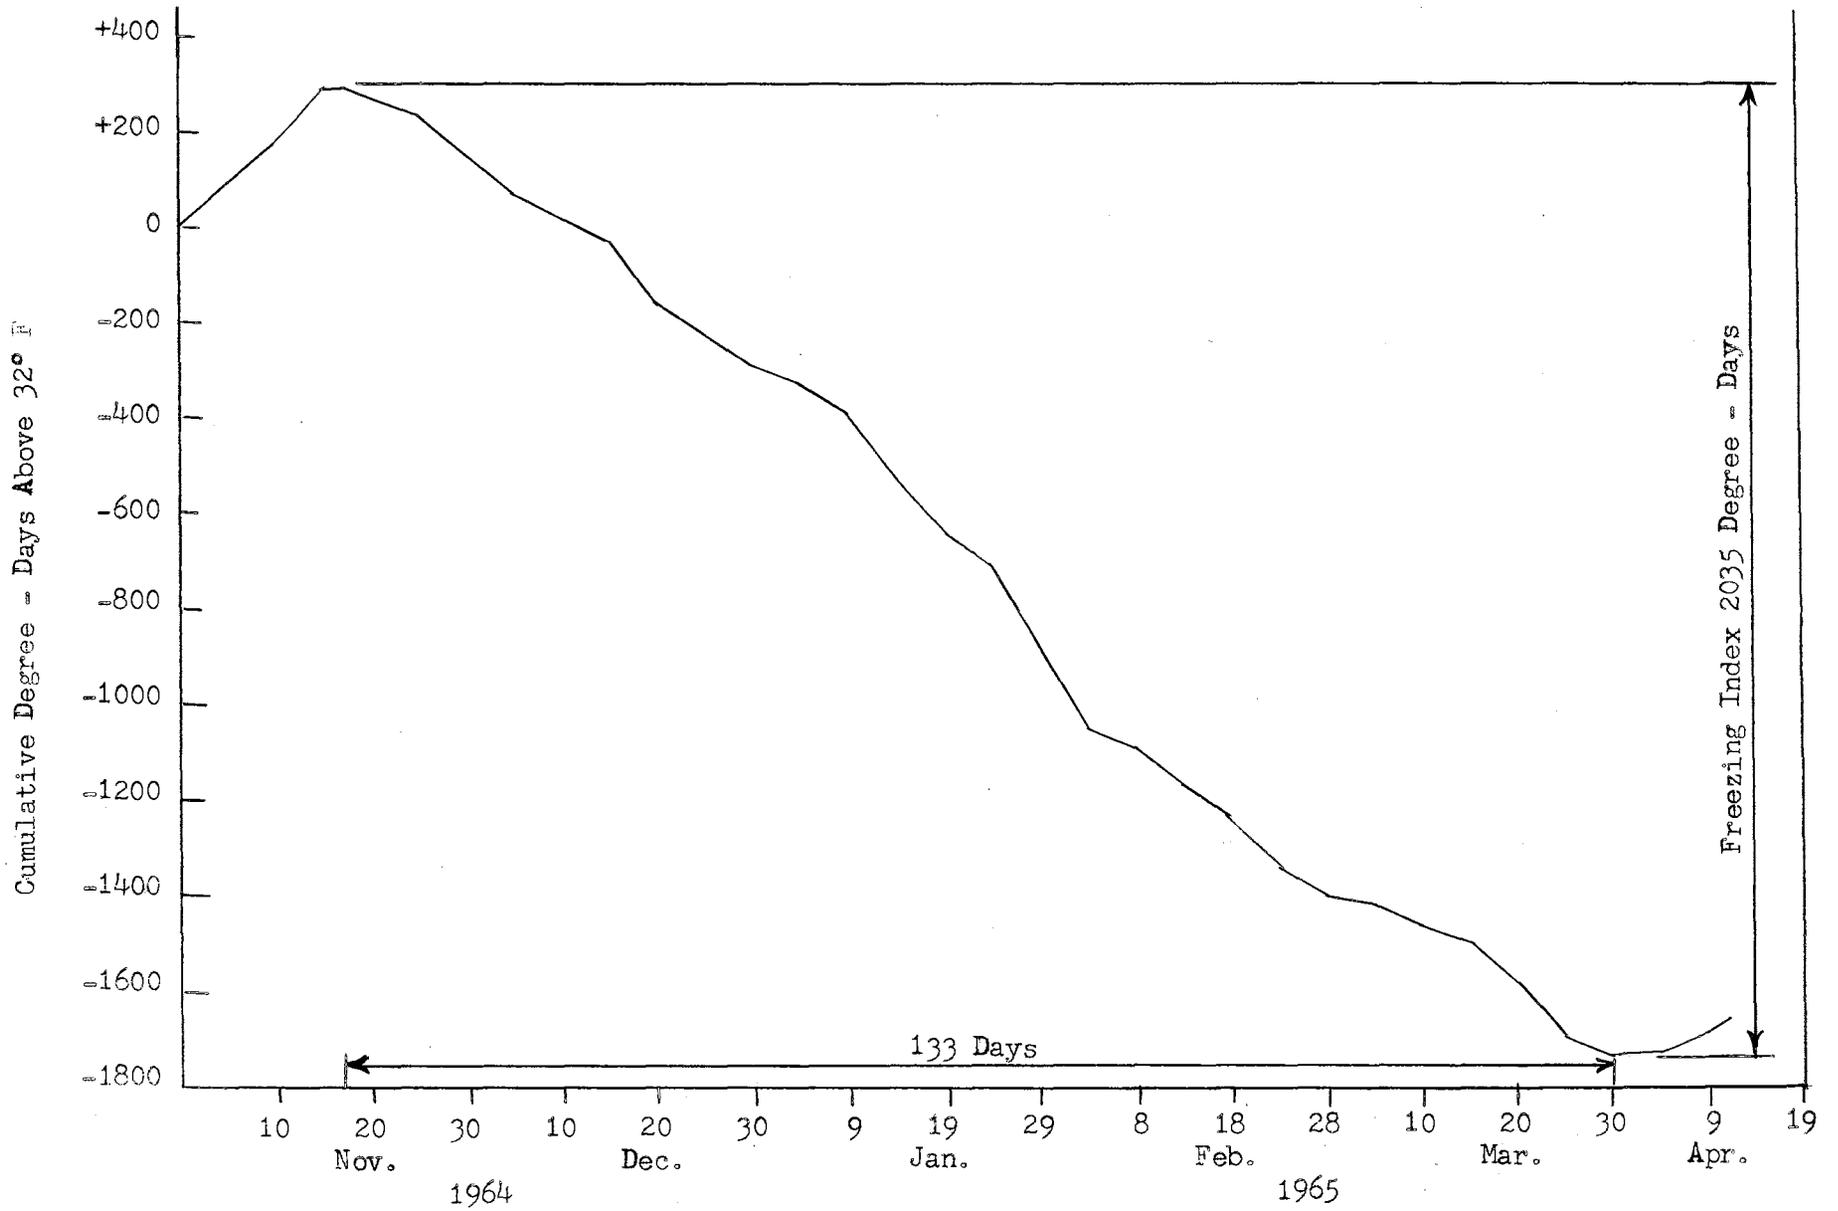
Figure 20: Determination of Freezing Index

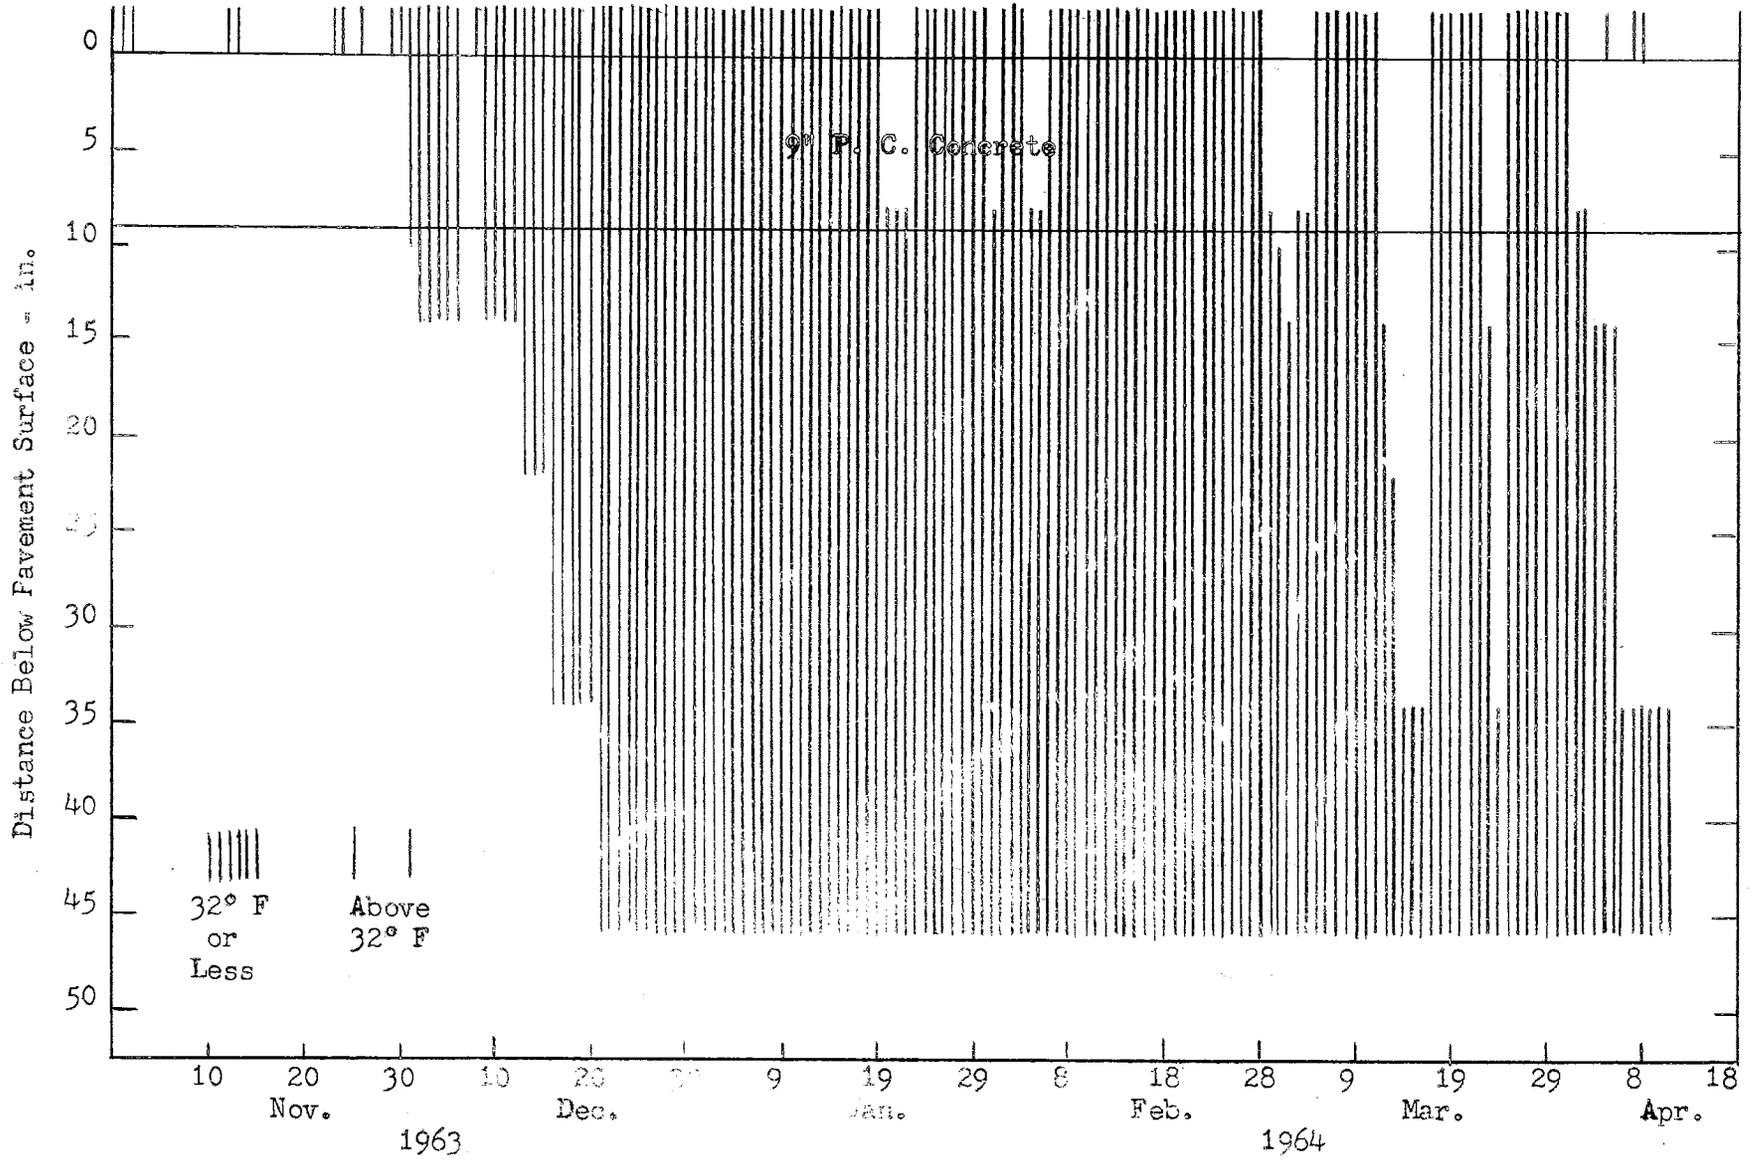
Figure 21: Depth at which average temperatures of 32° F or less were recorded

Figures 21 through 24 show the depth of frost penetration down to and including 46 inches below the top of the P.C. concrete in the section containing the granular backfill material.
