Iowa Highway Research Board

Project HR-87

SUBGRADE INSULATION

Final Report  
December 1965

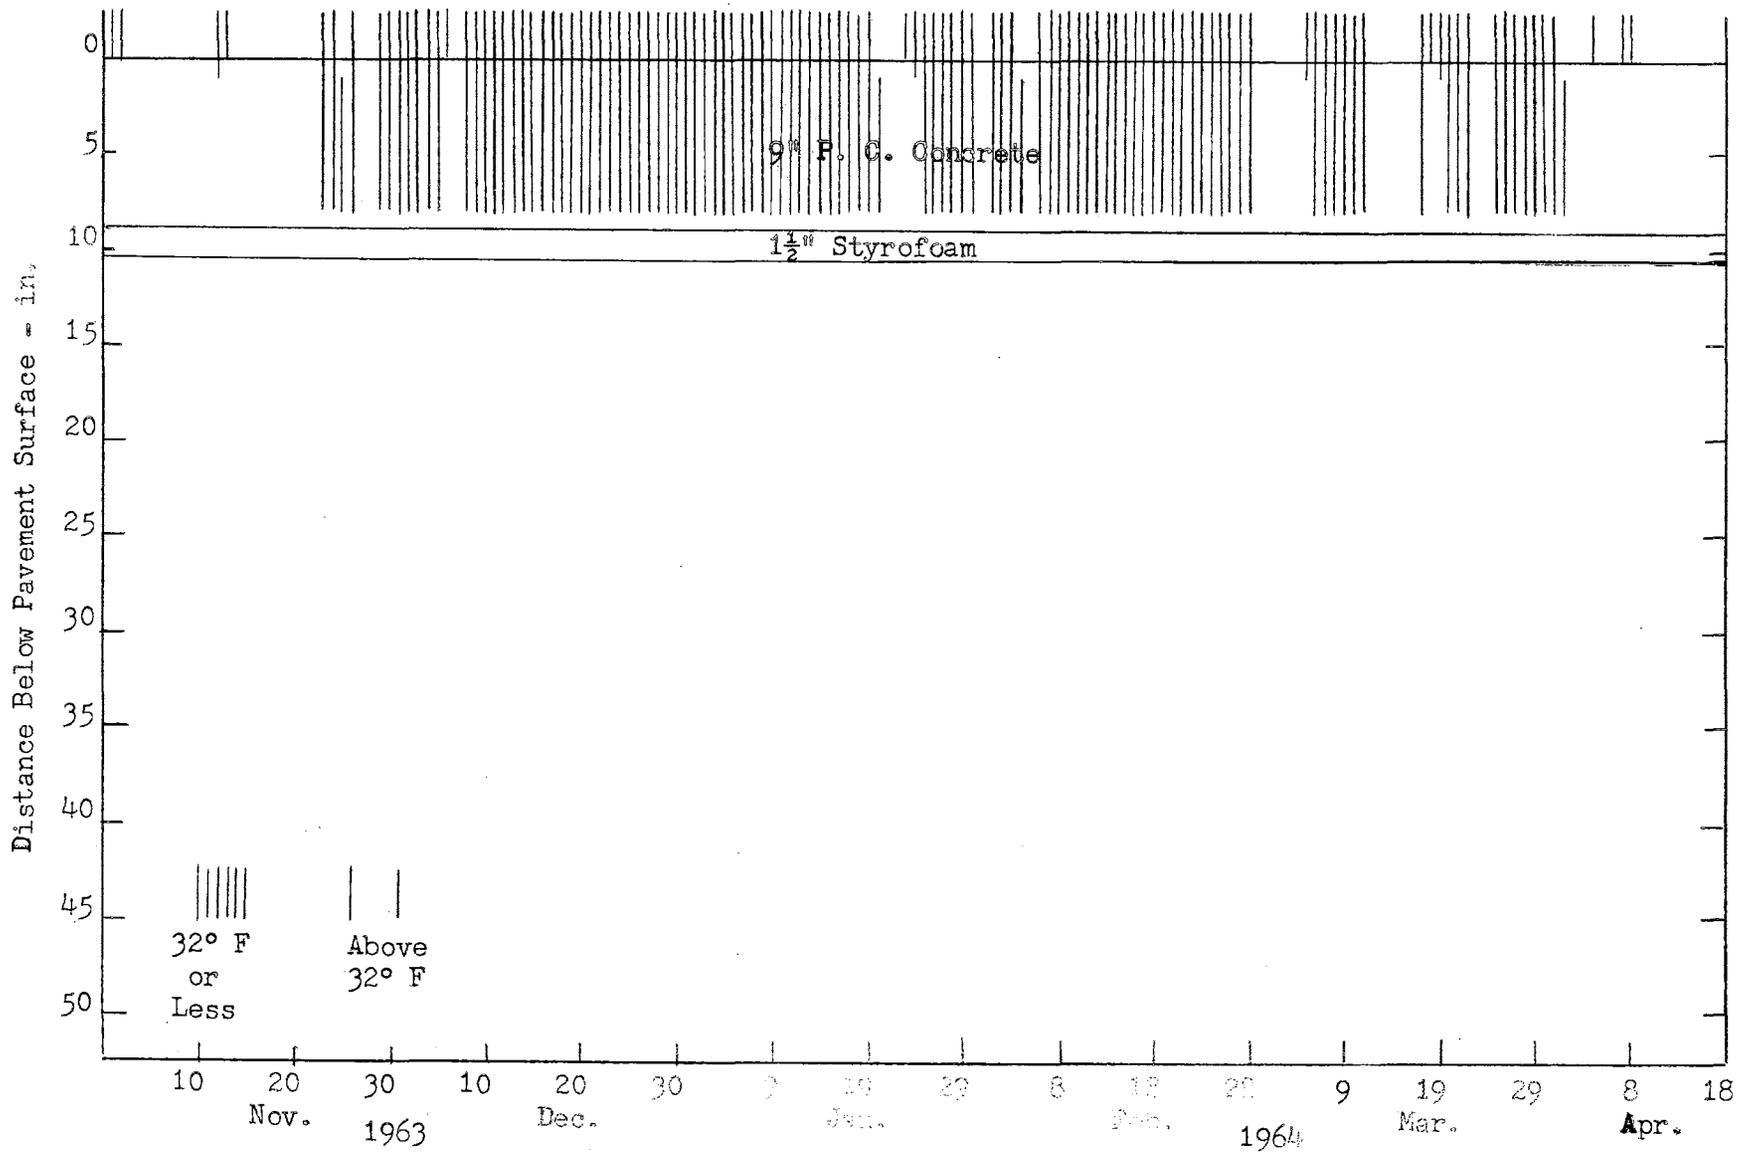
Figure 22: Depth at which average temperatures of 32° F or less were recorded

Figures 21 through 24 show the depth of frost penetration down to and including 46 inches below the top of the P.C. concrete in the section containing the granular backfill material.

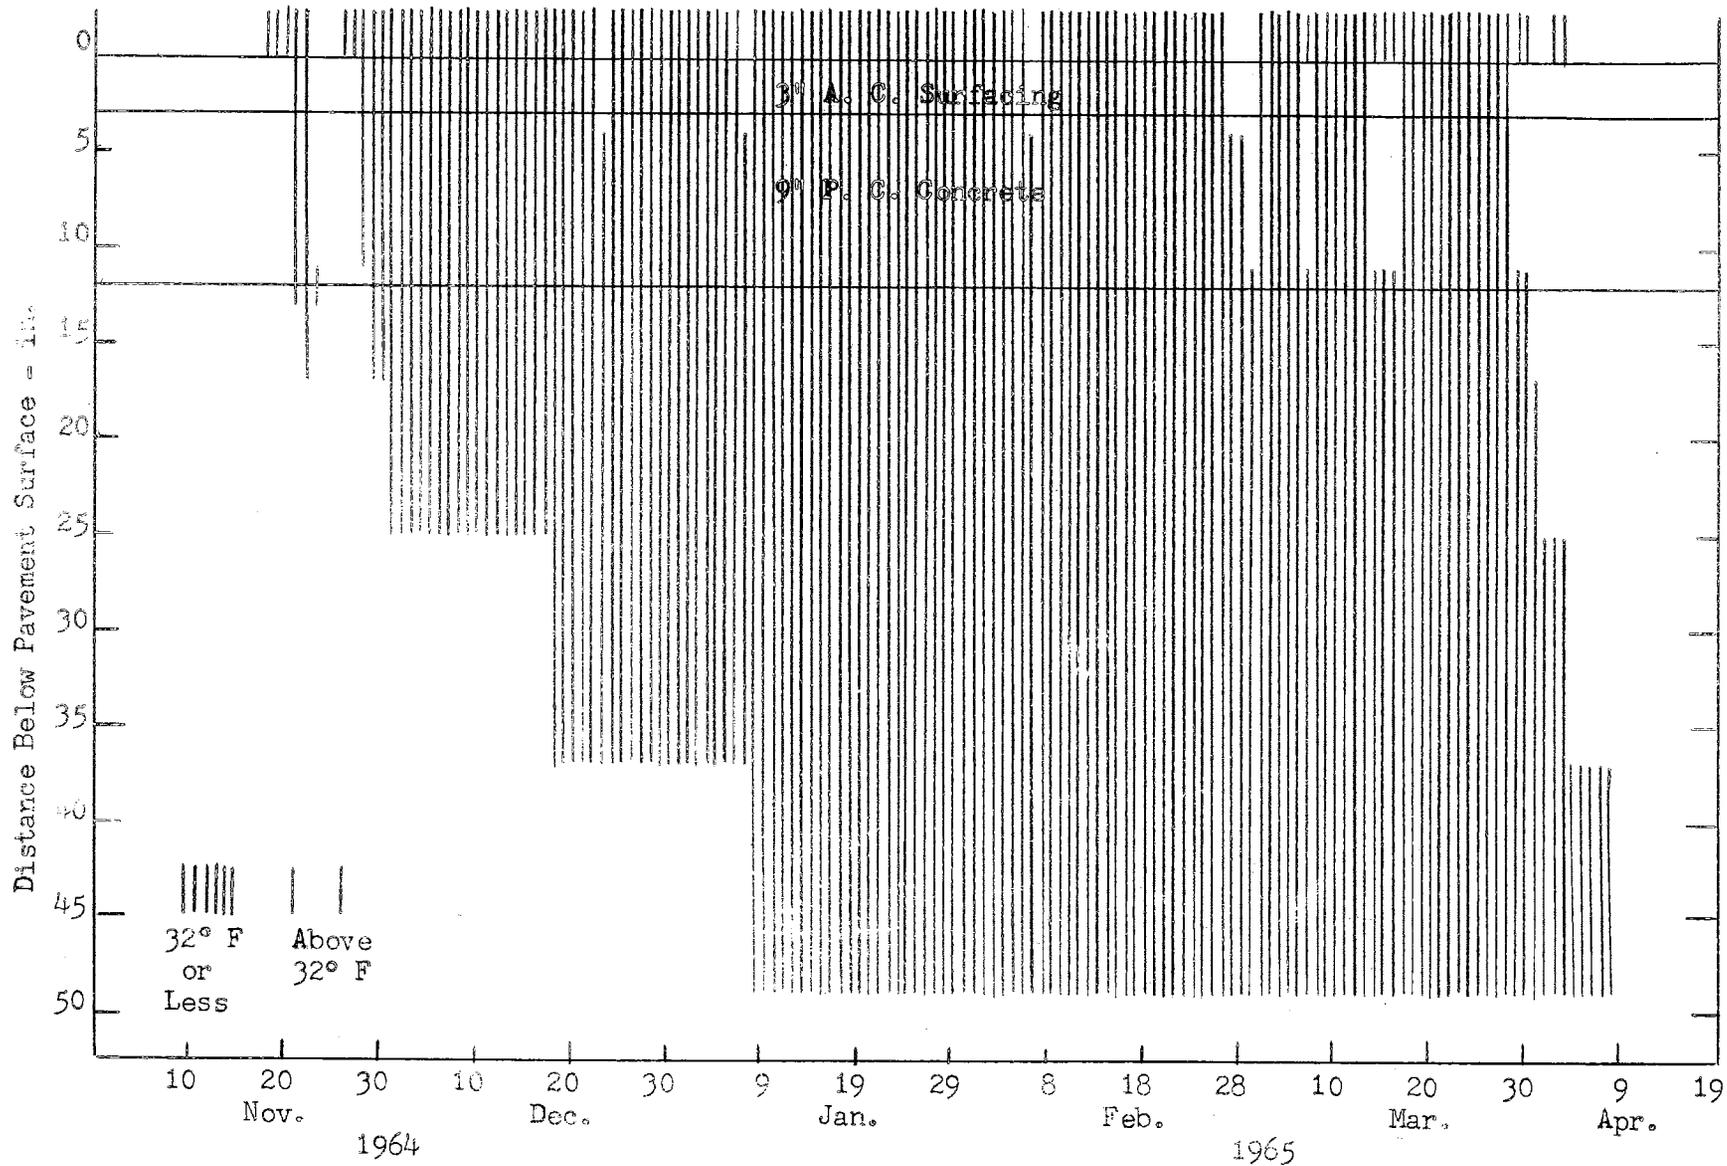
Figure 23: Depth at which average temperatures of 32° F or less were recorded

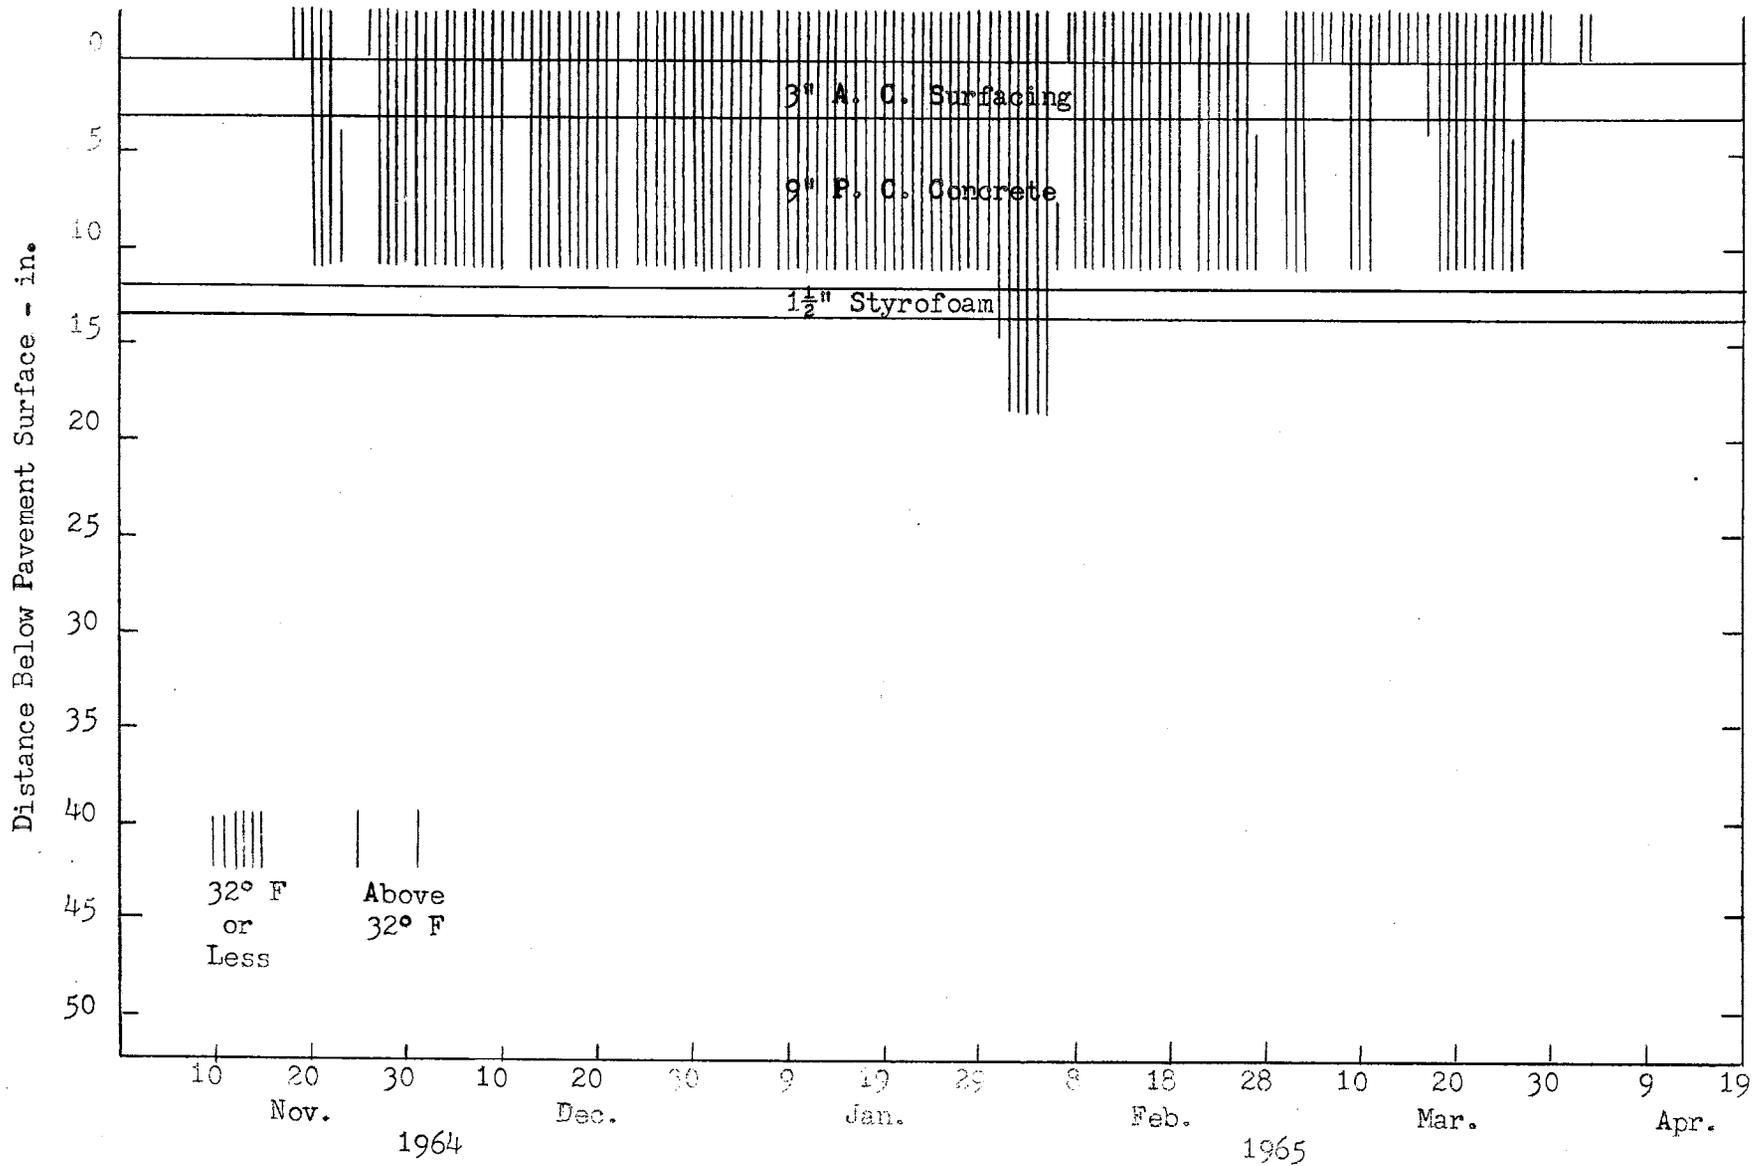
Figure 24: Depth at which average temperatures of 32° F or less were recorded
