Investigation of Steel-Stringer Bridges: Superstructures and Substructures, Volume I

Final Report
October 2007

Sponsored by
the Iowa Highway Research Board (Project TR-522)
and the Iowa Department of Transportation (CTRE Project 04-184).

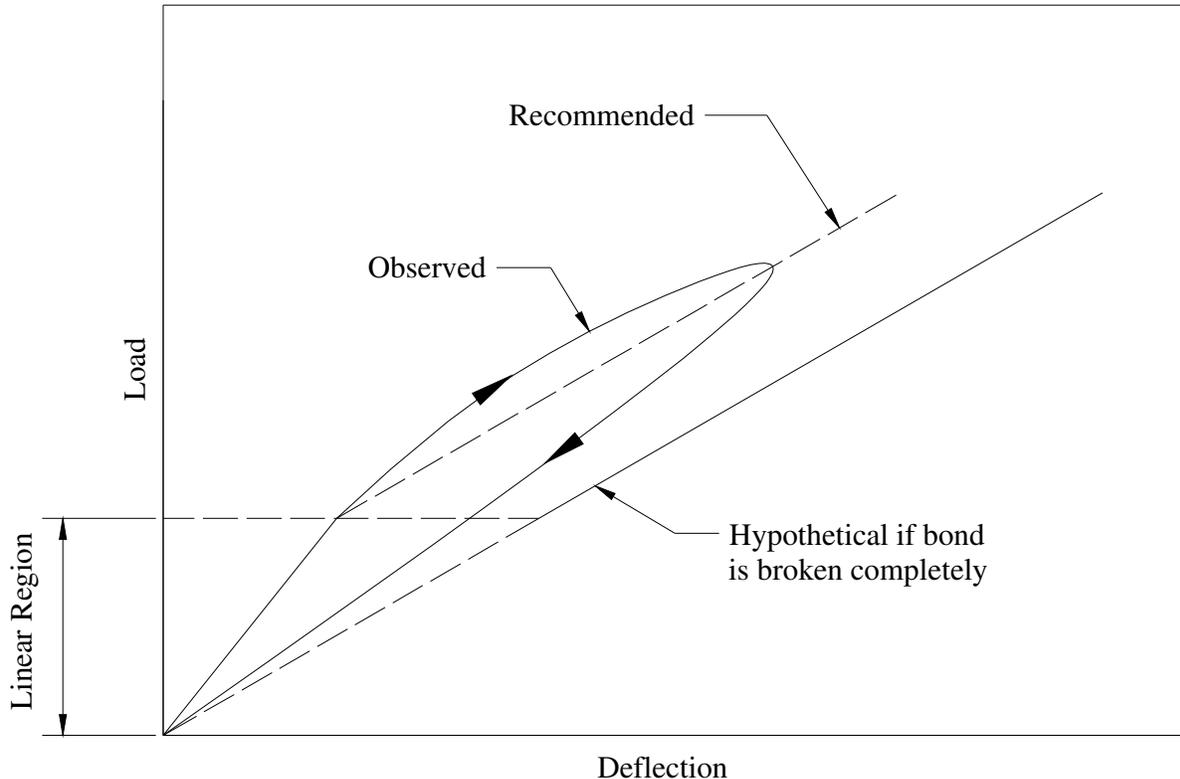
Figure 2.2. Load-Deflection Curve for a Girder With Composite Action.

In order to estimate the degree of composite action that can be relied upon beyond the loads applied during a diagnostic load test, the load-deflection curve for an actual load test must be analyzed. During the initial stages of loading, the load-deflection curve is linear and follows that of the predicted fully composite section. The linear region labeled in Figure 2.2 shows two lines; the line with the larger slope corresponds to a load-deflection curve for a composite girder. The observed load deflection line follows that of a composite section then, once the bond between the concrete and steel becomes compromised, the behavior is nonlinear. It is important to note though, that once the bond has been compromised a sudden increase in deflection is not observed, but rather there is a gradual decrease in the slope of the load-deflection curve. In other words, the bond strength is not completely compromised but gradually “deteriorates” with increased loading. Also, it is important to note that the “deterioration” of the bond strength under high load levels is not permanent. Lichtenstein proposed a load-deflection curve for an analytical model, as shown in Figure 2.2, having a linear relationship following the curve of a composite girder. This linear relationship terminates when the bond strength is compromised. At that point, the load-deflection curve is linear with the same slope as that of a non-composite section. Determining the load at which the bond strength becomes compromised is found through load testing.

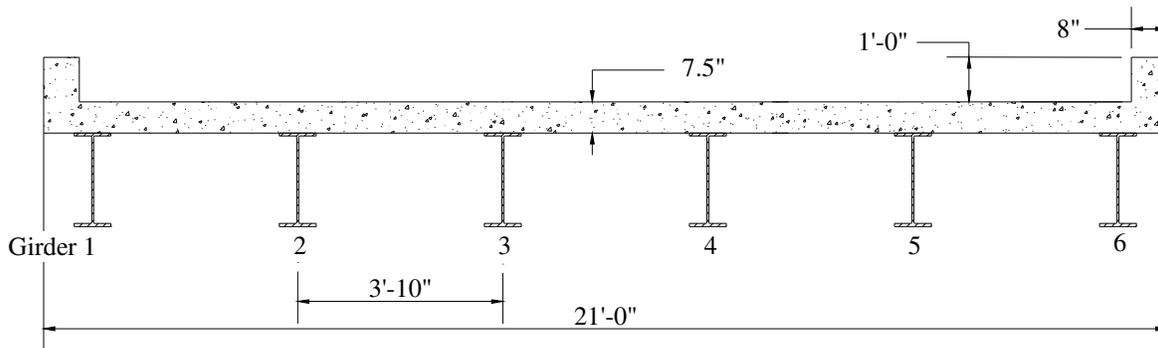
Figure 3.6. Cross Section of BCB Looking North.

The superstructure, a cross section of which is shown in Figure 3.6, consists of six W21x68 girders with a 7.5-inch thick concrete deck. There are C-channel diaphragms at the 1/3 points of the bridge as shown in Figure 3.4(a). On both sides of the bridge there are concrete curbs eight inches wide twelve inches deep as well as a steel railing.

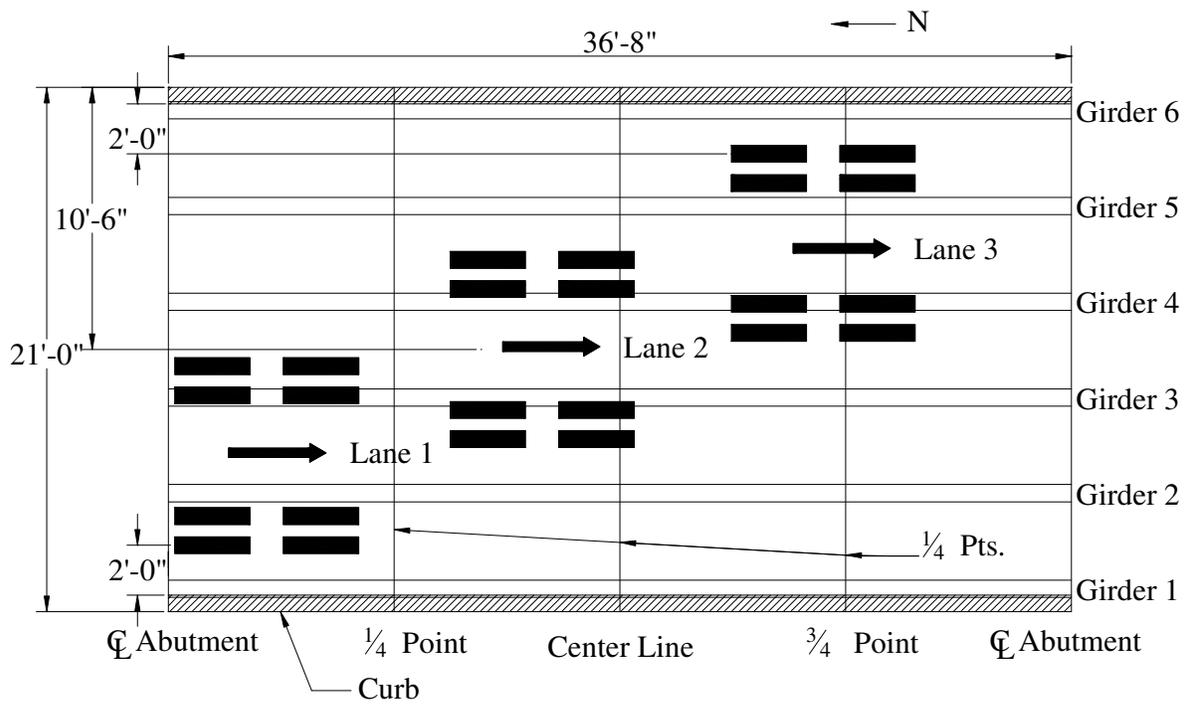
Figure 3.9. Plan View of Loading Lanes Used in BCB Test.

There were three paths or lanes, shown in Figure 3.9, selected for the truck to follow as it crossed the bridge. Each lane was tested twice for each load increment to check repeatability of the test results. Measurements (strains and deflections) were taken when the centroid of the tandem was at the centerline of each abutment and at each quarter point (see Figure 3.9). The location of the centerline of the abutments and each quarter point were painted on the bridge as shown in Figure 3.10; the location of the tandem axle centroid in relation to one of the transverse lines painted on the bridge is shown in Figure 3.11.

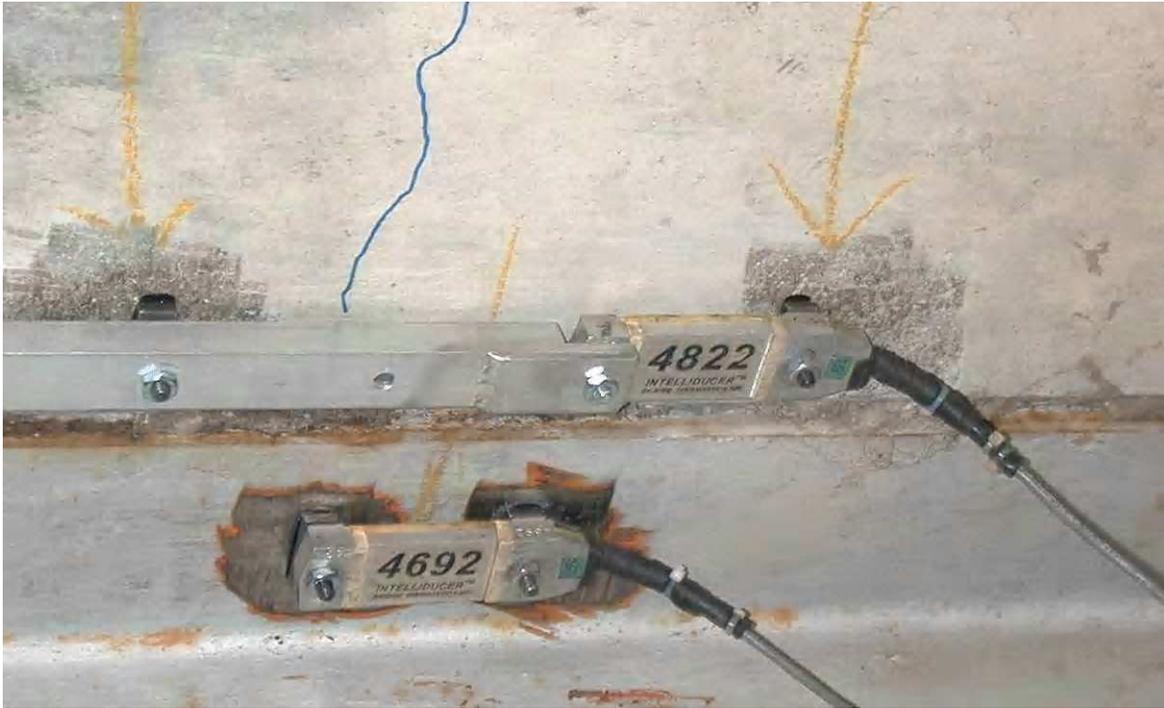
Figure 3.15. Concrete and Steel Mounted Transducers at Midspan of BCB.

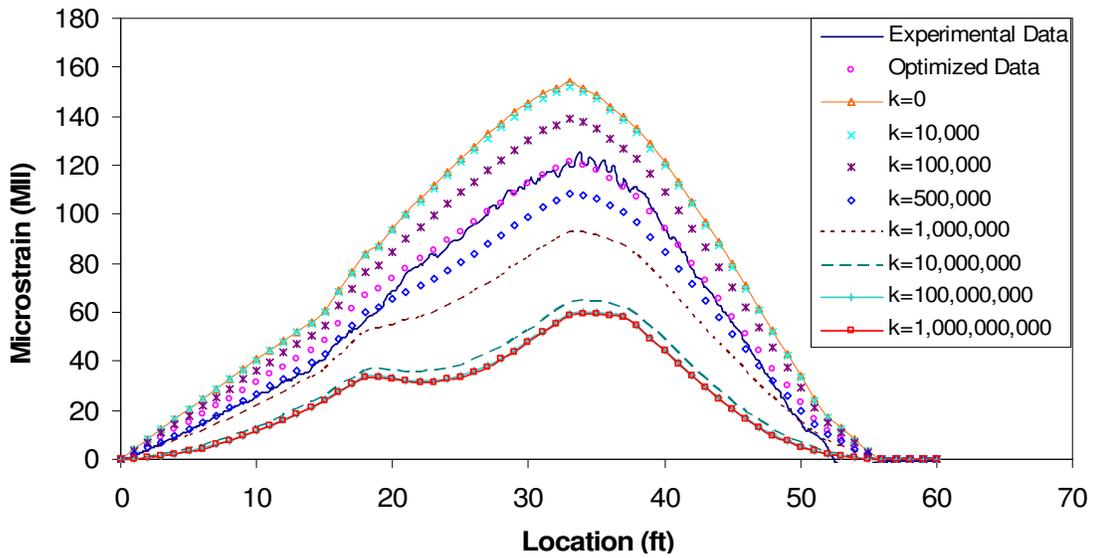
Figure 3.28. BCB Spring Constant Comparison for Lane 1 Girder 1.

The optimized spring constants show that the bridge is neither completely simply supported nor completely fixed. Based on the results for the spring constant comparison, a value of 10 million kip-in/rad for the spring constant represents a condition of 95% fixity and the increase from a spring constant of 100 million to 1 billion kip-in/rad was insignificant. This was determined by comparing the maximum strain in the bridge with a spring constant of 10 million to the maximum strain for a spring constant of zero and the maximum strain for a spring constant equal to 1 billion. From Figure 3.29, it can be observed that the optimized spring constants result in a condition of 35% fixity; therefore, the optimized model will produce midspan strains lower than those calculated assuming simply supported end conditions on the girders.

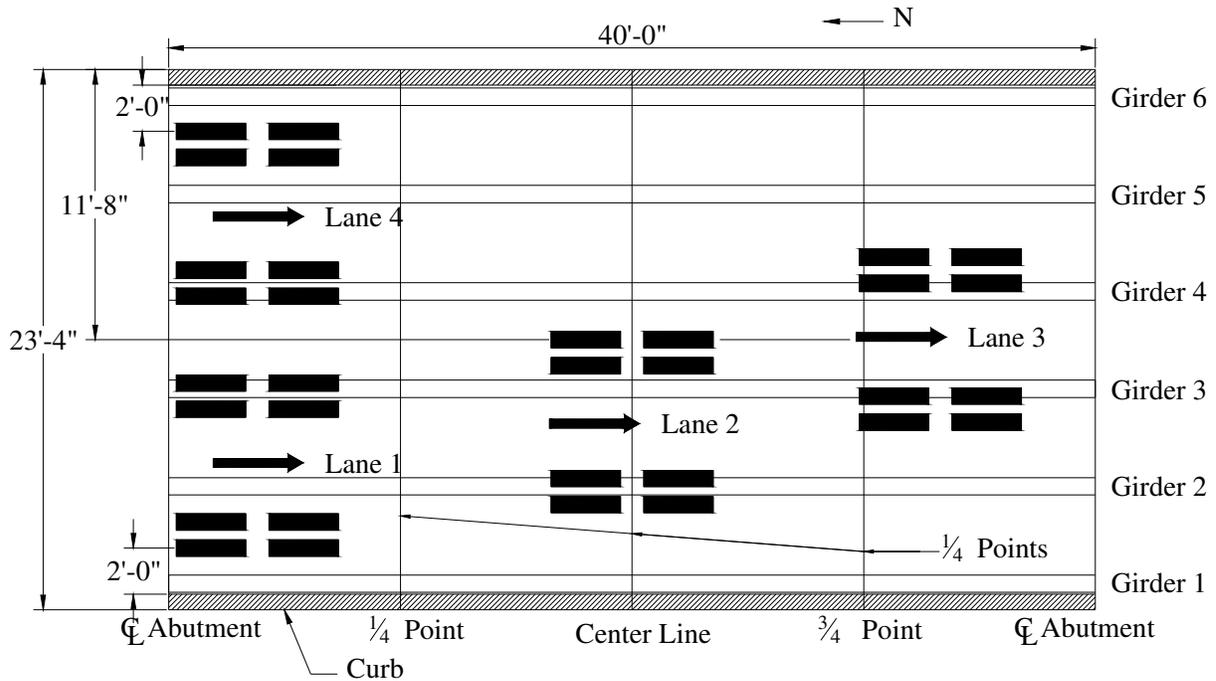
Figure 4.7. Plan View and Loading Lanes Used in MCB Test.

There were four paths or lanes, shown in Figure 4.7, selected for the truck to follow as it crossed the bridge. Each lane was tested twice for each load increment to check repeatability of the test results. Measurements (strains and deflections) were taken when the centroid of the tandem was at the centerline of each abutment and at each quarter point (See Figure 4.7). The locations of the abutment centerlines and the quarter points were painted on the bridge in a manner similar to that used in the BCB test.

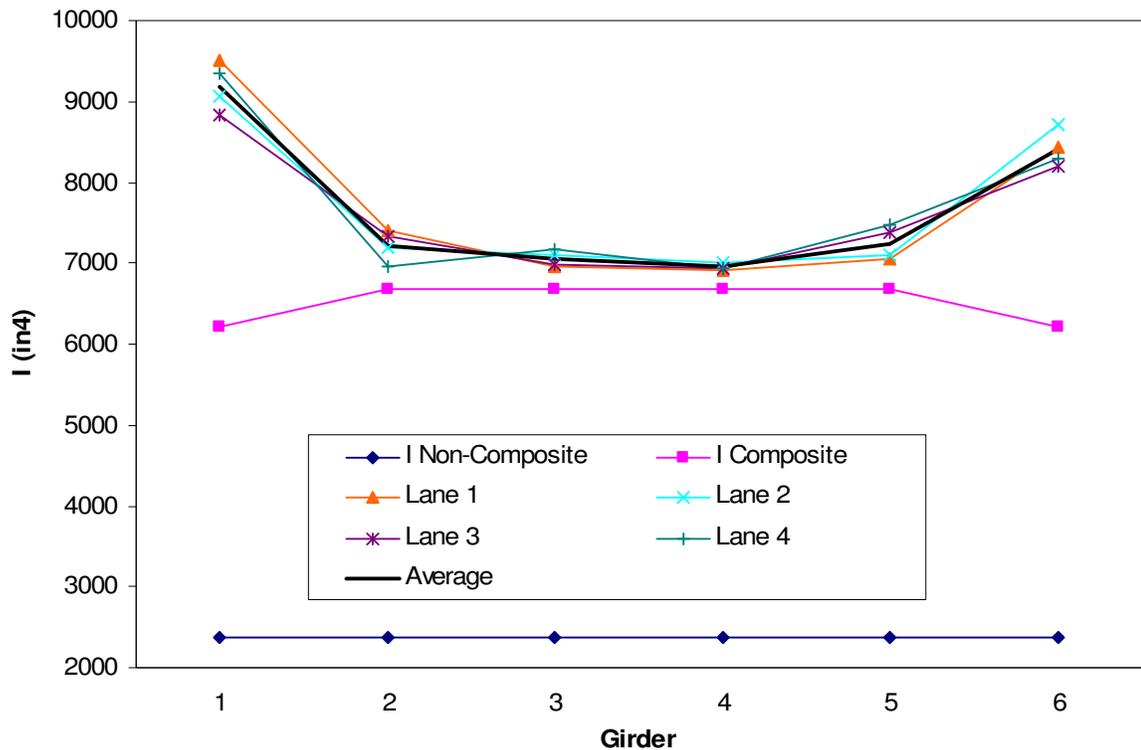
Figure 4.18. MCB Effective Moments of Inertia.

The bridge was once again modeled using software (WinGEN) provided by Bridge Diagnostics Inc. that utilizes the actual test data to create a model that is close to the actual bridge based on the response of the structure to the truck loadings. This bridge model consisted of modeling each girder separately so that the moment of inertia for each girder could be optimized. Even though the interior girders had moments of inertia close to the same as previously noted, it was important to model each girder separately to verify the similarity

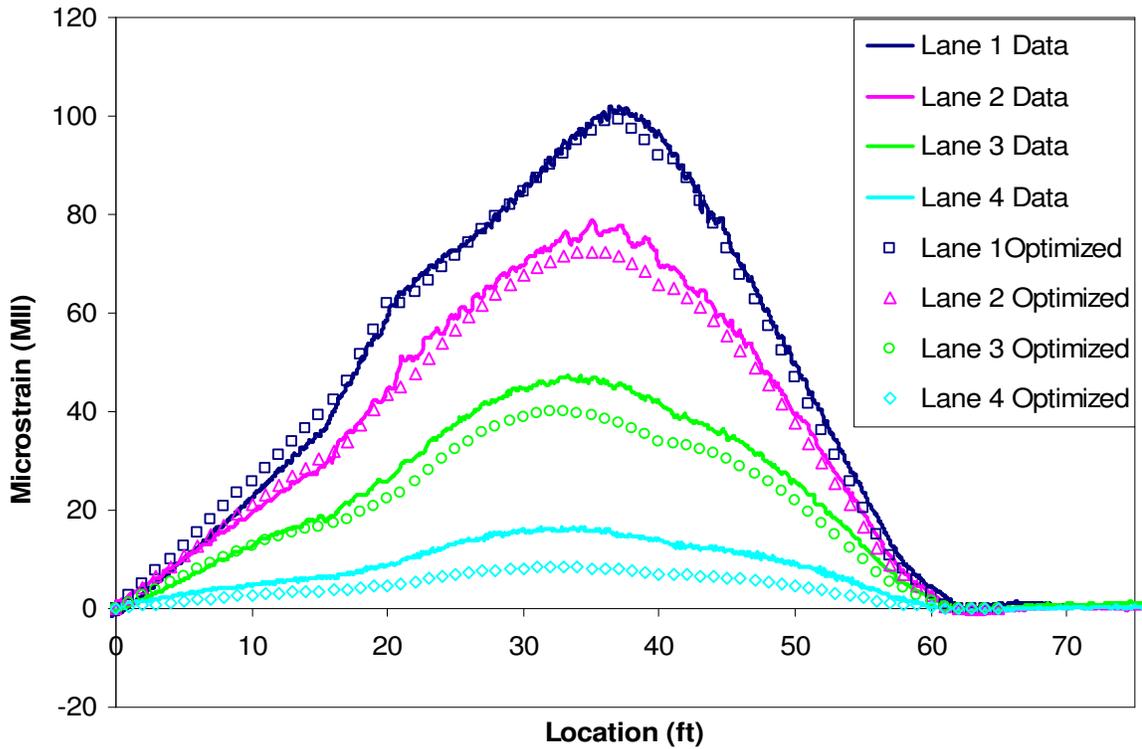
Figure 4.19. MCB Girder 1 Optimized Strain Comparison.

In almost all cases, the optimized strain values were close to the actual strains from the test truck. The correlation between the optimized strain values and the actual strain values are summarized in Table 4.10. The scale error ranged from 0.6 to 5.3 and the correlation ranged from 0.890 to 0.950.

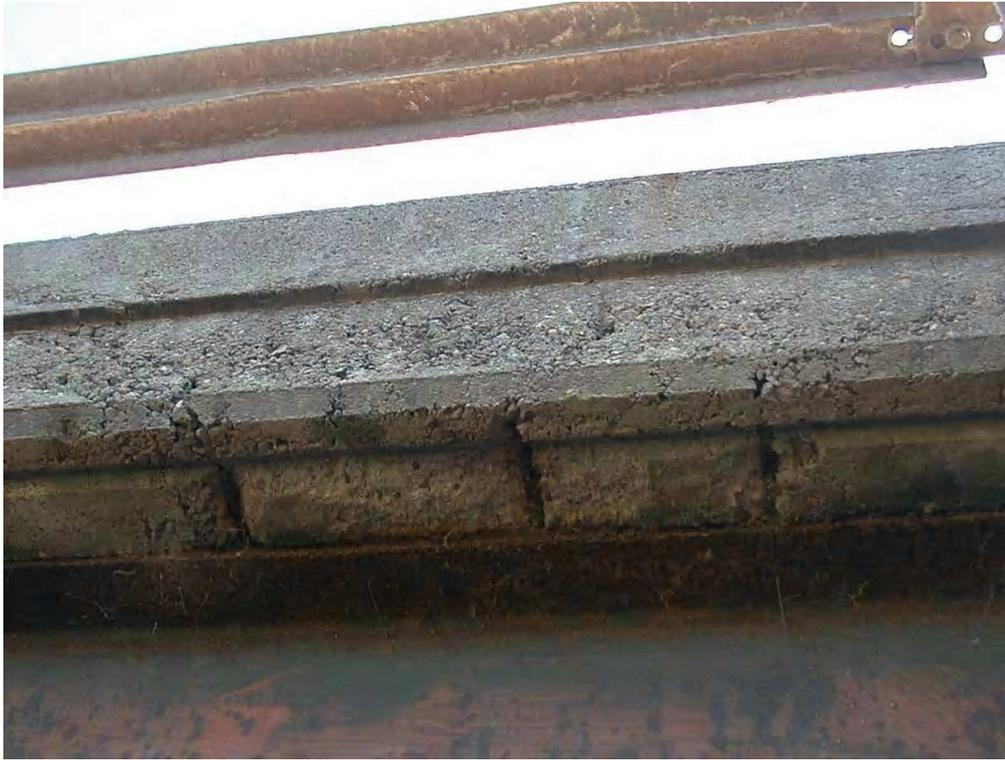
Figure 5.2. KCB1 Poor Concrete Consolidation.

The superstructure was in relatively good condition with only minor rust on the girders. Signs of poor concrete consolidation during the construction of the deck were observed on the underside of the deck where there were large voids near the midspan. The poor consolidation caused some of the reinforcing steel to be exposed as shown in Figure 5.2. There was also a large crack in the concrete deck located at the midspan of the bridge, a photograph of which is provided in Figure 5.3.

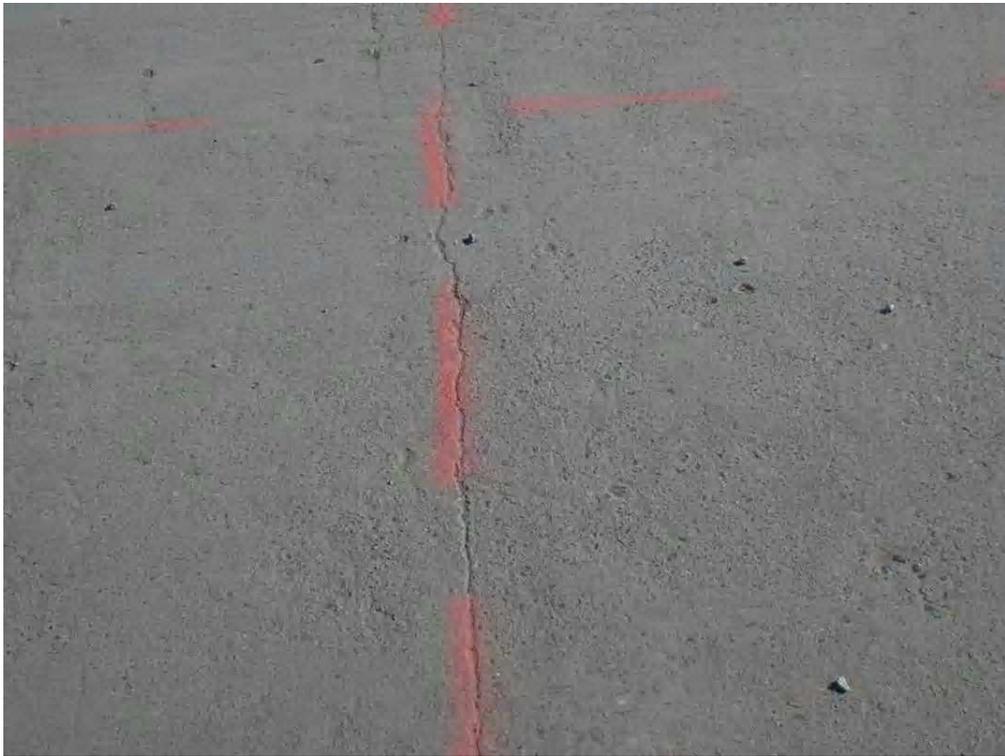
Figure 5.3. KCB1 Deck Crack.

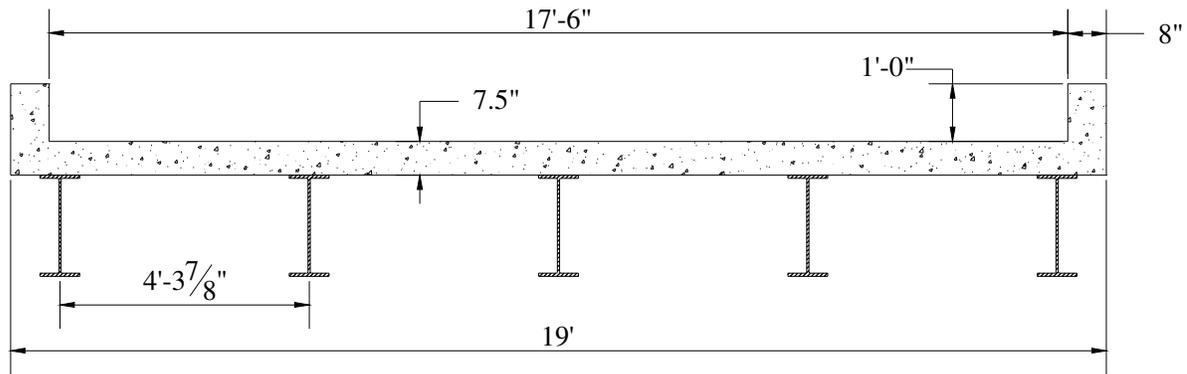
Figure 5.4. KCB1 Cross Section Looking North.

The superstructure, a cross section of which is shown in Figure 5.4, consists of five W21x62 girders with a 7.5-inch thick concrete deck. There are C-channel diaphragms at the 1/3 points of the bridge, concrete curbs eight inches wide by one foot tall, and steel railing on both sides of the bridge. The bridge was relatively narrow and only capable of allowing a single lane of traffic.

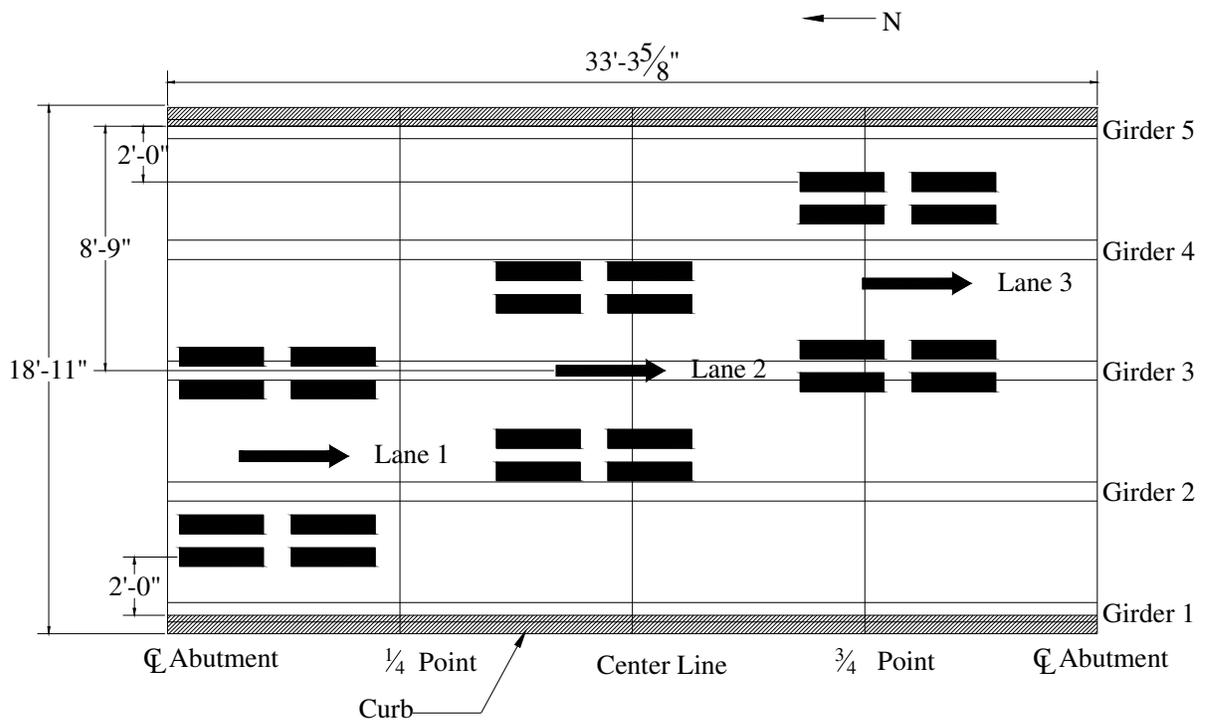
Figure 5.7. KCB1 Plan View Loading Lanes Used in KCB1 Test.

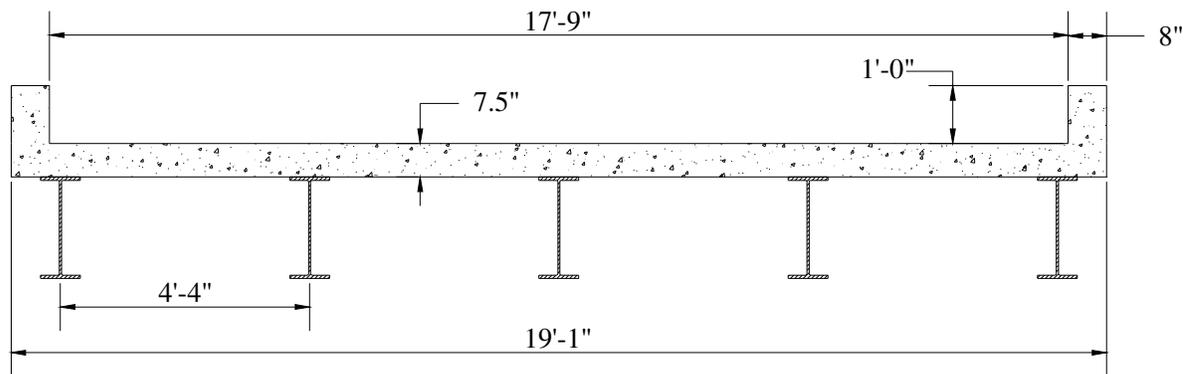
Figure 7.4. Cross Section of KCB2 Looking Northwest.

The superstructure, a cross section of which is shown in Figure 7.4, consists of five W24x76 girders with a 7.5-inch thick concrete deck. There are C-channel diaphragms at the 1/3 points of the bridge, concrete curbs eight inches wide by one foot tall and steel railing on both sides of the bridge.

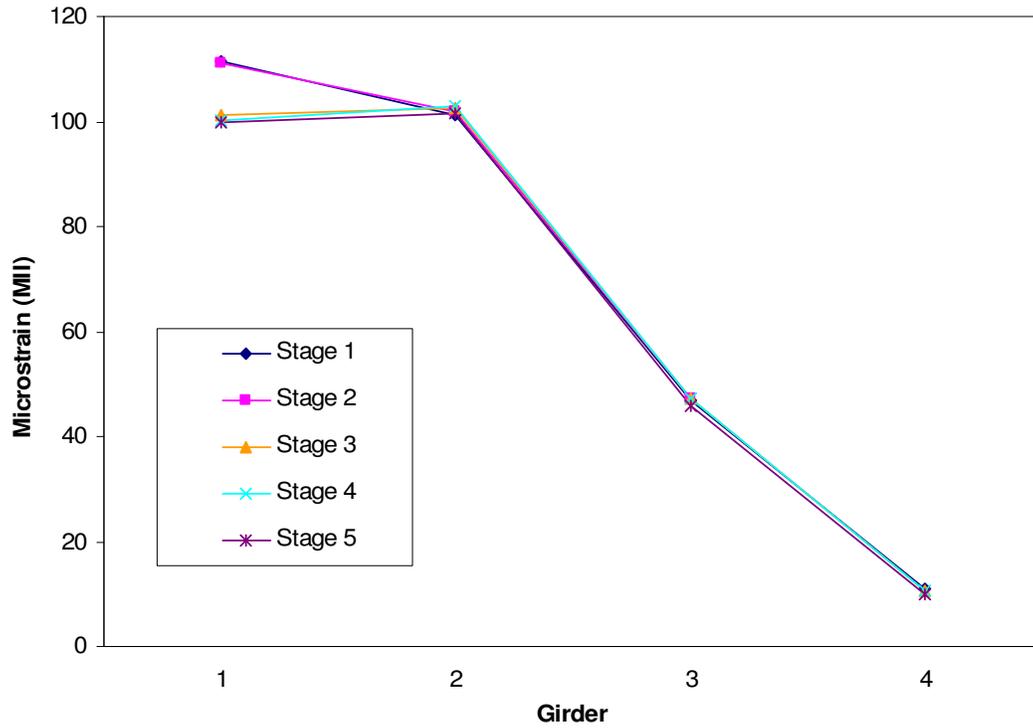
Figure 8.24. HCB Lane 1 Destructive Testing Strain Profile at Midspan.
