Feasibility of Forming Transverse Joints with Joint Forming Devices

tech transfer summary

Evaluation of Transverse Joint Forming
Methods for PCC Pavement

Iowa Highway Research Board (TR-532)

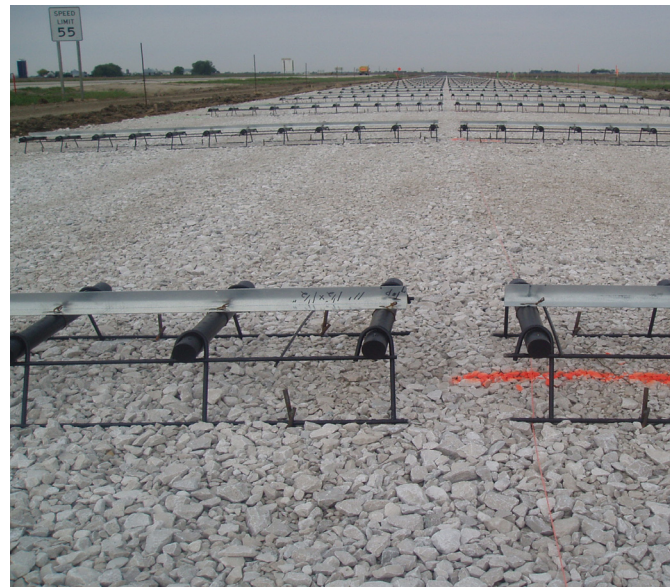
Cross-section of joint-forming device on top of the dowels

The joint-forming devices tested each consisted of a galvanized, L-shaped piece of metal placed in the area of the dowel basket to form the joint.

Six separate installations of six joints each (a total of 36 joint-forming devices) were made. The joint formers were placed either below the dowel baskets or on top of the dowels. The joint formers placed on the base were secured with dowel basket pins on approximately 610 mm centers along the joint formers. The pins were driven behind the L-shaped metal of the joint-forming devices (away from the paver) to prevent the metal from being overturned during paving. The joint formers above the dowels were secured with wire ties to the dowels themselves at 305 mm intervals to prevent rollovers.

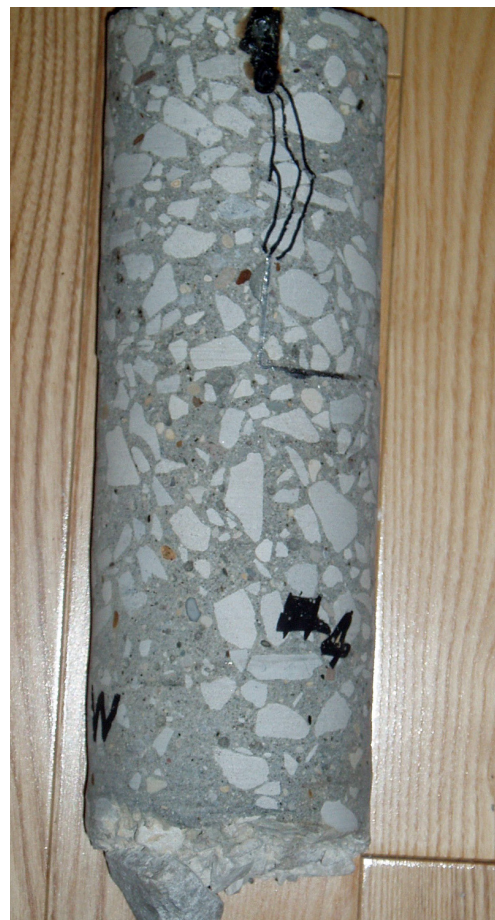
Core sample showing a crack extending from the joint former
