# Use of Ultra-High-Performance Concrete for Bridge Deck Overlays

**Final Report**  
**March 2018**

**Sponsored by**  
Iowa Highway Research Board  
(IHRB Project TR-683)  
Iowa Department of Transportation  
(InTrans Projects 16-573 and 16-574)  
Federal Highway Administration

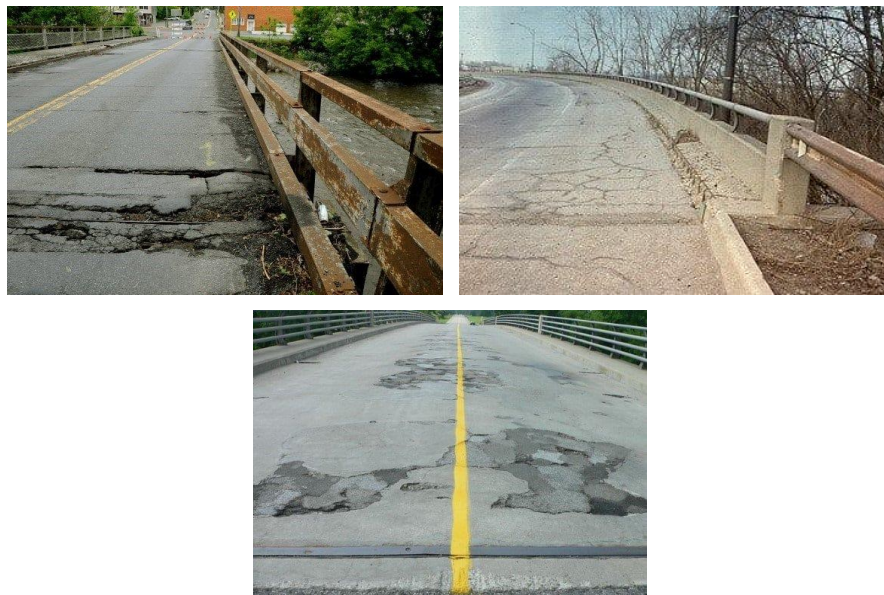
**Figure 1.1. Typical examples of bridge deck deterioration**

The situation is not much different in Iowa. Iowa ranks fifth on the list of states with the largest number of bridges. The state of Iowa and its counties and cities own a total of about 24,000 bridges, with the condition of these bridges earning a letter grade of D+ (ASCE 2015). This rating is worse than the grade of C+ assigned to the condition of bridges nationwide (ASCE 2017). Iowa is listed in the top three states with the most deficient bridges, with approximately 20% of its bridges considered deficient and/or posted with weight restrictions. The coupled problems of aging infrastructure, the growing number of structurally deficient or obsolete bridges, and the continuous increase in both the traffic volume and heavier vehicles in the US require rapid improvements to the nation's bridge stock. Therefore, there is an urgent need to develop technologies that are not only economical and durable but can also be safely and rapidly implemented in practice. Such technologies will remedy the aforementioned problems and extend the life of bridges, whose deterioration often starts with cracking on the top surface of bridge decks, as shown in Figure 1.1.

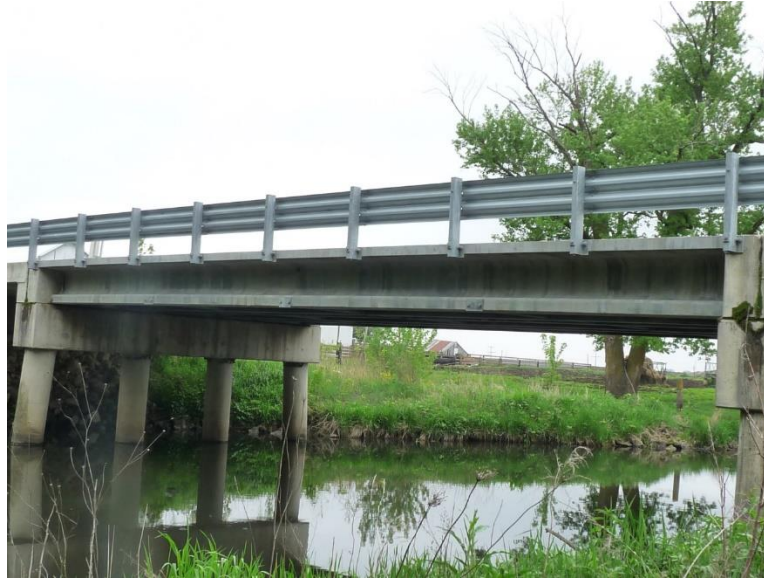
**Figure 1.3. Jakway Park Bridge with UHPC pi-girders in Buchanan County, Iowa**

durability properties (Vande Voort et al. 2008, Sritharan 2015), which can give bridges a design life of 75 years or longer. The combined engineering and durability properties help to control deck cracking and penetration of chloride ions into the bridge deck, both of which are, as previously noted, common problems in today's bridge decks. However, UHPC is a relatively costly material and may not be feasible for use in the entire bridge deck, as UHPC was used in the Jakway Park Bridge shown in Figure 1.3, or the whole bridge.

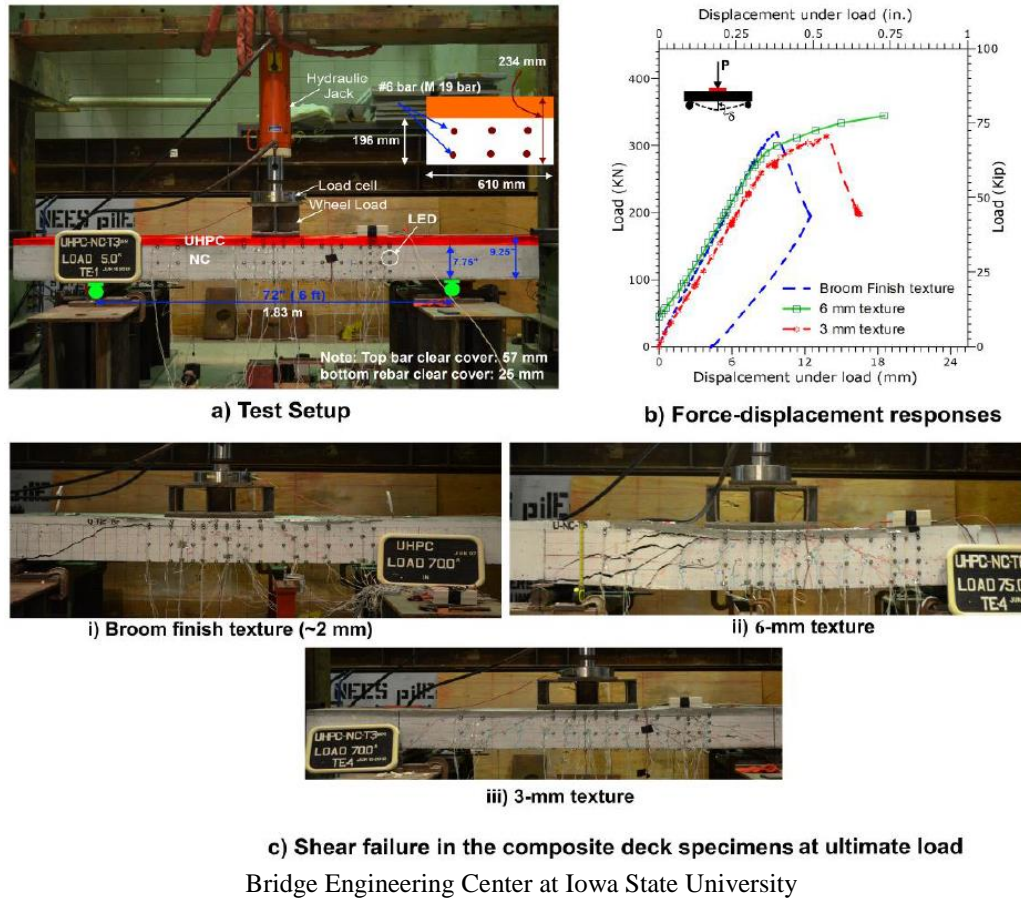
**Figure 2.3. Flexural tests conducted at Iowa State University**

previously carried out at Iowa State University. Through 60 slant shear tests (shown in Figure 2.2) and four flexural tests (shown in Figure 2.3) performed on concrete beams overlaid with UHPC, it was found that the desired response for the composite action can be achieved when a minimum interface roughness of about 1/8 in. (or 3 mm) is ensured by placing thin grooves on top of a newly cast concrete deck or through hydro-demolition of the top layer of an existing bridge deck (Aaleti et al. 2013).

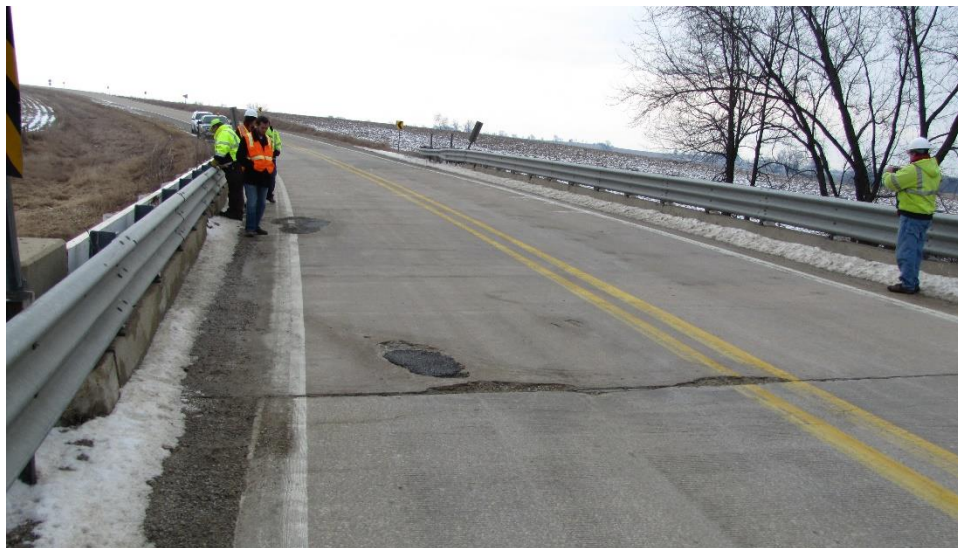
**Figure 3.1. Mud Creek Bridge deck before UHPC overlay application**

Mud Creek Bridge, built in the mid-1960s in Buchanan County, Iowa, was selected for the UHPC overlay demonstration project. The bridge is located between the towns of La Porte and Brandon. This is a three-span, two-lane, straight continuous concrete slab bridge. The bridge is 100 ft long and 28 ft wide. In addition, the bridge has a 5% superelevation. Prior to the UHPC overlay retrofit, the deck of this bridge had some locally damaged regions, as shown in Figure 3.1.

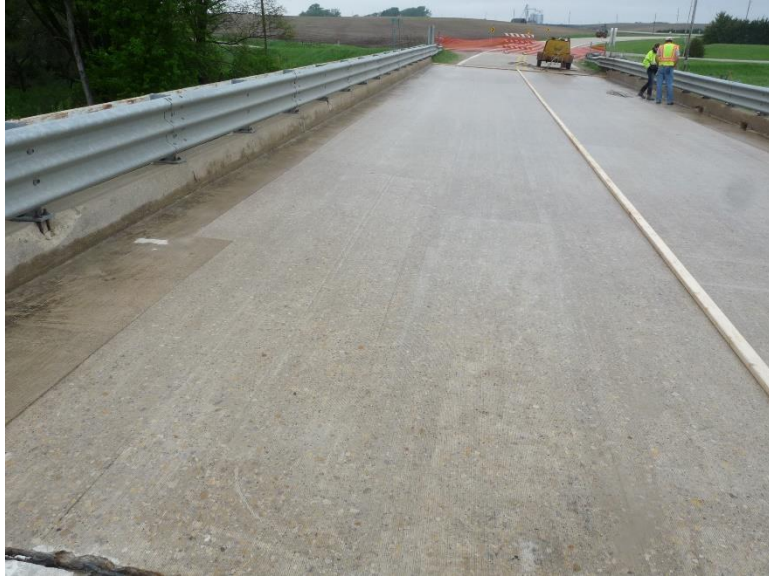
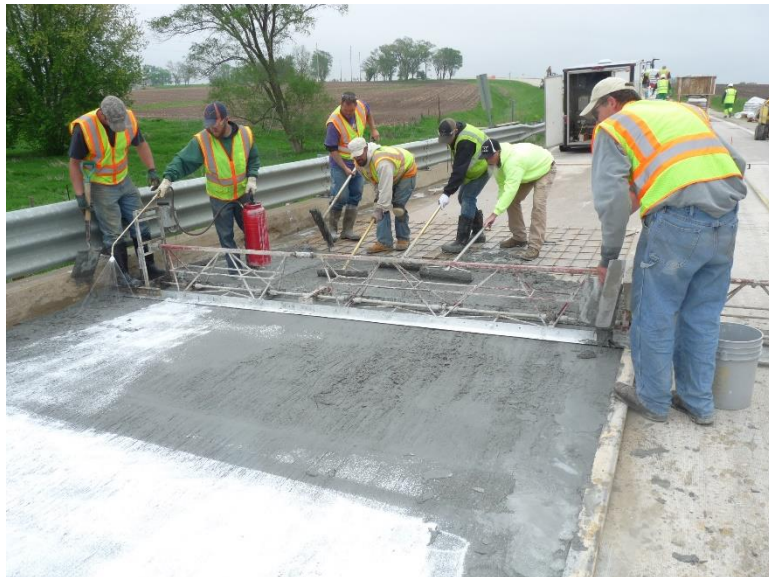
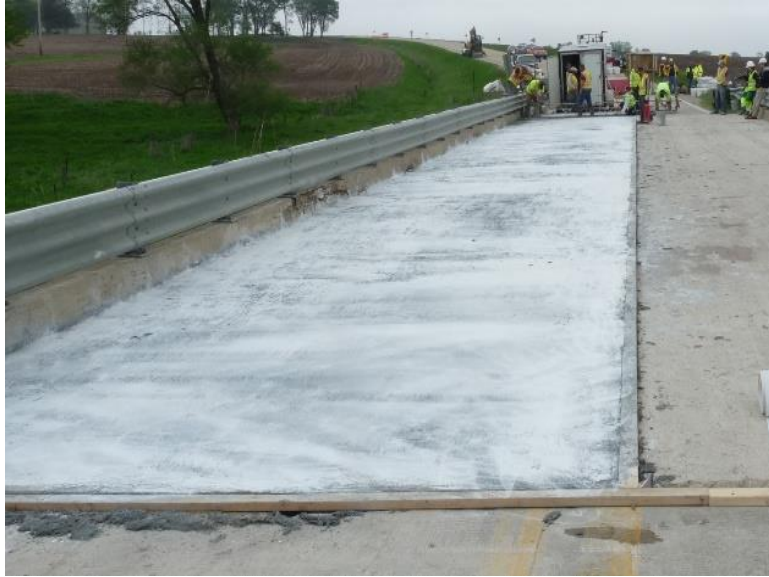
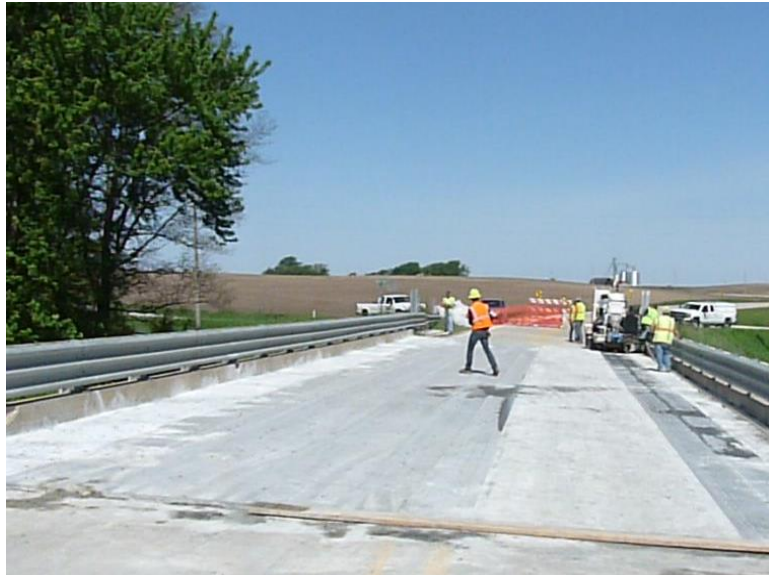
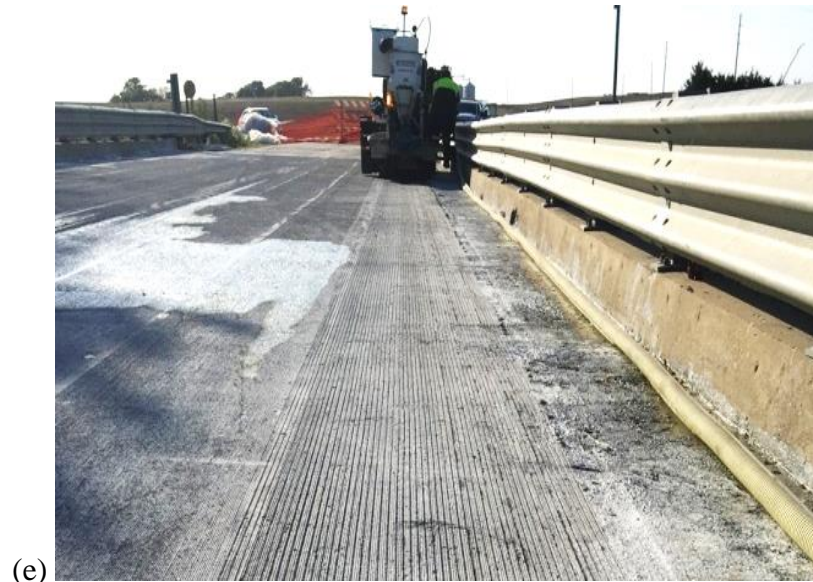
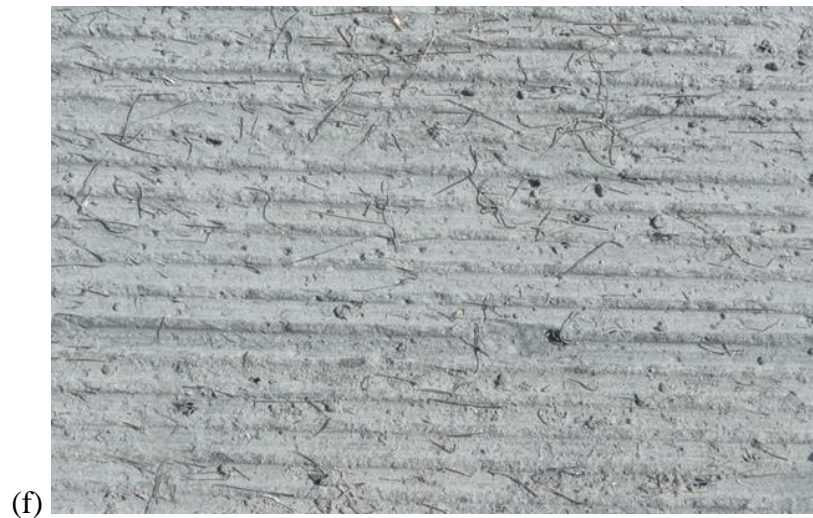
**Figure 3.3. Overlay construction: (a) roughened deck surface prior to placing the overlay, (b) placing of the UHPC overlay with a screed, (c) UHPC overlay after casting one lane, (d) grinding of the surface, (e) grooving of the surface, and (f) close-up view of the finished surface**

Construction began with removal of the old asphalt overlay and the damaged concrete from the deck. Then, the surface of the deck was ground and grooved to expose the aggregate and create a target surface roughness of about 1/8 in. or 3 mm. After that, water was sprayed on the deck surface and rebars were placed at the pier locations. Then, the UHPC overlay was placed on top of the deck along the entire length of one lane to avoid the formation of construction joints in the transverse direction. A regular vibratory concrete screed was used for placing the material, and a concrete curing compound was sprayed on top of the UHPC overlay immediately afterwards. A few days later, UHPC overlay construction was performed on the other lane, with a construction joint along the centerline of the bridge. No special detailing was adopted for the construction joint. Once the UHPC hardened, the surface was ground and grooved to give the appropriate roughness for vehicular traffic. Some of the construction pictures are presented in Figure 3.3.

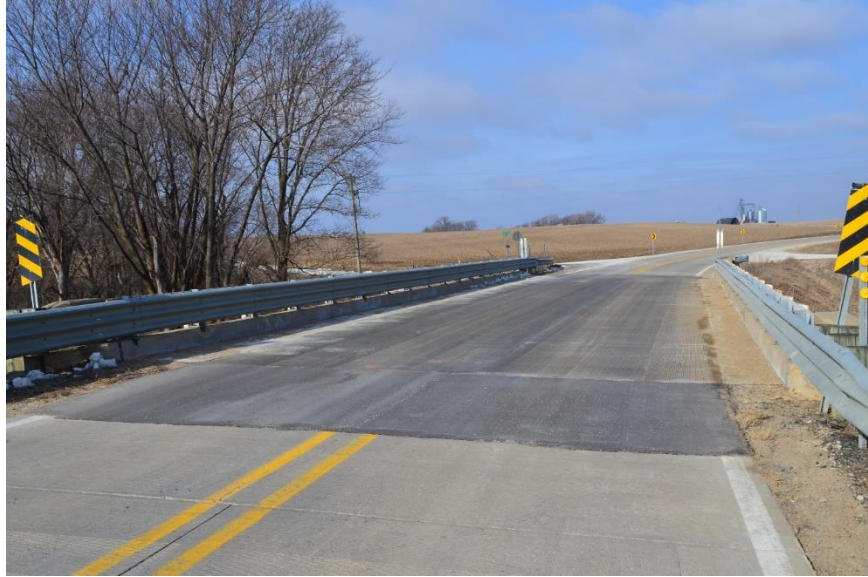
**Figure 3.4. Completed Mud Creek Bridge in February 2017**

Figure 3.4 shows the finished UHPC overlay on top of the bridge deck.

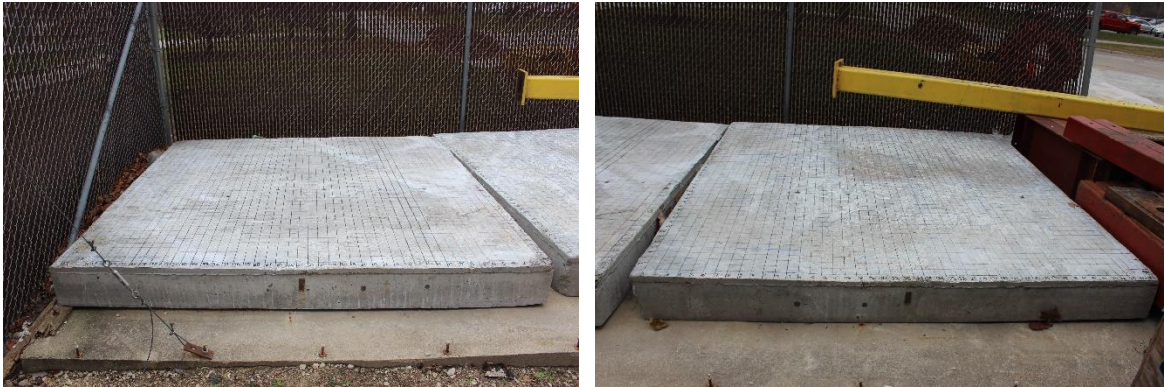
**Figure 3.8. Test specimens placed outside of the laboratory: Slab A (left) and Slab B (right)**

When the slabs were 43 days old, a 1.5 in. thick UHPC overlay was placed on the top of each slab on July 22, 2015. In both cases, the slabs were positioned at a 6% slope to ensure that the UHPC overlay could be placed on sloping surfaces. Curing of the slab specimens and overlays was performed inside the structural laboratory. Afterwards, the slab specimens were moved to an outdoor location for environmental exposure, as shown in Figure 3.8.

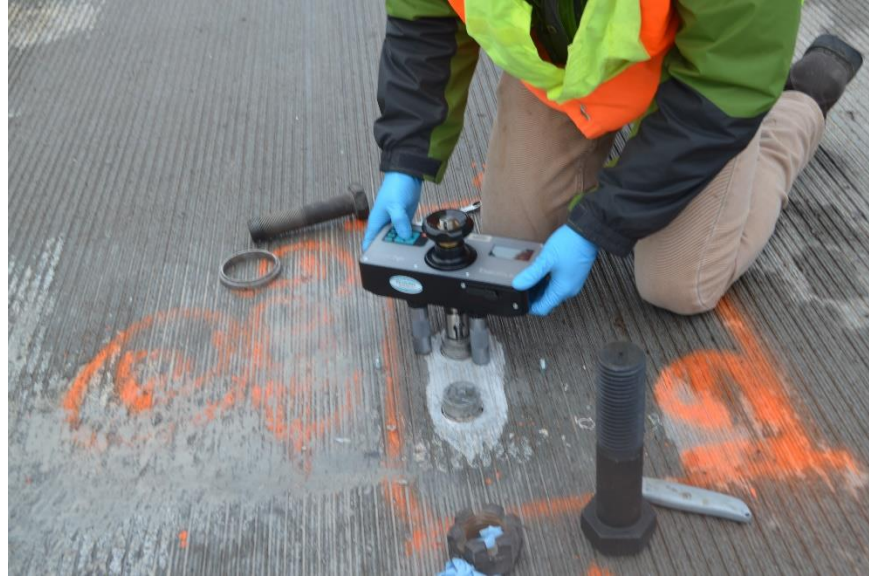
**Figure 3.11. Pull-off test on Mud Creek Bridge deck**

On a field inspection carried out by the Secondary Roads Department in Buchanan County using the chain drag method, it was suspected that some areas on the deck of Mud Creek Bridge had potential delamination issues. To evaluate this concern, the FHWA conducted several pull-off tests on Mud Creek Bridge deck on November 28 and 29, 2016. Another set of chain drag tests was conducted, and eight potential delamination regions were found. Out of these eight, two potentially delaminated regions were selected for testing, one in the eastbound lane and one in the westbound lane. For comparison, three good or intact bond areas were identified and tested, two in the eastbound lane and one in the westbound lane. The pull-off tests were carried out according to the direct tension bond pull-off test method described in ASTM C1583. A 2 in. diameter saw corer was used to make a circular cut with a depth of approximately 4 in. on the deck so that a 1.97 in. (50 mm) diameter specimen could be extracted. A pull-off tester, Proceq DY-225, shown in Figure 3.11, was utilized to pull the specimen off.

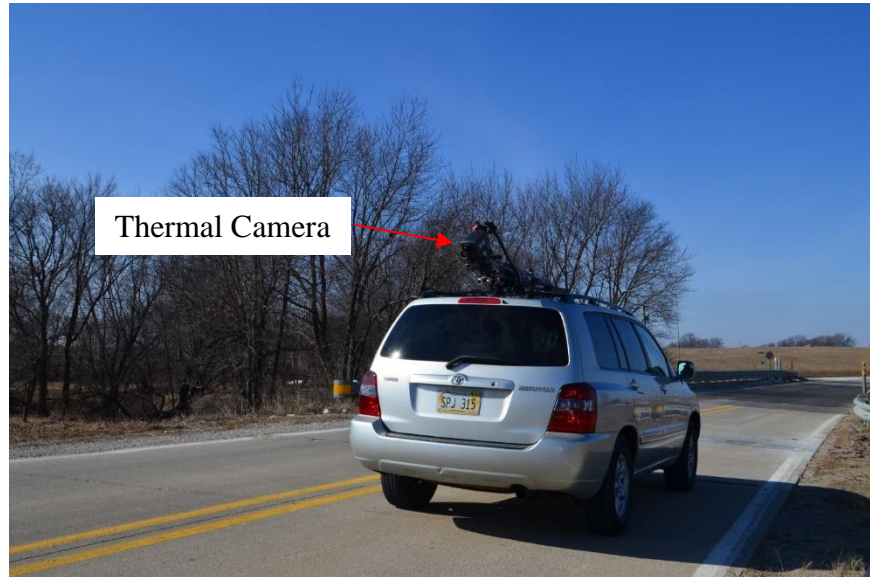
**Figure 3.13. Thermal image scanning of Mud Creek Bridge using thermal camera mounted on a vehicle**

Thermal image scanning was performed on Mud Creek Bridge on February 5, 2017 to assess the delamination potential of the UHPC overlay. The thermal camera was mounted on top of a car before the car was driven over the bridge, as shown in Figure 3.13.

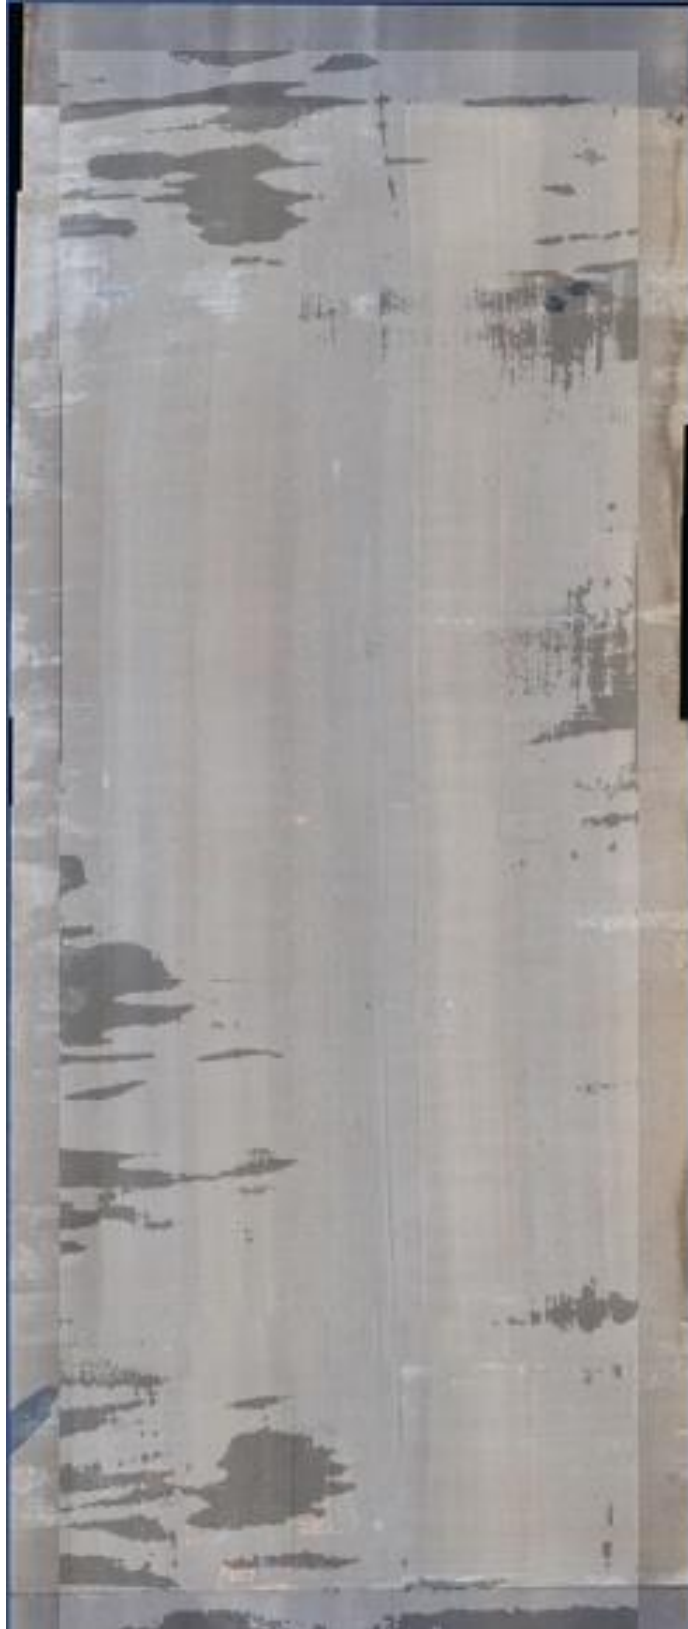
**Figure 3.14. Infrared imaging results for Mud Creek Bridge deck**

A camera was also mounted on a drone and flown over the bridge to obtain an aerial view of the bridge. The thermal camera used was a FLIR A8303sc. The spectral range of this camera is 3 to 5  $\mu\text{m}$ , and the camera has a resolution of  $1,280 \times 720$  pixels. The standard temperature range is  $-20^{\circ}\text{C}$  to  $350^{\circ}\text{C}$  ( $-4^{\circ}\text{F}$  to  $662^{\circ}\text{F}$ ). The filtered results of the thermal imaging are presented in Figure 3.14.

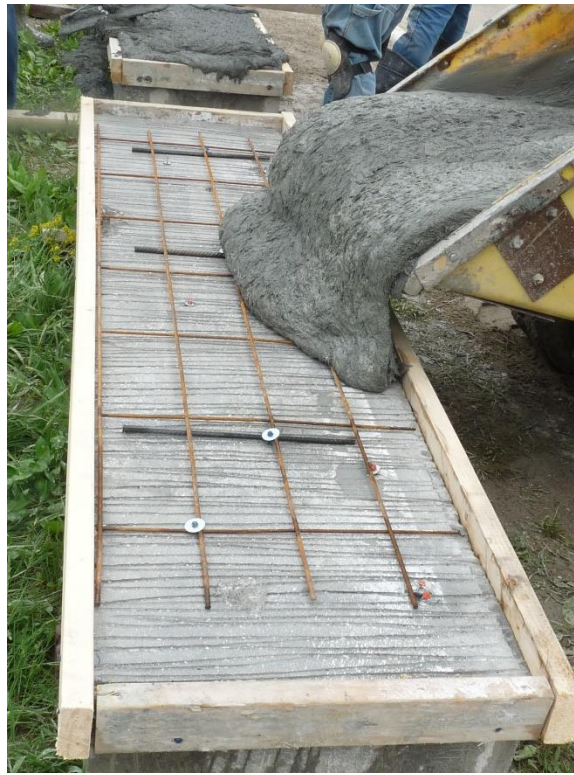
**Figure 4.2. Pouring of UHPC overlay on the slab specimens**

to absorption by the unsaturated normal concrete deck panel. Then, a layer of UHPC overlay was poured on top of the slabs, as shown in Figure 4.2.

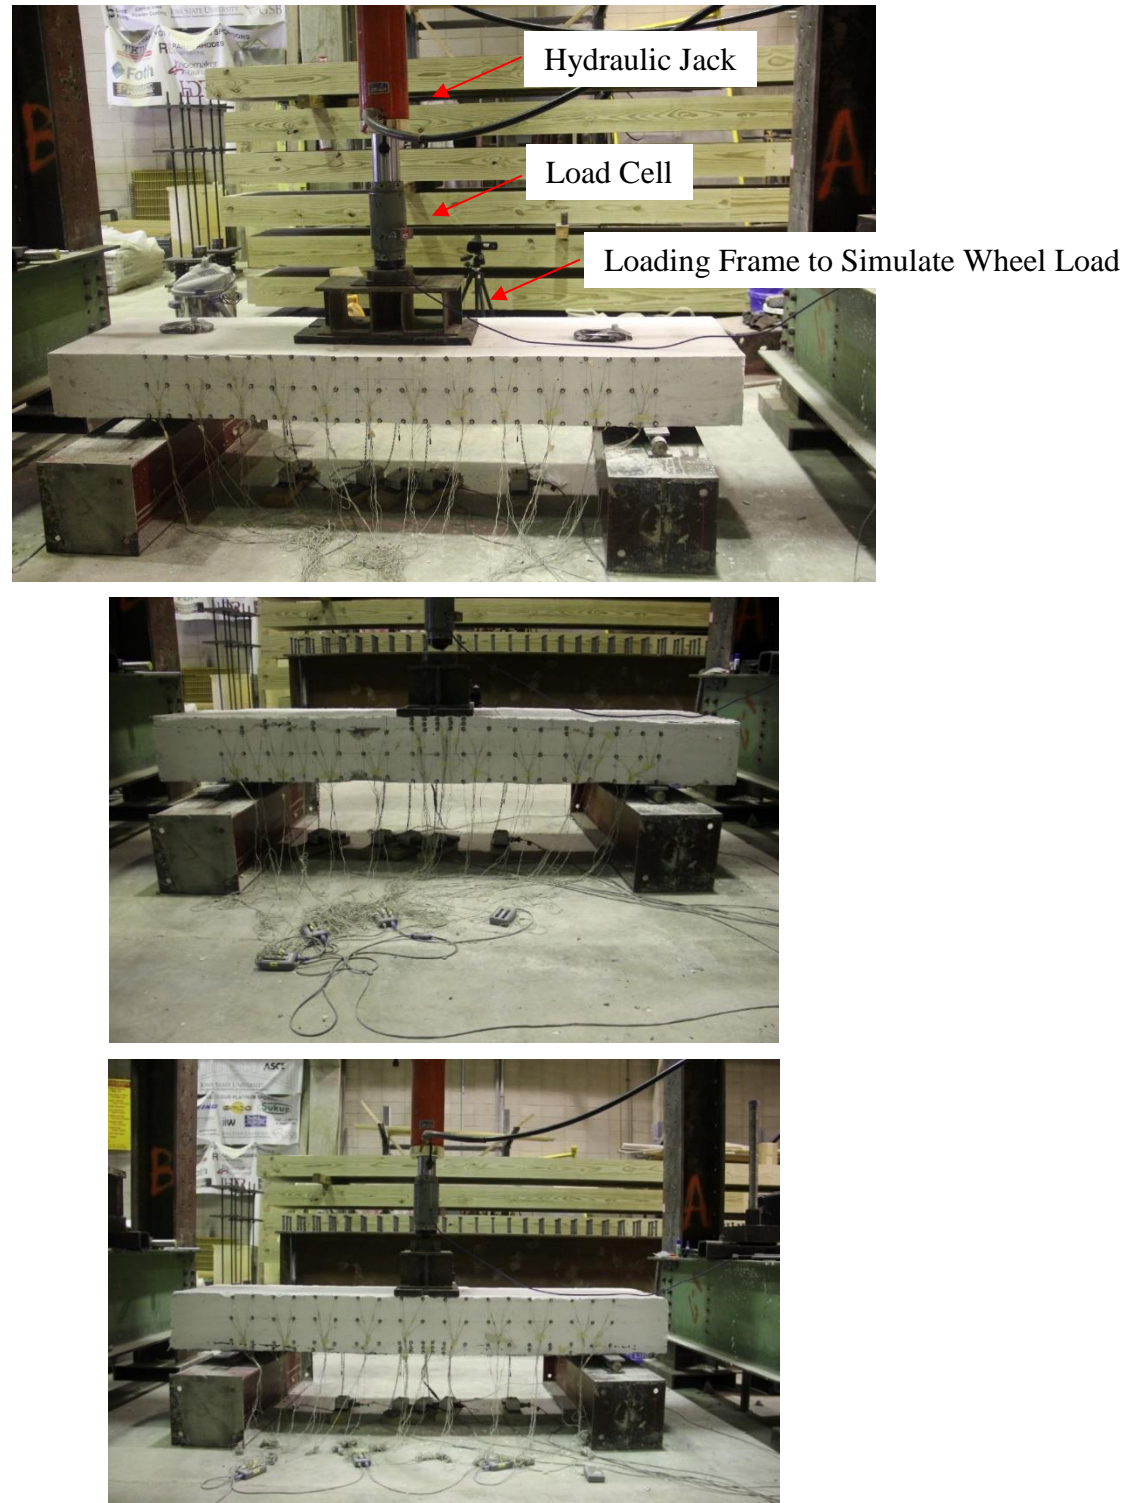
**Figure 4.3. Test setup for Specimens NO (top), OT (center), and OB (bottom)**

The test setup for all three cases is shown in Figure 4.3.

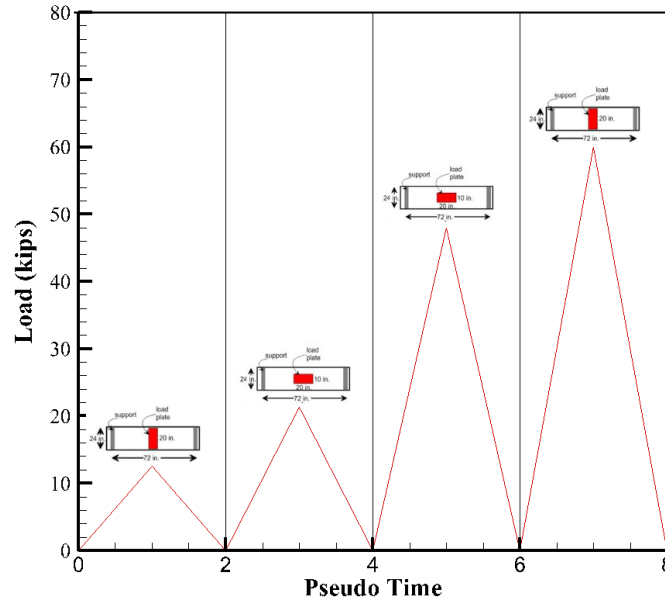
**Figure 4.5. Load protocol for the tests**

1. Loading up to 12.5 kips in Load Orientation 1
2. Loading up to 21.3 kips and 48 kips in Load Orientation 2 to represent the service load conditions expected in the prototype bridge
3. Loading up to 60 kips using Load Orientation 1 to cause shear cracking in the normal concrete

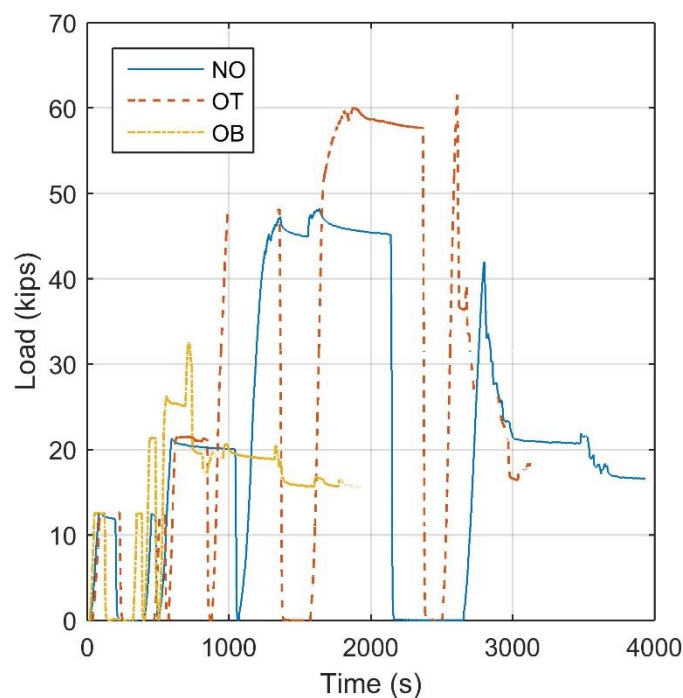
**Figure 4.8. Load histories used during test for all specimens**

The load histories for all three specimens are presented in Figure 4.8 and follow the load protocol described earlier.

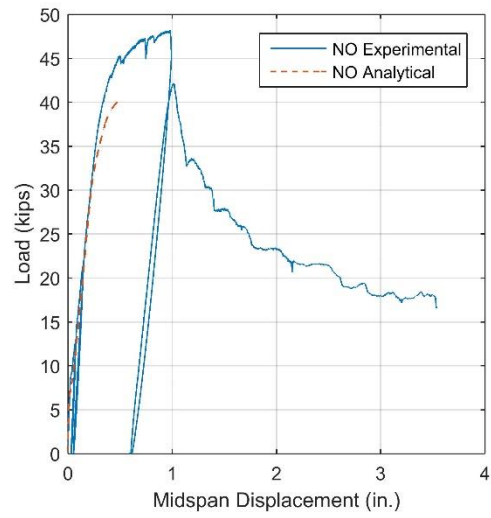
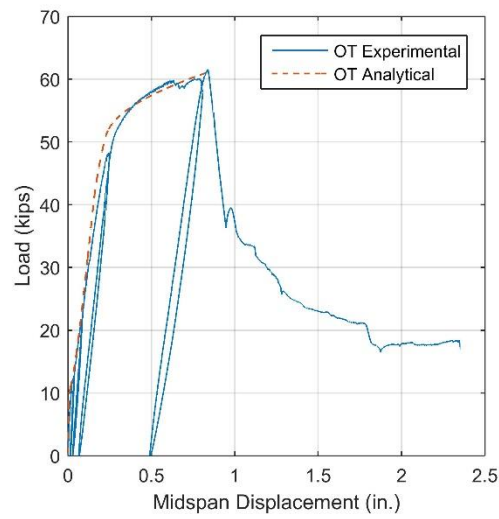
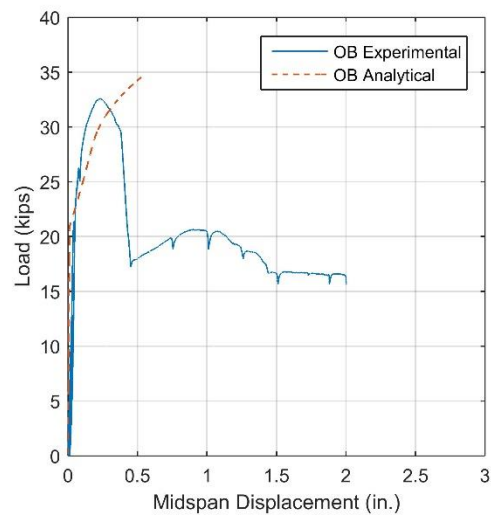
**Figure 4.12. Experimental and analytical load versus deflection plots for Specimens NO (top), OT (middle), and OB (bottom)**

The analytical moment-curvature of the slab sections and the corresponding force-displacement plots of the slabs are shown in Figure 4.11 and Figure 4.12, respectively.

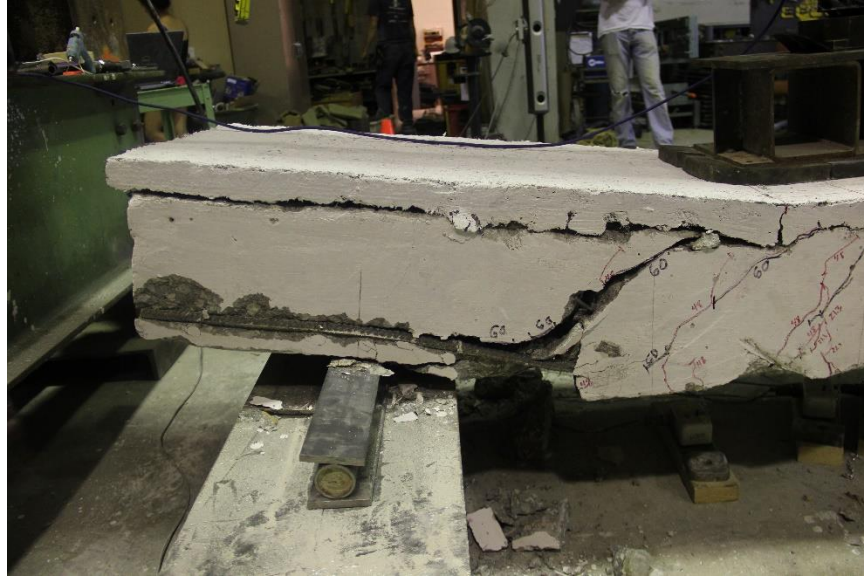
**Figure 4.17. Damage to UHPC-NC interface after specimen reached peak load and shear failure ensued**

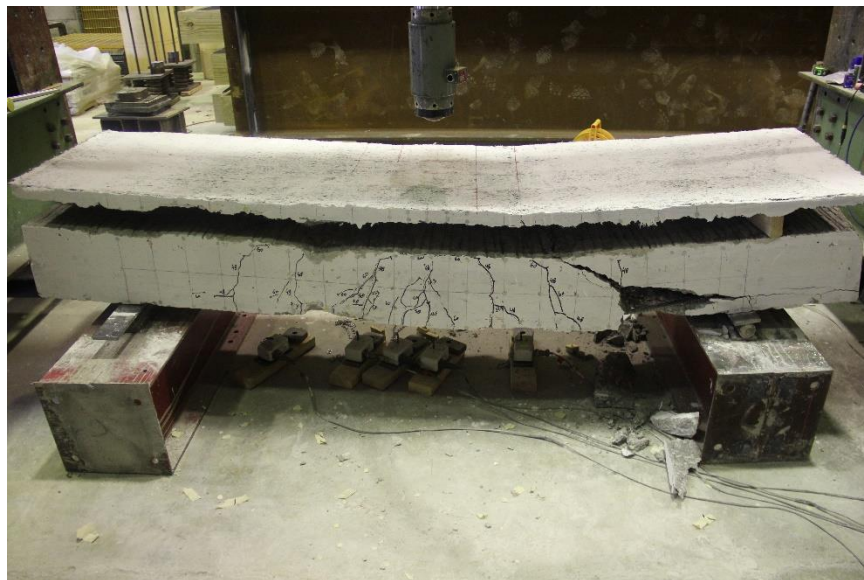
**Figure 4.18. UHPC layer pried open after the test**

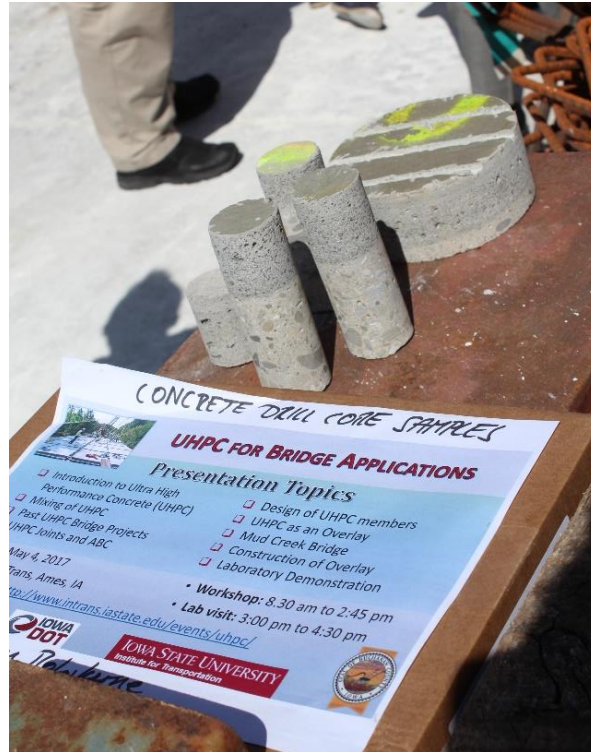
**Figure A9. Drilled UHPC-NC core samples**
