# Effective Shoulder Design and Maintenance

## Final Report June 2007

**Sponsored by**  
the Iowa Highway Research Board  
(IHRB Project TR-531)  
and  
the Iowa Department of Transportation  
(CTRE Project 05-198)

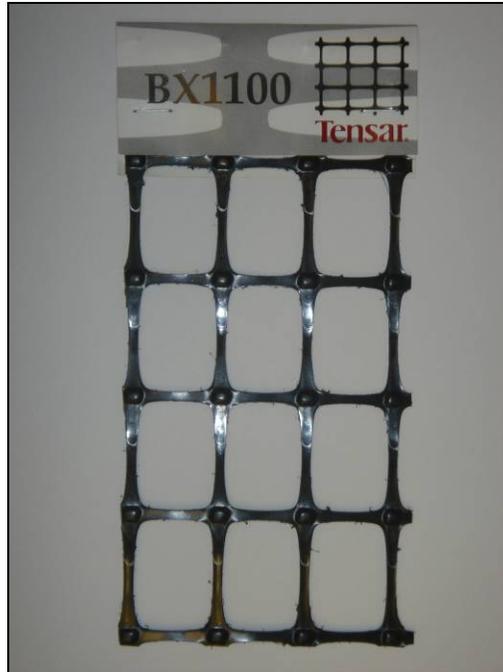
**Figure 4. Tensar BX1100 geogrid (image scale 1:2.5)**

Three fundamental reinforcement mechanisms have been identified involving the use of geogrids: (1) lateral restraint, (2) improved bearing capacity, and (3) tensioned membrane effect. Lateral restraint refers to the interlocking and confinement of aggregate during loading, restricting the lateral flow of the material. This increases the modulus of the base course material, which thus increases the vertical stress distribution applied to the subgrade. Improved bearing capacity is achieved by shifting the failure envelope from the weaker subgrade to the stiffer base course. The tensioned membrane effect is based upon the concept of an improved vertical stress distribution resulting from tensile stress in a deformed membrane. In early research stages, the tensioned membrane effect was believed to govern the reinforcement mechanism. However, later research demonstrated that reinforcement benefits are obtained without significant deformation and that lateral restraint is the primary reinforcement mechanism, followed by the improved bearing capacity concept (U.S. Army Corps of Engineers 2003). Figure 4 shows a biaxial geogrid commonly used for soil reinforcement.

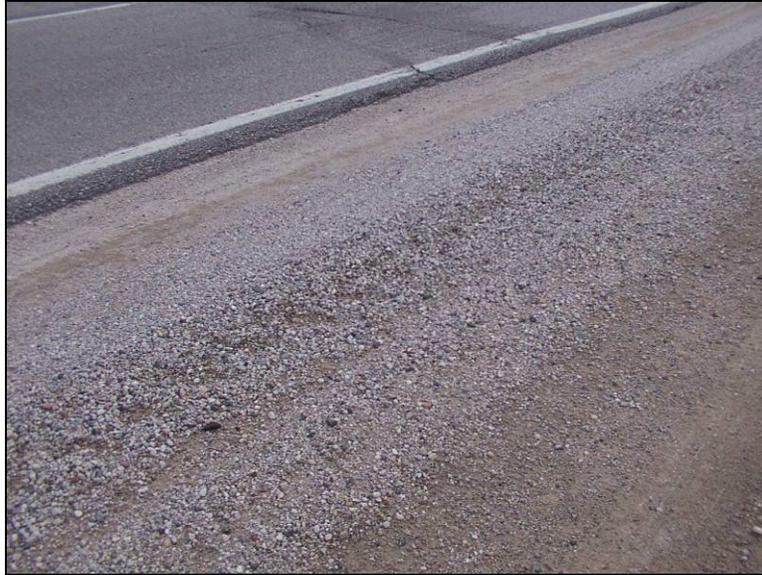
**Figure 11. Shoulder section at U.S. 30 milepost 151.95 E.B., September 2, 2006**

The first shoulder section (milepost 151.95 E.B.) is about 8 ft. wide and is comprised of crushed limestone, as shown in Figure 11. The edge line is 6 in. from the pavement edge. A 2 in. drop-off was measured at this section. Aggregate samples were collected at 0, 24, and 36 in. from the pavement edge, and grain size analysis was conducted. The results of the grain size analysis, shown in Figure 12, indicate that the granular material gets coarser with increasing distance from the pavement. The soil properties of the collected samples are shown in Table 10.

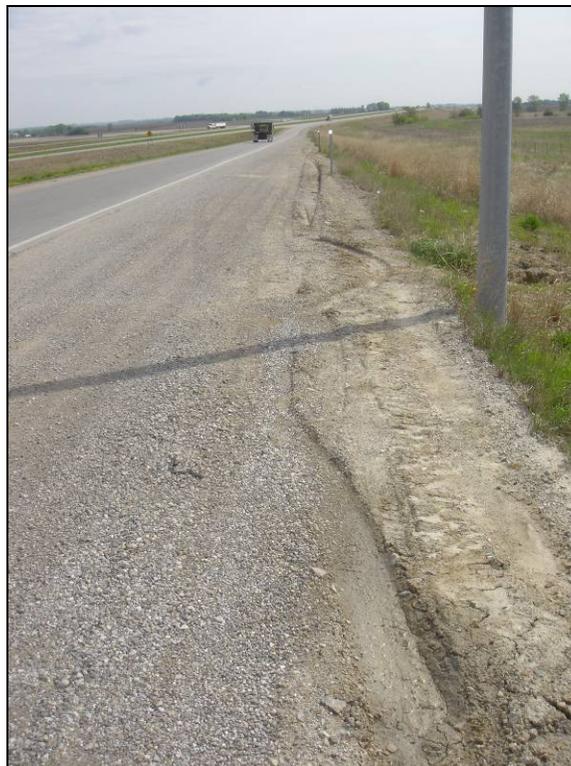
**Figure 39. Shoulder rutting caused by soft subgrade and absence of granular layer on Hwy 65 exit ramp to Hwy 27, May 10, 2006**

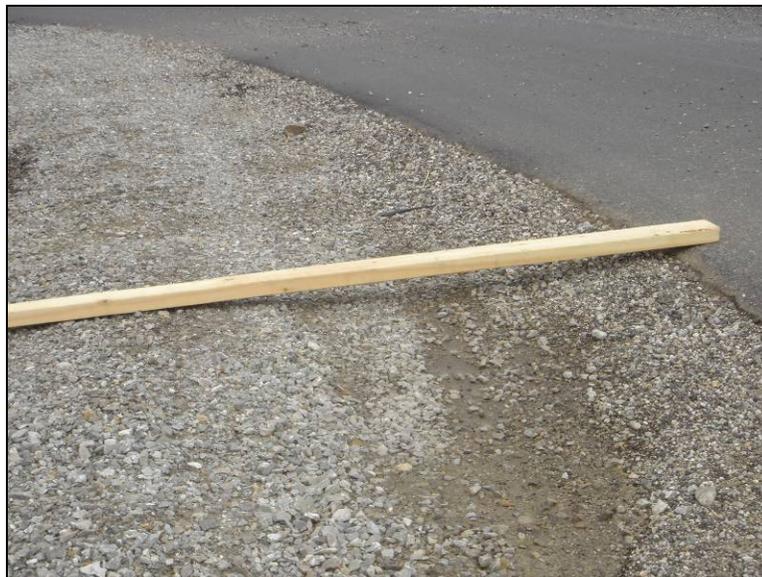
**Figure 44. Cross slope damage at the intersection with Larke Ave. on Hwy 122, July 26, 2005**

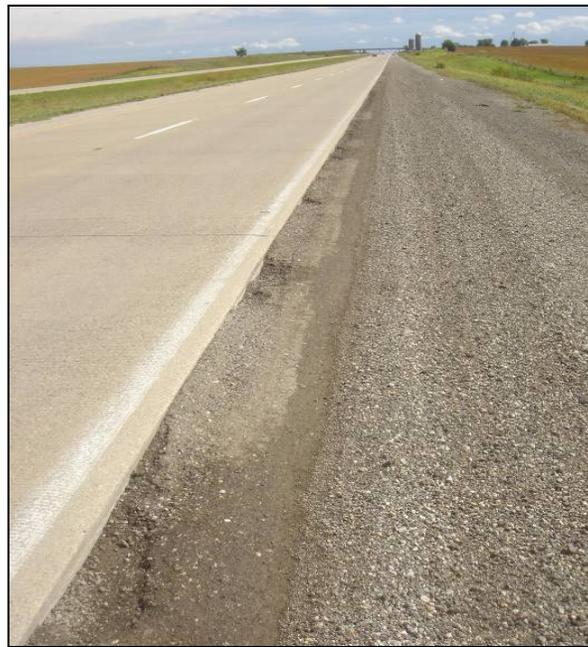
**Figure 47. Granular shoulder section maintained with asphalt millings on Hwy 20 milepost 242 E.B., September 23, 2006**

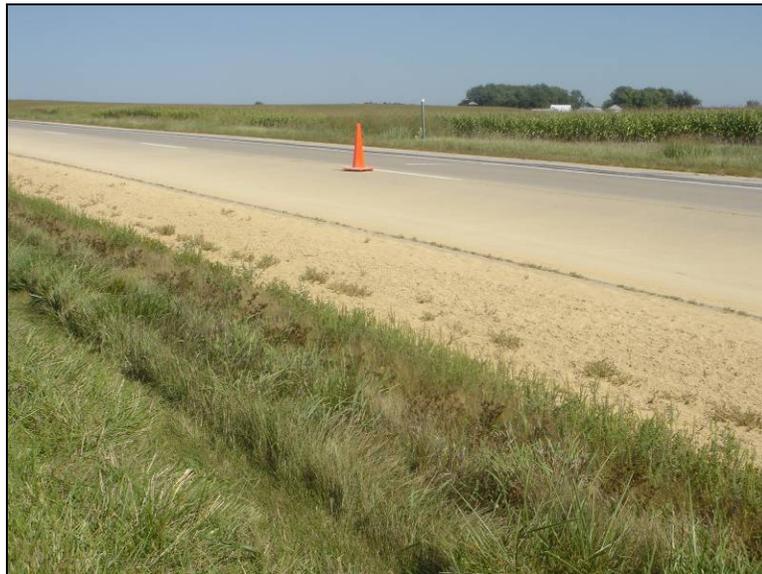
**Figure 95. Fly ash added to the granular material on I-35 milepost 150 northbound, September 1, 2005**

The construction procedures included mixing about 3% to 4% class C fly ash with the granular material prior to placing the FA (Figure 95). Full-depth reclamation of existing shoulder materials with FA and fly ash was conducted to a depth of 10 in. using a reclaimer, as shown in Figure 96. The reclaiming drum was 8 ft. wide. Water was added to the reclaimed foamed asphalt via a water truck that followed the road reclaimer to achieve moisture content near the optimum for compaction. Compaction of the FA was accomplished using a vibratory pad foot followed by a smooth drum roller. Two days after construction, the FA surface was sealed using a seal coat (chip seal), as shown in Figure 97.

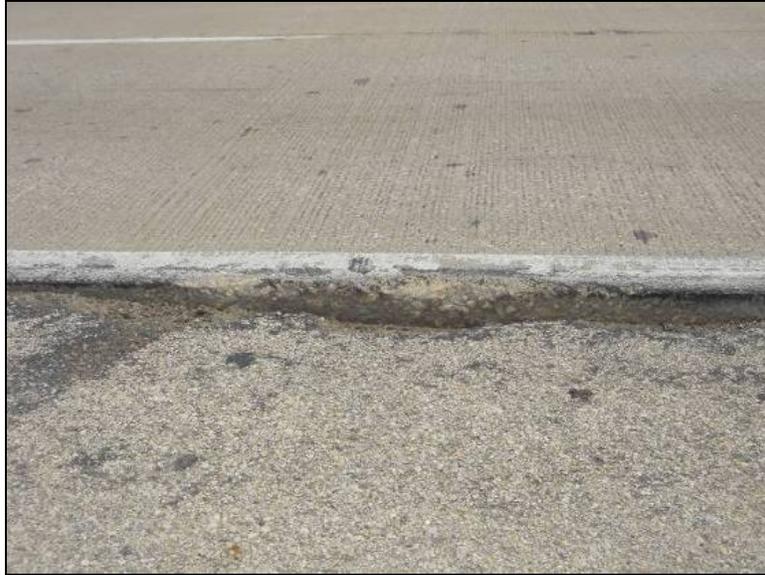
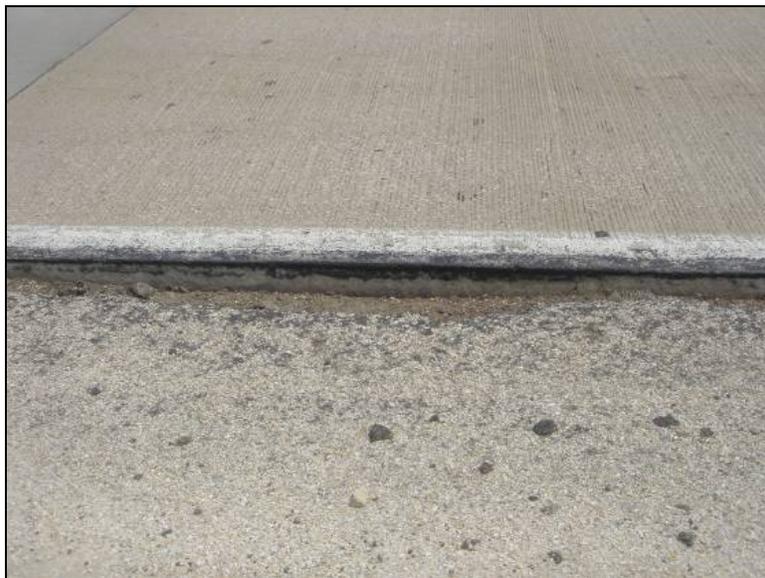
**(a) Milepost 154 southbound**

**(b) Milepost 151 northbound**

**Figure 102. Edge drop-off caused by failure of foamed asphalt-stabilized section, July 25, 2006**

The test section was inspected after 10 months from the reconstruction date. It was observed that the test section failed along the pavement edges. Due to this failure, and as shown in Figure 102, edge drop-offs varying from 3 to 5 in. were formed. Along the horizontal curved road sections (in particular milepost 150, northbound lane), where vehicle off-tracking is likely, edge drop-offs had developed in a number of places. Thus, the area adjacent to the pavement edge was patched, as shown in Figure 103. Foamed asphalt was successful in improving the shoulder's short-term performance, as evidenced by the increase in CBR values. However, this stabilization technique failed to withstand loads imposed by off-tracking vehicles at the pavement edge. Inspection of the seal coat after 12 months from reconstruction did not result in any indications of seal coat failure, such as delaminating or substantial snow plow damage.

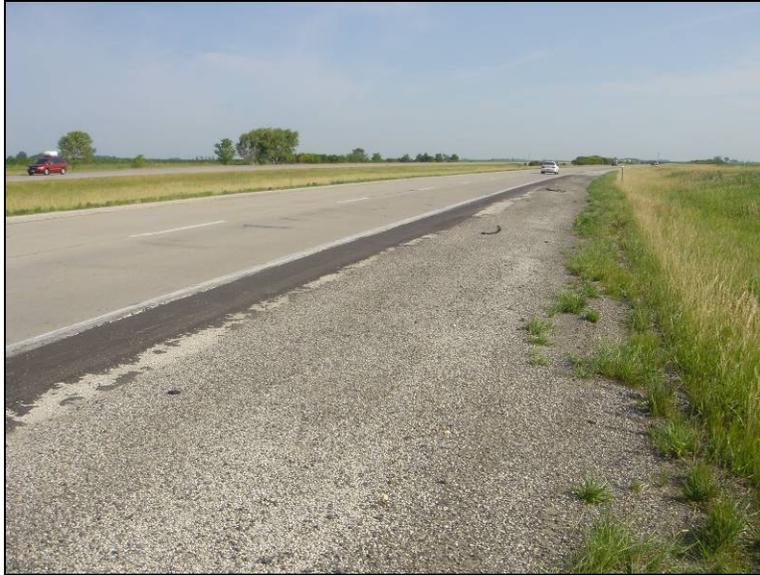
**Figure 103. Asphalt patch placed on the deteriorated shoulder adjacent to a horizontal curve, I-35 milepost 150 northbound, July 7, 2006**

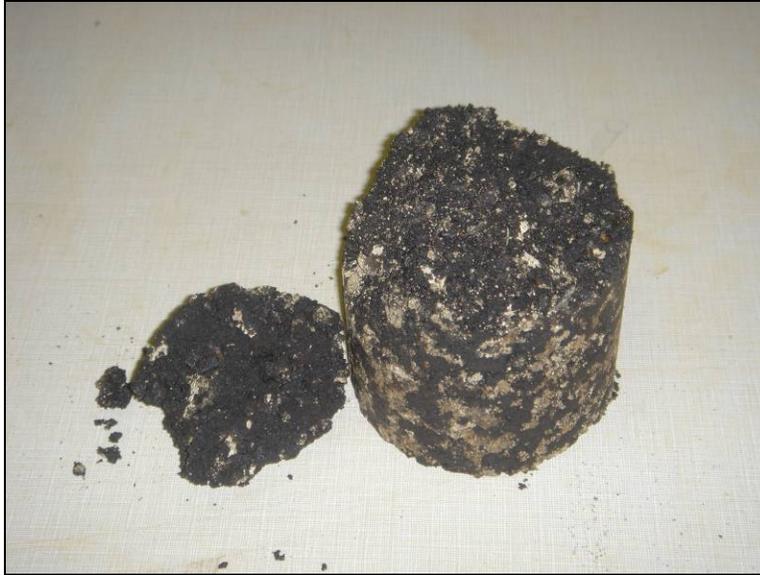
**Figure 105. Failure of foamed asphalt stabilized sample during wet-dry testing**

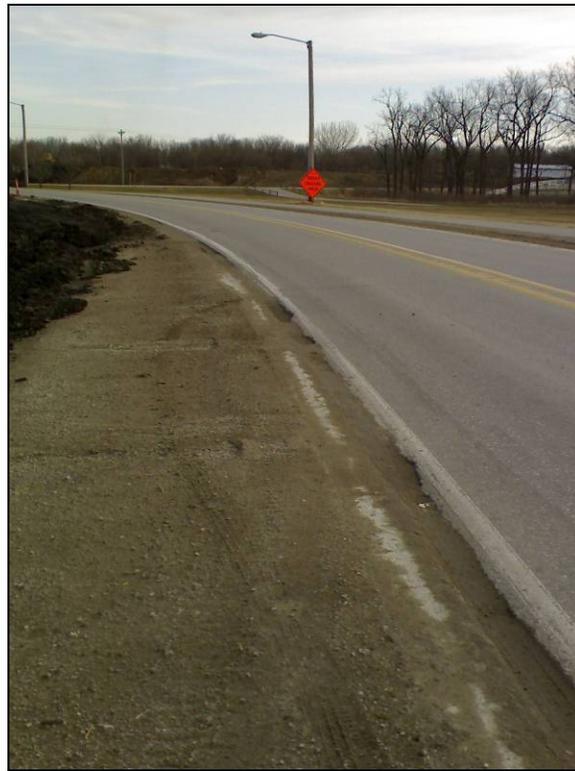
**Figure 130. Significant edge drop-off observed after four months on 16th St. Ames, IA, December, 2007**

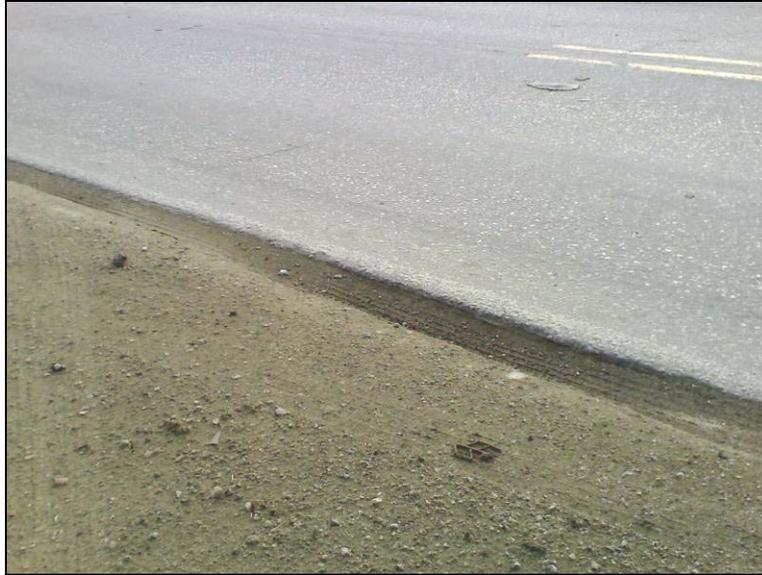
**Figure 131. Three-inch edge drop-off adjacent to pavement after eight months, May 18, 2007**

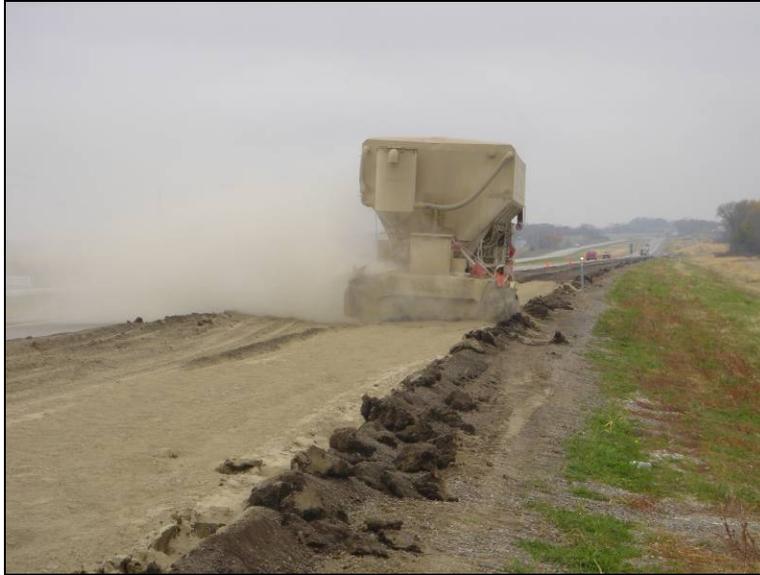
**Figure 148. Semi trailer bottom dump truck spreading fly ash on top of subgrade layer, October 31, 2005**

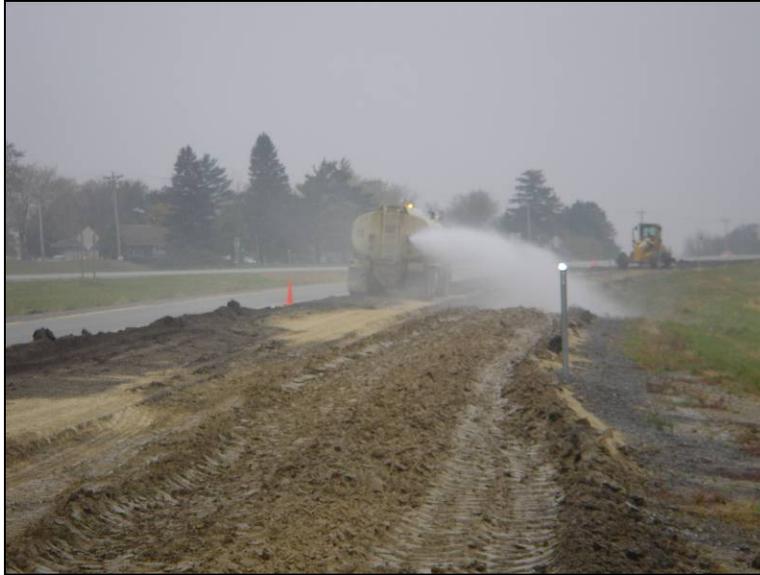
**Figure 150. Water truck used to increase moisture content of clay-fly ash mixture, October 31, 2005**

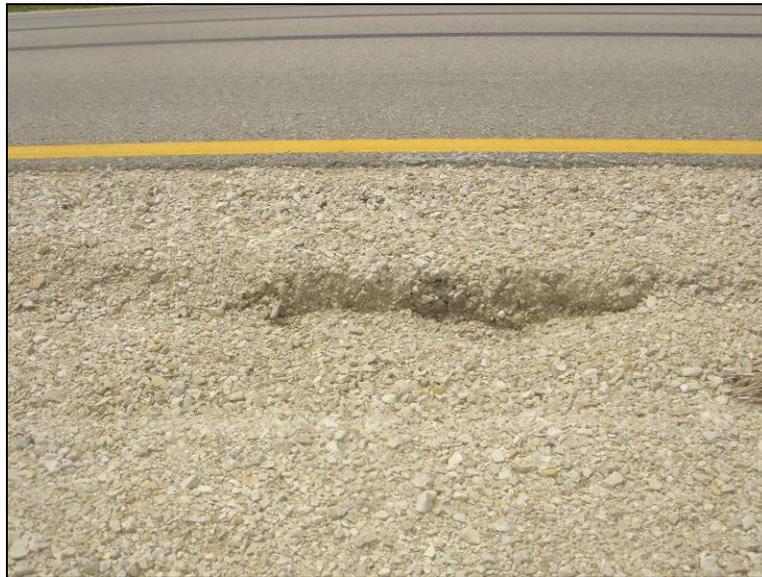
**Figure 181. Development of shoulder rutting one month after shoulder construction, July 25, 2006**
