Strengthening of an Existing Continuous-Span, Steel-Beam, Concrete-Deck Bridge by Post-Tensioning

Iowa Department of Transportation

College of Engineering Iowa State University

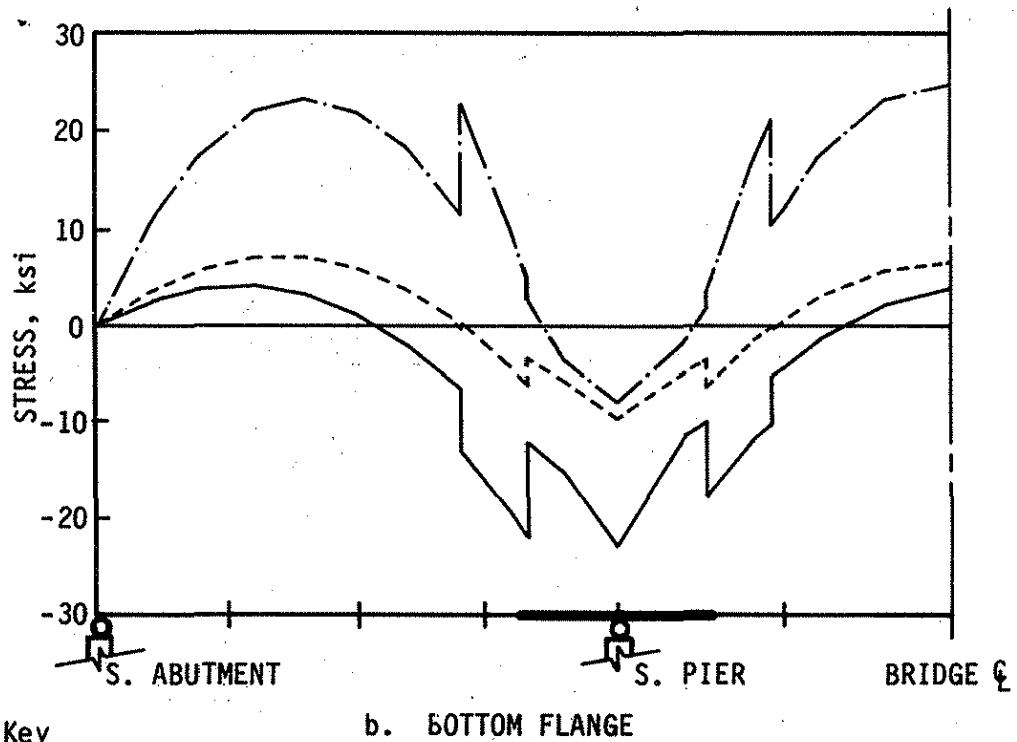
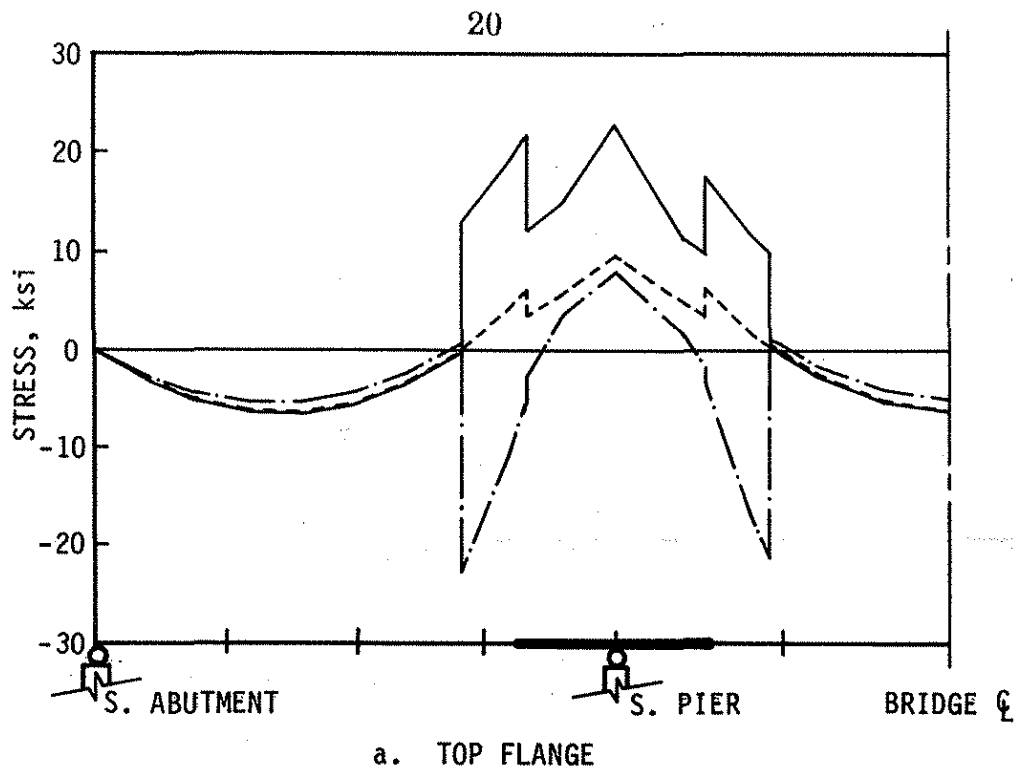
Fig. 2.4. Exterior beam stress envelopes for unstrengthened bridge.

Excluding loads from a possible future wearing surface, flexural stress envelopes for top and bottom flanges of an exterior beam are given in Fig. 2.4. For A7 steel, the maximum allowable inventory stress, except for laterally unsupported regions with compression stress reductions, is 18 ksi. Figure 2.4a shows overstresses within the short regions, sections D-F and H-J, and near

Without the future wearing surface, the maximum allowable operating stress for A7 steel, 24.75 ksi, is exceeded only at section L, and that amount of overstress requires posting of the bridge. With the wearing surface, the operating stress would be exceeded at additional sections. Stress envelopes for an interior beam are similar but less critical than those for the exterior beam.

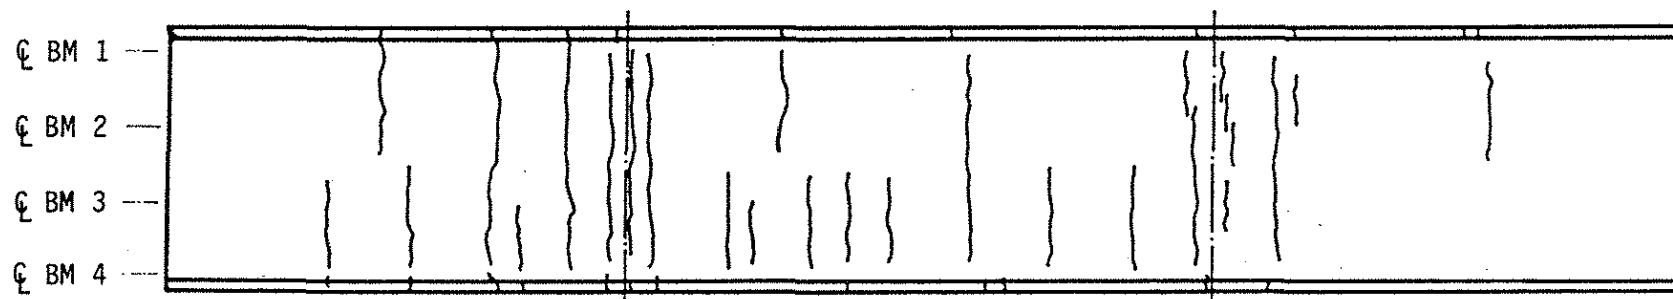
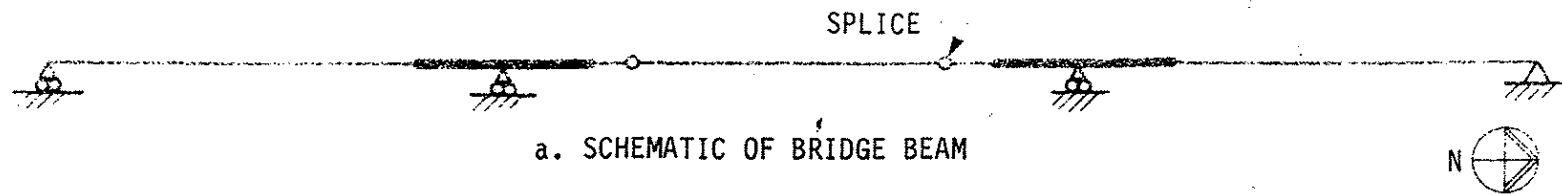
## Deck Crack Patterns, Fonda Bridge

After the initial post-tensioning was applied to the Fonda bridge in August 1988, the bridge was inspected several times before the post-tensioning was removed and re-applied in June 1989. It was apparent from the deck crack pattern in September 1988 that the deck had cracked since the post-tensioning was applied. (See Appendix C for deck crack patterns for the Fonda bridge and Appendix D for deck crack patterns in the single-span bridges previously strengthened [4,26].) The deck continued to crack and, in June 1989, the total estimated crack length was more than double the crack length in the bridge deck before post-tensioning. The cracks additionally were distributed throughout the deck rather than being concentrated over the piers and in the east lane of the center span.

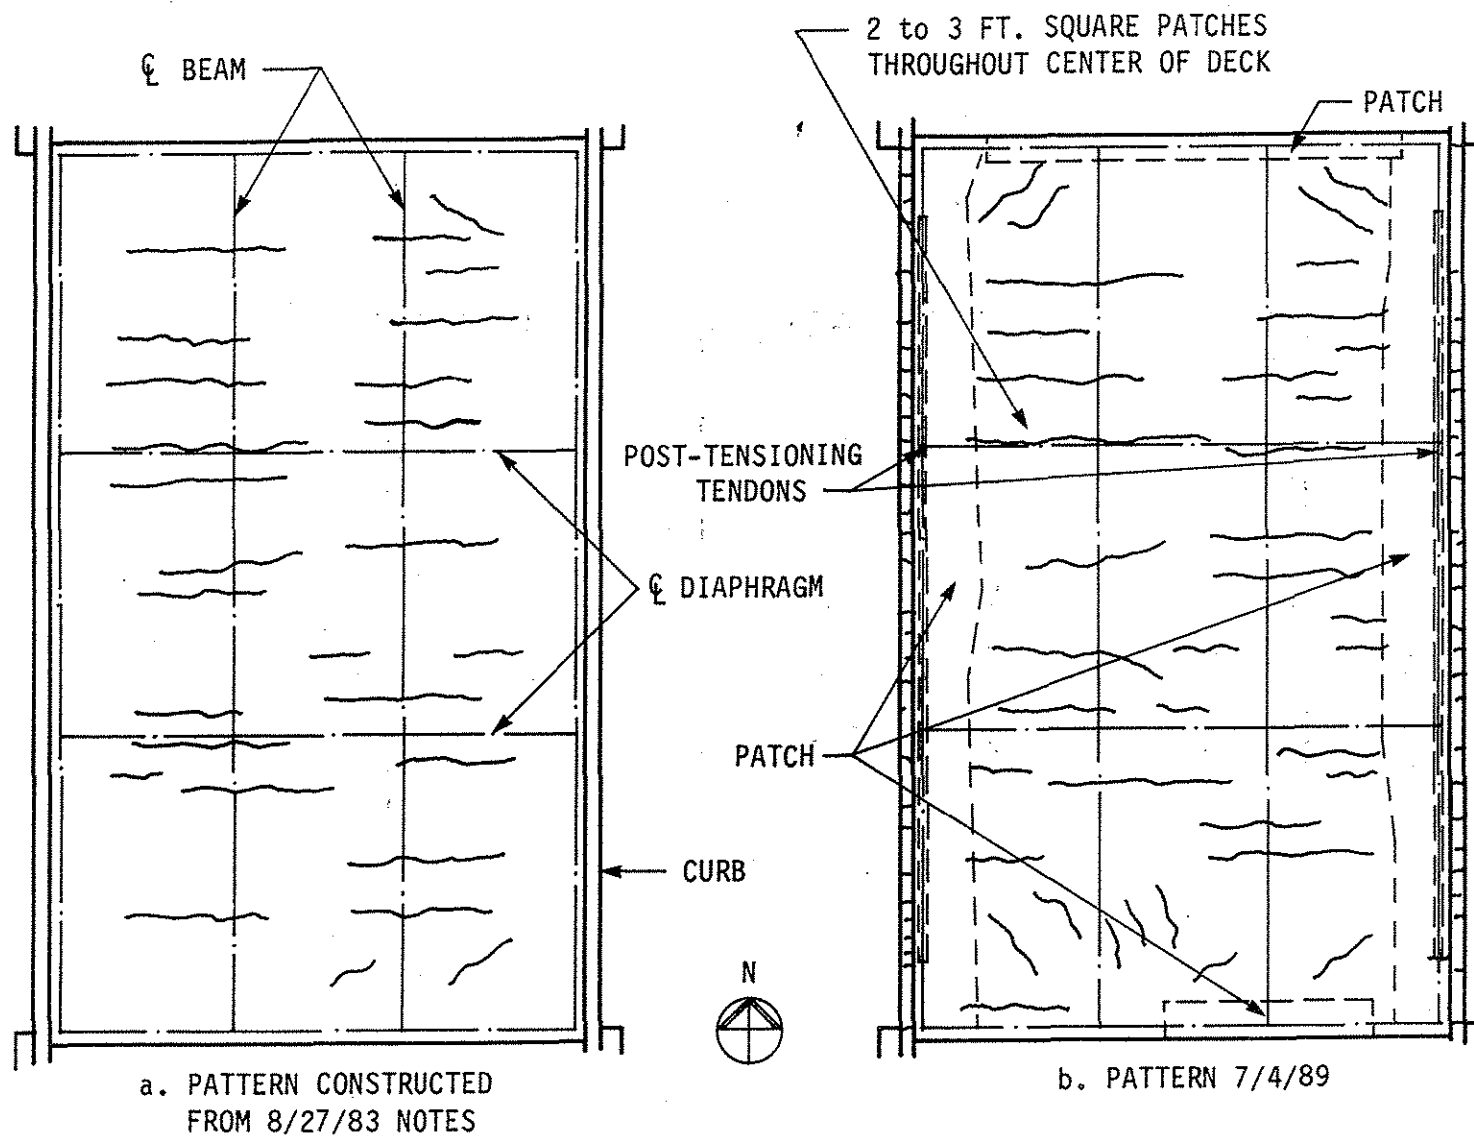
Fig. D.1   Deck crack patterns, bridge no. 1, Terril, Iowa.

Observation of the existing deck and curb cracking patterns of the post-tensioned and unstrengthened single-span bridges suggests that post-tensioning causes moderate cracking of the bridge deck. If the deck is resurfaced using the Iowa high-density concrete overlay process, it apparently is not subject to significant cracking caused by post-tensioning. Either old or new curbs are subjected to significant cracking caused by post-tensioning.

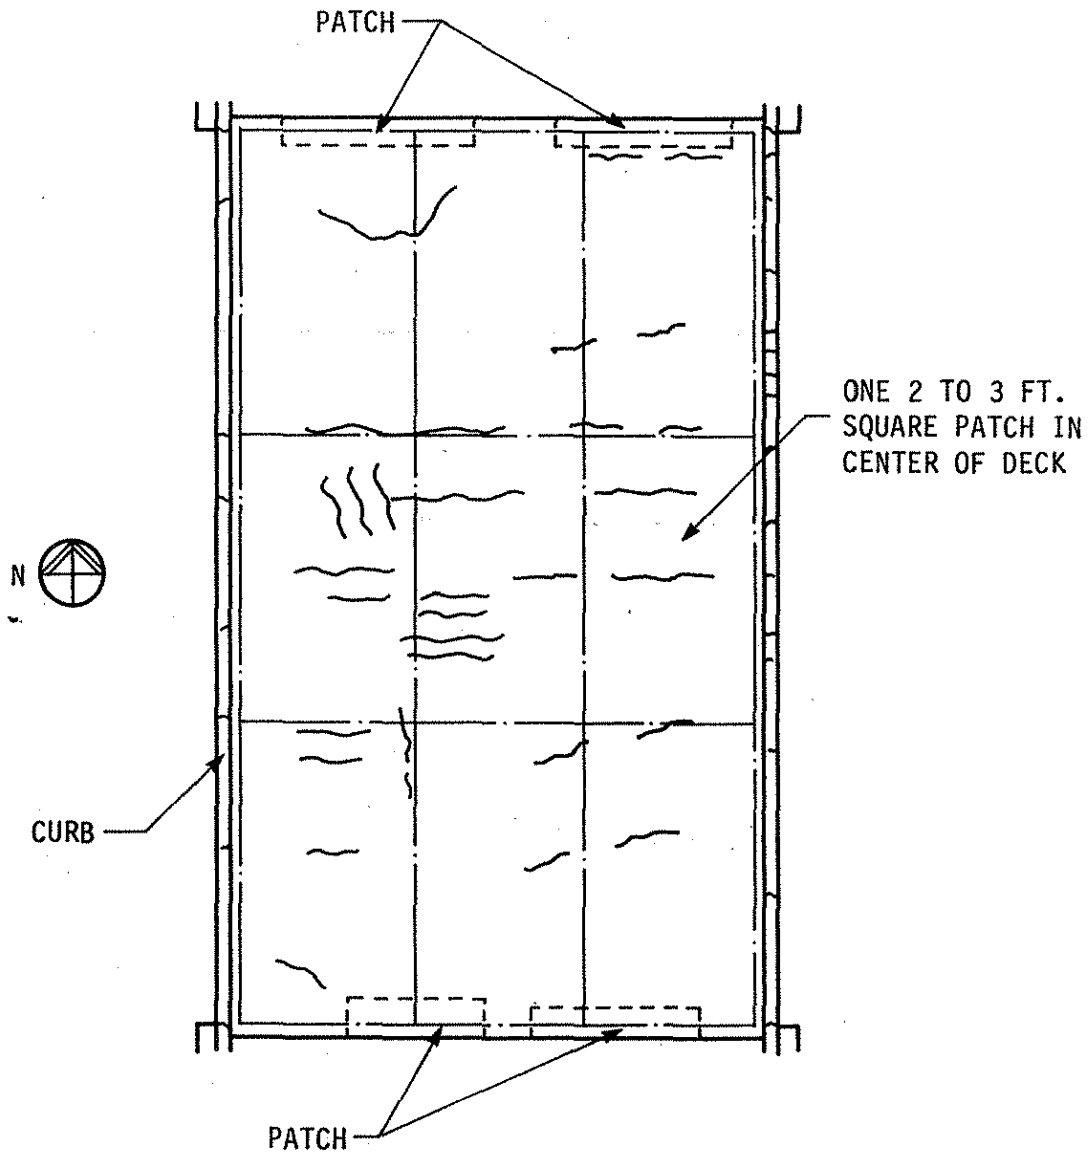
Fig. D.2. Deck crack pattern, bridge 0.7 miles
north of bridge no. 1, 7/4/89.

ONE 2 TO 3 FT.
SQUARE PATCH IN

CENTER OF DECK
