USE OF LONGITUDINAL SUBDRAINS IN THE 3R PROGRAM

Progress Report #2
Project HR-509

Highway Division
January 1981

PROGRESS REPORT #2
FOR
PROJECT HR-509

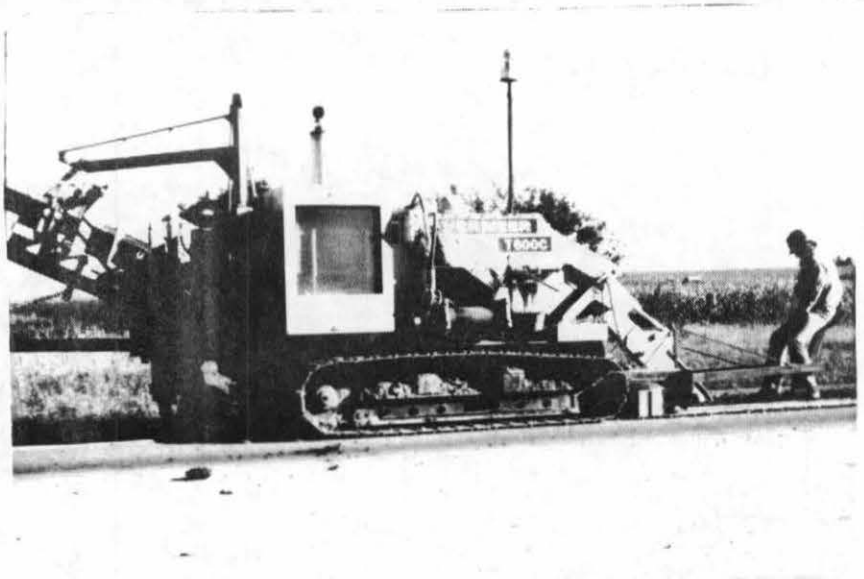
The first operation utilized a Vermeer T-600C (Figure 1) trencher to cut the one foot wide, 2 foot deep trench. Initially, this trencher was equipped with a disc cutter wheel (Figure 2) to aid in maintaining proper alignment. Later, this was of questionable benefit. The trencher cut very neat side walls and alleviated some initial concern that chunks might be torn from the asphalt concrete shoulder surfacing. It was, however, relatively severe to the trencher's cutting teeth.

Figure 1: Vermeer T-600C Trencher

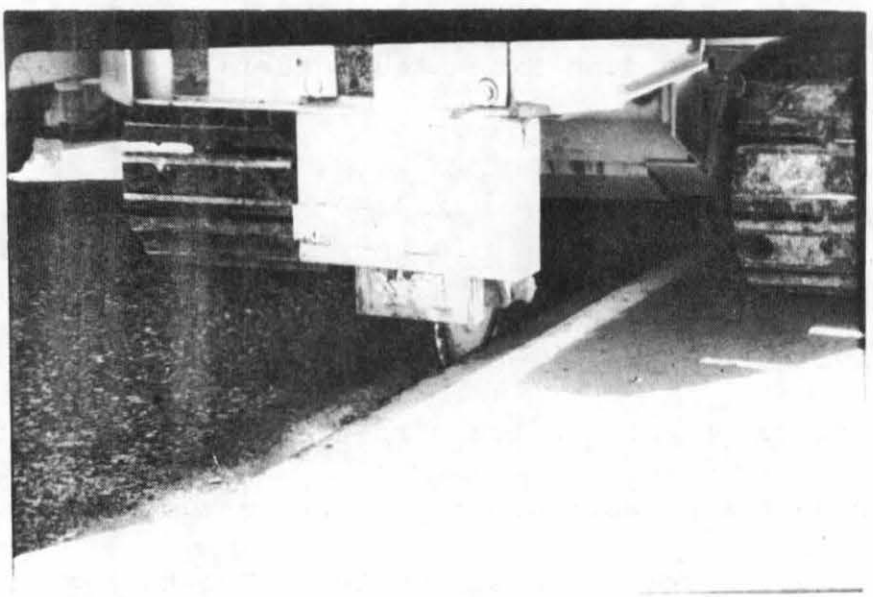
Figure 2: Disc Cutter Wheel to Aid in Alignment

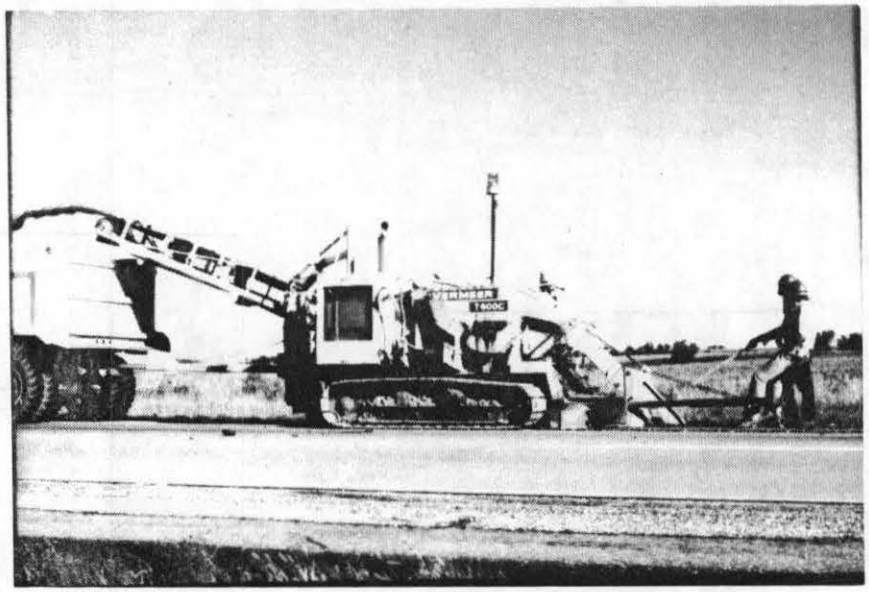
Figure 3: Loading Excavated Material

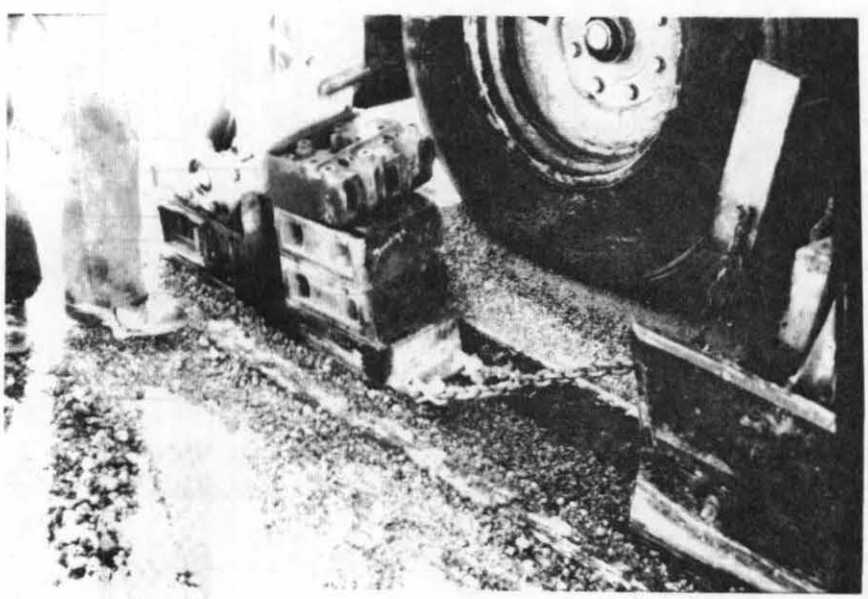
Figure 6: Vibrating Pan Compaction of Porous Backfill

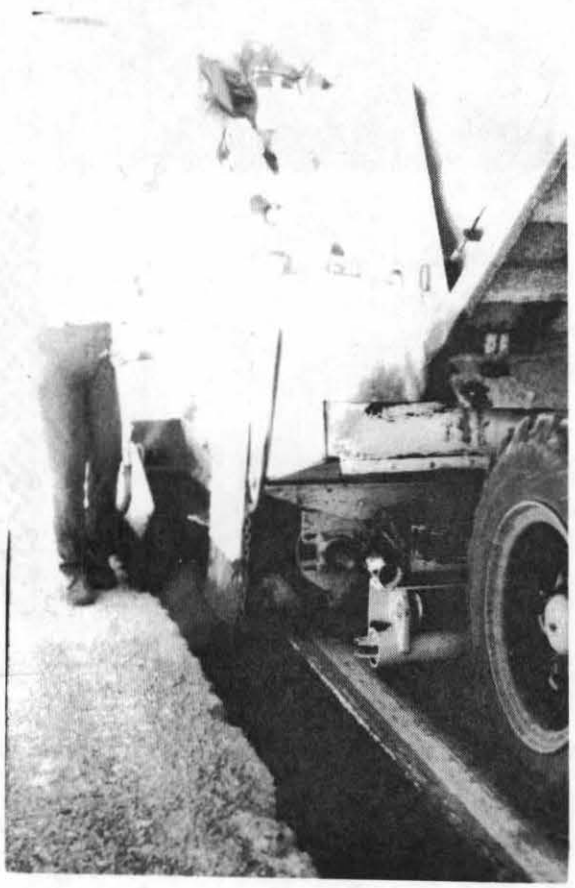
Figure 7: Placing Asphalt Concrete with Blawknox RW-38

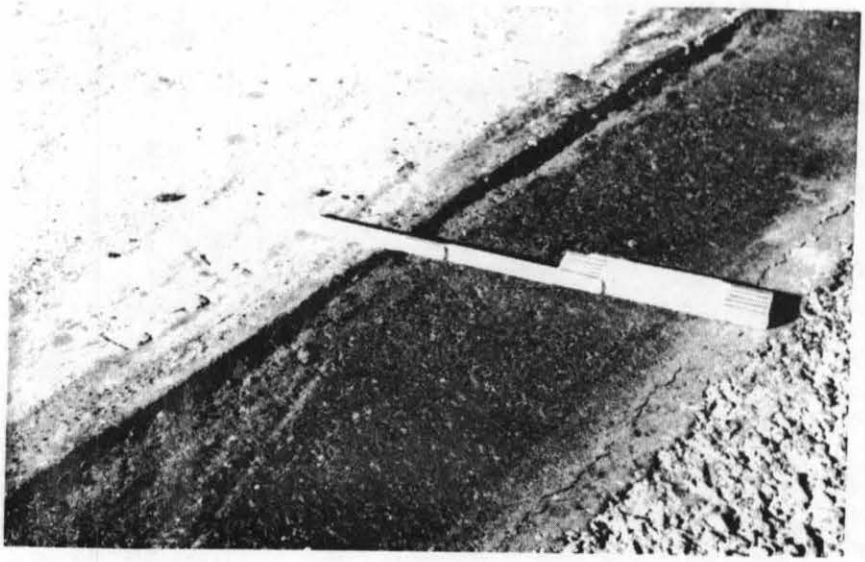
Figure 8: Finished Trench Prior to Cover Aggregate Placement

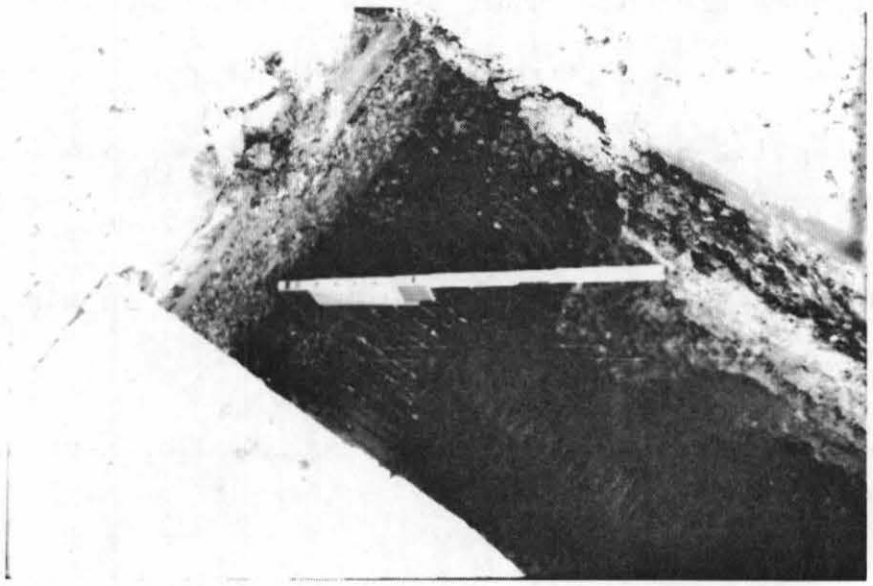
Figure 9: Preformed T for Outlet

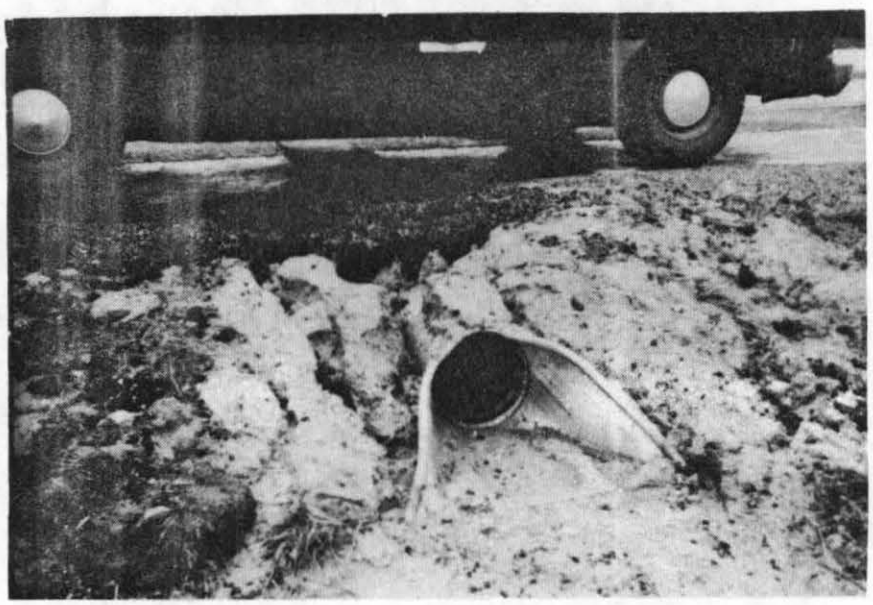
Construction was not completed during 1978. Another problem was recognized in the early spring of 1979. The RF-22 outlets froze shut during the winter period. Early spring flow from the subdrains eroded the earth fill around the RF-22 outlet (Figure 11). This problem was solved by carrying the porous backfill the total length of the RF-22 outlet.

Figure 11: Erosion Around the RF-22 Outlet

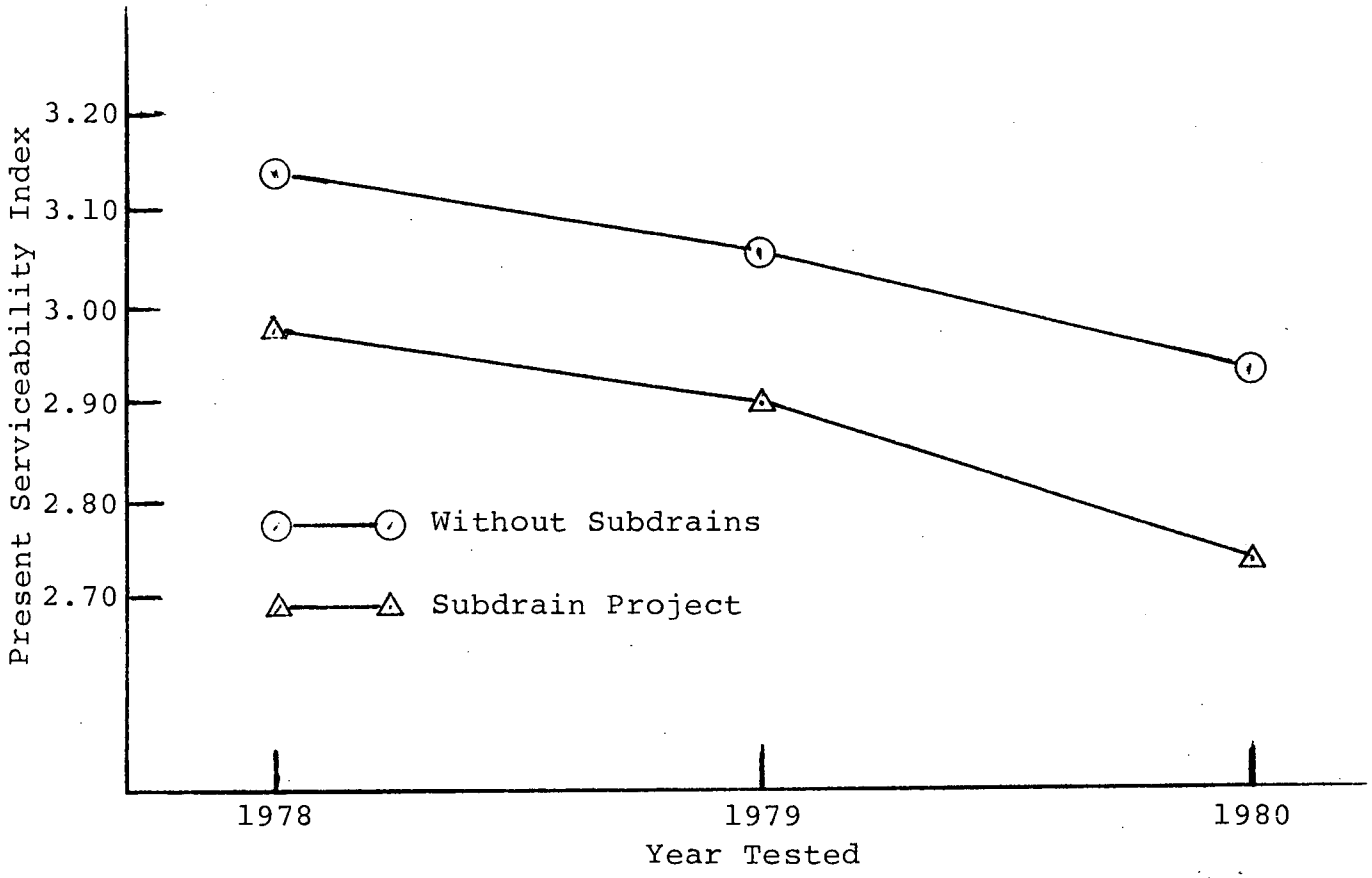
The graphical plot of PSI in figure 12 indicates no significant change in the rate of pavement deterioration when compared to an adjacent section of pavement without longitudinal subdrain installation.

FIGURE 12 - PAVEMENT DETERIORATION

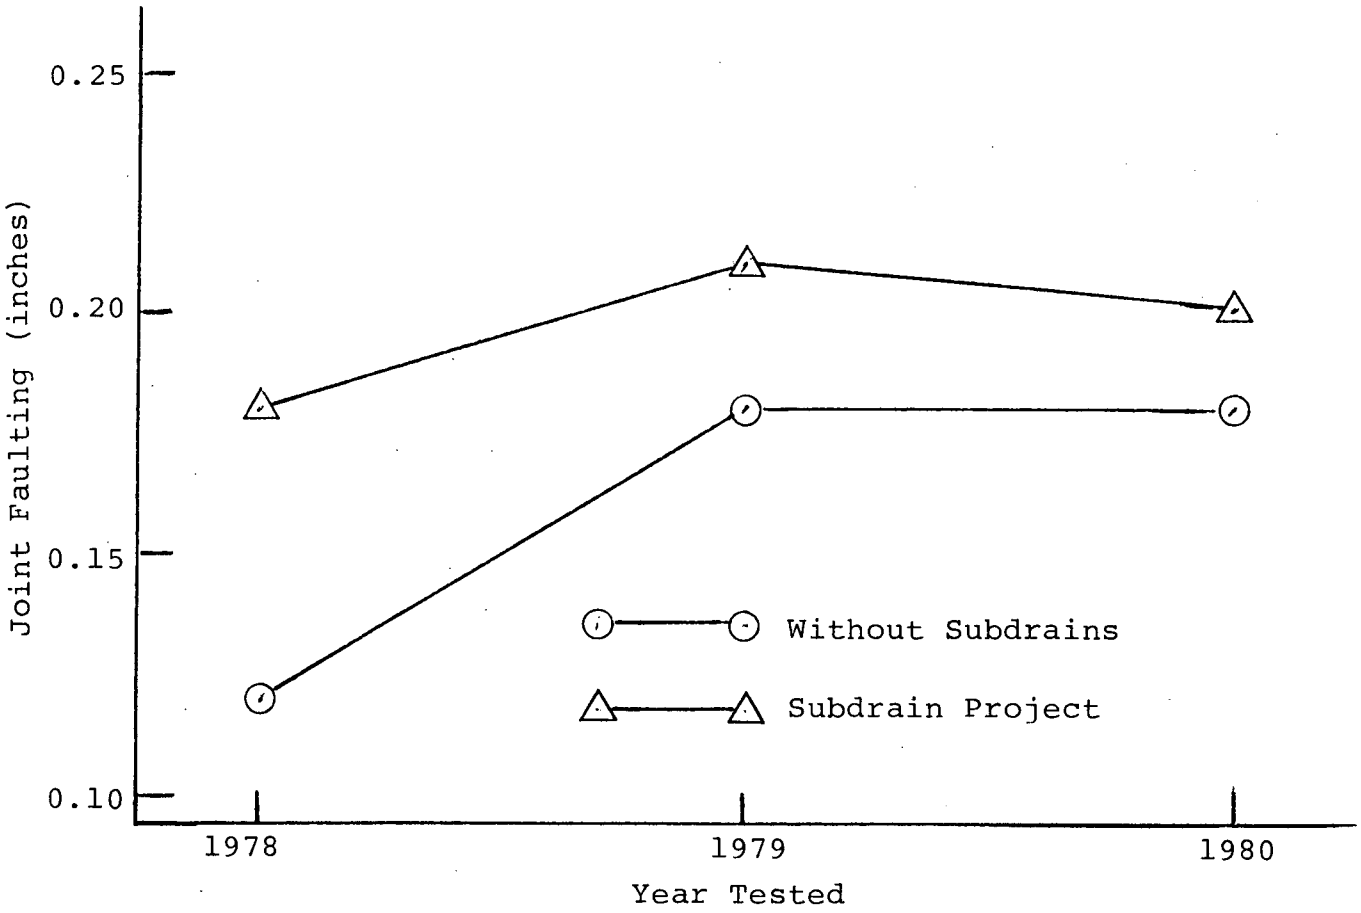
Again, a graphical plot (figure 13) does not indicate significant difference between the pavement within the subdrain project and the adjacent pavement without subdrains. The data would indicate a decrease in the rate of joint faulting for both the subdrained and the comparison section. Because the rate change is similar for both, weather or temperature variations may account for the difference.

FIGURE 13 - JOINT FAULTING
