**AN INVESTIGATION
OF THE
INTERSTATE 80 RUTTING
IN
ADAIR COUNTY**

October 1983
Highway Division

**Iowa Department
of Transportation**

BY
VERNON J. MARKS
515/239-1447

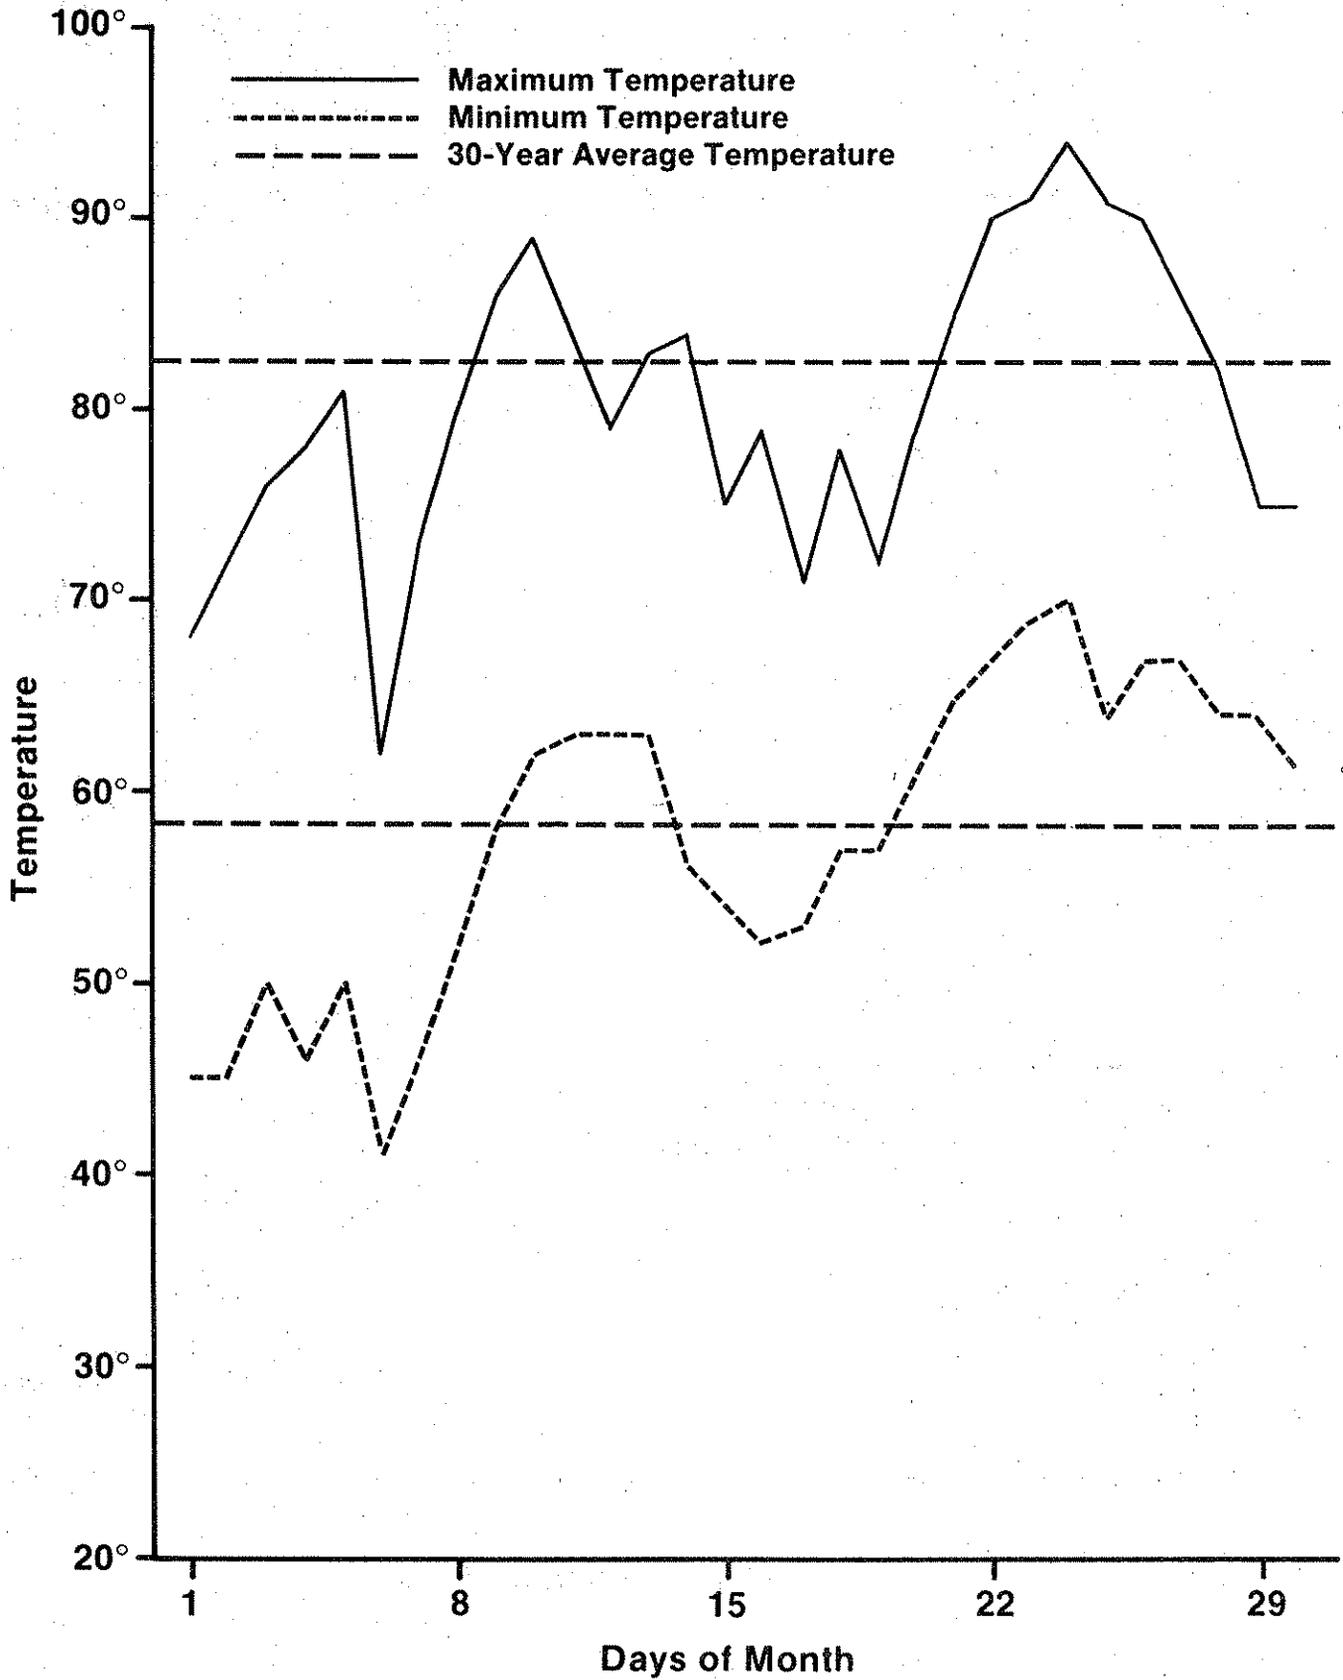
CLIMATOLOGICAL DATA I-80 ADAIR COUNTY JUNE 1983

The 1983 ambient temperatures were extremely high from June 20 through September 10.
