IOWA STATE HIGHWAY 92 OVER DRAINAGE DITCH #25

Performance Evaluation Galvanized Reinforcing Bars

Louisa County, Iowa

June 15, 2015

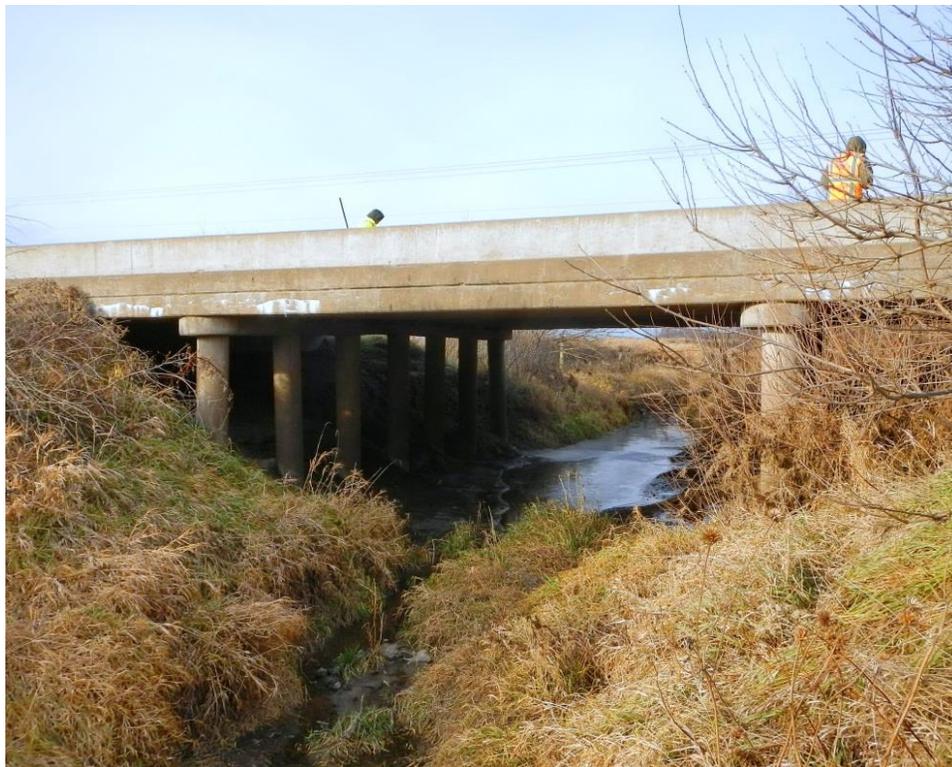
Figure 1.2. South elevation of subject bridge.

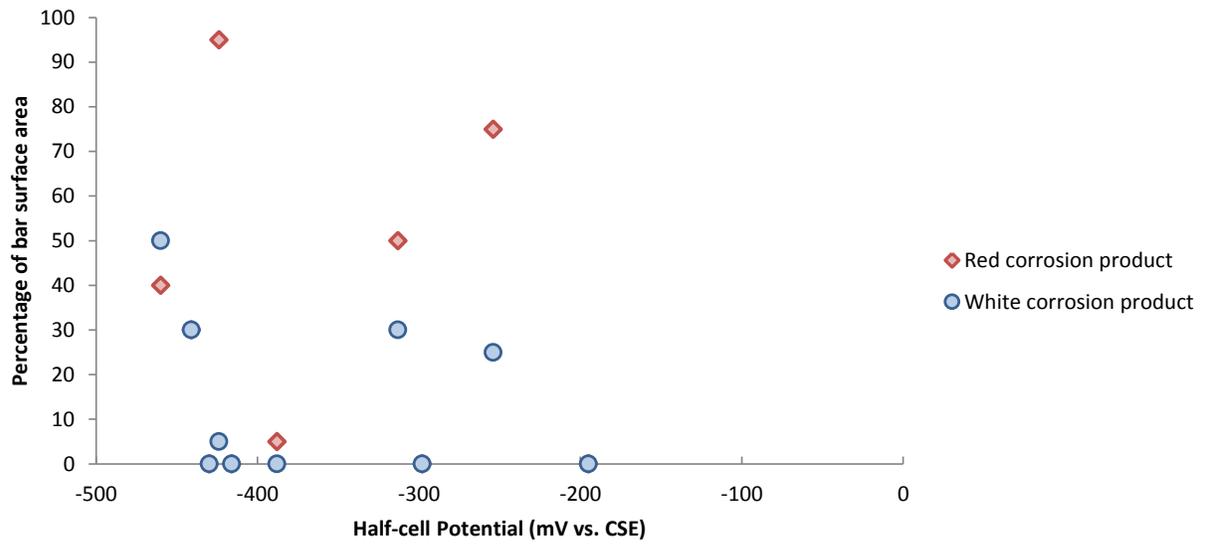
To determine if the half-cell potentials could be used to identify the condition of the galvanizing for the embedded reinforcing, the corrosion state for each core was plotted versus the measured potential at that location (see Figure 3.9), as determined by the rolling wheel contour map. The corrosion state was considered as the percentage of corrosion product on the bar for both white corrosion product (zinc corrosion) and red corrosion product (steel corrosion). The plot shows that no clear relationship was evident between the corrosion product on the bar and the measured half-cell potential.

Figure 3.9. Relationship of half-cell potential to corrosion product observed on extracted bar sample.

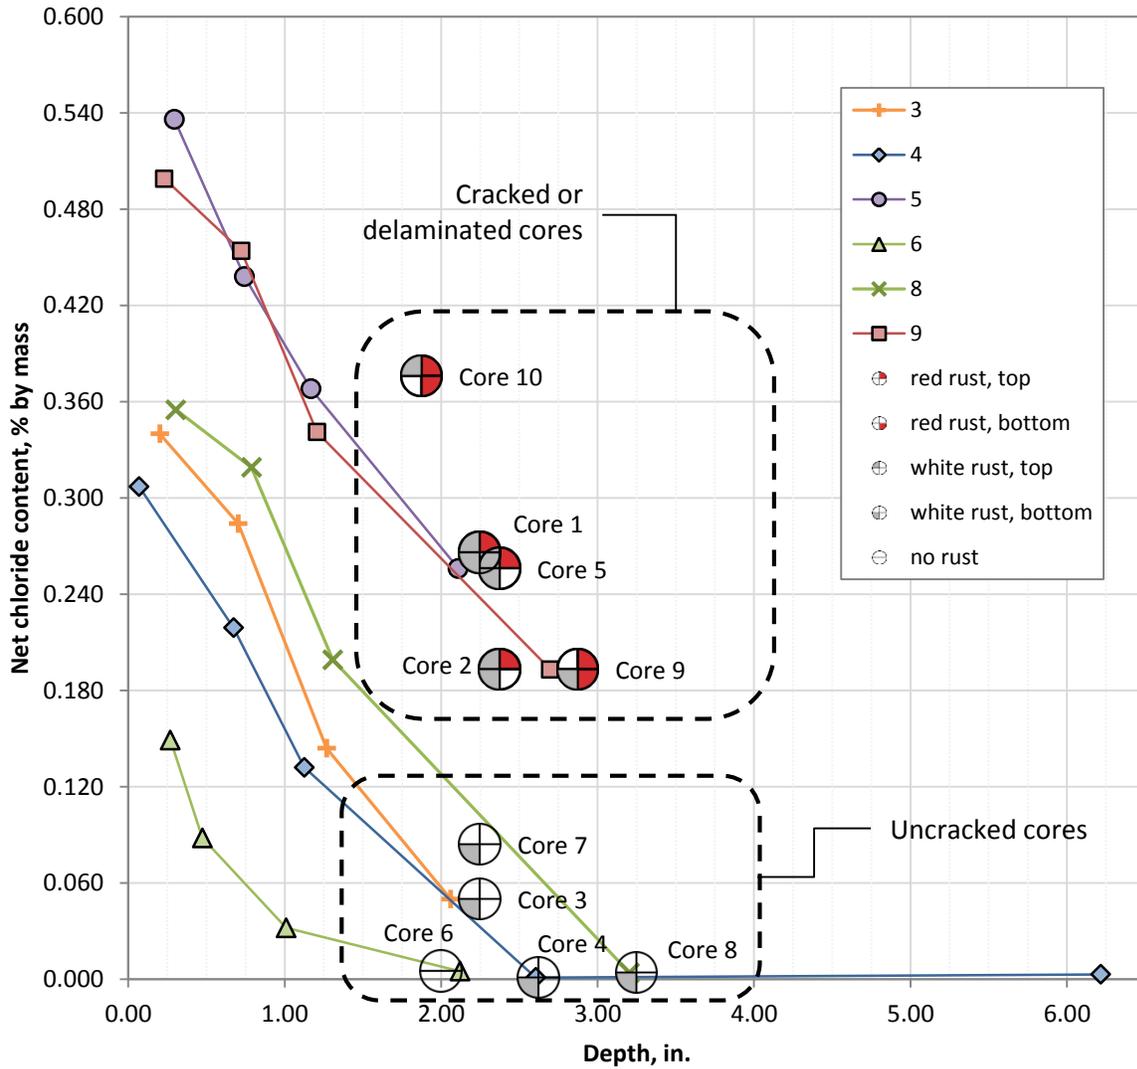
Figure 3.10. Chloride content profiles with depth for 6 cores. Chloride content at bar depth is also shown for all 10 cores. The corrosion state of extracted bars is indicated by the symbol shown for each core, where a colored indication (grey or red) denotes that 10 percent or more of the bar exhibited white or red rust. Lines for the chloride profiles do not pass exactly through the bar designation for each core, because the actual position of the slice varied slightly relative to the top of the bar.

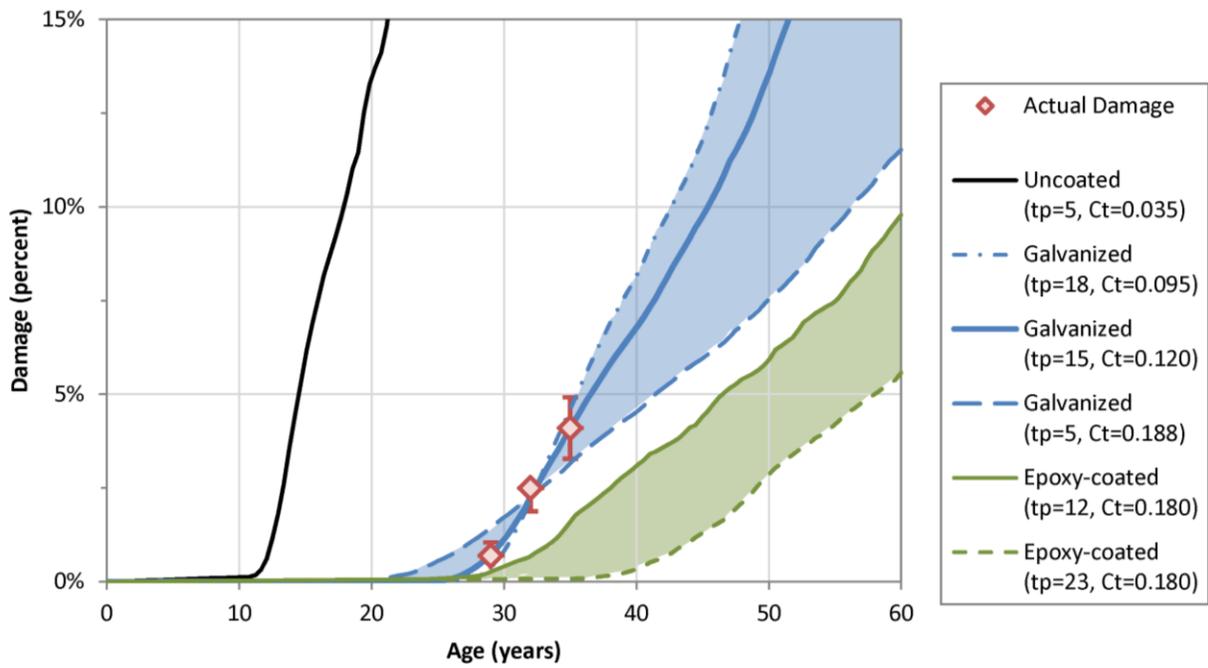
The predicted damage evolution for galvanized bars in Figure 4.3 shows generally good agreement with the damage history for all three modeled cases, considering the uncertainty outlined above, when the assumed chloride thresholds (representing the lower bound, “best estimate” and upper bound based on the laboratory investigation) are paired with the appropriate propagation time (i.e., when the lower threshold is paired with higher propagation time and vice versa). Because the selected chloride threshold effectively controls the slope of the damage curve, chloride thresholds outside the upper and lower bounds found by the laboratory studies would not fit the measured progression of damage.

Figure 4.3. Results of service life model for bridge. (Propagation time (t_p) is given in years, and chloride threshold (c_t) is given in percent by weight of concrete.)

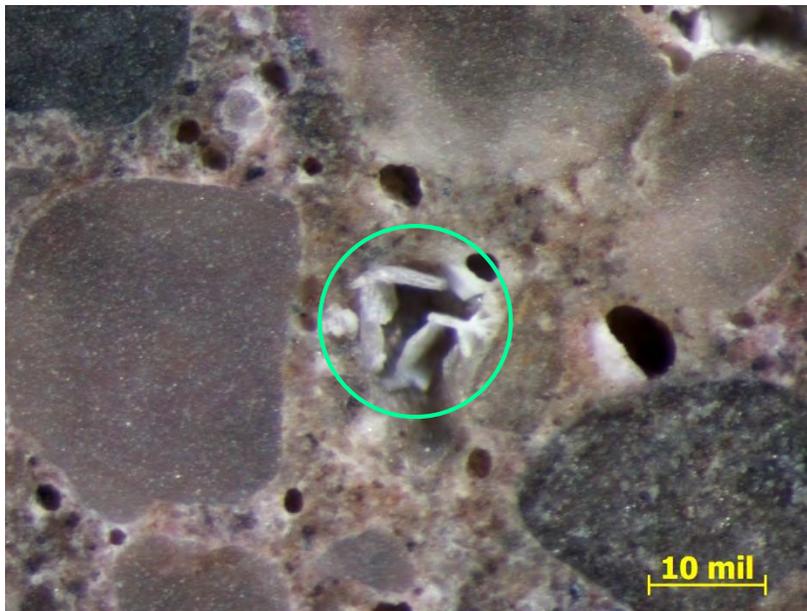
Small amounts of secondary mineral deposits, mainly calcium hydroxide, some ettringite, and possibly deicing salts, were detected inside some air-voids only in the top ¼ inch of the concrete (Fig.4). This suggests that the concrete from this particular area is moderately dense or was not subjected to a lot of moisture.

Figure 4. Lapped surface just below the top of Core 8 showing secondary deposits of calcium hydroxide inside an air void (encircled).

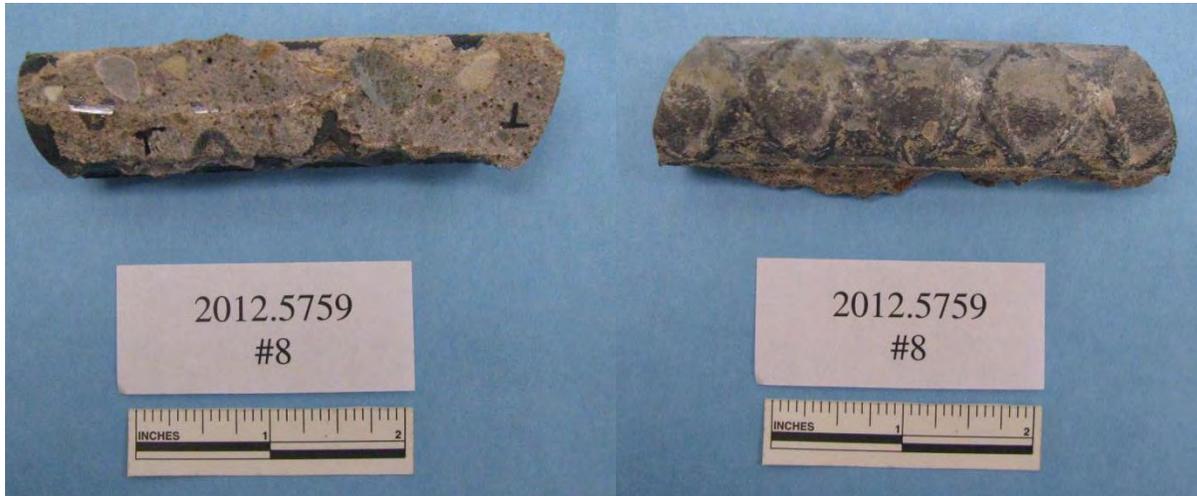
The bottom surface of Sample 8 has areas of both light green-gray shiny surface and dark gray surface. White deposits are present in limited areas. The top surface of the bar is uniform dark gray indicating the absence of corrosion. Light white discoloration may indicate minor surface corrosion of the bottom side of the bar. Photographs and micrographs of the sample are provided in Figure 1 through Figure 3.

Figure 1. Sample 8. Top side (left) and bottom side (right).

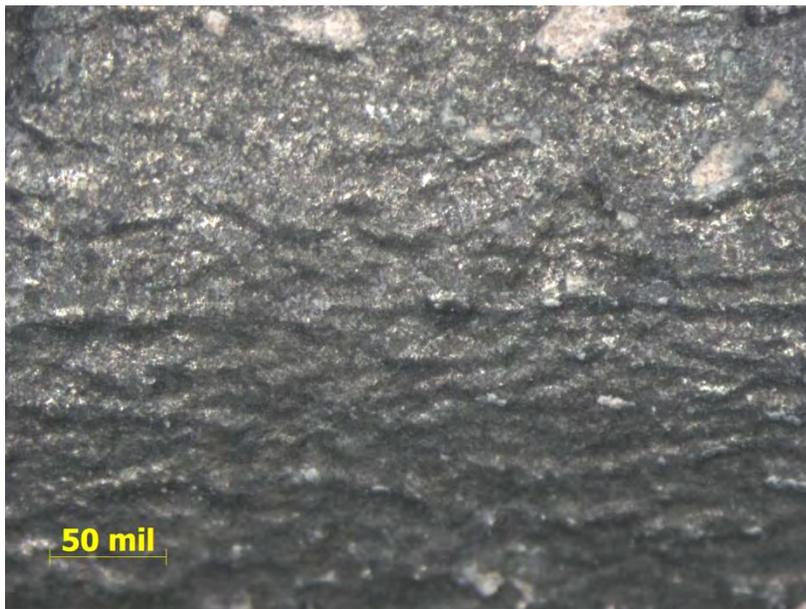
Figure 2. Micrograph of the top side of Sample 8. Note the uniform dark surface.

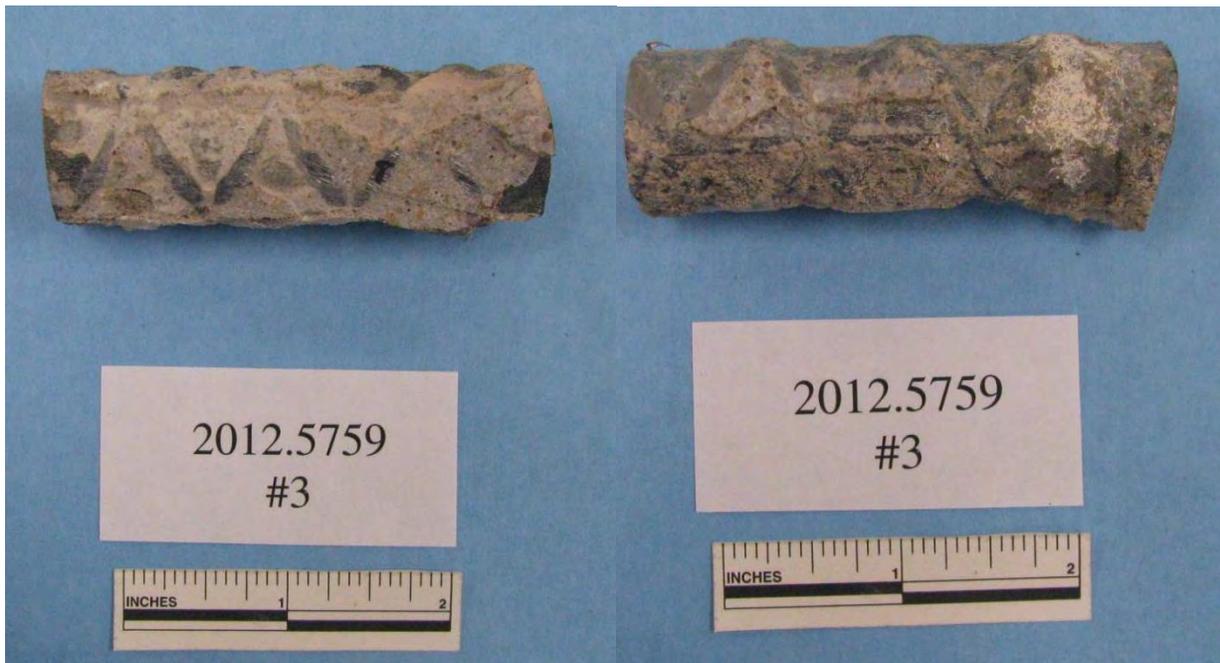
The surface of Sample 3, where not covered with adherent concrete, was light gray, shiny with a metallic appearance on the bottom of the bar. White deposits were present in one area of the bottom of the bar indicative of zinc surface corrosion. The top of the bar had a darker gray appearance with the absence of notable corrosion. Photographs and micrographs of the sample are provided in Figure 4 through Figure 7.

Figure 4. Sample 3. Top side (left) and bottom side (right).

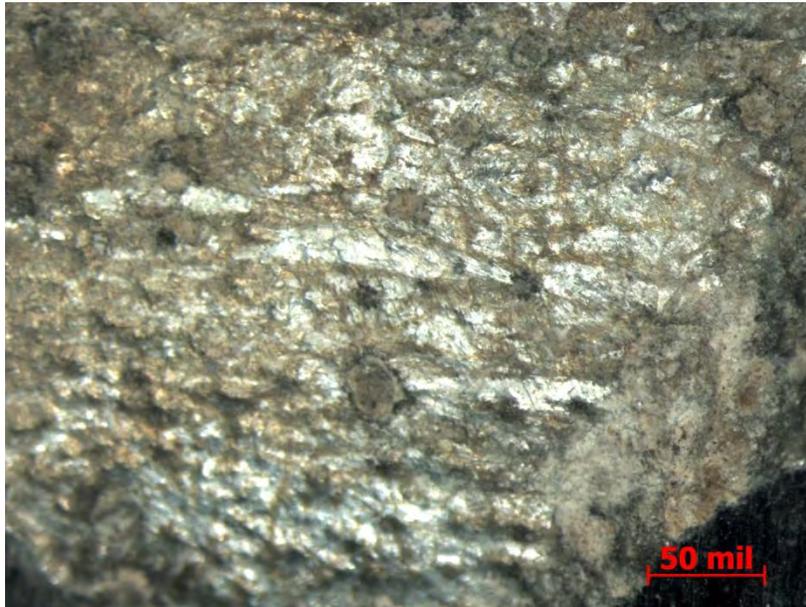
Figure 5. Micrograph of the bottom of Sample 3, showing the gray shiny surface.

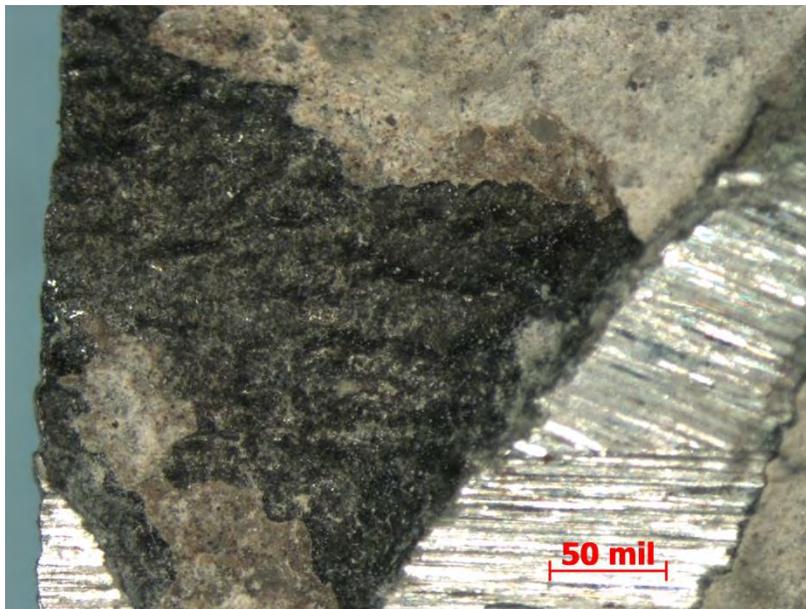
Figure 6. Micrograph of the top surface of Sample 3, showing the gray surface. The lighter color material on the surface is residual concrete.

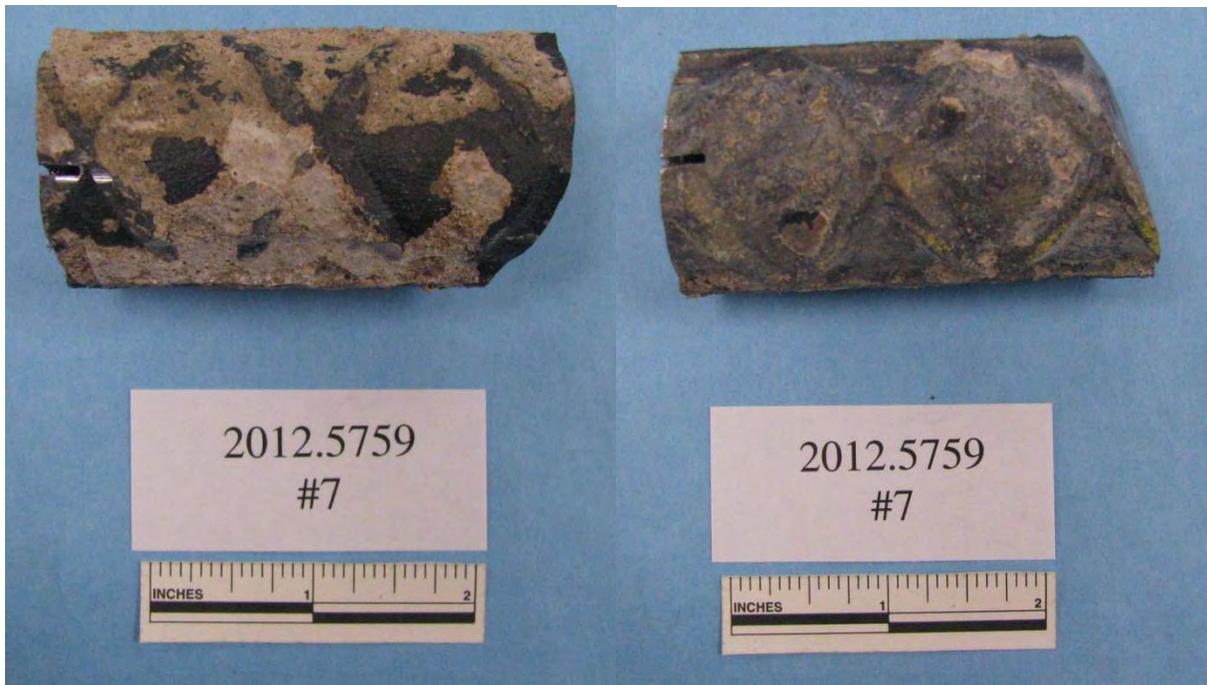
The bottom surface of Sample 7 was lighter in color than the top surface. The appearance ranged from light gray to slightly green and shiny, to spots of white deposit, and a few spots of yellow-green deposit. Surface corrosion of the zinc is likely along the bottom surface of the bar. The top surface had more adherent concrete, but where the bar was exposed, was a uniform dark gray and corrosion was absent. Photographs and micrographs of the sample are provided in Figure 8 through Figure 12.

Figure 8. Sample 7. Top side (left) and bottom side (right).

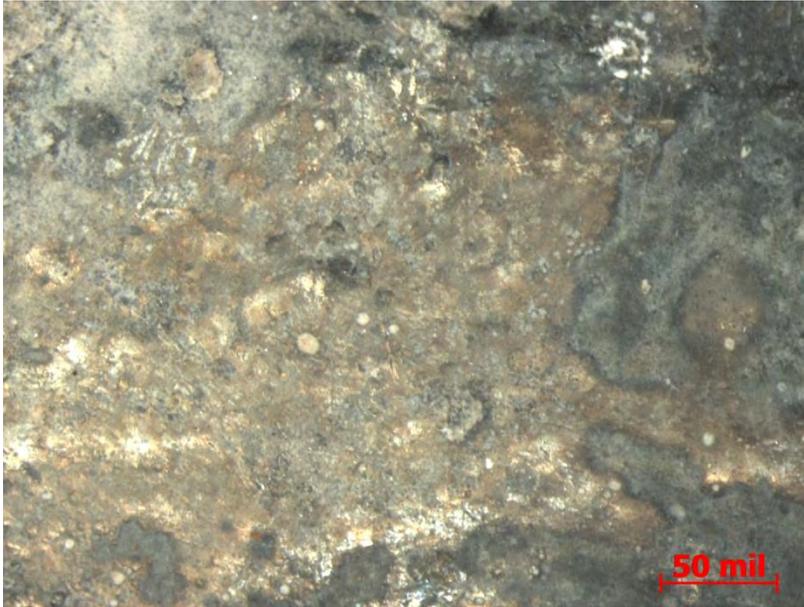
Figure 9. Micrograph showing the light green-gray shiny surface on the bottom of Sample 7.

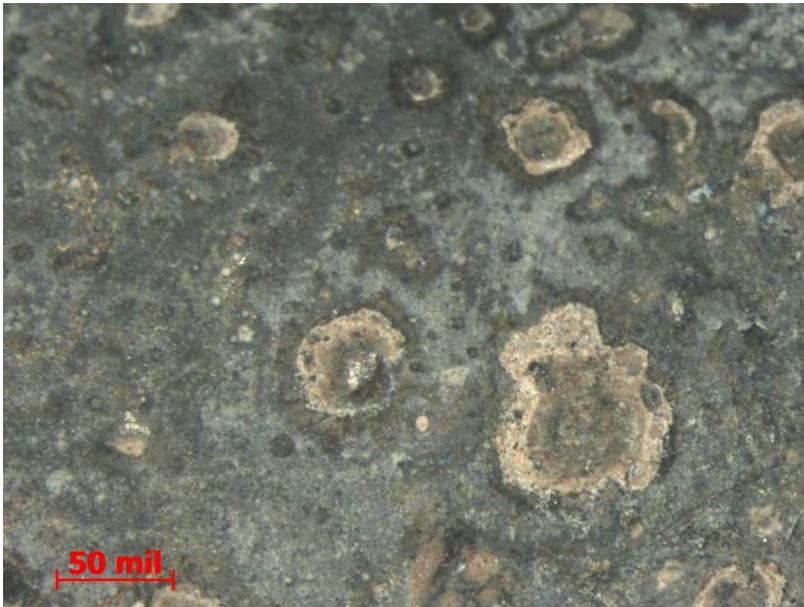
Figure 10. Micrograph showing the light gray surface of the bottom of Sample 7. The lighter colored deposits are adhered concrete.

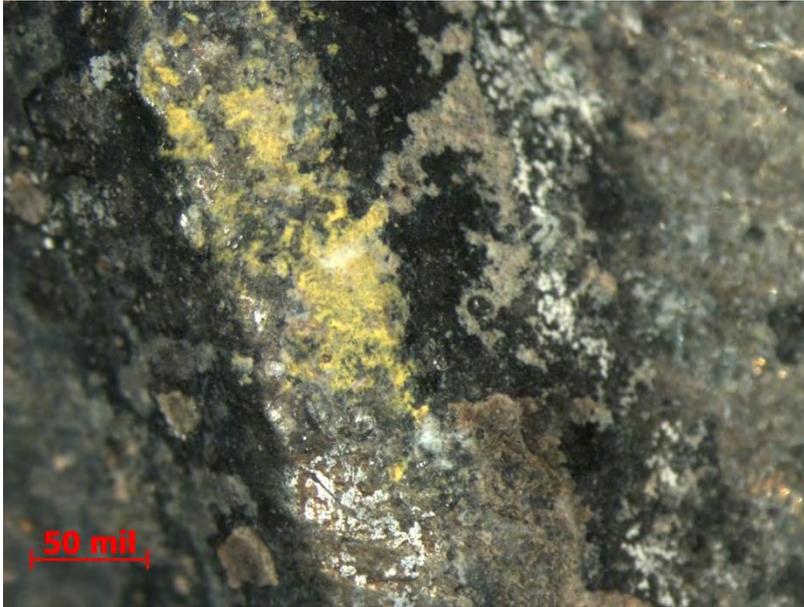
Figure 11. Micrograph showing the yellow-green and white deposits on the bottom of Sample 7.

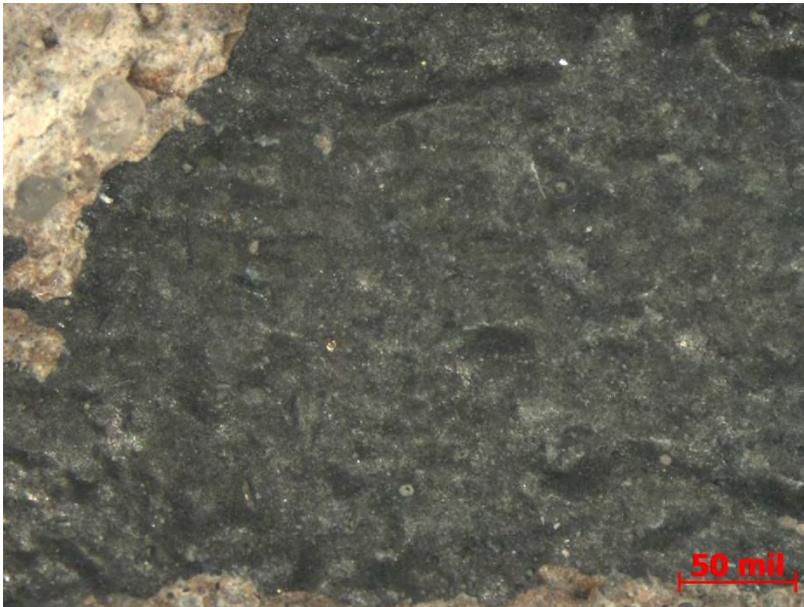
Figure 12. Micrograph showing the uniform, dark surface of Sample 7.

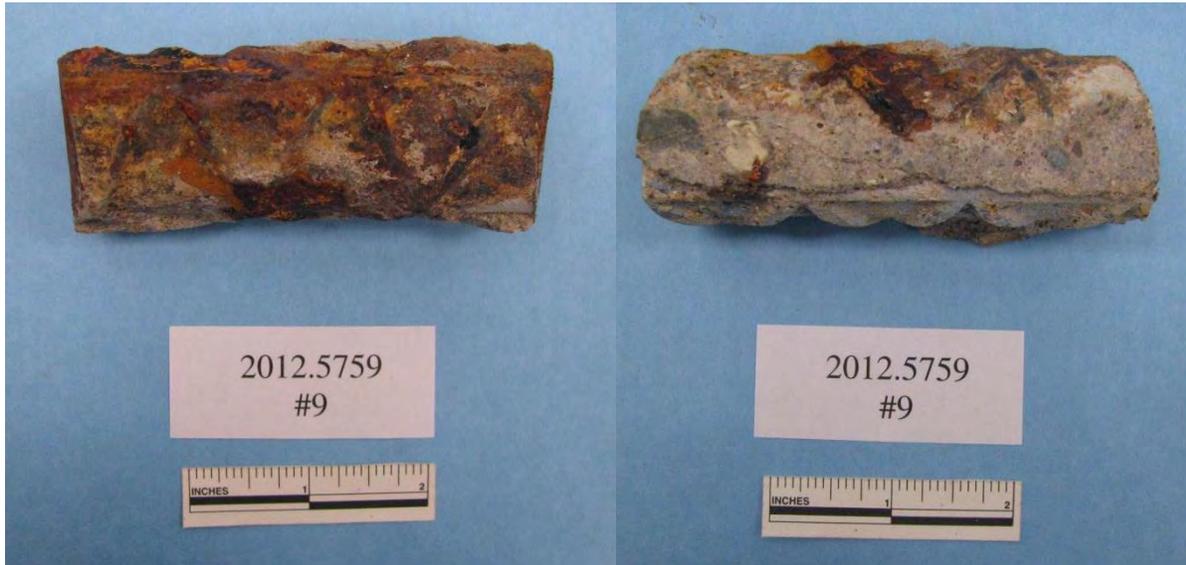
The bottom surface of Sample 9 is covered primarily in white corrosion deposits, although some localized areas have no apparent deposit. The top surface is primarily red corrosion product, with some white corrosion product present. This indicates that the zinc layer has been mostly consumed. Photographs and micrographs of the sample are provided in Figure 13 through Figure 15.

Figure 13. Sample 9. Top side (left) and bottom side (right).

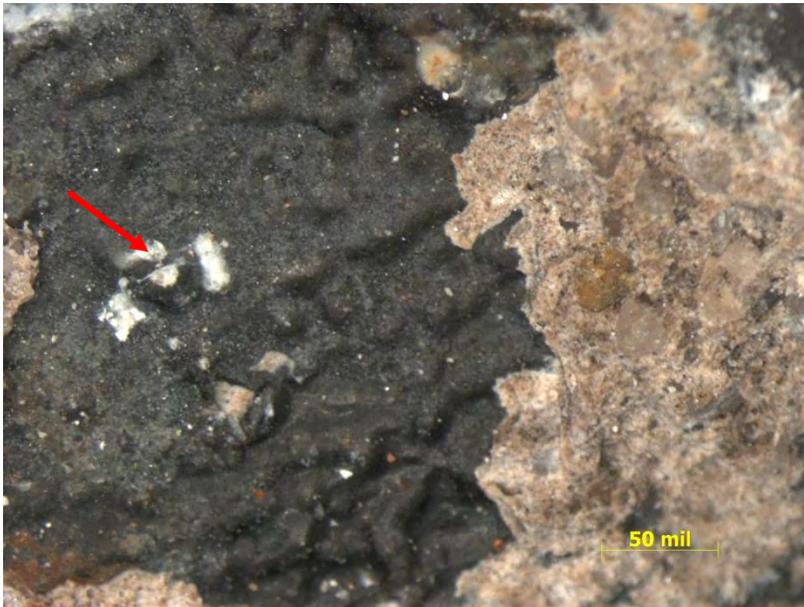
Figure 18. Micrograph of the side of Sample 10, showing concrete (indicated with an arrow) and a dark gray surface with only a small amount of white corrosion product.

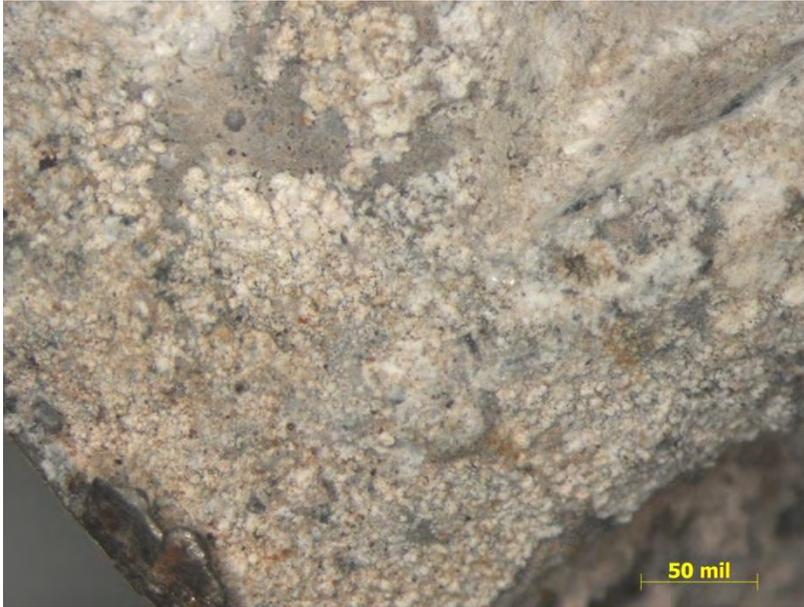
Figure 19. Micrograph of the bottom surface of Sample 10, showing a white deposit.

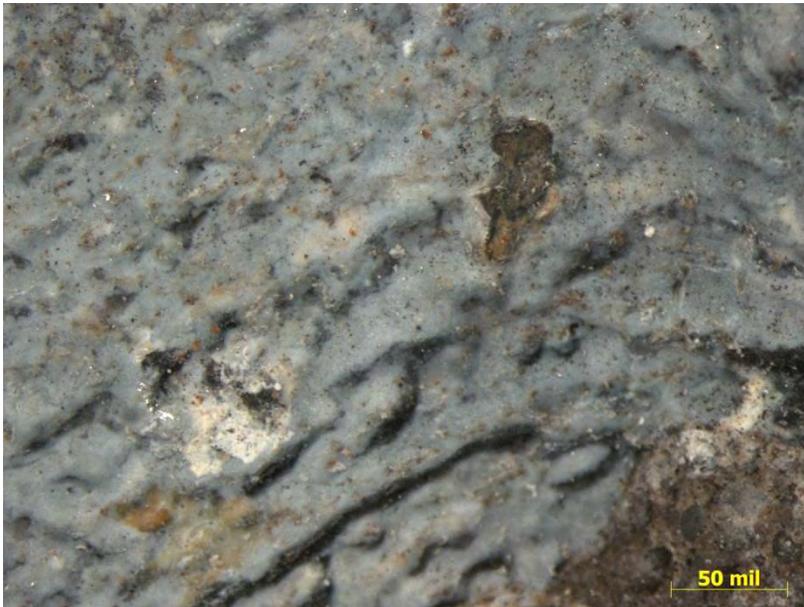
The bottom surface of Sample 10 consists primarily of white and red corrosion product, with some gray surface visible. The top surface consists primarily of red corrosion product, with a stripe of blue-gray deposit near the side of the bar. Corrosion is wide spread and the zinc has been consumed in areas. Photographs and micrographs of the sample are provided in Figure 16 through Figure 20.

Figure 20. Micrograph of the blue-gray deposit on the side of Sample 10.

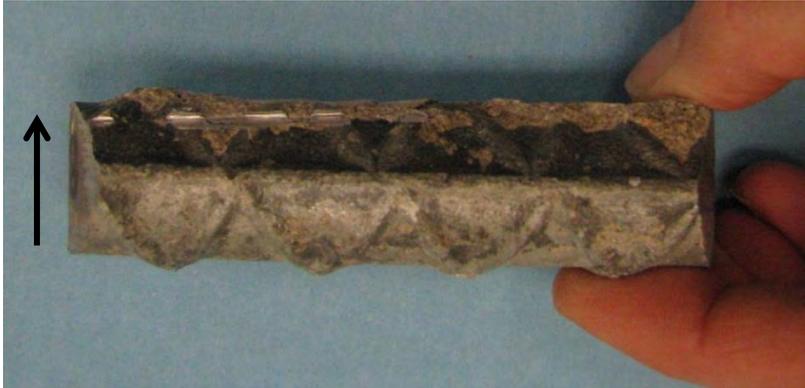
Sample 8 had a distinct dual-color appearance, with the top of the bar (as it was placed in the slab) having a dark gray appearance, with a lighter gray/silver/white appearance on the bottom of the bar (Figure 21). To evaluate compositional differences between the two colors, the surface of Sample 8 was examined using SEM/EDS.

Figure 21. Photograph of Sample 8, showing the dual colors. An arrow indicates which side faced up in the slab.

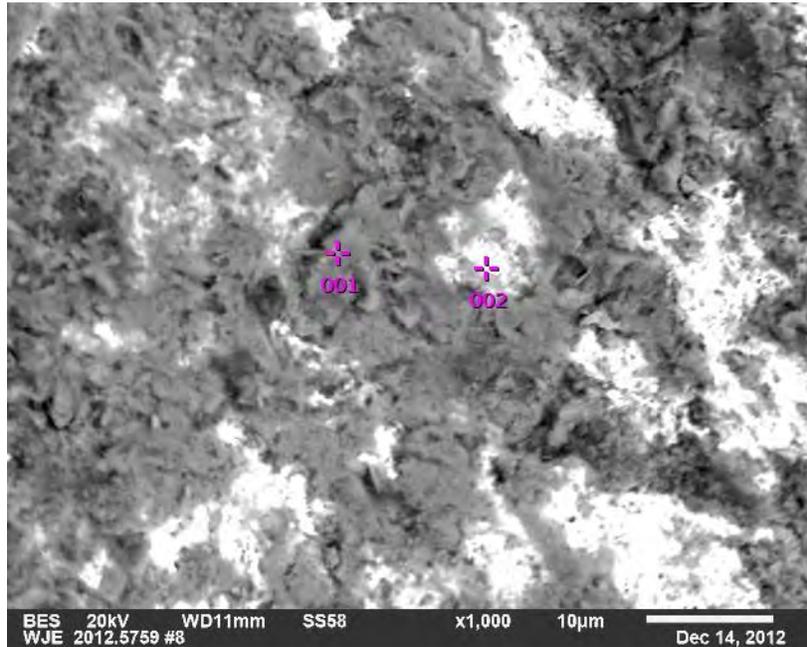
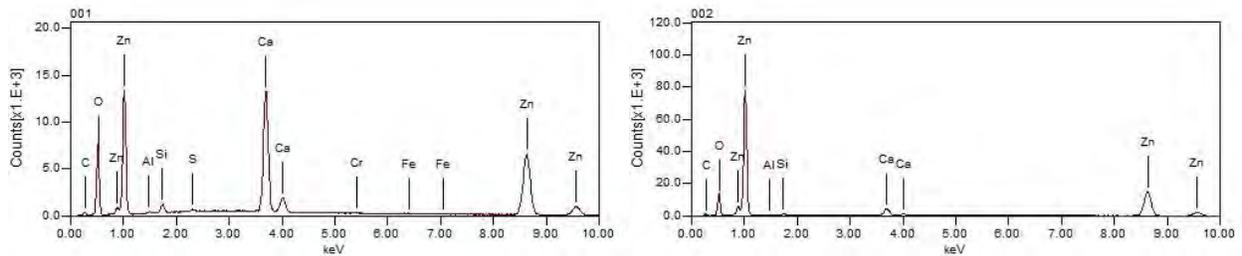
No significant compositional differences were observed between the darker and lighter portions of the bar (Figure 22 and Figure 23). Both consist primarily of zinc and oxygen, with varying amounts of calcium, and small quantities of aluminum, silicon, sulfur, lead, chromium, and iron. The zinc is from the

Figure 22. BE micrograph and point EDS spectra from the dark portion (top) of Sample 8. Each EDS spectrum has a number above the upper left corner which corresponds to the location indicated on the micrograph.

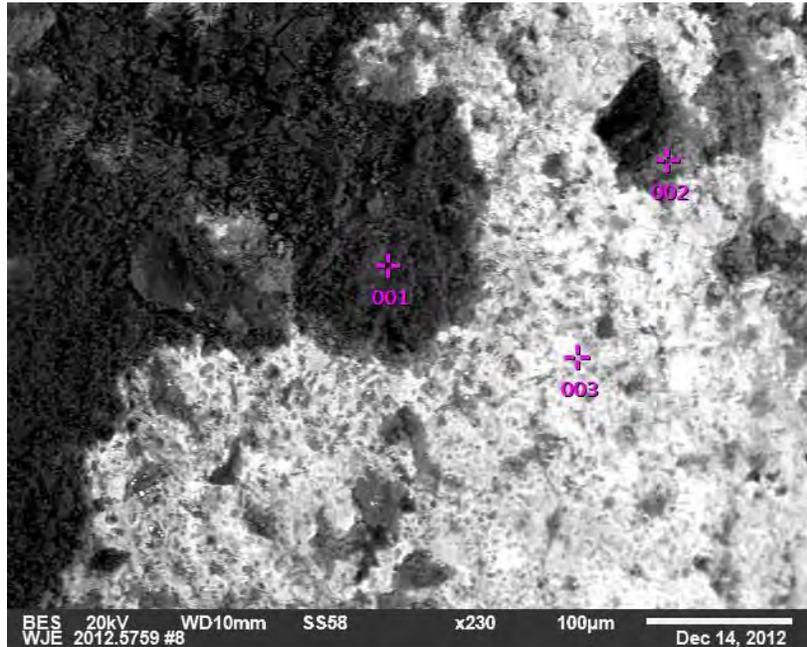
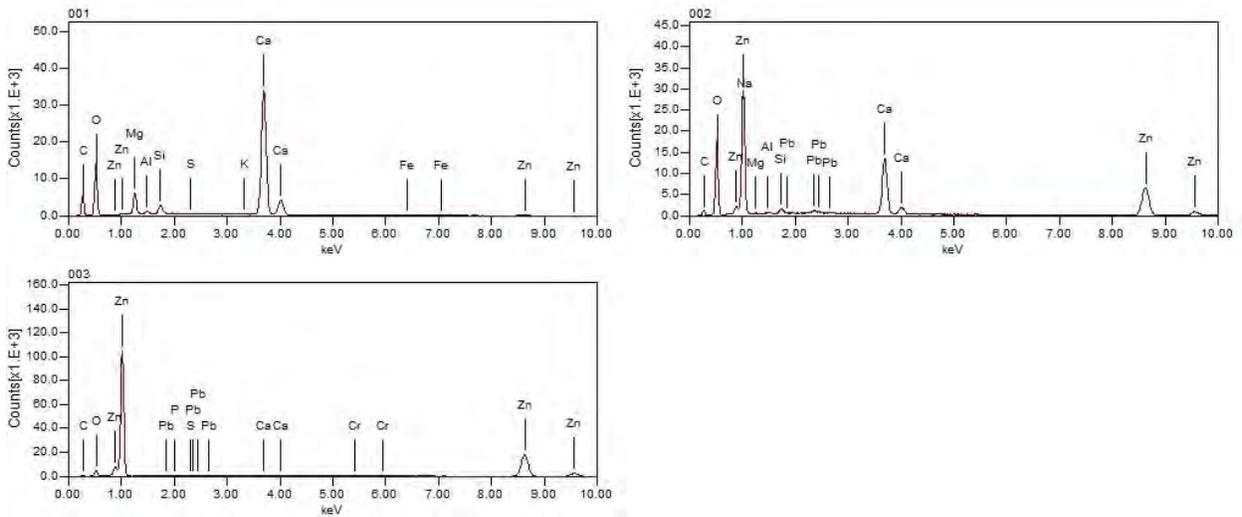
Figure 23. BE micrograph and point EDS spectra from the light portion (bottom) of Sample 8. Each EDS spectrum has a number above the upper left corner which corresponds to the location indicated on the micrograph.

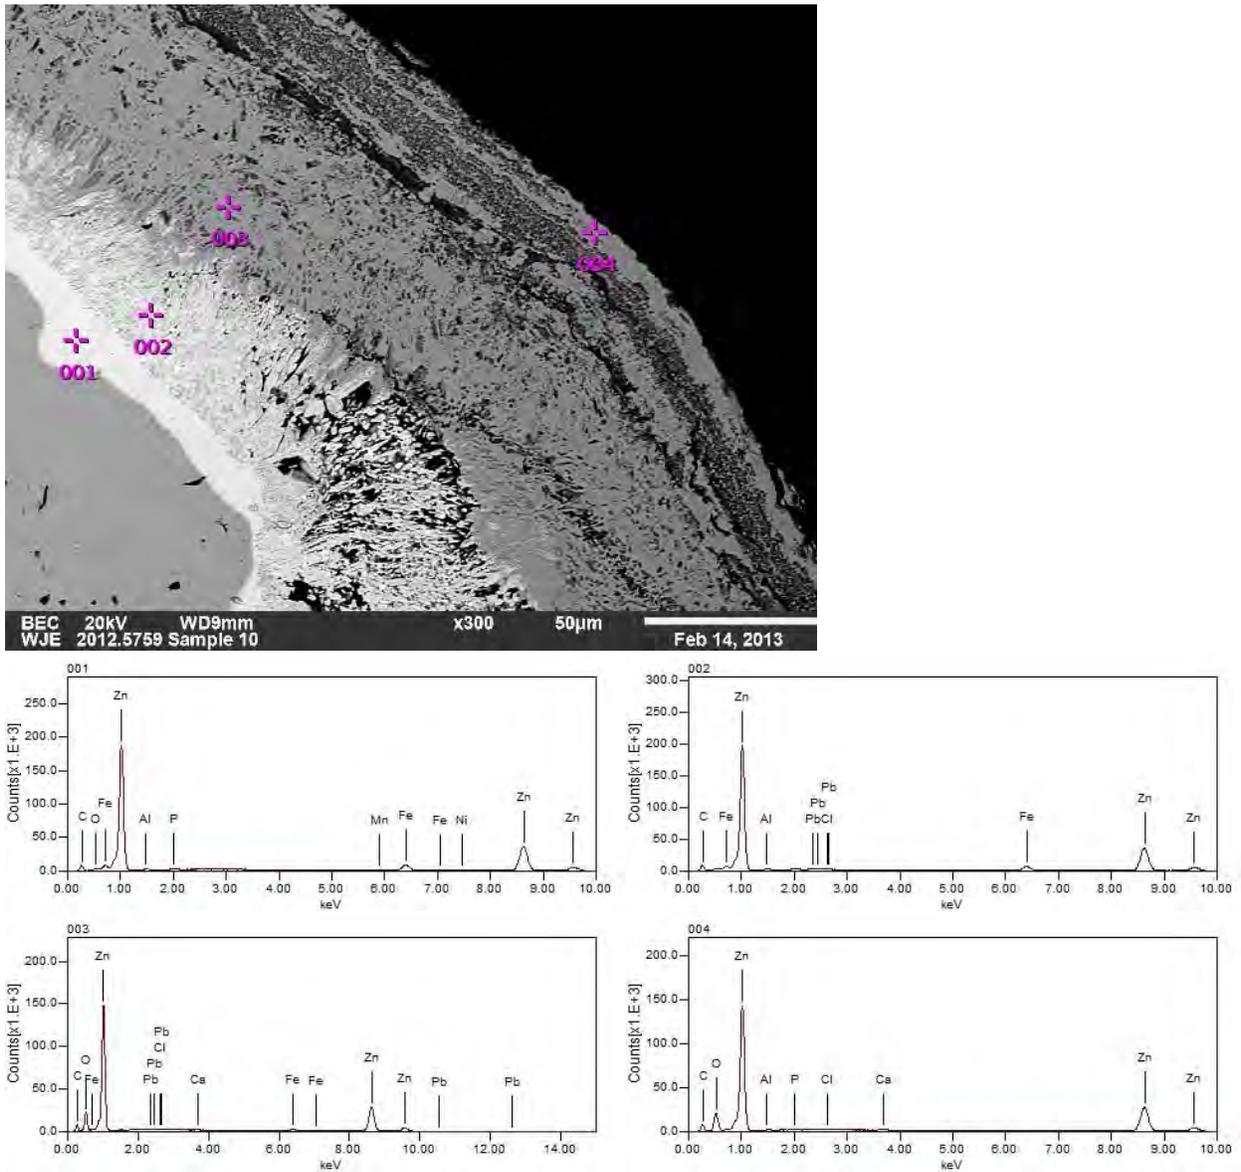
A cross-section of Sample 10 was examined using SEM/EDS to evaluate the composition of the corrosion product and zinc layer. A large pit filled with iron corrosion product was examined. Significant, but varying, amounts of chlorine were detected in different layers of the corrosion product (Figure 24). This confirms a chloride-induced pitting mechanism. Examination of the zinc layer indicated corrosion (oxidation) beginning at the exterior (Figure 25). Little to no chlorine (beyond the small amount present in the epoxy mounting medium) is present in the zinc layer that is beginning to corrode.

Figure 25. Cross-sectional BE image and point EDS spectra of the zinc layer Sample 10. Very little chlorine is incorporated into the zinc corrosion product (see EDS 004). Each EDS spectrum has a number above the upper left corner which corresponds to the location indicated on the micrograph. A minor amount of chlorine is present in the epoxy mounting medium.

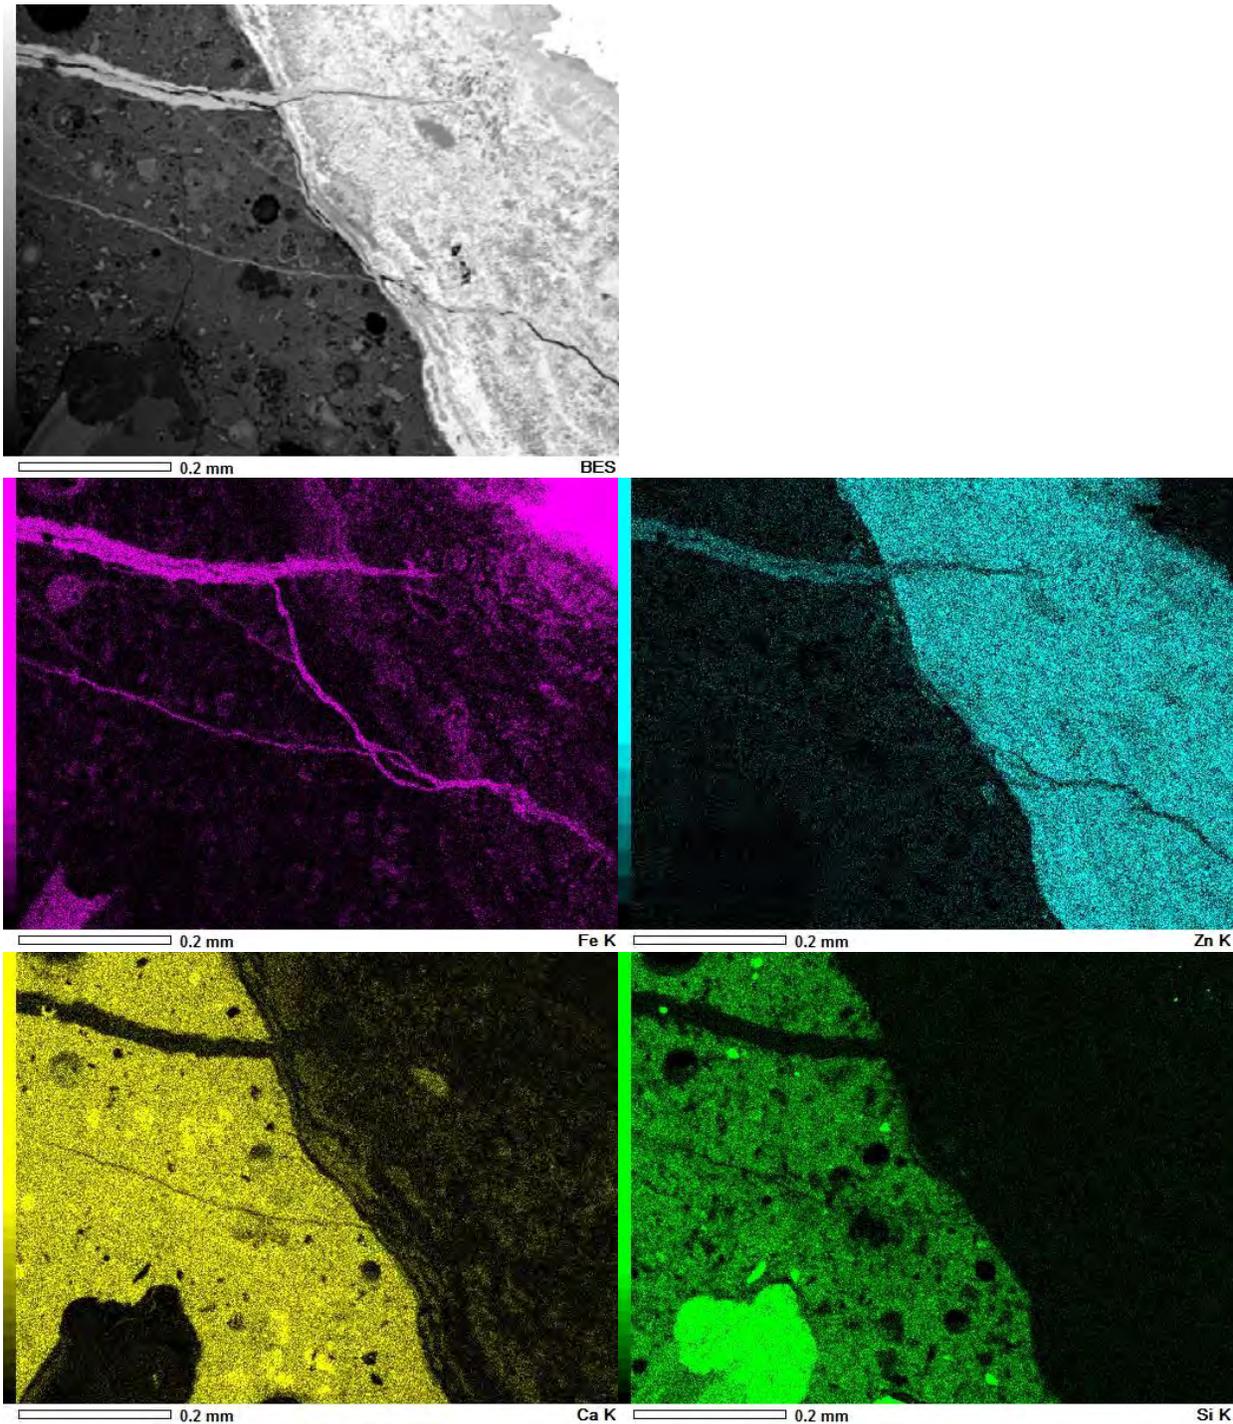
A small amount of concrete remained adhered to the rebar of Sample 10 in the location prepared for cross-sectional analysis. This portion was examined in detail to determine if the corrosion product diffused into the concrete. Dot map analysis indicated that iron and zinc corrosion product penetrated through cracks in the concrete, but do not appear to have diffused into the concrete itself (Figure 26). It is not known if the cracks existed prior to the corrosion of the reinforcing bar.

Figure 26. Dot map showing corrosion product/concrete interface of Sample 10. The corrosion product is on the right. The upper image is a BE micrograph. The elemental dot maps are, from left to right: purple -- iron, blue -- zinc, yellow -- calcium, green -- silicon. The iron and zinc can be seen penetrating the concrete along cracks, where calcium and silicon (constituents of cement paste) are not present.

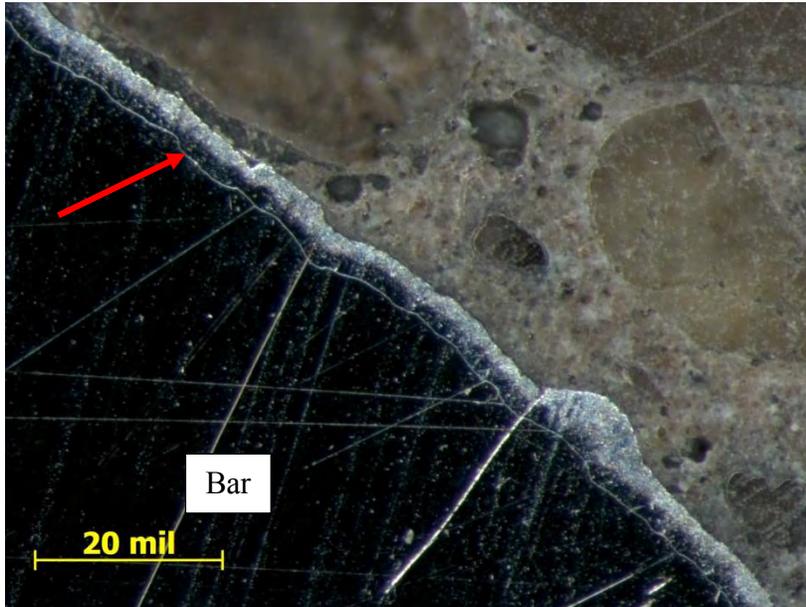
Figure 27. Cross-section of Sample 3, showing the bar, the zinc layer (arrow), and concrete adhered to the bar.

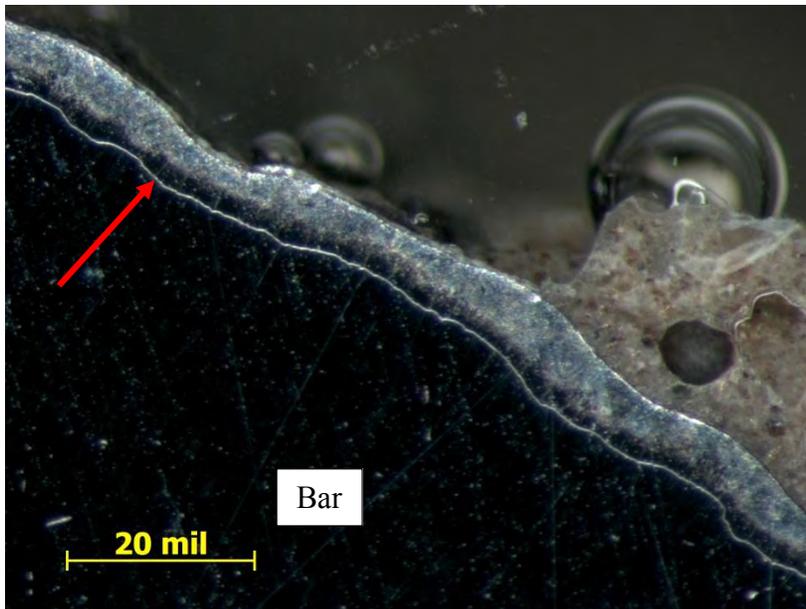
Figure 28. Cross-section of Sample 7, showing the bar (black), the zinc layer (arrow), and small section of concrete adhered to the bar. Epoxy (translucent bubbles), used in the preparation of the cross-section, is also present adhered to the zinc layer.

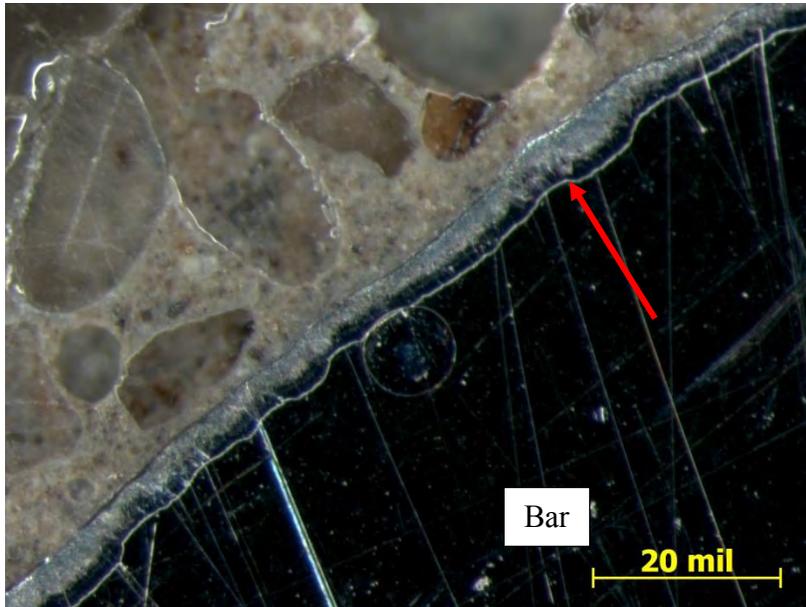
Figure 29. Cross-section of Sample 8, showing the bar (black) and the zinc layer (arrow), and concrete adhered to the bar.

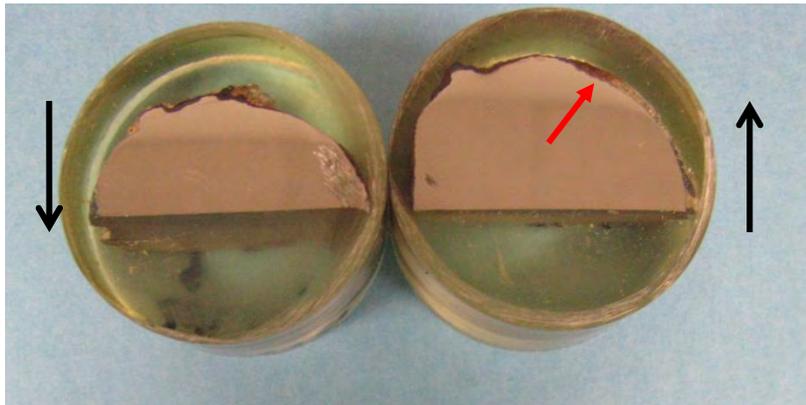
The thickness measurements indicated that metallic zinc is present in areas while completely corroded through in others. Samples 9 and 10 both exhibited surface corrosion, including white corrosion (zinc) and red corrosion (steel) and came from cores with significant chloride concentrations at the bar level. Pitting and significant zinc loss was also observed on Samples 9 and 10. The greatest degree of pitting was observed on the top surfaces (as placed in the slab) on both Samples 9 and 10. In contrast, little corrosion product was observed on Samples 3, 7, or 8. No difference in zinc layer thickness or degree of corrosion was apparent around the circumference of the bar; the thickness of zinc was the same on the top and bottom of the bar. Most of the zinc was consumed in Sample 9 and Sample 10 and pitting corrosion of the mild steel was noted. Micrographs showing the general condition of the zinc layers on the bar samples are provided in Figure 27 through Figure 35.

Figure 30. The polished cross-sections of Sample 9. The bar was cut in half so it could be placed into the epoxy molds. Arrows indicate which side was facing up in the slab. Some pitting can be seen on the top surface of the right-hand specimen (red arrow).

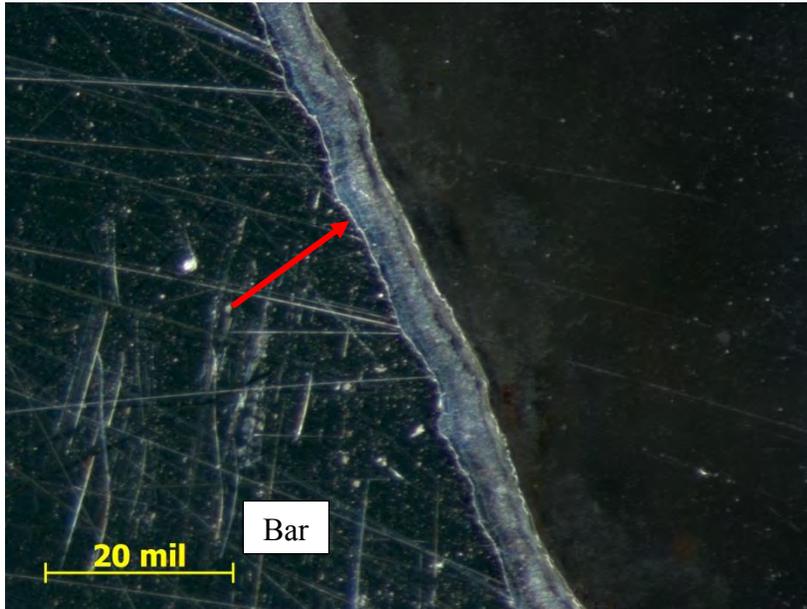
Figure 31. Cross-section of Sample 9, showing the bar and an intact zinc layer (arrow).

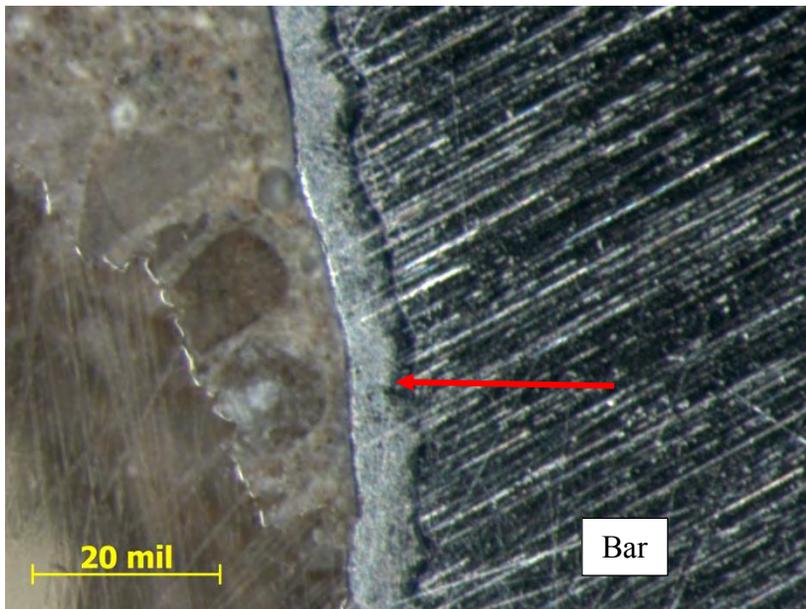
Figure 34. Cross-section of Sample 10, showing the bar, the intact zinc layer (arrow), and concrete adhered to the bar.
