IOWA STATE HIGHWAY 92 OVER DRAINAGE DITCH #25

Performance Evaluation Galvanized Reinforcing Bars

Louisa County, Iowa

June 15, 2015

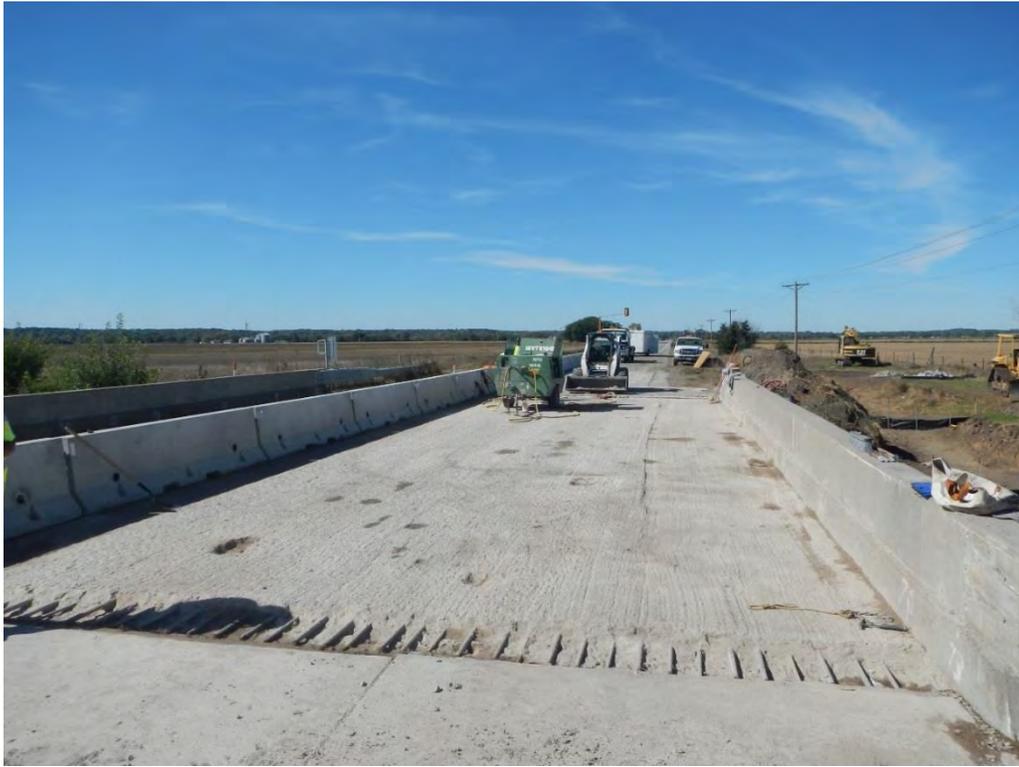
Figure E1. Overall view of IA92 deck, westbound lanes during Oct. 7, 2013 site visit.

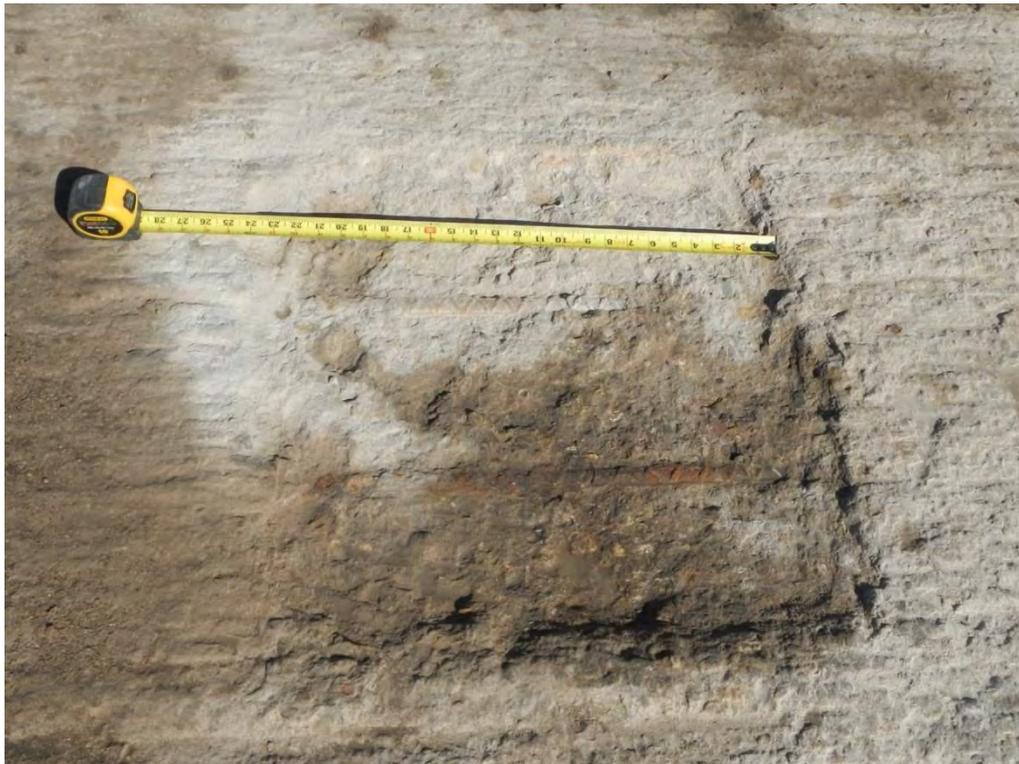
Figure E2. Close-up of typical repair location in IA92 deck, westbound lanes.

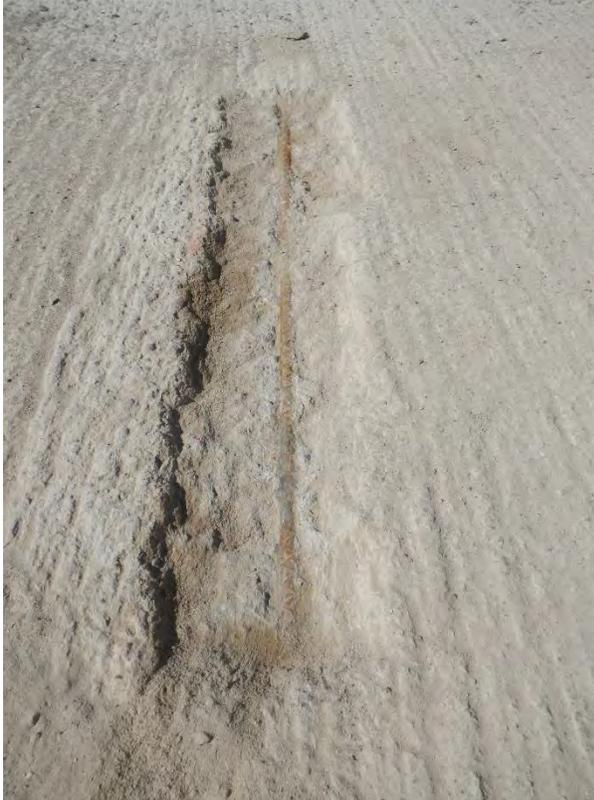
Figure E3. Typical repair location in IA 92 deck, westbound lanes

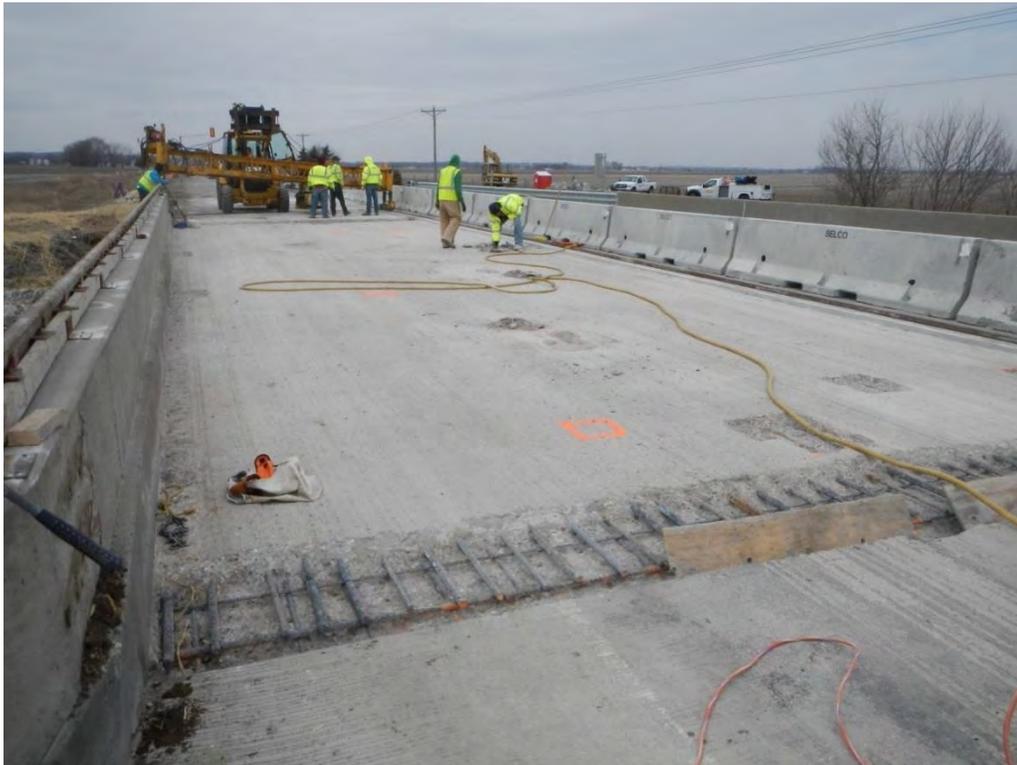
Figure E5. Overall view of IA92 deck, eastbound lanes during April 2, 2014 site visit.

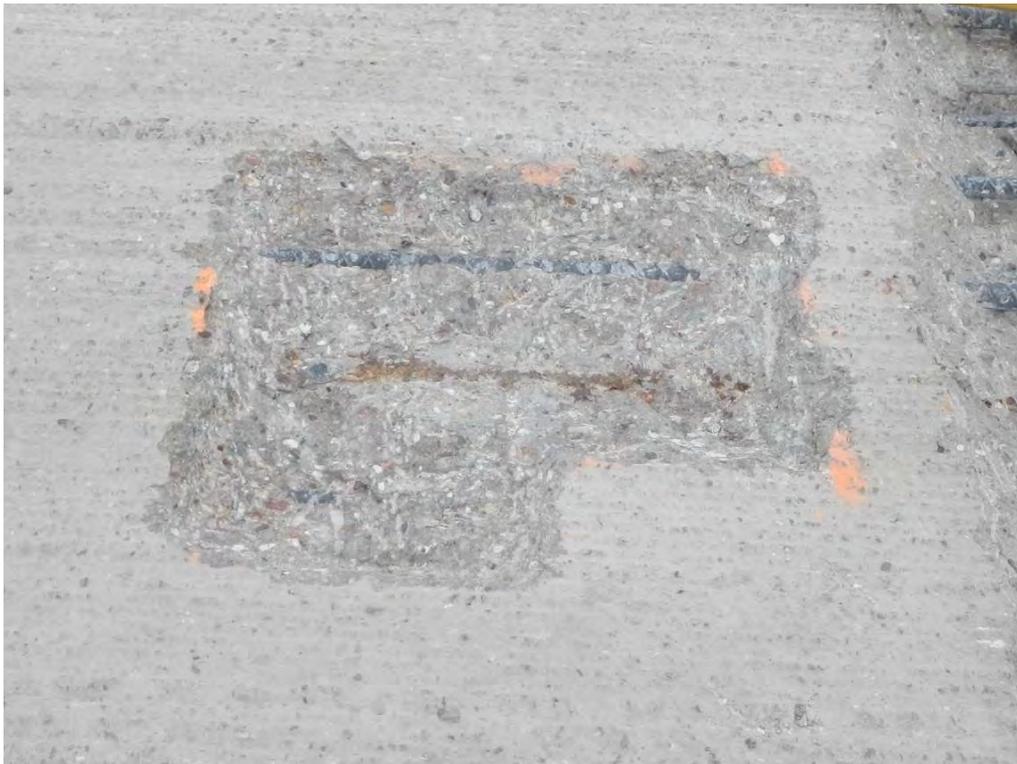
Figure E6. Close-up of repair location in IA92 deck, eastbound lanes.

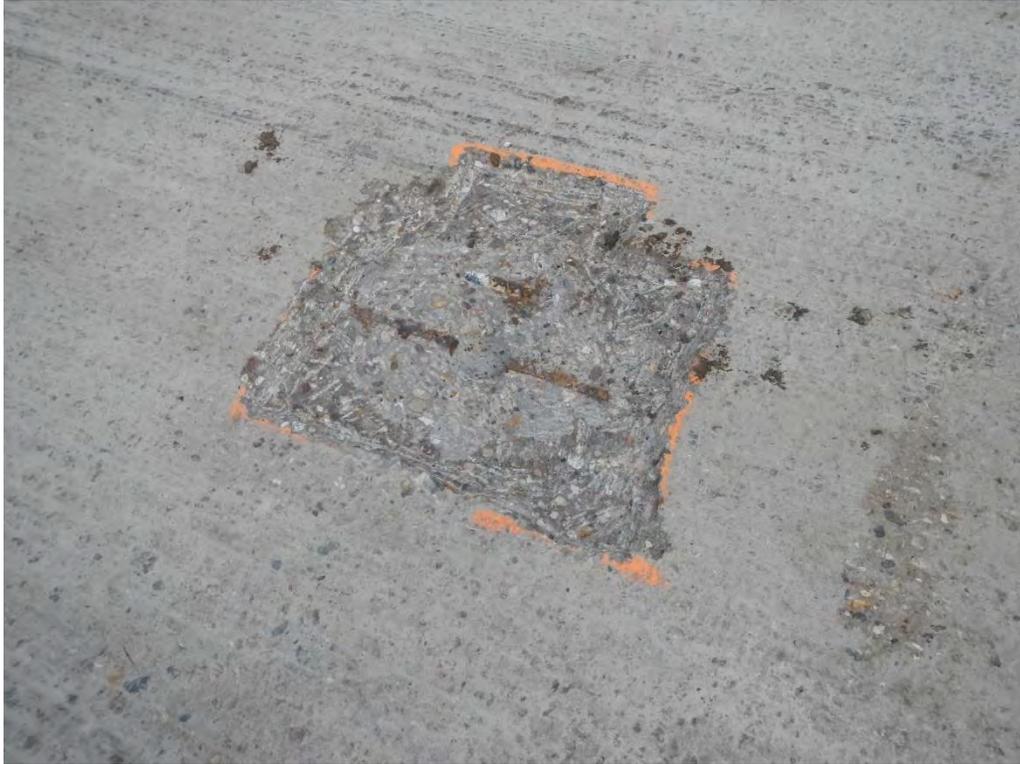
Figure E7. Typical repair location in IA 92 deck, eastbound lanes.

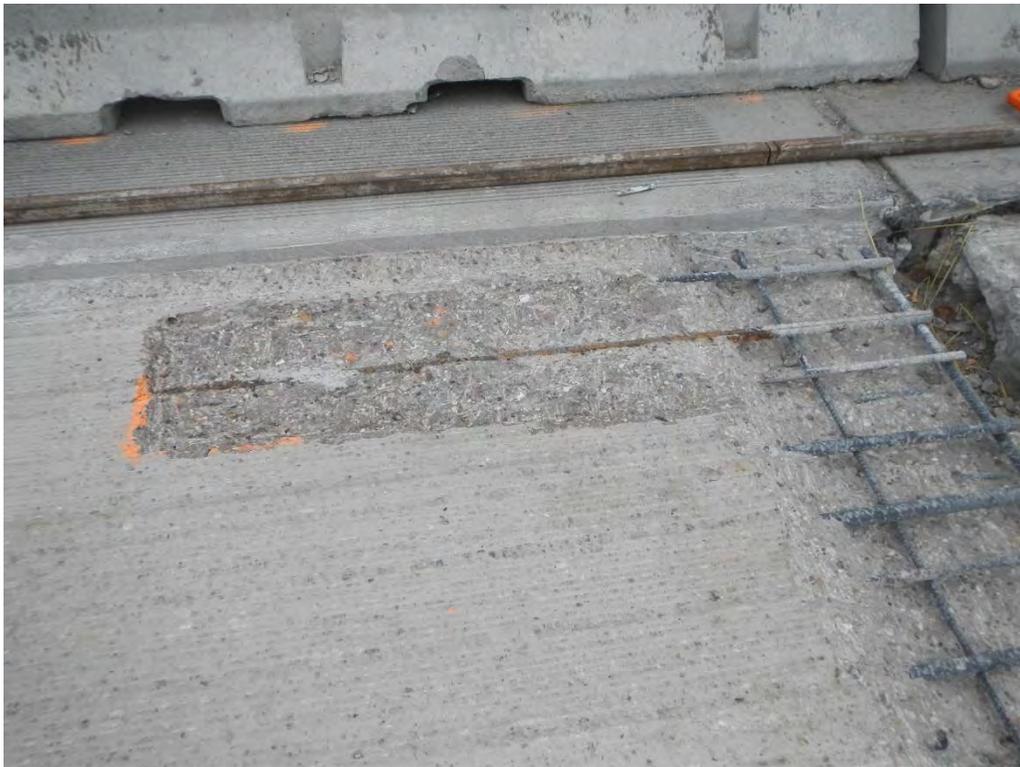
Figure E8. Deck repair location extending from deeper repair at end joint in eastbound lanes of IA 92 deck.

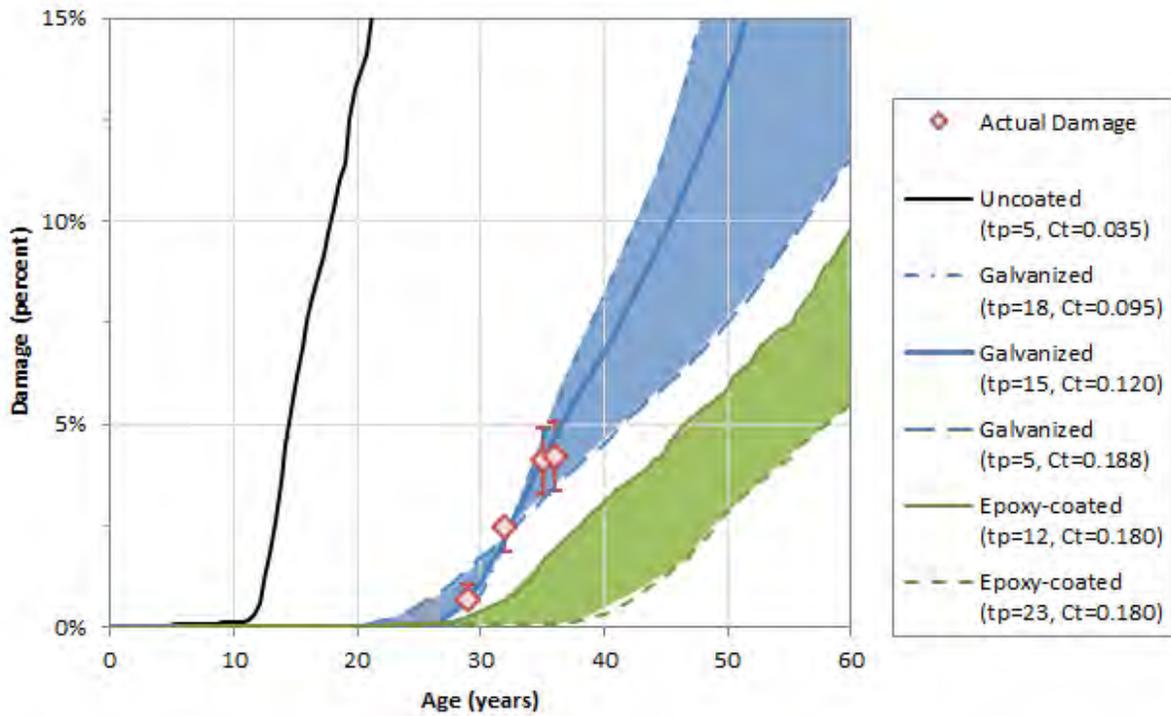
Figure E13. Results of service life model for bridge - updated to show additional distress through 2013/2014. (Propagation time (t_p) is given in years, and chloride threshold (C_t) is given in percent by weight of concrete.)
