# Investigation and Evaluation of Iowa Department of Transportation Bridge Deck Epoxy Injection Process

**Final Report  
February 2019**

**Sponsored by**  
Iowa Department of Transportation  
(InTrans Project 10-381)

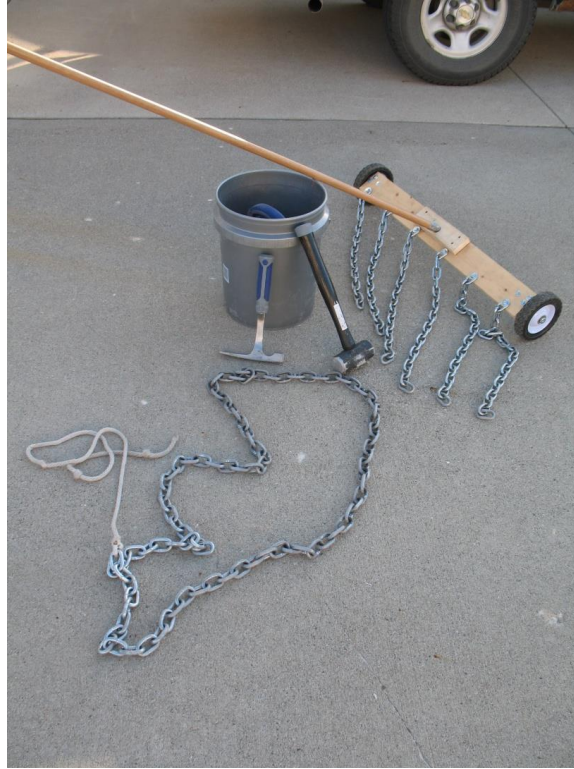
**Figure 3.2. Delamination detection tools**

During the fall of 2010, 26 bridges identified as being injected between 2003 and 2006 were visited and a performance evaluation of each was conducted. In addition to visual inspection of the deck surface, sounding of the concrete overlay was completed. Sounding of the deck was performed by dragging chains and hammer tapping, processes in which delaminated portions of the overlay are revealed by tonal fluctuations. Though this process cannot be considered highly scientific, it has been widely accepted as a standard practice for locating delaminated sections. Figure 3.2 shows the tools used for sounding the overlays, including a chain drag, chain whip, five-pound maul, and masonry hammer.

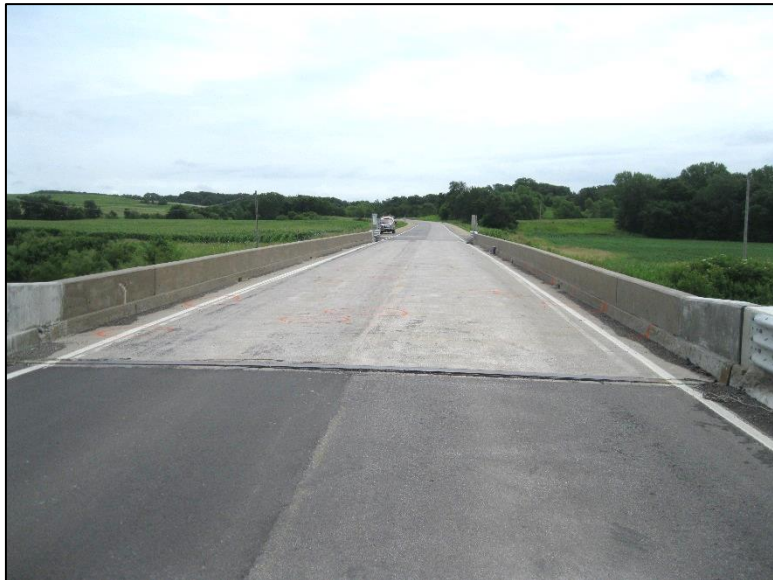
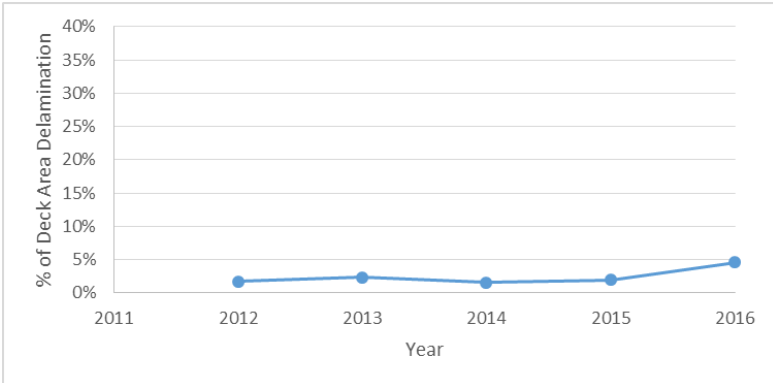
<table><tr><th>Year</th><th>% of Deck Area Delamination</th></tr><tr><td>2012</td><td>2%</td></tr></table>
