Exploration of Ultrasound for the Evaluation and Preservation of Structures

**Final Report
January 2021**

Sponsored by
Iowa Highway Research Board
(IHRB Project TR-757)
Iowa Department of Transportation
(InTrans Project 18-671)

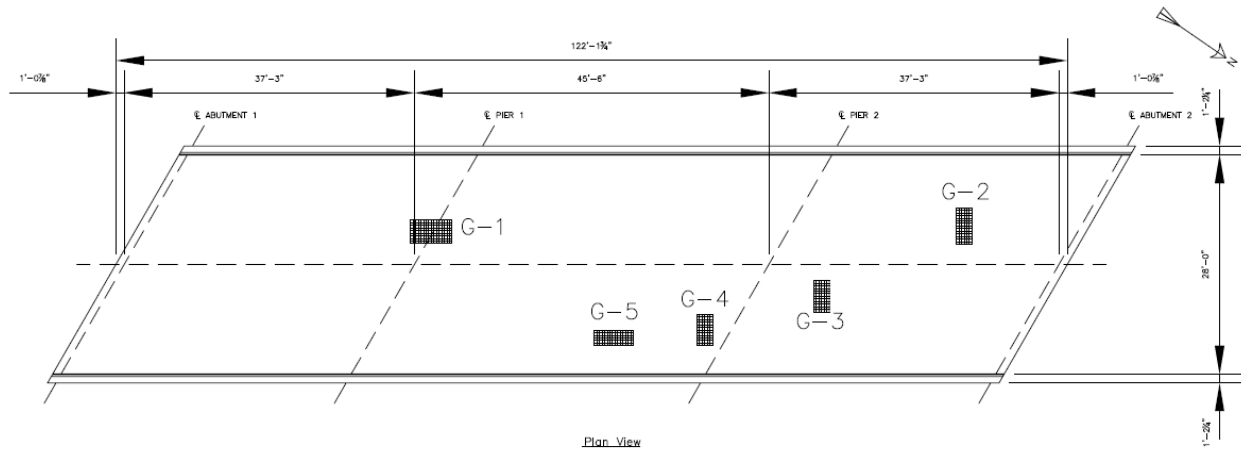
Figure 8. Mingo Bridge layout with testing locations identified

These locations were selected to obtain a wide variety of results, in that two areas with major cracking (G-1 and G-3), two areas with no cracking (G-2 and G-4), and one area with minor cracking (G-5) were selected.

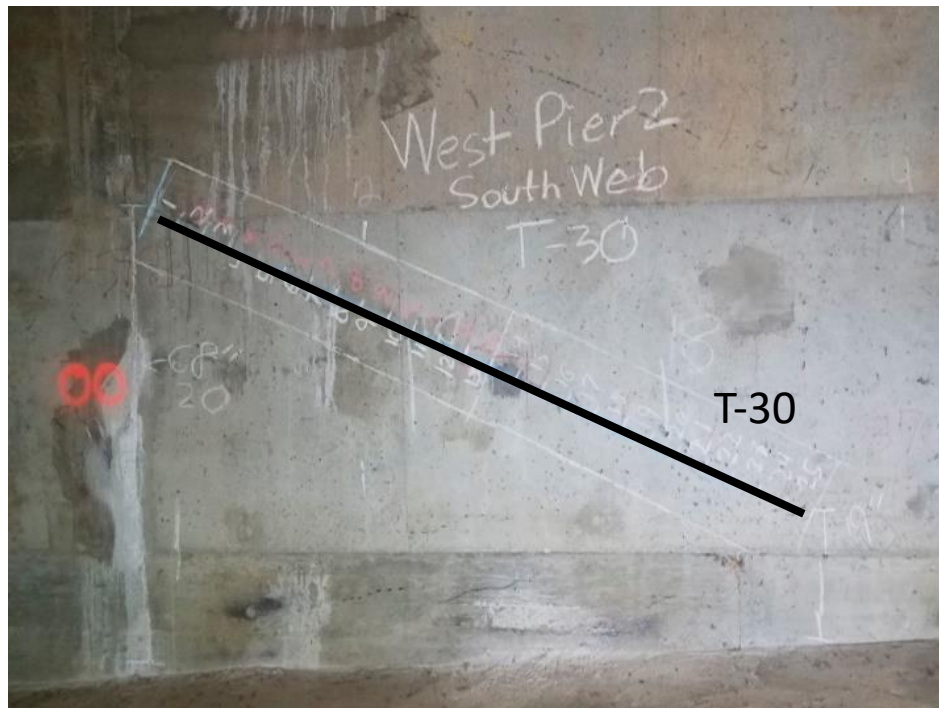
Figure 21. MIRA testing layout for T-30

One tendon (T-30) west of Pier 2 (Span 2) in the south web was also tested. The web tendon tested is shown in Figure 20 and Figure 21.

T-30 was the second void location determined by VCS. Figure 22, Figure 23, and Figure 24 show the C-scan, B-scan, and 3D image for T30, respectively.
