Utility Cut Repair Techniques— Investigation of Improved Cut Repair Techniques to Reduce Settlement in Repaired Areas

Final Report December 2005

the Iowa Highway Research Board (IHRB Project TR-503)

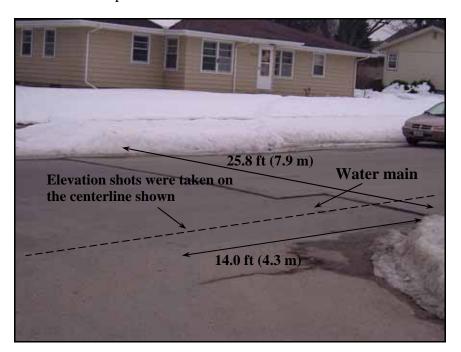
In Ames, Iowa, a utility cut in an asphalt-surfaced pavement on the corner of Wilson Avenue and 16th Street resulted in noticeable settlement (see Figure 1). The trench is 14 feet (4.3 m) long and 25.8 feet (7.9 m) wide, with elevation shots taken on the centerline as shown in Figure 1. Figure 2 shows a cross-section of the elevation shots taken on the restoration and the noticeable settlement difference that has developed since construction of the patched utility cut. This figure illustrates the effect this restoration is having on the site, with considerable settlement occurring around the perimeter of the trench, as well as near the water main valve. The perimeter of the trench currently has a 1.1-inch (2.8 cm) elevation

drop between the assumed trenching excavation limits and existing pavement, indicating significant settlement on the patched or reconstructed site.

Figure 1. Poorly performing utility cut in asphalt pavement

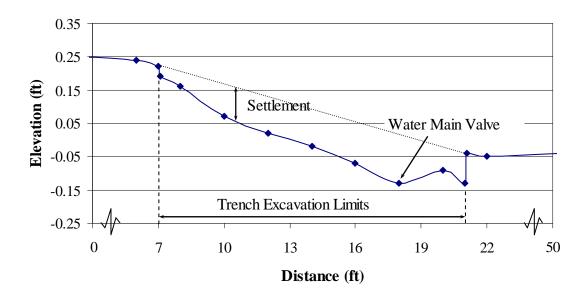
Figure 2. Settlement profile of poorly performing utility cut in asphalt pavement

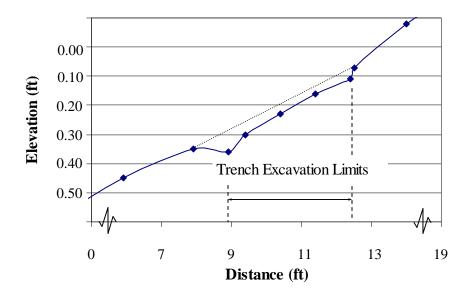
In Cedar Rapids, Iowa, a poorly performing utility cut in concrete pavement was documented and evaluated as a result of visible settlement and damage occurring in and around the pavement cut. The utility cut shown in Figure 3 is located near the intersection 12th Street SW and 21st Avenue SW on 12th Street SW. The patch is 3.6 feet (1.1 m) long and 8.3 feet (2.5 m) wide, with elevation shots taken along the centerline of the trench, as shown in Figure 3. Elevation differences of 0.12 inches (0.30 cm) and 0.48 inches (1.22 cm) were measured along the edge of the assumed excavation limits of the utility cut (see Figure 4). With nearly 0.5 inches (1.3 cm) of difference in elevation, this amount of settlement was noticeable in a moving vehicle.

Figure 4. Settlement profile of poorly performing utility cut in concrete pavement

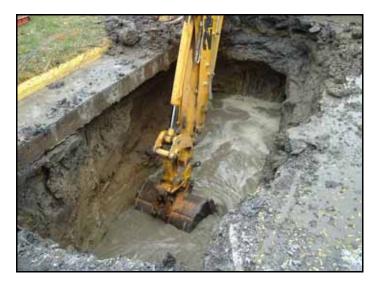
The restoration of a water main break on 20th Street south of Hayes Avenue occurred on October 18, 2004. The excavation and construction of this trench was completed by the city of Ames. The trench is sixteen feet (5 m) long, six feet (2 m) wide and about ten feet (3 m) deep, excluding the cutback region. Figure 23 shows the excavation of the trench as it approaches the broken water main and illustrates the tough working conditions that exist. A dewatering device was used to pump excess water from the break into inlets on the street. This was done by immersing the pump, which was placed in the backhoe bucket, into the trench, and pumping soiled water through a hose into the street. As the excavation proceeded and additional water was removed during the dewatering process, saturated material along the perimeter of the trench began to slough off (see Figure 24). Cavities continued to develop around the perimeter of the trench until the broken water main was reached.

Figure 23. Trench excavation

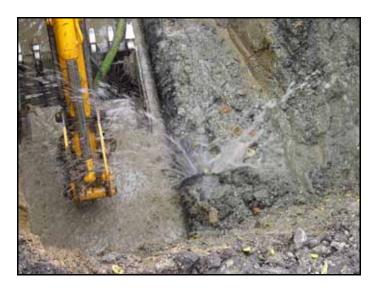
The water main break was reached at a depth of about ten feet (3 m) into the trench. After the trench was dewatered, construction crew members were able to repair the break. Figure 25 shows the break in the pipe as water sprayed out, and Figure 26 shows the shoring box being placed into the excavation. This shoring box acts as a support brace from the surrounding soil, which protects workers from material caving in during break repairs. The break was repaired with a pipe sleeve and the shoring box removed.

Figure 25. Ames water main break

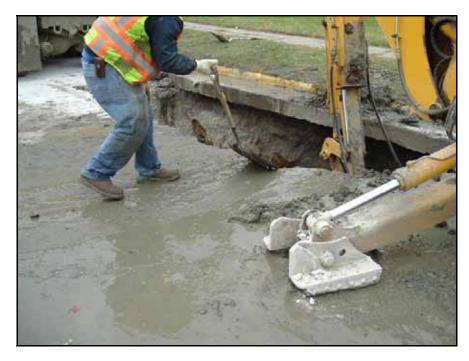
Approximately four feet (1.2 m) of one-inch limestone was placed as a bedding and backfill material up to two feet (0.6 m) above the pipe crown. This bedding material was compacted in two-foot (0.6 m) layers with a vibrating plate. Figure 27 shows the bedding material being dumped into the trench. A material referred to as 3/8 minus was then used as a backfill material extending from the top of the bedding material to the surface of the excavated area. This material was also compacted in about two-foot (0.6 m) layers with a vibrating plate. Figure 28 shows the compaction of the 3/8 minus material using the vibrating plate connected to the end of the backhoe. As a result of the construction, saturated material and debris from the excavation and surrounding area were shoveled into the trench during the backfilling process (see Figure 29).

Figure 29. Saturated material shoveled into the trench

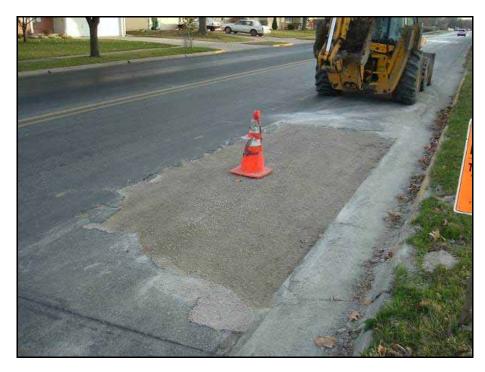
The final lift was compacted with excess material on the top and leveled off with the backhoe bucket. The final compaction was completed by rolling over the constructed trench with the backhoe. Figure 30 shows the completed utility cut. The utility cut was then left open and unpaved for about two weeks, allowing traffic to further compact the material.

Figure 30. Utility cut left open for two weeks

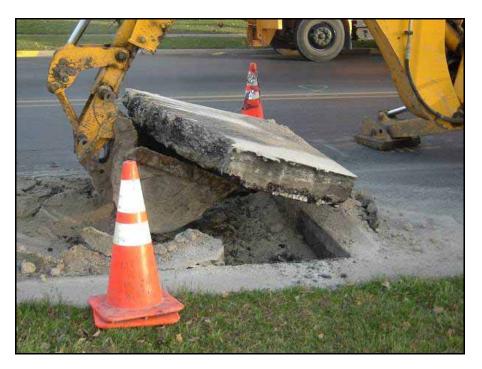
After the two week period, the pavement was cut back and removed to about 2.5 feet (0.8 m) from the edges. This pavement removal, in most cases, was standard in Ames because during the initial excavation, pavement was broken up with the backhoe bucket, leading to a non-uniform edge. Therefore, this cut in the pavement was made because of a need for straight edges in surfacing the trench. Once the cut was made, excess pavement was removed and hauled away. As stated before, the purpose of leaving the trench unpaved for two weeks was to reduce future settlement, however during this pavement removal process conducted by the backhoe, backfill material was disturbed and loosened (see Figure 31). After this backfill material disturbance, no additional compaction equipment was brought in to compact this area. Instead, the backhoe leveled off excess material and then completed several passes with the weight of the backhoe and patting the material with the backhoe bucket as a method of compaction (see Figure 32). Figure 33 shows the completed trench in Ames.

Figure 31. Pavement removal

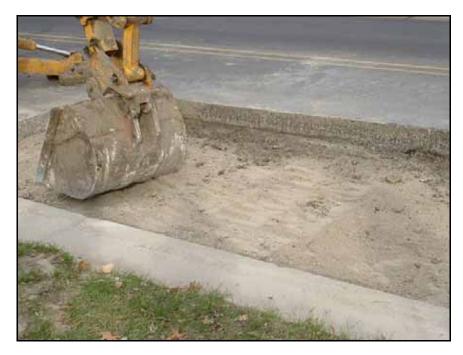
Figure 32. Backhoe bucket compaction

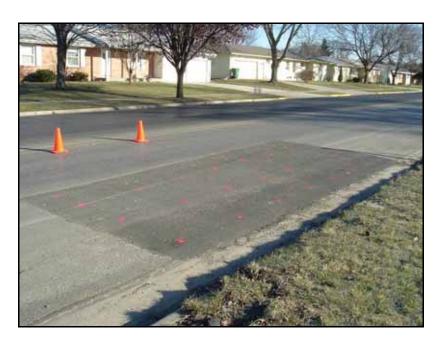
Figure 33. Ames site completed

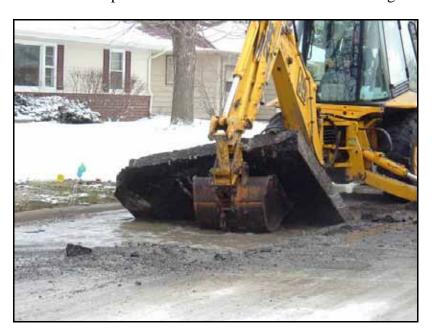
This winter water main break in Ames occurred near the intersection of Marston Avenue and 16th Street on February 7, 2005, where water was temporarily turned off. The excavation on the site was 7.5 feet (2.3 m) long, and 8.5 feet (2.6 m) wide, with a depth of 6 feet (1.8 m). This utility cut was constructed by the city of Ames, in pavement consisting of 10 inches (0.3 m) of asphalt. The removal of pavement from the trench can be seen in Figure 34.

Figure 34. Pavement removal from Ames winter break site

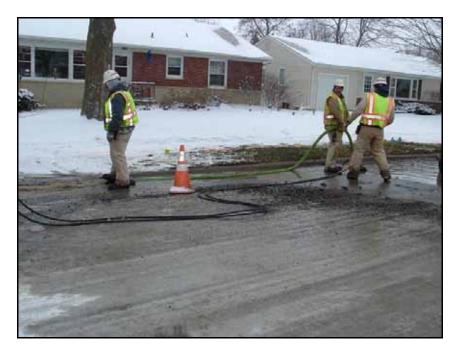
Figure 35. Dewatering the trench

After pavement was removed from the surface, dewatering of the trench began. The trench was dewatered before excavation began (see Figure 35). While the water level was lowering, saturated material was excavated from the trench. Figure 36 shows the saturated material being excavated and the damage that has resulted to the surrounding pavement. Once the break was located the pipe was cut and repaired. Backfill material, which consisted of the SUDAS specification and 1.5-inch limestone, as a bedding material, was then added to the trench. The SUDAS backfill material segregated in the dump truck, therefore coarse material was placed near the center of the excavated trench and fines on the top. Figure 37 shows the backfill material being dumped and placed into the trench. Again, near the end of construction, saturated material was incorporated into the trench to clean the area up (see Figure 38). The completed unpaved trench is shown in Figure 39. The following day the trench had an asphalt cold patch placed on it until spring when the asphalt plant reopens.

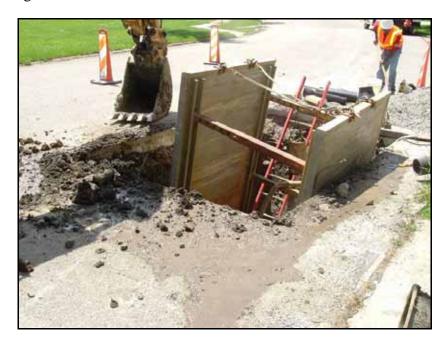
Figure 40. Shoring box in place

A standard vertical cut was made in the pavement and excavation of the native material began. At the completion of the excavation a shoring box was placed into the trench (see Figure 40). The leaking valve was repaired and a 2" x 4" block of wood and concrete block was placed beneath the pipe for support. The pipe was also wrapped with black plastic wrap for protection against corrosion.

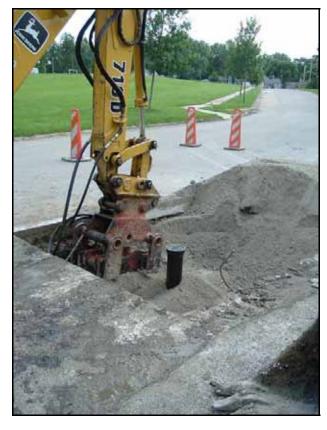
Figure 41. Backfill compacted into trench

A 1-inch clean material was then used as a bedding material around the pipe, where this material was worked around the pipe and block with a shovel. A recycled crushed concrete backfill material classified with particle sizes 3/4-inch or less was imported from the landfill where it has been reclaimed from previous concrete pavement excavations. This site was backfilled with two lifts of material dumped about three to four feet (0.9 m to 13.1 m) deep each, and was tamped with a vibrating plate for about three to four seconds in no specific compaction pattern. Figure 41 shows a lift of the material being tamped in place. The pavement surface consists of 6 inches of concrete and 2 inches of asphalt overlay. As a result of the backhoe rolling over the edge of the trench during the backfill compaction process, the surrounding composite pavement was damaged (see cracked pavement in Figure 42).

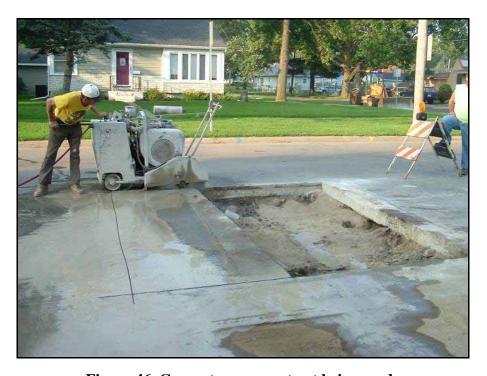
Figure 46. Concrete pavement cut being made

Excavation and construction of the trench began on June 30, 2004. The sewer main break repair was completed by a contractor in Des Moines and is located east of E. 28th Street and Grand Avenue. This site was excavated, filled, and plated the day before the research team arrived, therefore documentation of the construction procedures were not made. The site was covered with a metal plate since surfacing was unable to be placed the following day. When the plate was removed, the manufactured sand (crushed limestone) used as backfill material had begun to settle along the trench edges, likely as a result of traffic vibrations (see Figure 45). Therefore, the concrete pavement was cut back to compensate for these cavities (see Figure 46).

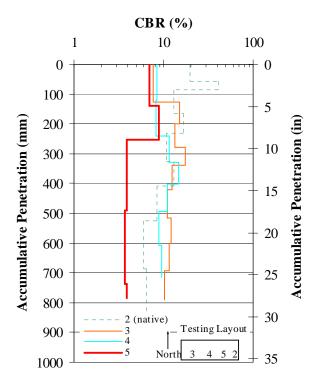
Figure 52. CBR profile for Ames

The CBR values of all testing locations in imported material using the DCP indicate high and low values of 17.4% and 3.7% (see Figure 52). According to Table 17 in the literature review, typical CBR values for an SM classified material ranges from 20% to 40%, indicating the values obtained from the field are lower than these typical values. Based on Figure 52, the CBR results appear to be relatively consistent throughout the trench. The native material in the cut back region indicates a stiffer response near the surface, but with depth, these results had a similar stiffness response with the imported material. This may be an indication of the loss in lateral support during the excavation.

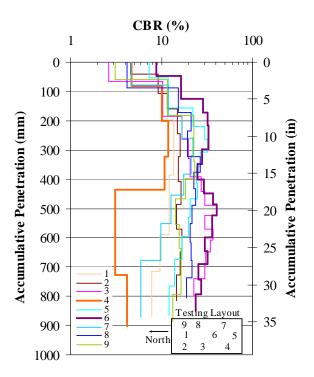
Figure 53. CBR profile for Cedar Rapids

DCP results directly obtained from the field (i.e., no DCPI weighted average value) indicate a high CBR value of 40.5% and low of 2.6% (see Figure 53). When comparing these values to typical values stated in Table 12 of the literature review, this SC material had values above and below these the typical 10% to 20% CBR values. The results from Figure 53 indicate a higher CBR value near the center of the trench, to a low CBR value near the edge. Again, the CBR values are relatively consistent though the trench.

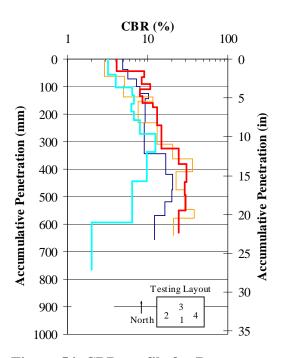
Figure 54. CBR profile for Davenport

DCP results directly obtained from the field indicate a high CBR value of 37.8% and low of 2% (see Figure 54). When comparing these values to typical GC classified materials values of 20% to 40% stated in Table 12 of the literature review, values resulted at or below this typical range. Figure 54 indicates a stiffer response with depth and again the CBR values were fairly uniform with depth, except location four where stiffness decreased.

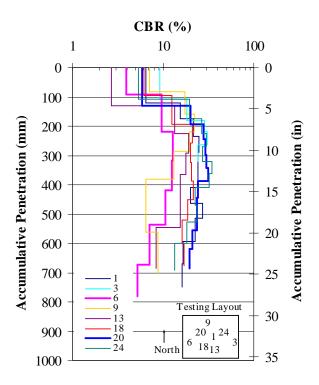
Figure 55. CBR profile for Des Moines

DCP results directly obtained from the field indicate a high CBR value of 34.9% and a low of 2.7% (see Figure 55). When comparing these values to typical SW classified materials values of 20% to 50% stated in Table 12 of the literature review, values resulted at and below this typical CBR range of this material. Figure 55, shows the material compacted near the center to have a stiffer response when compared to the material near the edge and again, the CBR values trend was fairly uniform.

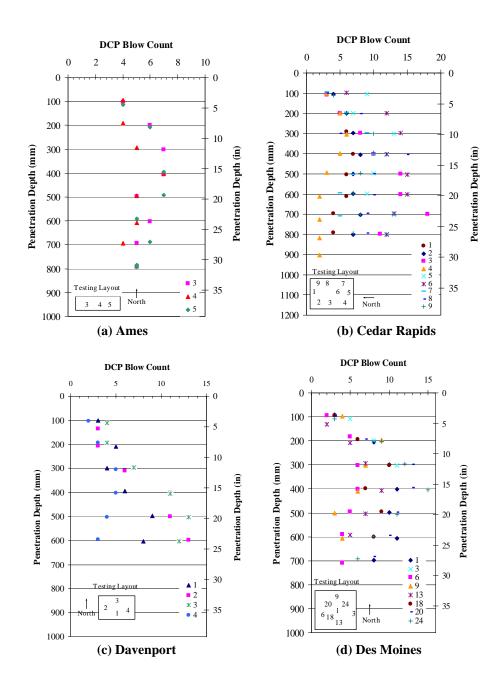
Figure 56. DCP blow count profiles

When comparing the DCP blow count profiles in Figure 56 to the CBR plots in Figures 52, 53, 54, and 55, a trend was observed where the greater the number of blows needed to penetrate a 3.9-inch (100 mm) depth, the higher the CBR value obtained. When comparing the Ames data, the maximum number of blows for location three was 7 per 3.9 inches (100 mm), with a CBR value of approximately 15% and Cedar Rapids with maximum of 18 blows per 3.9 inches (100 mm), with approximately 43%. Davenport had a maximum of thirteen blows per 3.9 inches (100 mm) indicating a CBR value of 30% and Des Moines, with a maximum blow count of fifteen blows per 3.9 inches (100 mm), with a CBR value of 35%. Typical CBR values according to Table 13, indicate Ames material to have CBR values between 20% and 40%, Cedar Rapids between 10% and 20%, Davenport between 20% and 40%, and Des Moines between 20% and 50%. These typical CBR values obtained were then compared to the data obtained from each material (i.e., the number of blows per 3.9 inches (100 mm)). Material in Ames indicated CBR values on the lower range of typical values, Cedar Rapids resulted in CBR values significantly higher than typical values, and both Davenport and Des Moines indicated CBR values in the middle of typical CBR values.

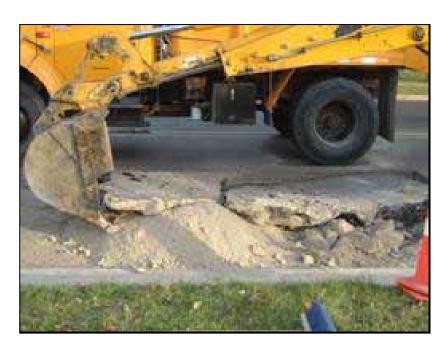
Figure 58. Pavement removal

The city of Ames leaves constructed trenches unpaved for about one to two weeks, to let settlement occur under traffic before surfacing the trench. Therefore testing was done at the completion of the trench construction and 20th Street and then again two weeks later when surfacing preparations began. The testing conducted includes the nuclear gauge, DCP, and the Clegg Hammer. These tests were done to obtain dry density, moisture content, and stiffness values. These tests were conducted to determine if there are significant advantages to leaving a trench open for several weeks. Figure 57 shows the rough edges that are formed in the pavement during the trench excavation site before the removal of pavement, and Figure 58 shows the site during pavement removal where the trench edges are reshaped with an approximate 2-foot (0.61 m) cutback. Note in Figure 58 the amount of material disturbance resulting on the site due to the pavement removal.

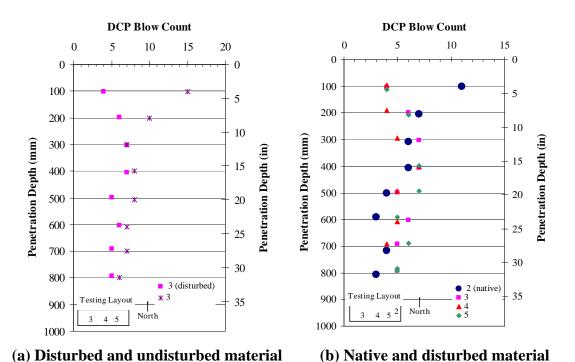
Figure 60. Ames DCP profile

The data shows that after testing the trench near the surface, there was no significant advantage in leaving trenches open for several weeks. The material was loosened by the disturbance when pavement was removed. If further compaction with a vibratory source were to be used after the pavement cutback, the strength of the material may have increased.

The DCP blow counts were again compared with respect to a 3.9-inch (10 cm) penetration depth. Figure 60(a) indicates the disturbed material had a lower number of blows need to penetrate 3.9 inches (100 mm), near the top 7.9 inches (200 mm) of the trench. The disturbed material indicated a maximum blow count of seven to penetrate between 11.7 inches to 15.7 inches (300 mm and 400 mm). The undisturbed material indicated a maximum blow count of eight to penetrate a depth of 11.7 inches to 15.7 inches (300 mm to 400 mm). Figure 60(b) shows the DCP profile of the imported material and native material. The native material was stiffer at the top 7.9 inches (200 mm) of the trench. From 11.7 inches (300 mm) and deeper, the imported material showed a greater number of blow counts per 3.9 inches (10 cm), indicating a slightly stiffer material. The decrease in stiffness of the native material may be an indication of the loss in lateral support during the excavation.

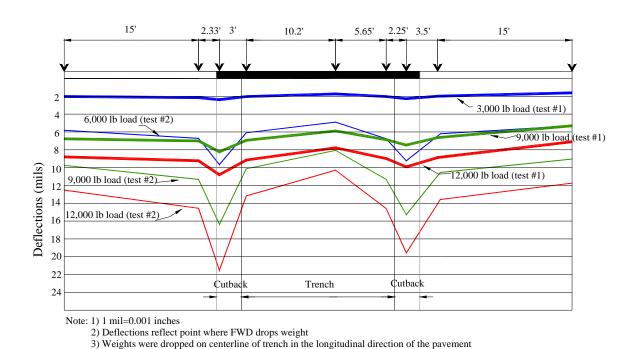
Figure 62. Ames FWD response profile

The FWD was tested on a payement surface consisting of 8 inches of asphalt. The construction of this trench involved a pavement cutback before pavement could be placed on the excavated area. The trench was originally tested on November 22, 2004 and again on April 11, 2005 with the FWD. The dimensions of the original utility cut and pavement cut are shown in Figure 61. FWD responses were tested at 17 feet and 2 feet (5.2 m and 0.6 m) from the east and west edge of the cutback, the center of the cutback, and the east and west edge and center of the trench, to determine the effect of the influence zone on the trench. The 17-foot (5.2 m) deflection in the far field of the utility cut area was measured assuming this point represents the response of undisturbed pavement (i.e., utility cut has negligible influence on the pavement system). Figure 61 shows these locations and Figure 62 shows the response profiles of the maximum point on FWD deflection basins. Figure 62 shows profiles for test #1 (November 22, 2004) and test #2 (April 11, 2005), therefore indicating deflection results with time. It is evident from the profile that within this cutback region material is weakened, resulting in a noticeable deflection. This cutback region is located in the zone of influence (2 feet to 3 feet (0.6 m to 0.9 m) around the perimeter) as discussed earlier. The deflection in this influence zone was significant compared to deflections at other points in the trench as a result of a decrease in lateral support during the excavation. Compaction in this region before surfacing may have strengthened this area and lowered the deflection.

As the literature review stated, an increased deflection in this zone of influence is an indication of premature patch deterioration resulting from a strength reduction of material in this zone. Figure 62 also indicates a minimum deflection near the center of the trench and is comparable to the deflection existing in the far field. When comparing the FWD results with time, the profiles indicate an increase deflection within this approximate five-month period. The deflection difference (i.e., from test #1 to test #2), ranged from a maximum and minimum value of 11 mils and 2 mils at a 12,000 pound (5443 kg) load. The 9,000 pound (4082 kg) load had a maximum and minimum deflection difference of 8 mils and 2 mils. The lighter loading was run at two different loadings and therefore cannot be compared. Note that the first test was conducted in the November and the second test in April, therefore a seasonal effect is visible in the deflections. The figure also shows that lighter loads (e.g., 3000 pound (1361 kg) loads induced by cars) result in a lower deflection when compared to greater loads simulating loads, such as 9,000 pound (4082 kg), induced by trucks.

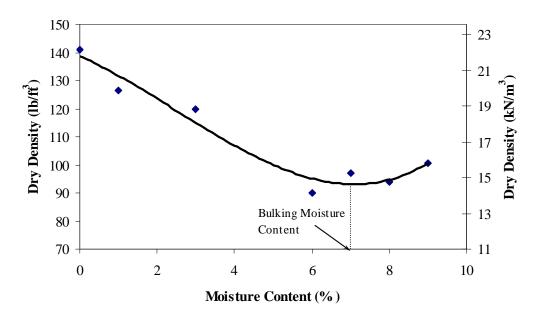
Figure 72. Ames 3/8 minus maximum density test results, SM

A backfill material known as 3/8 minus limestone is generally used in Ames for utility cut restorations. This material has a bulking moisture content of 7% (see Figure 72). The nuclear gauge was used in the field to determine moisture content in several locations throughout the trenches top layer, which was found to range from 4.3% to 5.4%. This material at the surface was placed just under the critical bulking moisture content which increases the potential of collapse due to seasonal changes of moisture contents and could be watered to overcome this collapse potential. Figure 72 also shows a maximum and minimum compacted dry density of 140 pcf and 90 pcf (22.0 kN/m³ and 14.1 kN/m³) respectively, with a density difference of approximately 50 pcf (7.9 kN/m³) for this material.

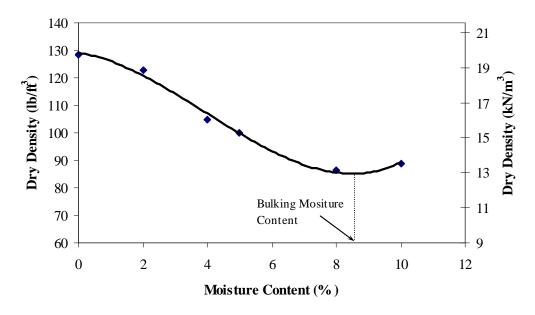
Figure 73. Cedar Rapids 3/4 minus maximum density test results, SC

The Cedar Rapids 3/4 minus material has a bulking moisture content at 8.5% (see Figure 73). In the field, the trench top layer was tested in several areas with a maximum moisture content

of 7% and a minimum moisture content of 5%. This material was placed just below the bulking moisture content. Therefore this material should have been watered in the field to exceed the critical region and lower collapse potential. Figure 73 shows a maximum and minimum dry density of about 130 pcf and 85 pcf (20.4 kN/m³ and 13.3 kN/m³) respectively, with a density difference of approximately 45 pcf (7.1 kN/m³) for this material.

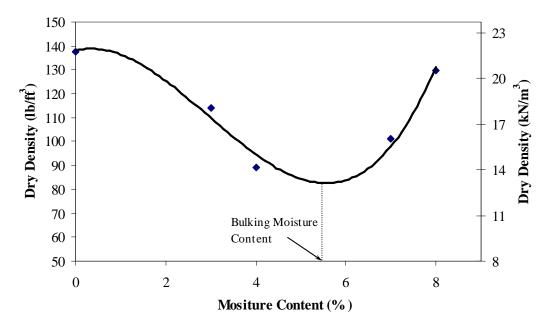
Figure 74. Davenport maximum density test results, GC

The material used in Davenport has a bulking moisture content of 5.5% as shown in Figure 74. The moisture contents of this material used in the field ranges from 6.3% to 7.8%. This material was placed above the bulking moisture content. Figure 74 shows a maximum and minimum compacted dry density 140 pcf and 85 pcf (22 kN/m³ and 13.3 kN/m³) respectively, with a density difference of approximately 55.0 pcf (8.6 kN/m³).

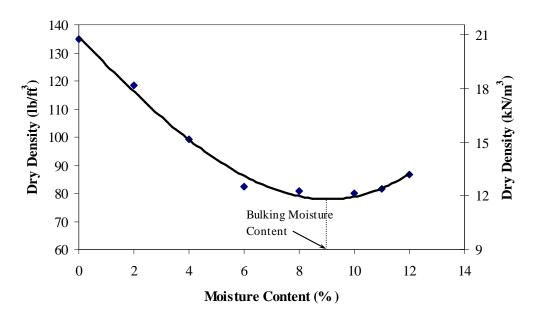
Figure 75. Des Moines maximum density test results, SW-SM

The manufactured sand obtained from Des Moines had a bulking moisture content of 9% (see Figure 75). After testing the site in the field, a maximum water content obtained was 11.7% and a minimum of 5.4%. Therefore, backfill material was placed at and around the bulking moisture content. Figure 75 shows a maximum and minimum compacted dry density of about 135 pcf and 80 pcf (21.2 kN/m³ and 12.6 kN/m³) respectively, with a density difference of approximately 55.0 pcf (8.6 kN/m³).

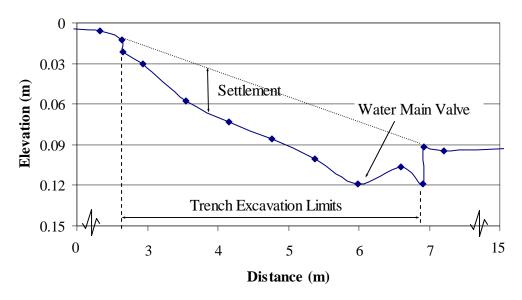
Figure C1. Settlement profile of poorly performing utility cut in asphalt pavement

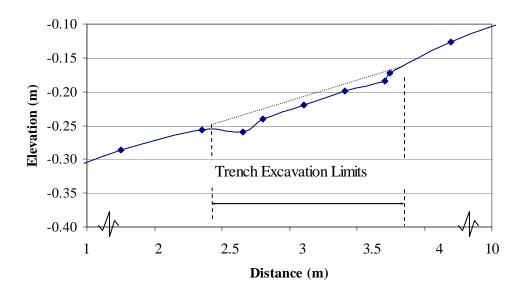
Figure C2. Settlement profile of poorly performing utility cut in concrete pavement
