C E N T E R F O R  
P O R T L A N D C E M E N T C O N C R E T E  
P A V E M E N T T E C H N O L O G Y

# Portland Cement Concrete Patching Techniques vs. Performance and Traffic Delay

Final Report  
January 2004

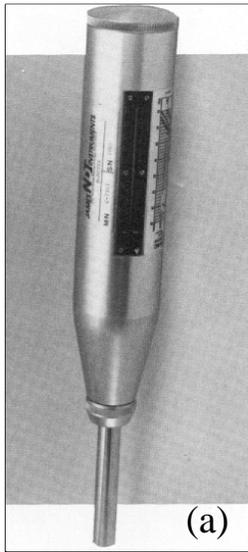
**Figure 1a. Schmidt hammer**

A rebound test, often performed using the Schmidt rebound hammer, is a simple, quick, and inexpensive method for checking the uniformity of in-place hardened concrete. The Schmidt rebound hammer (Figure 1a) consists of a spring-controlled hammer that slides on a plunger. When the plunger is pressed against the concrete surface, it retracts against the force of the spring; when completely retracted, the spring is automatically released. The hammer impacts the concrete surface and the spring-controlled mass rebounds, taking a rider with it along a guide scale that is used to gauge the hammer rebound number.

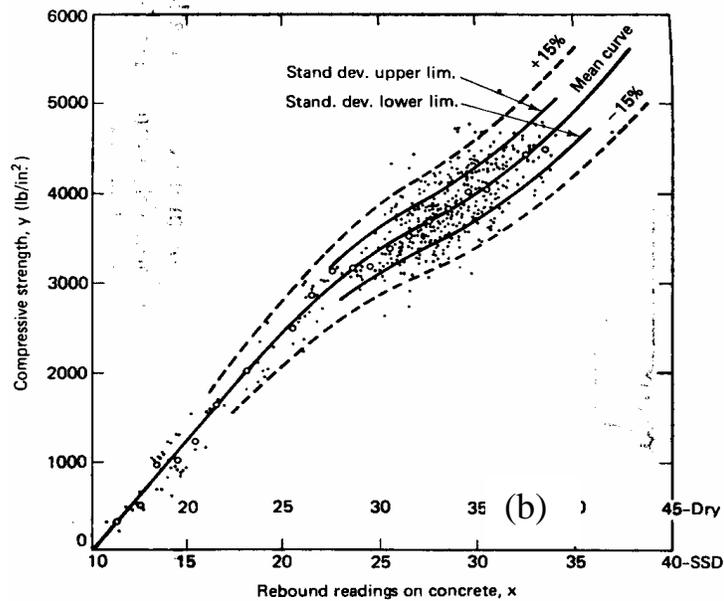
**Figure 1b. Rebound number vs. compression strength**

From a theoretical point of view, a rebound test represents a complex problem of impact loading and stress wave propagation. The rebound distance depends on the kinetic energy in the hammer before impact with the shoulder of the plunger and the amount of that energy absorbed during the impact. Part of the energy is absorbed by mechanical friction in the instrument, and part of the energy is absorbed in the interaction between the plunger and the concrete. The energy absorbed by the concrete depends on the stress-strain relationship of the concrete; therefore, rebound numbers are related to the strength and the stiffness of the concrete. A low-strength, low-stiffness concrete absorbs more energy than a high-strength, high-stiffness concrete and thus produces a lower rebound number. Although there is no theoretical relationship, empirical correlations between rebound number and concrete strength have been discovered (Figure 1b).

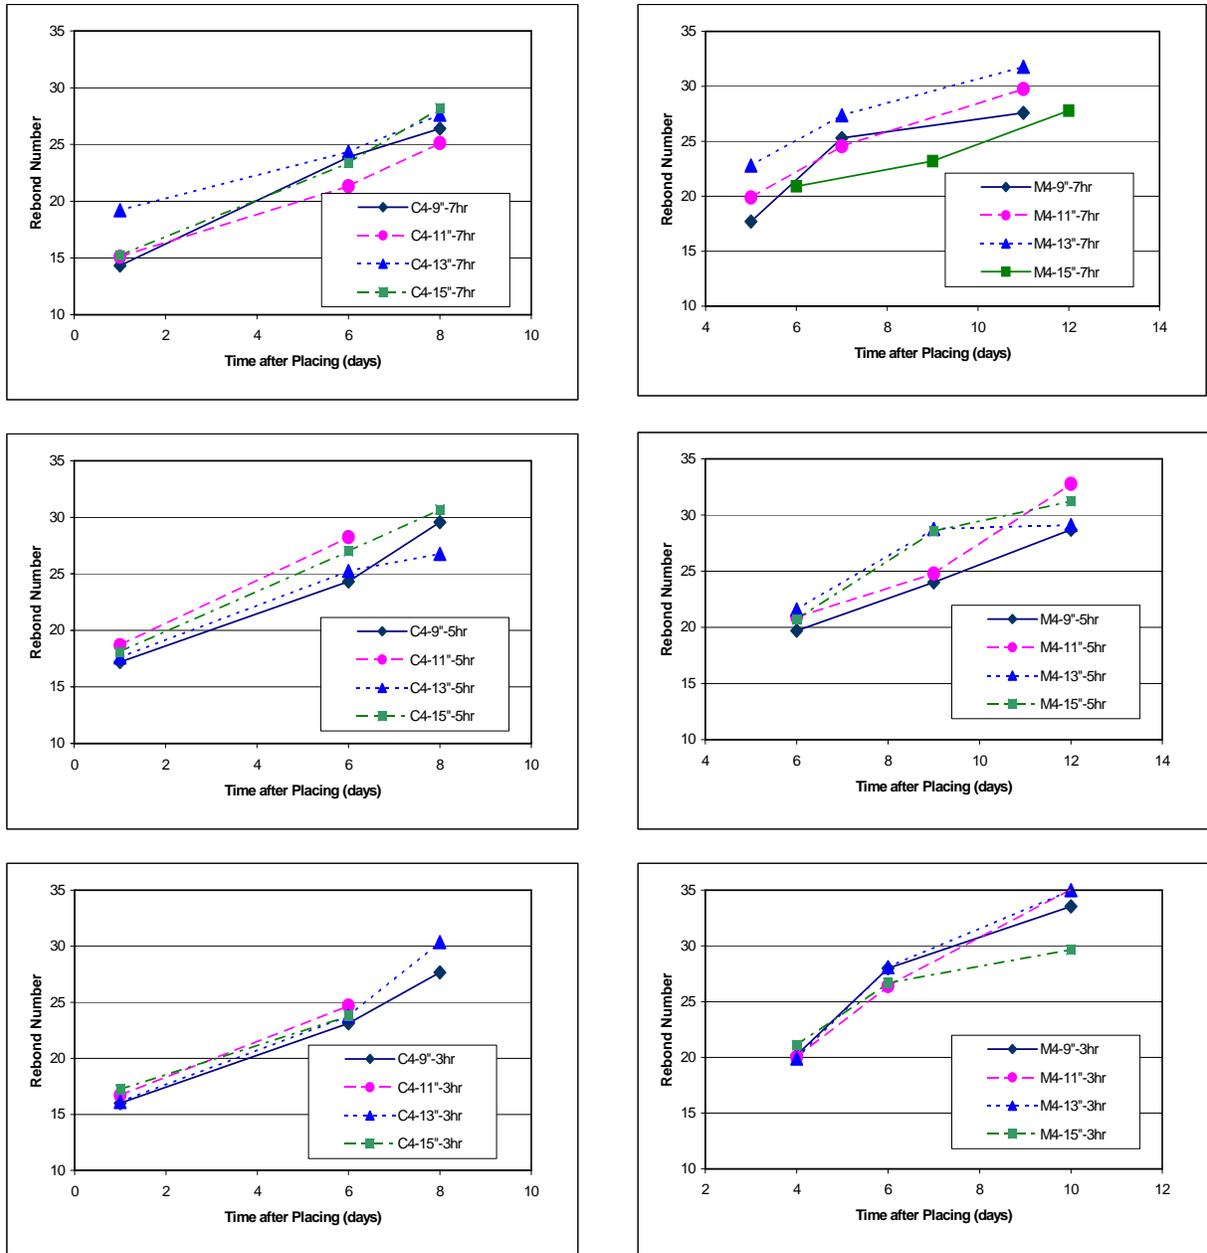
Figure 3. Effect of patch thickness on rebound numbers

Figure 3 plots the rebound numbers of the patches made with the same concrete mix and opened to traffic at the same time after placing, but having different patch thickness. The figure displays the effect of patch thickness on rebound numbers. The following is observed from the figure:

- (2) For a given patch thickness and opening time, patches made with M4 mix do not display significantly higher rebound numbers than patches made with C4 mix at the same age after placing. For example, at six days after placing, patches made with C4 mix and opened to traffic at seven hours display rebound numbers ranging from 21–24 (Figure 3a); these are similar to the patches made with M4 mix and opened to traffic at seven hours (Figure 3d).

- (4) No clear patterns in Figure 3 show how patch thickness influences concrete strength development. For example, among the patches made with C4 mix and opened to traffic at seven hours, the patch having a thickness of 13 inches displays the highest rebound number; while among the patches made with C4 mix but opened to traffic at five hours, the patch having a thickness of 13 inches has the second-to-lowest rebound number. This observation may indicate that patching thickness does not significantly influence near-surface concrete strength, though it may influence the internal concrete strength development. Therefore, maturity test results should be analyzed to determine whether patch thickness influences the internal concrete strength development.

The effects of concrete mix, patch thickness, and time patches were opened to traffic on rebound numbers are shown in Figures 3 and 4. The data points in the figures represent the average rebound values of tested patches. The rebound readings for all tested patches are presented in Appendix D. The average values were calculated based on the following rules: (1) if a reading differed by more than seven units from the average of all readings obtained from a tested patch, this reading was discarded and a new average was computed based on the remaining readings; and (2) if more than two out of ten readings differed from the average by seven units, the entire set of readings was discarded.

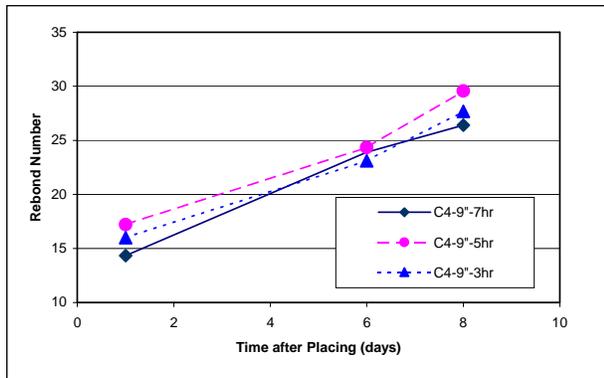
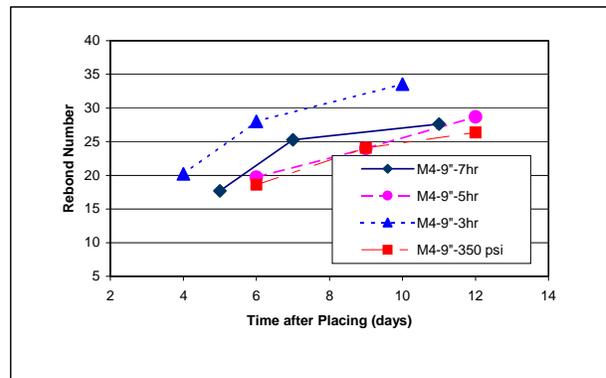
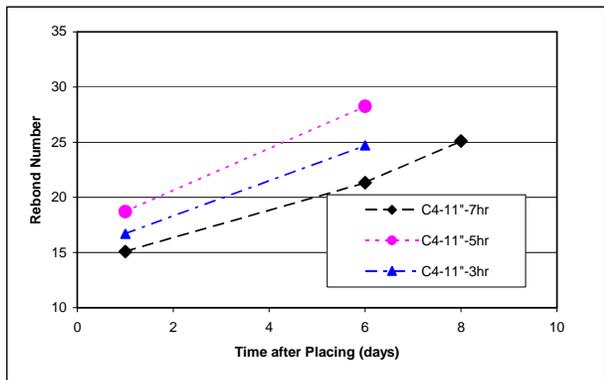
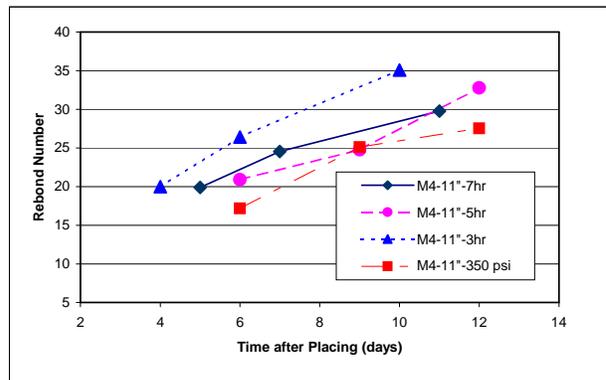
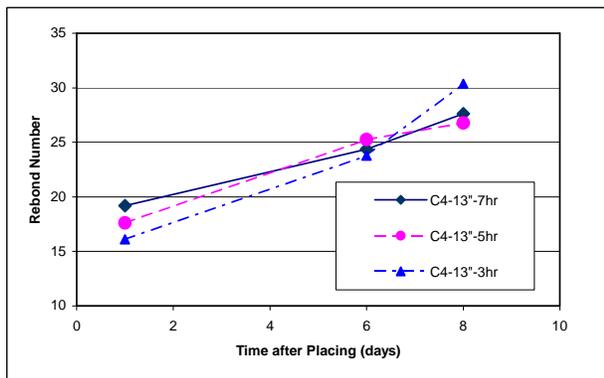
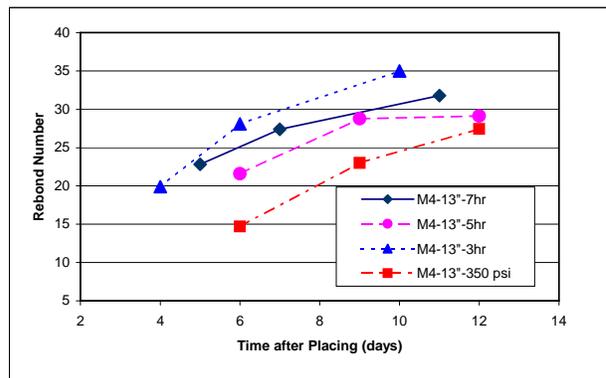
Figure 4. Effect of opening time on rebound numbers

To illustrate the effect of pavement opening time on rebound number, all rebound test data are re-plotted into an alternative form in Figure 4. Closely examining Figure 4, one can find some patterns that may reveal optimal opening times for patches made with different concrete mixes:

As mentioned above, near-surface concrete strength development may benefit from both the compression effect of early traffic loading and cement hydration. Before concrete starts to harden, proper compression from appropriate traffic loads may facilitate concrete early strength development by improving concrete density. However, if the load applied is too large and/or too early, it will damage the concrete. On the other hand, after the concrete hardens, applying traffic loads not only fails to make the concrete denser, but also requires the concrete to have sufficient strength to carry the load. As a result, there is an optimal time for pavement made with a given concrete mix to open to traffic. The present rebound test results indicate that the optimal opening time is five hours after placing for the patches made with C4 mix, and three hours for the patches made with M4 mix.

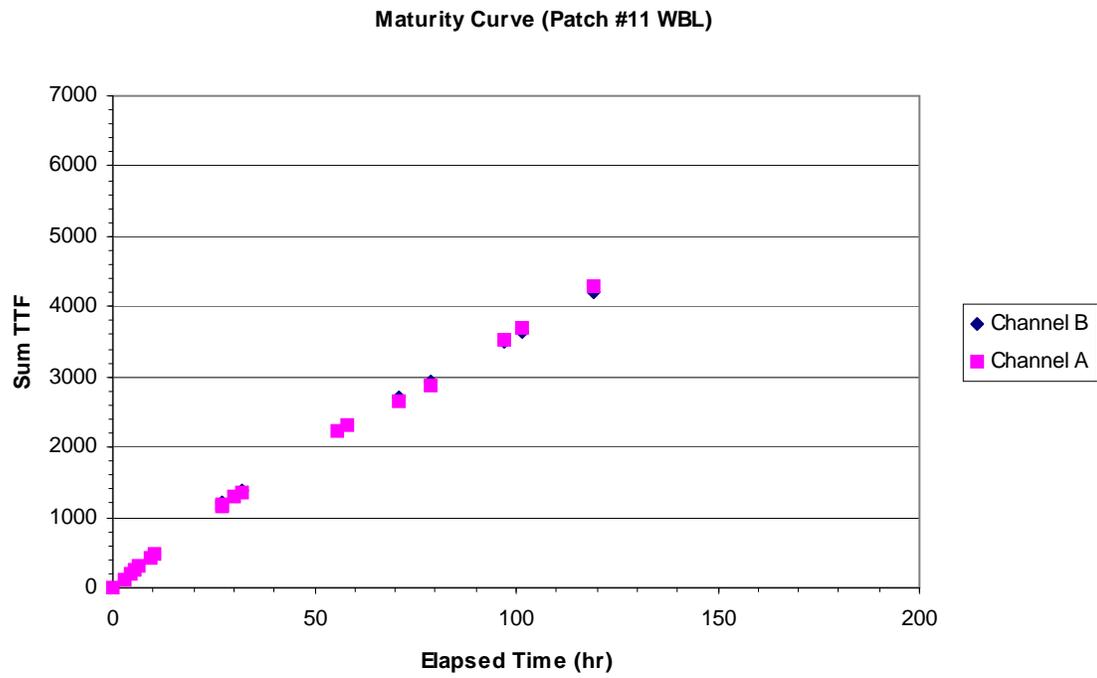
**Figure 30. Maturity curve for Patch 11, westbound lane**

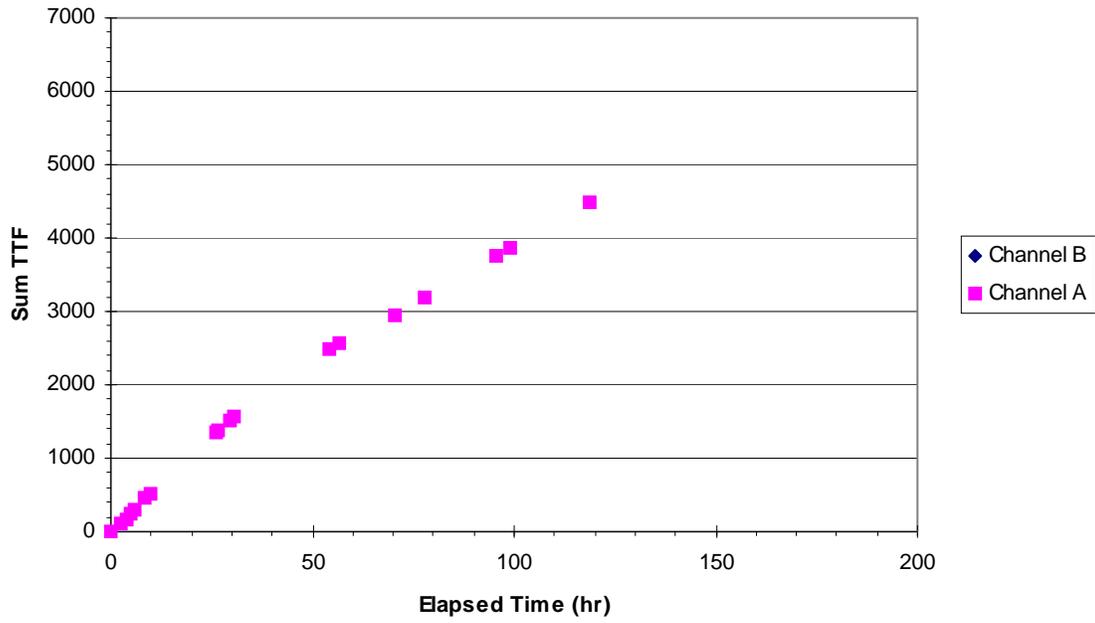
Maturity Curve (Patch #12 WBL)

Figure 31. Maturity curve for Patch 12, westbound lane

Patch #12 WBL

Time concrete place 11:20 AM      Air temp XX      Depth 15  
 Maturity start time 11:45 AM      Slump 2      Pave temp 71
