EFFECTIVENESS OF PARALLEL NOISE BARRIERS - An Iowa Study

Final Report

**Federal Highway Administration Work Order
DTFH71-83-3610-IA-12**

**Iowa Department
of Transportation**

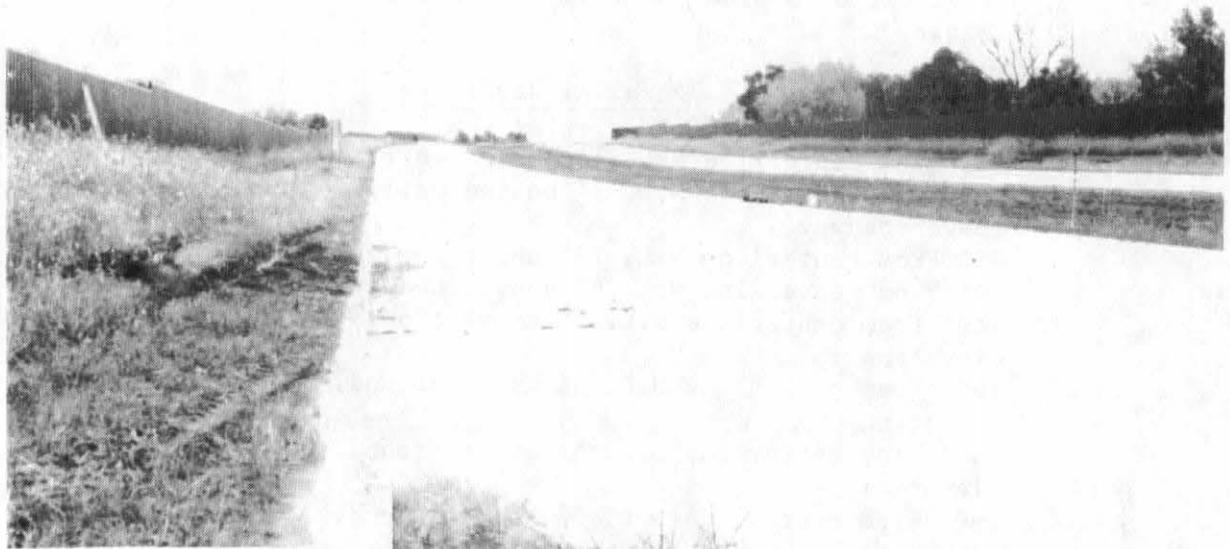
Figure 4. Parallel walls study site

- 1) The free field site was an open field location with no major obstructions (Figure 2)
- 2) The single wall site was a state-owned parcel lying between the highway right-of-way and residential land use.
(Figure 3)
- 3) The parallel wall site was the midpoint of the parallel wall section of I-380 in an established residential area (Figures 4 and 5)

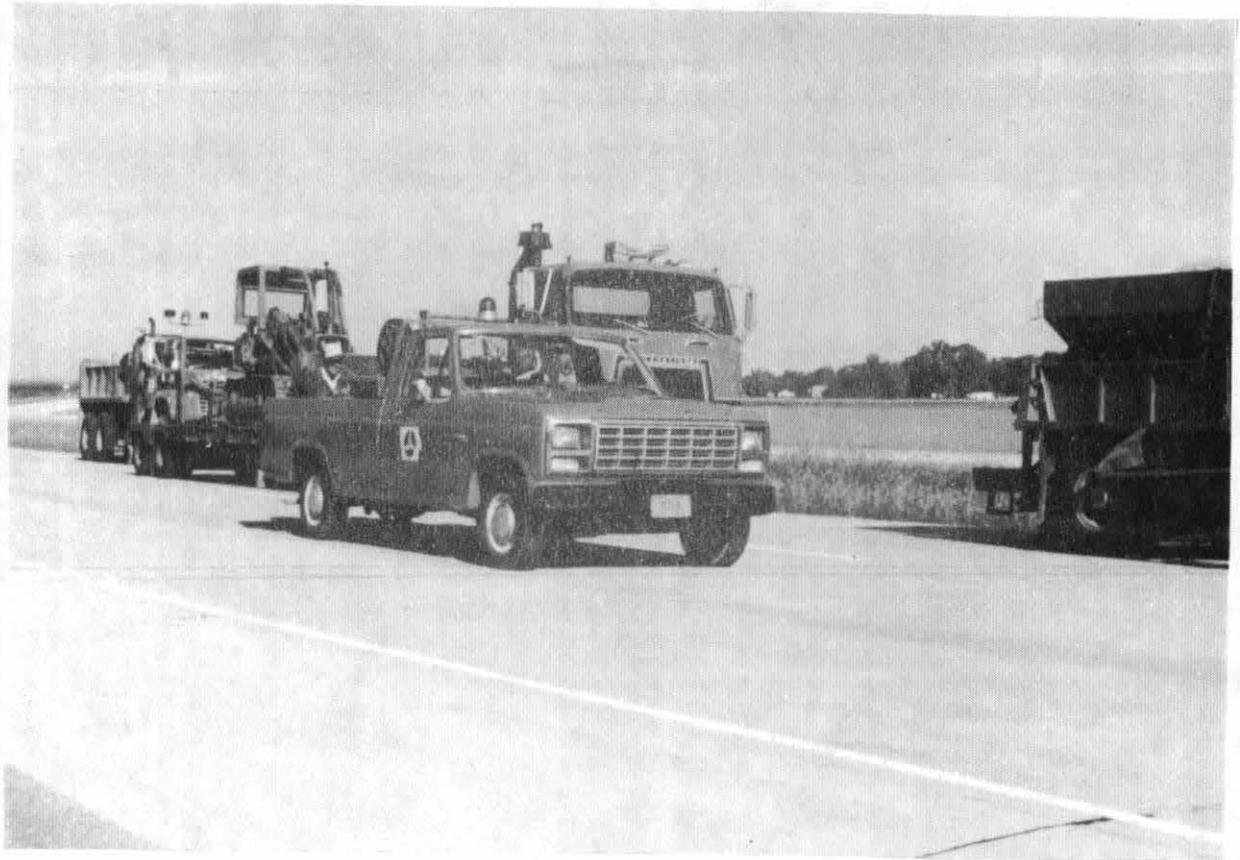
Figure 11. Pickup truck

1. 1971 International truck tractor, 6 cylinder diesel, 270 horsepower, 855 cubic inch, Fuller 13-speed transmission, pulling trailer carrying JD 450 dozer weighing 8 tons. Total Loaded Weight 48,000 lbs. (Figure 8)
2. 1981 Ford LT8000 tandem axle, 8 cylinder diesel, 210 horsepower, Caterpillar 3208 engine, Fuller R66-13 transmission (13-speed). Total Loaded Weight 52,000 lbs. (Figure 9)
3. 1975 Ford F700 two axle, 8 cylinder gas, 5-speed Clark transmission. Total Loaded Weight 28,000 lbs. (Figure 10)
4. 1980 Ford F150 $\frac{1}{2}$ ton pickup, 6 cylinder gas, 300 cubic inch engine, automatic transmission. Carried No Load. (Figure 11)
5. 1981 Chevrolet Impala Station Wagon, 8 cylinder gas, 267 cubic inch engine, automatic transmission.

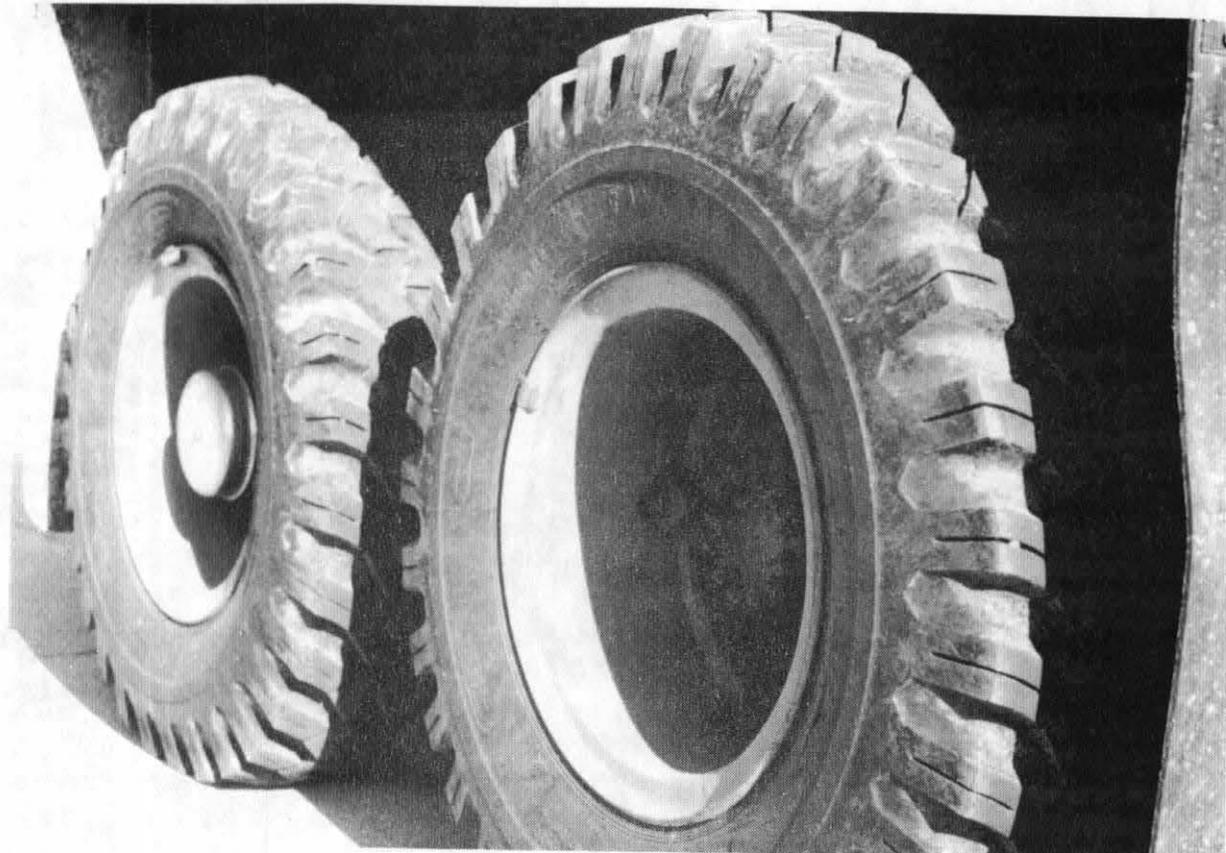
Figure 12. Cross bar type tread

The tandem axle and two axle trucks were equipped with Firestone Super All Traction tires on the rear axles. These have a cross bar type of tread design. (Figure 12) The semi tractor had Goodyear Super High Miler tires on the rear which are also cross bar type. The remainder of the test vehicle tires were of a conventional rib design. (Figure 13) The vehicle drivers were instructed to cruise past the microphone site in normal open-road gear at a steady speed of 50-60 mph. Actual passby speeds were measured with a portable radar gun.
