Polymer Concrete Overlay Evaluation

tech transfer summary

This project documents the state-of-the-practice with respect to polymer concrete overlays, as well as the placement of two overlays on bridge decks in Iowa, and then their field performance over a two-year period.

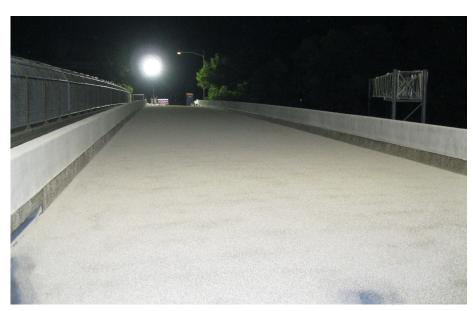
First polymer layer complete on the Johnson County bridge

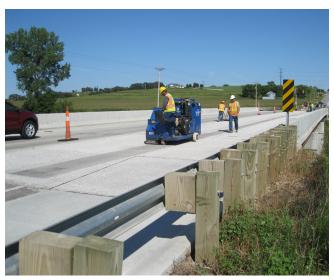
Shot blasting (and vacuuming) the Keg Creek Bridge deck to achieve deck surface relief as part of initial preparation

The deck preparation was completed similarly by shot blasting the deck to an approved surface roughness and blowing the deck free of debris. The blowing process differed slightly, but it appeared that the same result was achieved.

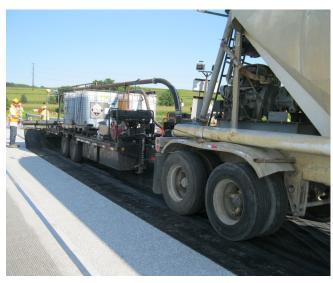
Semi-truck and trailer carrying hopper of flint chips, vats of epoxy polymer, and a blower on the Keg Creek Bridge

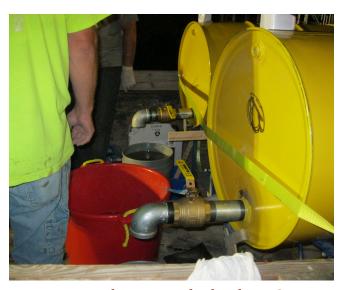
Two-part epoxy polymer mixing for the Johnson County bridge deck

The epoxy polymer for the Keg Creek Bridge deck was precisely measured using automated controls; whereas, the material used on the Johnson County bridge deck was closely approximated by dispensing each part into equally sized muck tubs.

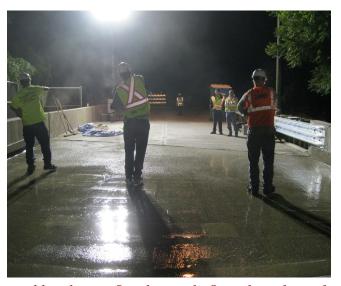
Hand-broadcasting flint chips on the first polymer layer of the Johnson County bridge deck

At Keg Creek, the aggregate was cast via a vacuum and blower; whereas, at the Johnson County bridge, the aggregate was cast via a more labor-intensive hand broadcasting method.
